**CALIFORNIA PUBLIC UTILITIES COMMISSION  
Consumer Protection and Safety Division  
Utilities Safety and Reliability Branch  
Preliminary Incident Investigation Report**

**Incident Number:** E 20110114-01

**Utility:** Southern California Edison Company (SCE)

**Utility Facilities involved:** 12 kV Vargas Circuit in Redlands District

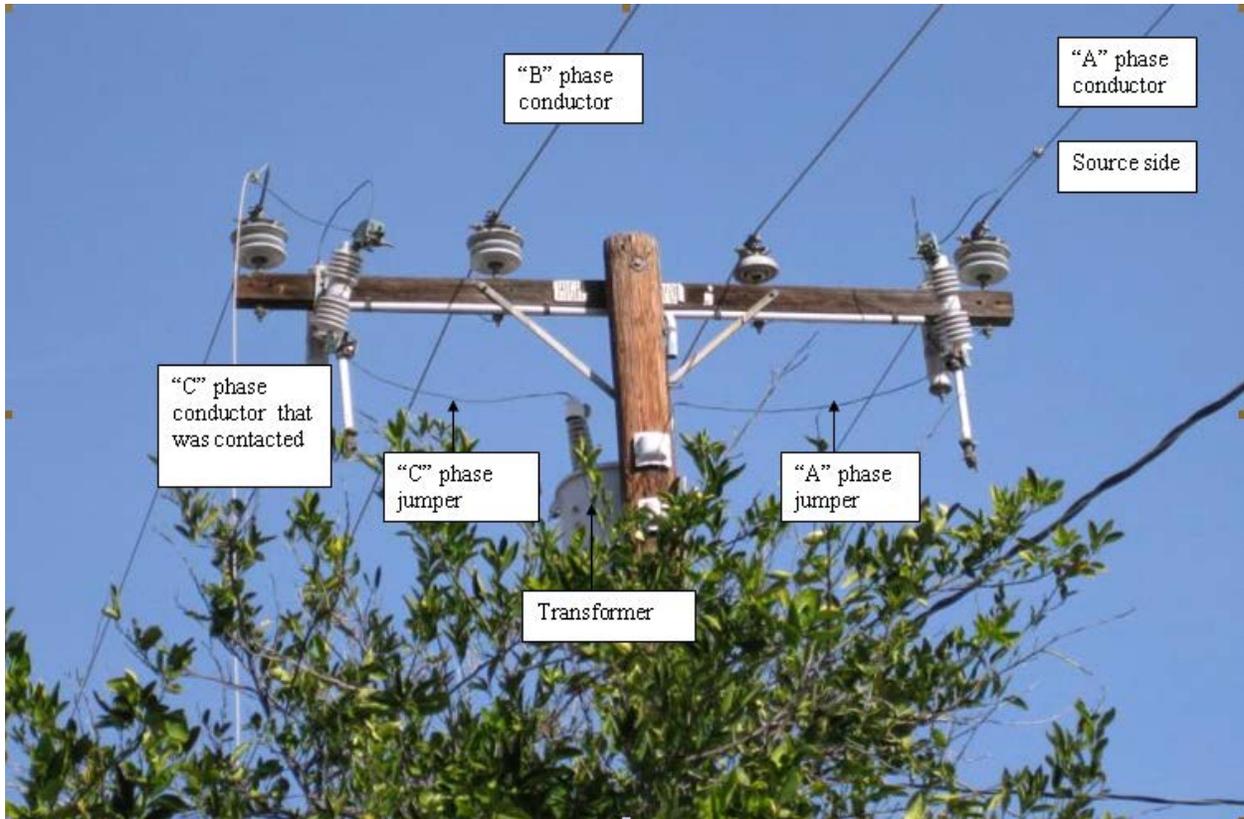
**Figure 1**  
Pole 1511596E

Figure 1 shows pole number 1511596E and the connection between the conductors and the transformer.

Poles numbered 2198978E and 1511596E supporting the overhead conductors that failed had damaged “HIGH VOLTAGE” signs. This is a violation of General Order 95, Rule 51.6-A.

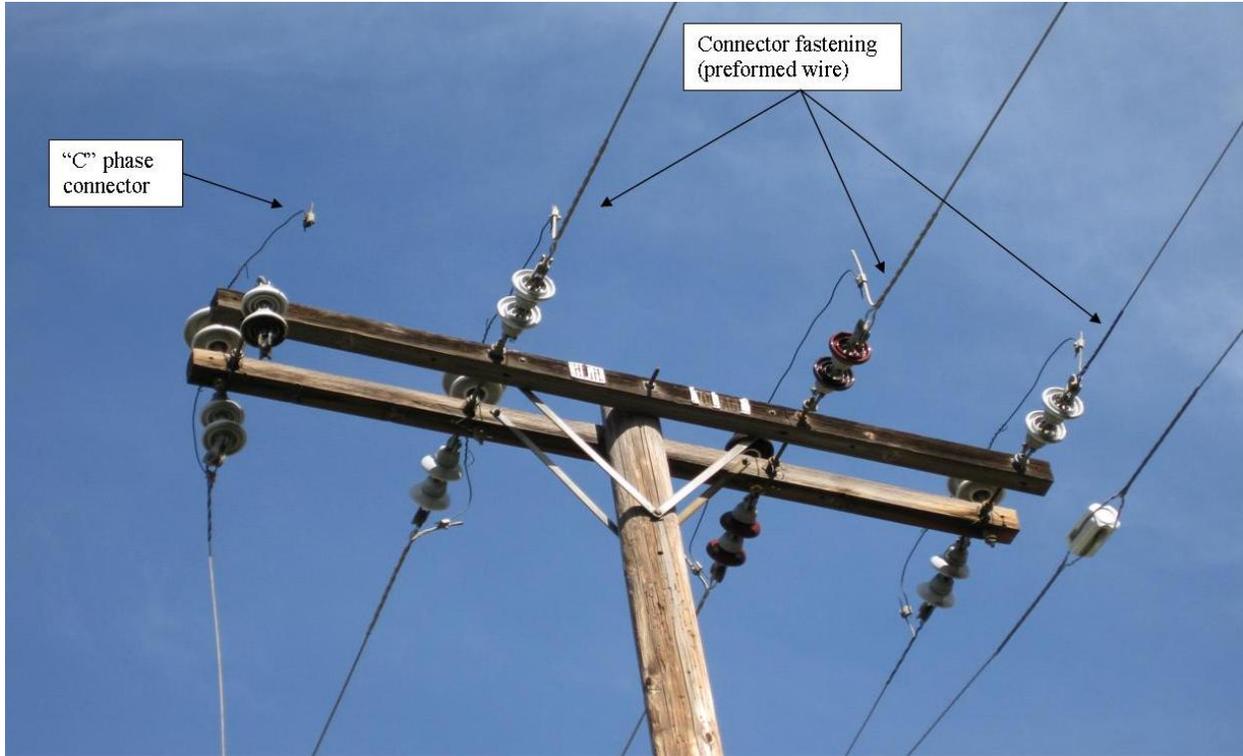
**Figure 3**  
Pole 2198978E

Figure 3, titled *Pole 2198978E*, shows the damaged “HIGH VOLTAGE”, sign on the crossarm, evidence that SCE has been in violation of General Order 95, Rule 51.6-A.

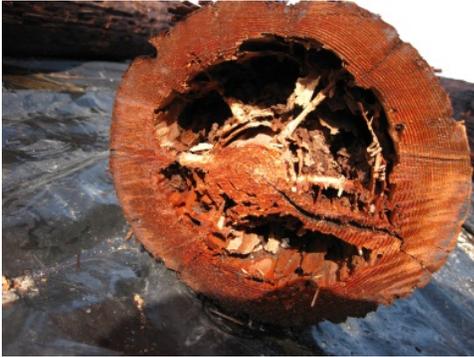
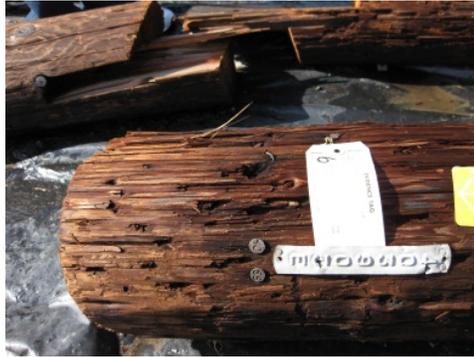
**Pole Segment 1**

Subterranean termite damage, with a significant loss of strength.

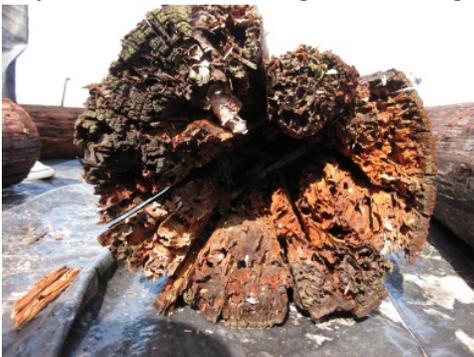
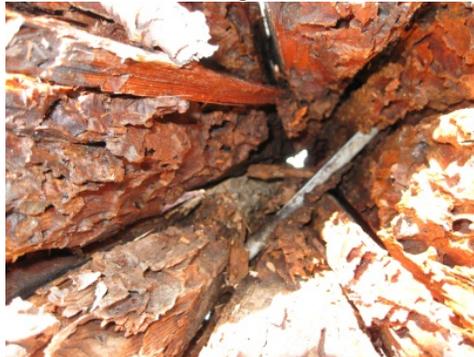
**Pole Segment 2**

Drywood termite damage, with a significant loss of strength.

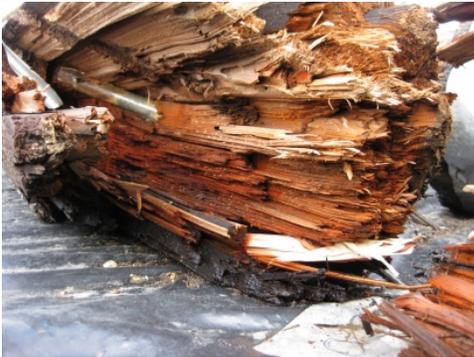
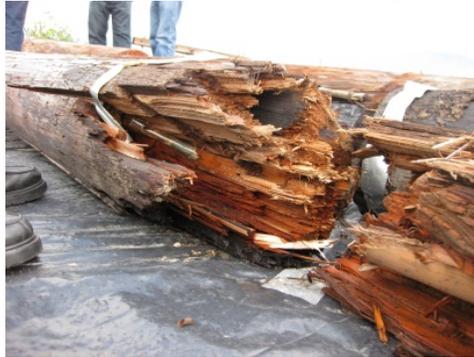
**Pole Segment 3**

Small termite galleries near the center of the pole. Small loss of strength.

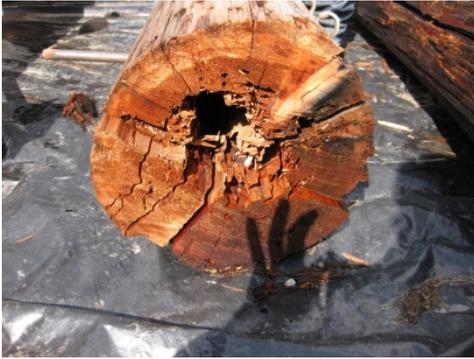
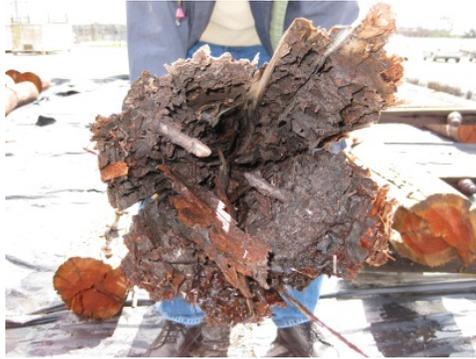
**Pole Segment 4**

Drywood termite damage, with virtually 100% loss of strength.

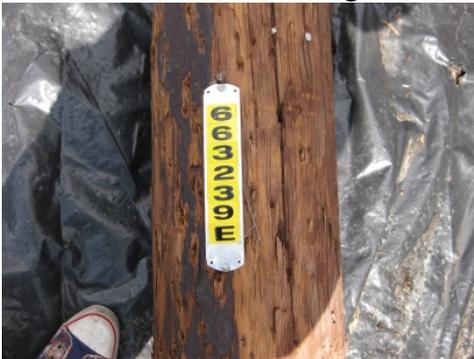
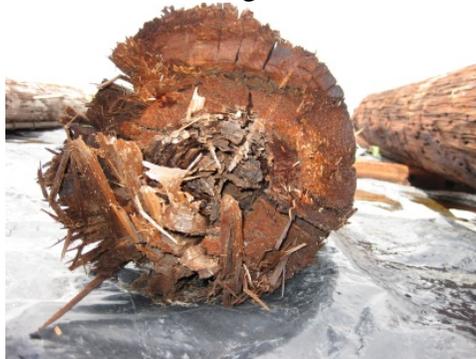
**Pole Segment 5**

Subterranean termite damage, with over 90% loss of strength.

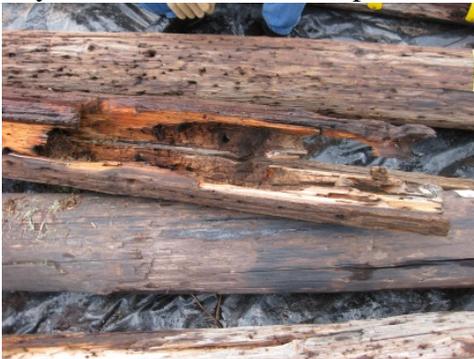
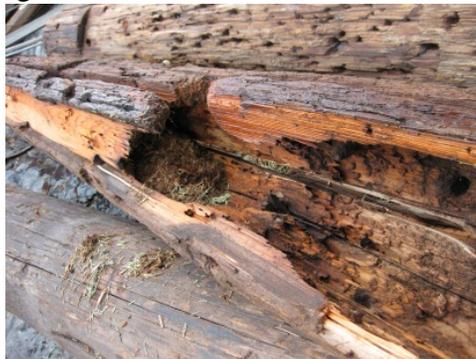
**Pole Segment 6**

Drywood termite and woodpecker damage.

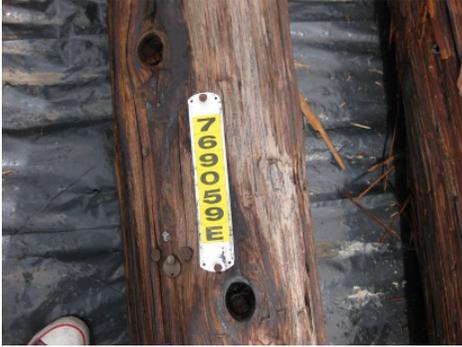
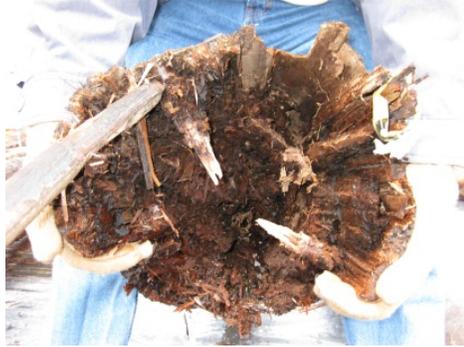
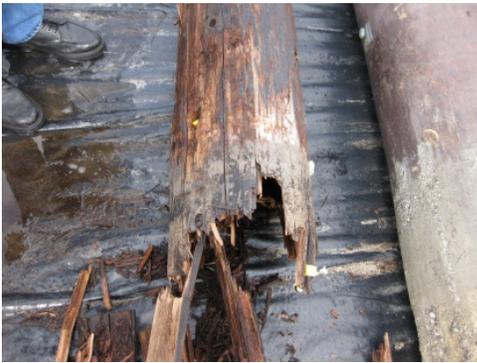
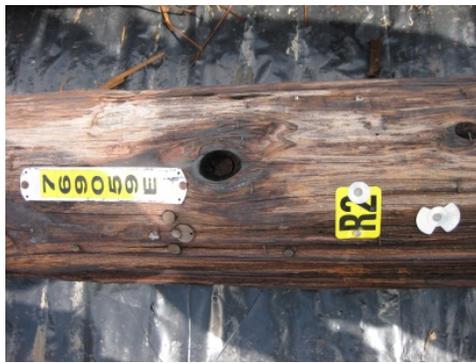
**Pole Segment 7**

Dry rot with virtually 100% loss of strength.

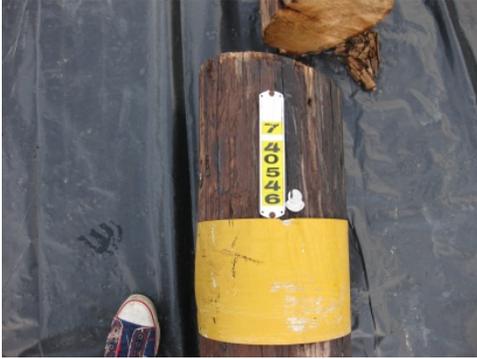
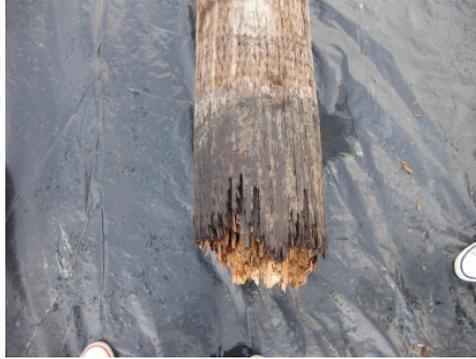
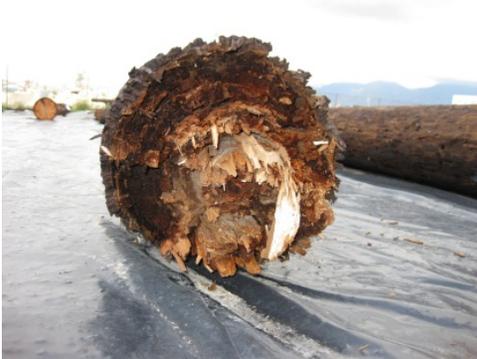
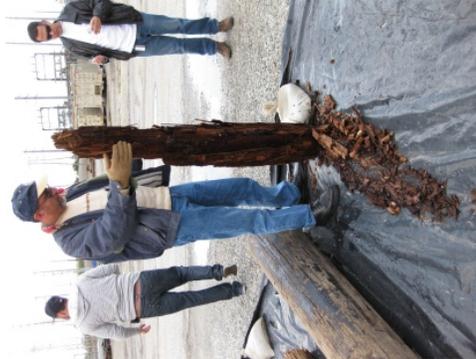
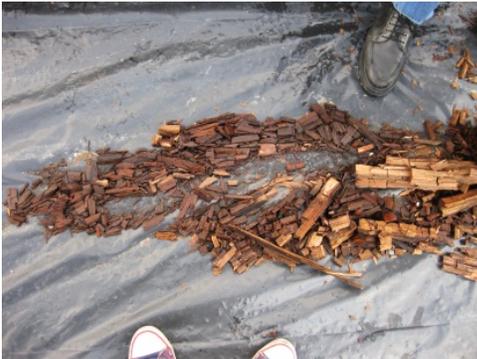
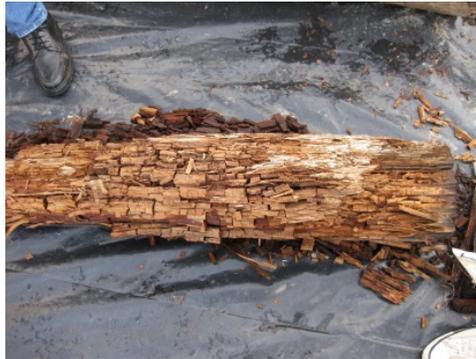
**Pole Segment 8**

Dry rot below groundline, with 80-90% loss of strength.

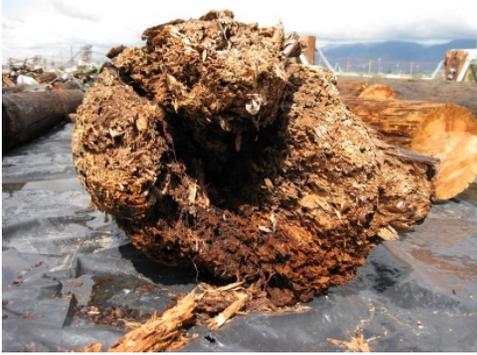
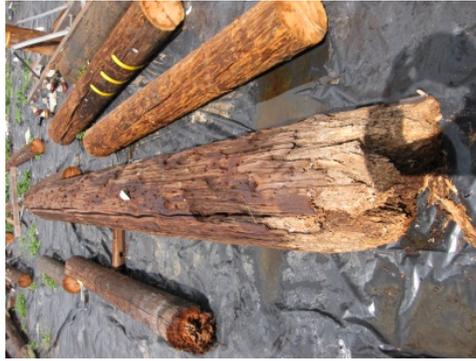
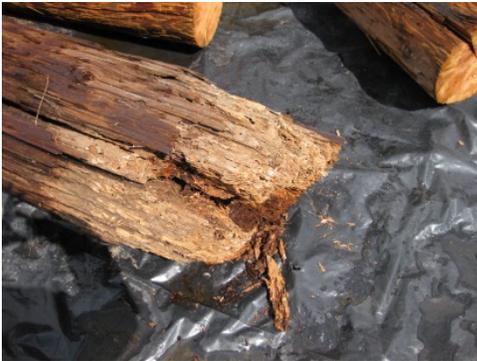
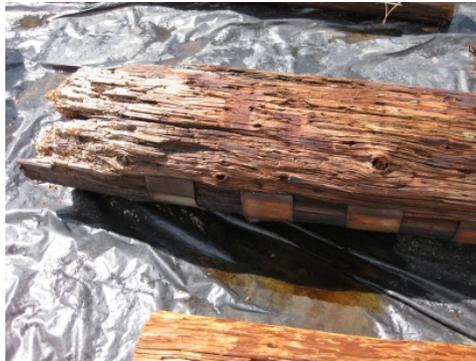
**Pole Segment 9**

Subterranean termite damage, with over 80% loss of strength.

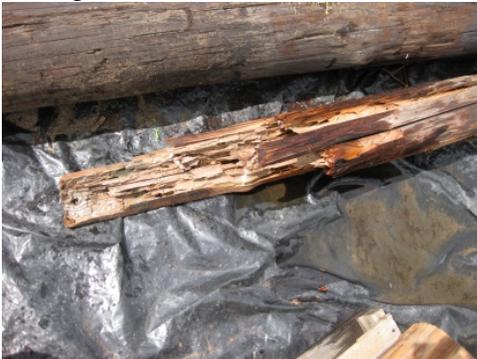
**Pole Segment 10**

Drywood termite and woodpecker damage.

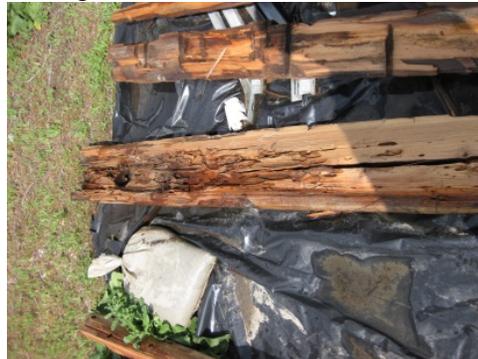
**Pole Segment 11**

Drywood termite and woodpecker damage.

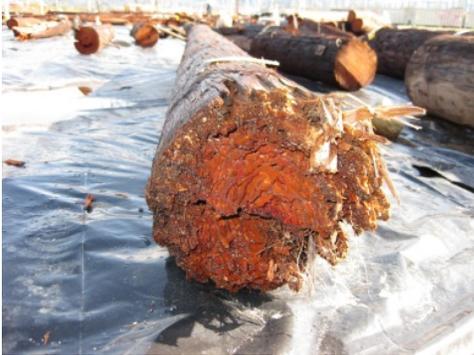
**Pole Segment 12**

Drywood termite damage

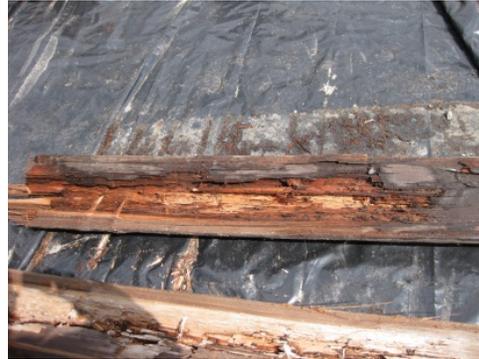
**Pole Segment 13**

Termite damage, with minimal loss of strength.

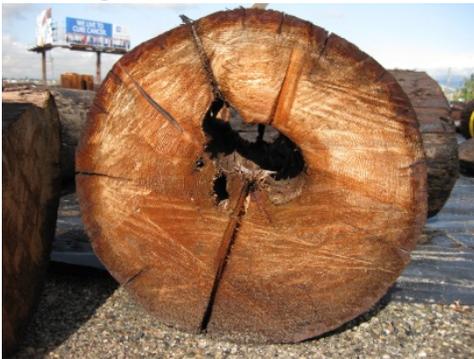
**Pole Segment 14**

Fungal decay, with less than 10% loss of strength.

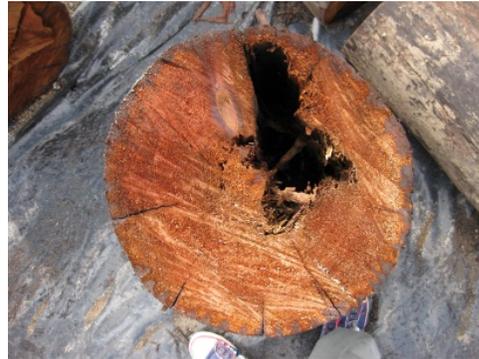
**Pole Segment 15**

Both fungal decay and termite damage.

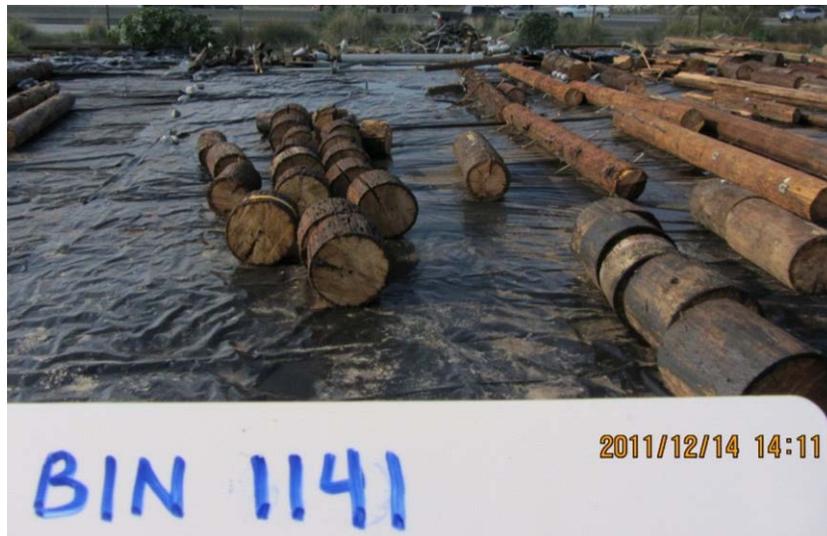
**Figure 34**  
One pole cut into numerous small segments
