**INVESTIGATION REPORT  
OF OUTAGES DURING JULY AND AUGUST OF 2015  
IN SOUTHERN CALIFORNIA EDISON COMPANY'S  
LONG BEACH DISTRICT**

**PREPARED BY  
THE SAFETY AND ENFORCEMENT DIVISION  
ELECTRIC SAFETY AND RELIABILITY BRANCH**

**LOS ANGELES  
JUNE 2016**

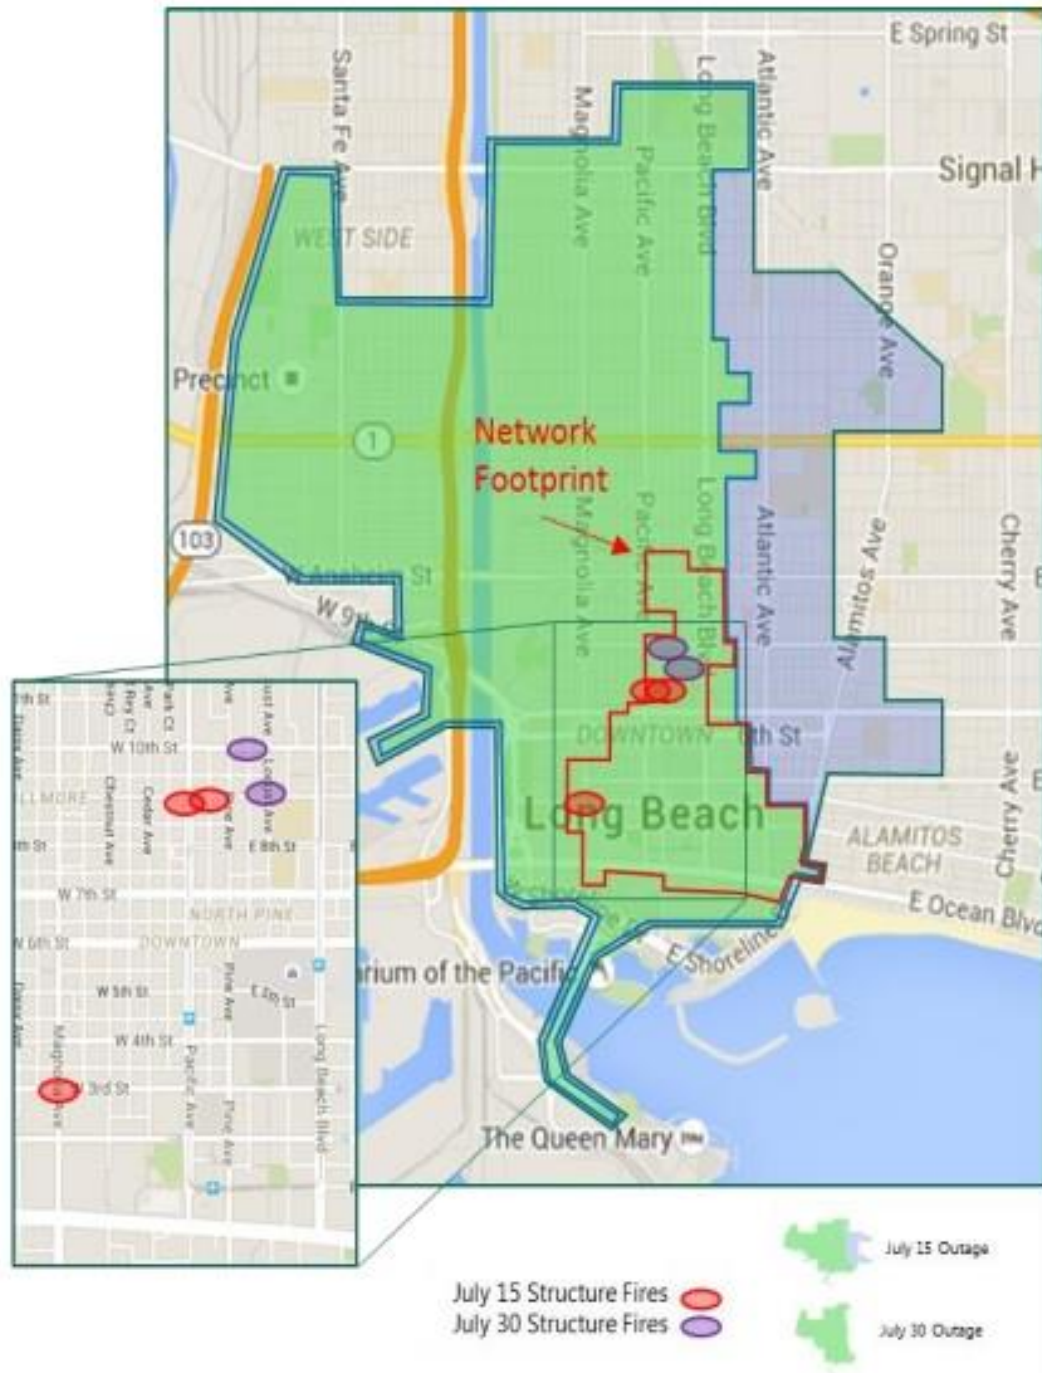
Figure 6: Downtown Long Beach Network System footprint and area of outages. Source: SCE, California State Legislature Town Hall: 2015 Long Beach Power Outages, August 22, 2015.

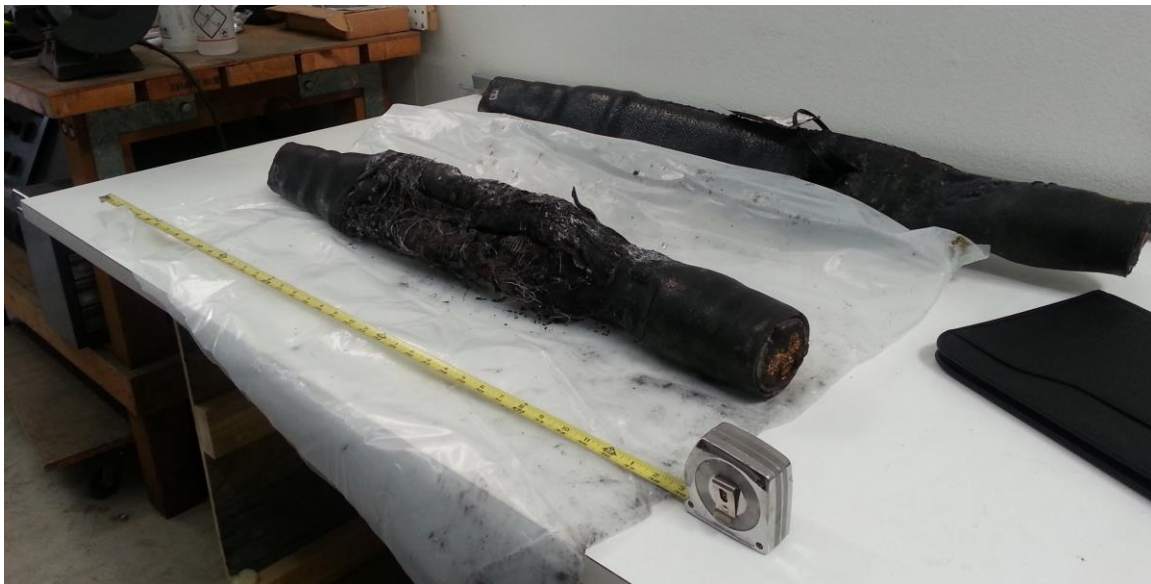
The precipitating event for the July 15, 2015, outages was insulation degradation and ignition of the Float 12kV Paper Insulated Lead Cable (PILC) splice. The splice failure also contributed to the accelerated and premature failure of the Steam 12kV PILC splice, as they were located in the same vault. The fire or electrical arcs from the Float 12kV PILC splice caused collateral damage to the Steam 12kV PILC splice. The failures of the Float and Steam 12kV PILC splices caused their respective circuits to relay and lockout,<sup>6</sup> ultimately de-energizing the circuits and significantly reducing the number of network protectors available to regulate and protect the network system, as well as interrupting power to SCE's radial network customers that are served by the Float and Steam 12 kV circuits.

Figure 6: Float 12kV (front) and Steam 12kV (rear) PILC splices. Source: CPUC

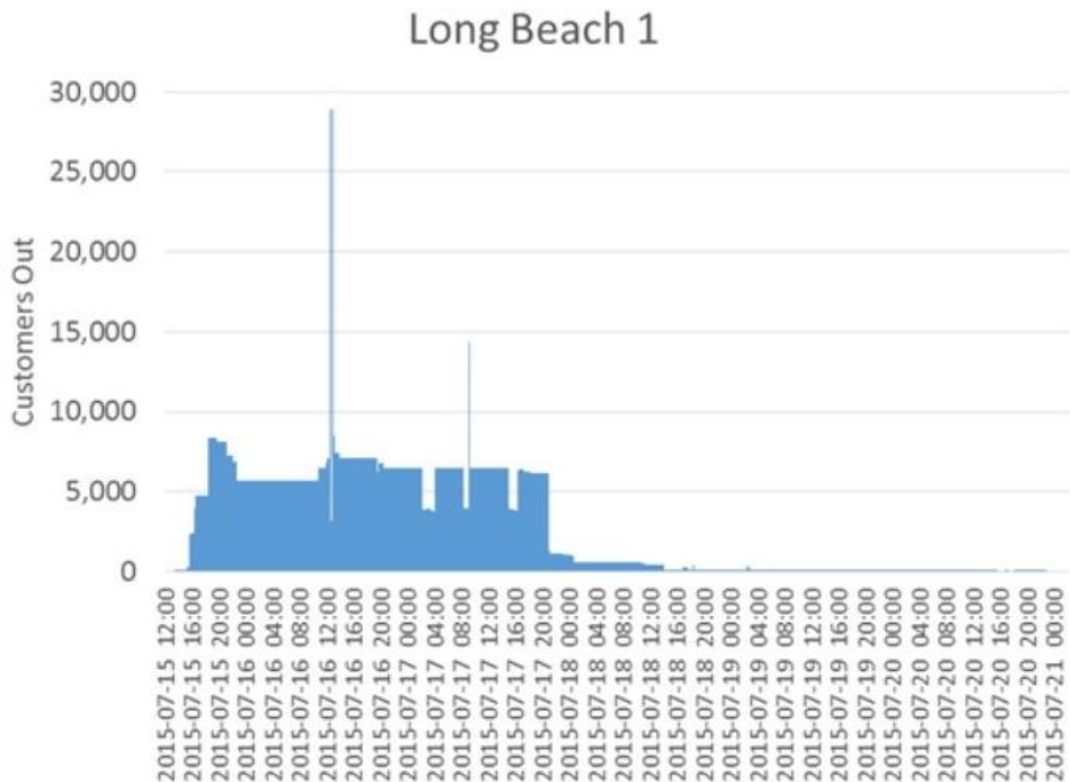
Figure 7: Number of customers out by date and time for July 15-20, 2015 outages. The large spikes in the customers out of power are due to SCE shutting off primary feeder circuits for troubleshooting purposes, causing outages to radial customers. The small customer outages after 20:00 hours on July 18, 2015, represent repairs and restoration activities for the final few customers. *Source: Davies Consulting.*

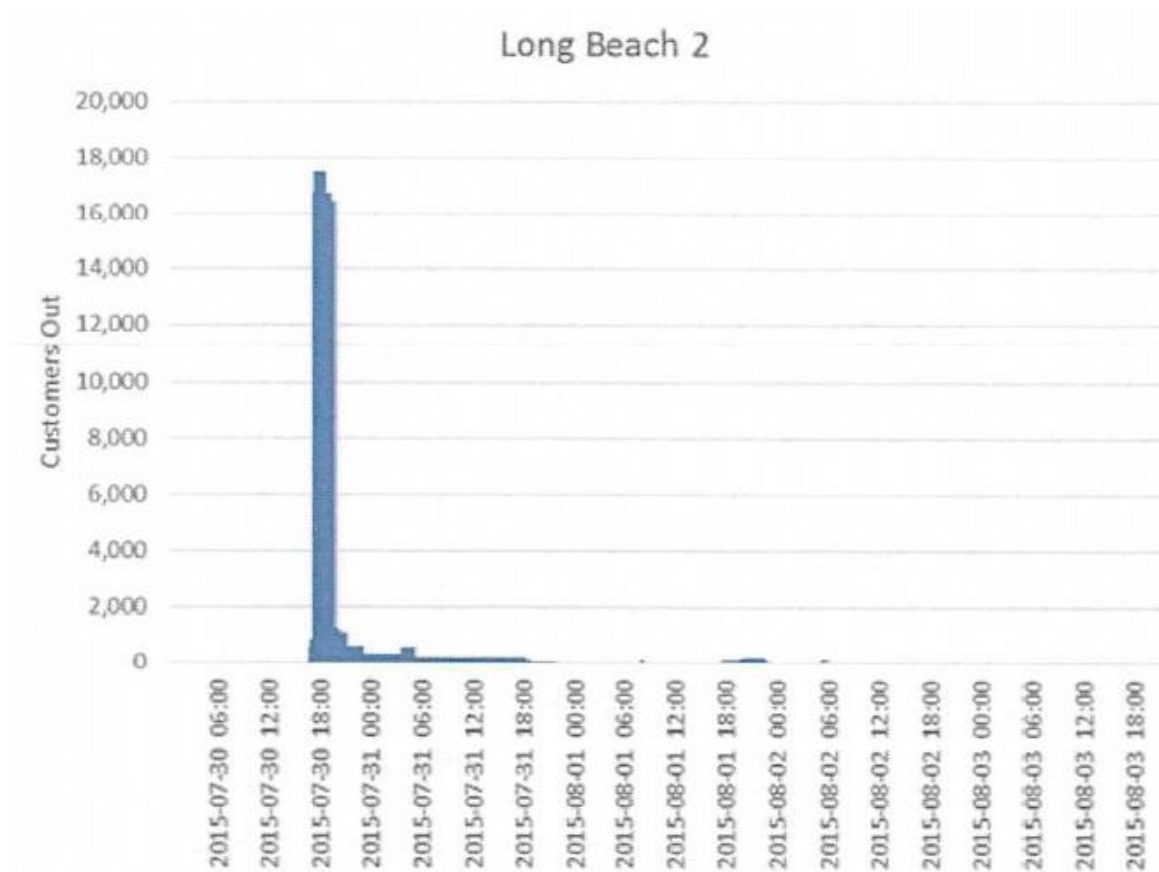
Figure 8: Number of customers out by date and time for July 30-August 3, 2015 outages. The small customer outages after 00:00 hours on August 1, 2015, represent repairs and restoration activities for the final few customers. *Source: Davies Consulting.*
