**California Public Utilities Commission
Consumer Protection and Safety Division**

**Investigation of Southern California Edison Company's Outages of
November 30 and December 1, 2011**

**FINAL REPORT
January 11, 2013**

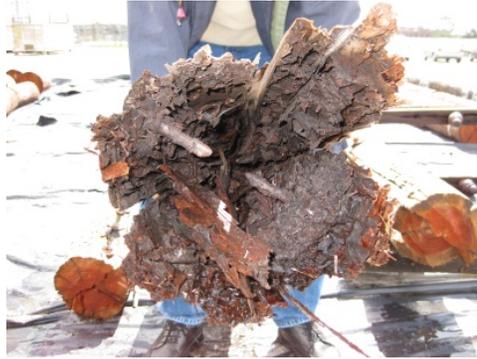
Pole Segment 4

Drywood termite damage, with virtually 100% loss of strength.

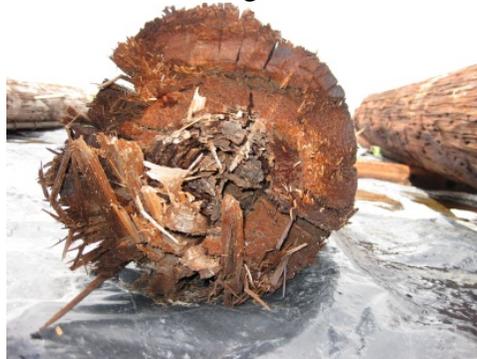
Pole Segment 5

Subterranean termite damage, with over 90% loss of strength.

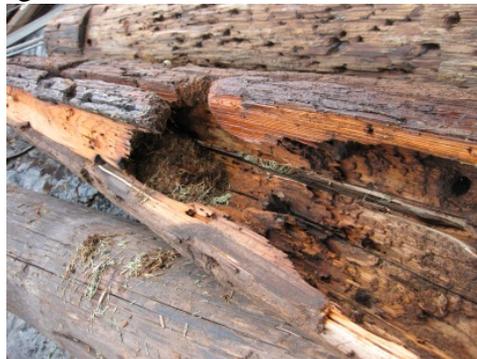
Pole Segment 6

Drywood termite and woodpecker damage.

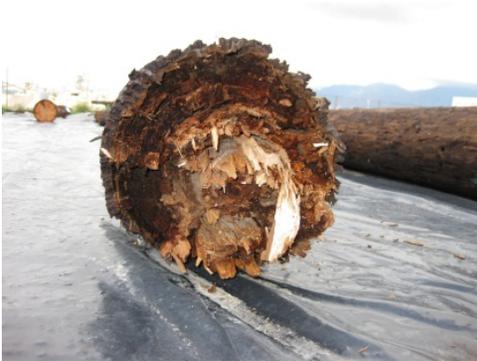
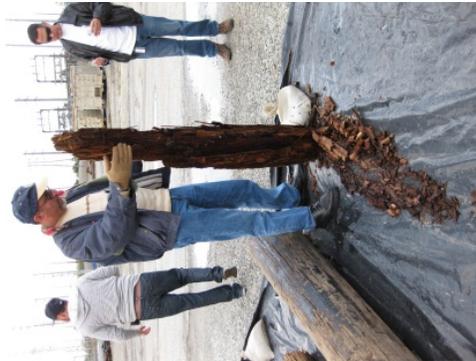
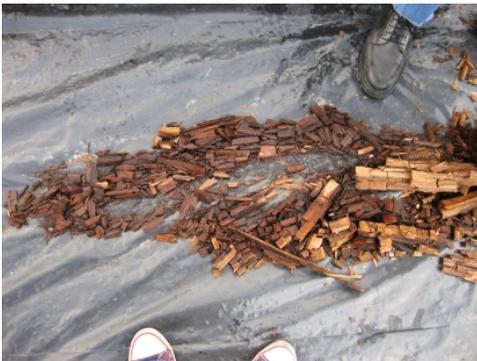
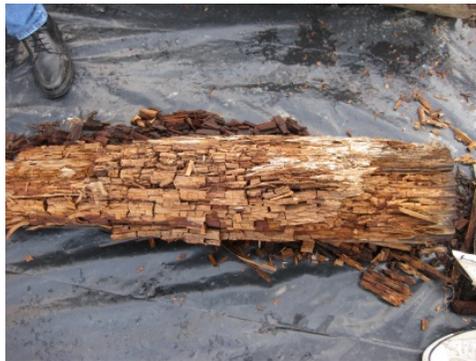
Pole Segment 8

Dry rot below groundline, with 80-90% loss of strength.

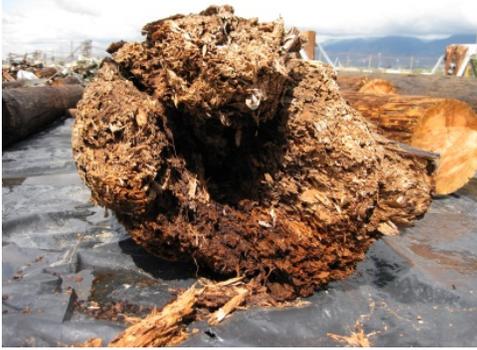
Pole Segment 9

Subterranean termite damage, with over 80% loss of strength.

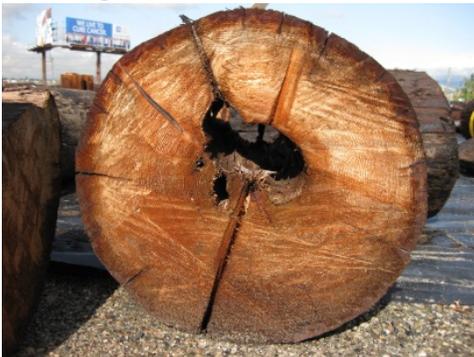
Pole Segment 14

Fungal decay, with less than 10% loss of strength.

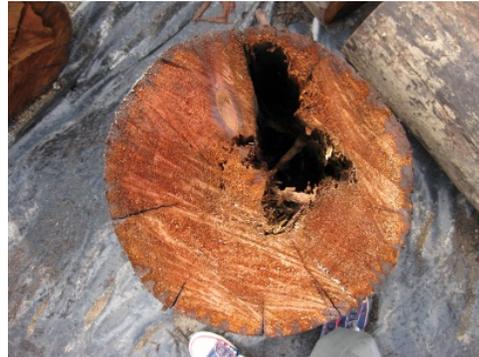
Pole Segment 15

Both fungal decay and termite damage.

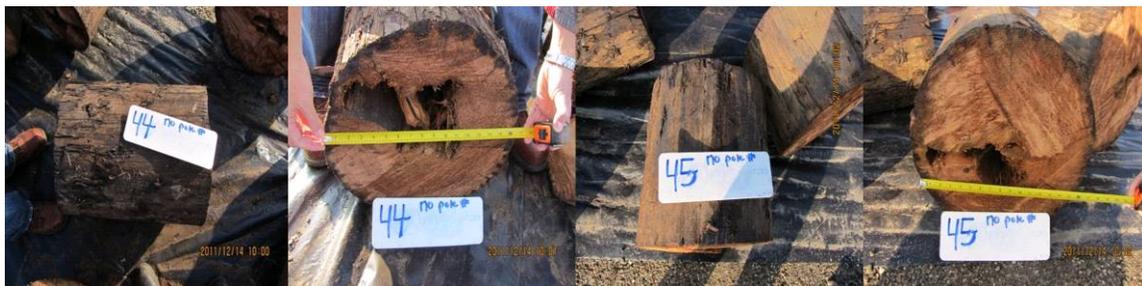
Figure 35
Examples of small individual pole segments

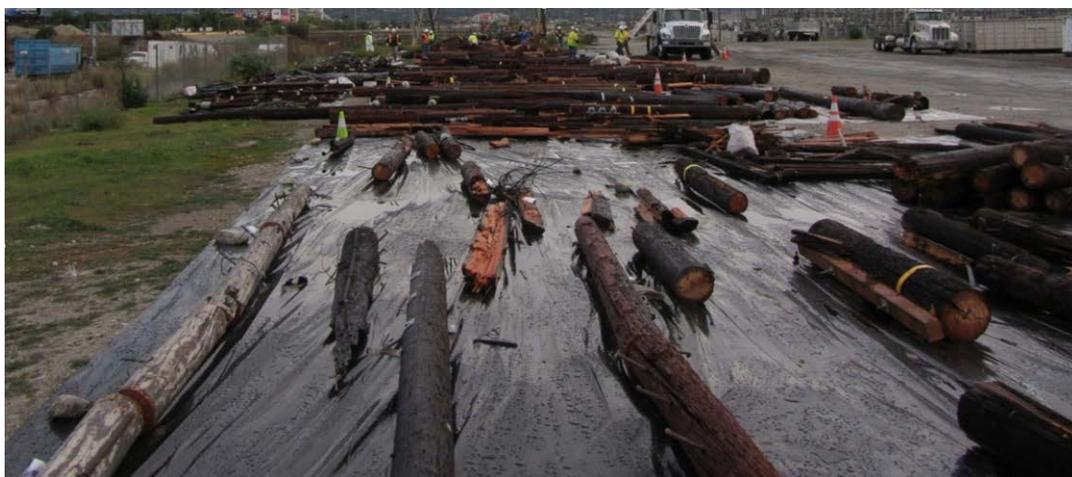
Figure 36
Portion of pole segments at Rio Hondo substation

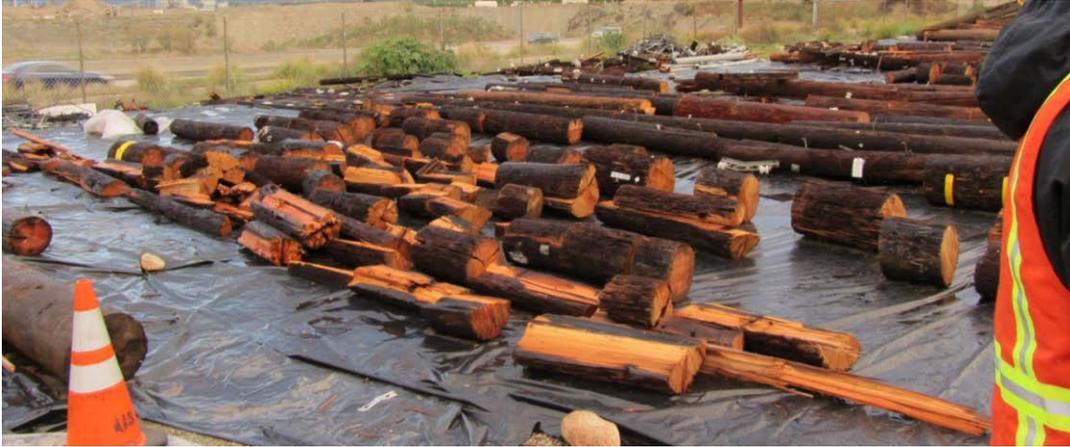
Figure 37

Small pole segments laid out for reconstruction at Rio Hondo substation
