### Preliminary Report

- Accident No.: DCA10MP008
- Type of System: 30-inch natural gas transmission pipeline
- Accident Type: Pipeline rupture
- Location: San Bruno, CA
- Date: September 9, 2010
- Time: About 6:11 p.m., Pacific Daylight Time
- Owner/Operator: Pacific Gas & Electric Company
- Fatalities/Injuries: Eight fatalities, multiple injuries
- Pipeline Pressure: 386 pounds per square inch gauge (psig) at the time of rupture
- Quantity Released: Approximately 47.6 million standard cubic feet (MMSCF)

From September 30, 2010 through October 8, 2010, a Metallurgical Group was convened at a facility in Ashburn, VA for the purpose of documenting and examining the ruptured pipeline pieces and determining which portions of the pipe should be removed for further examination at the Materials Laboratory in Washington, DC. Members of the group included:

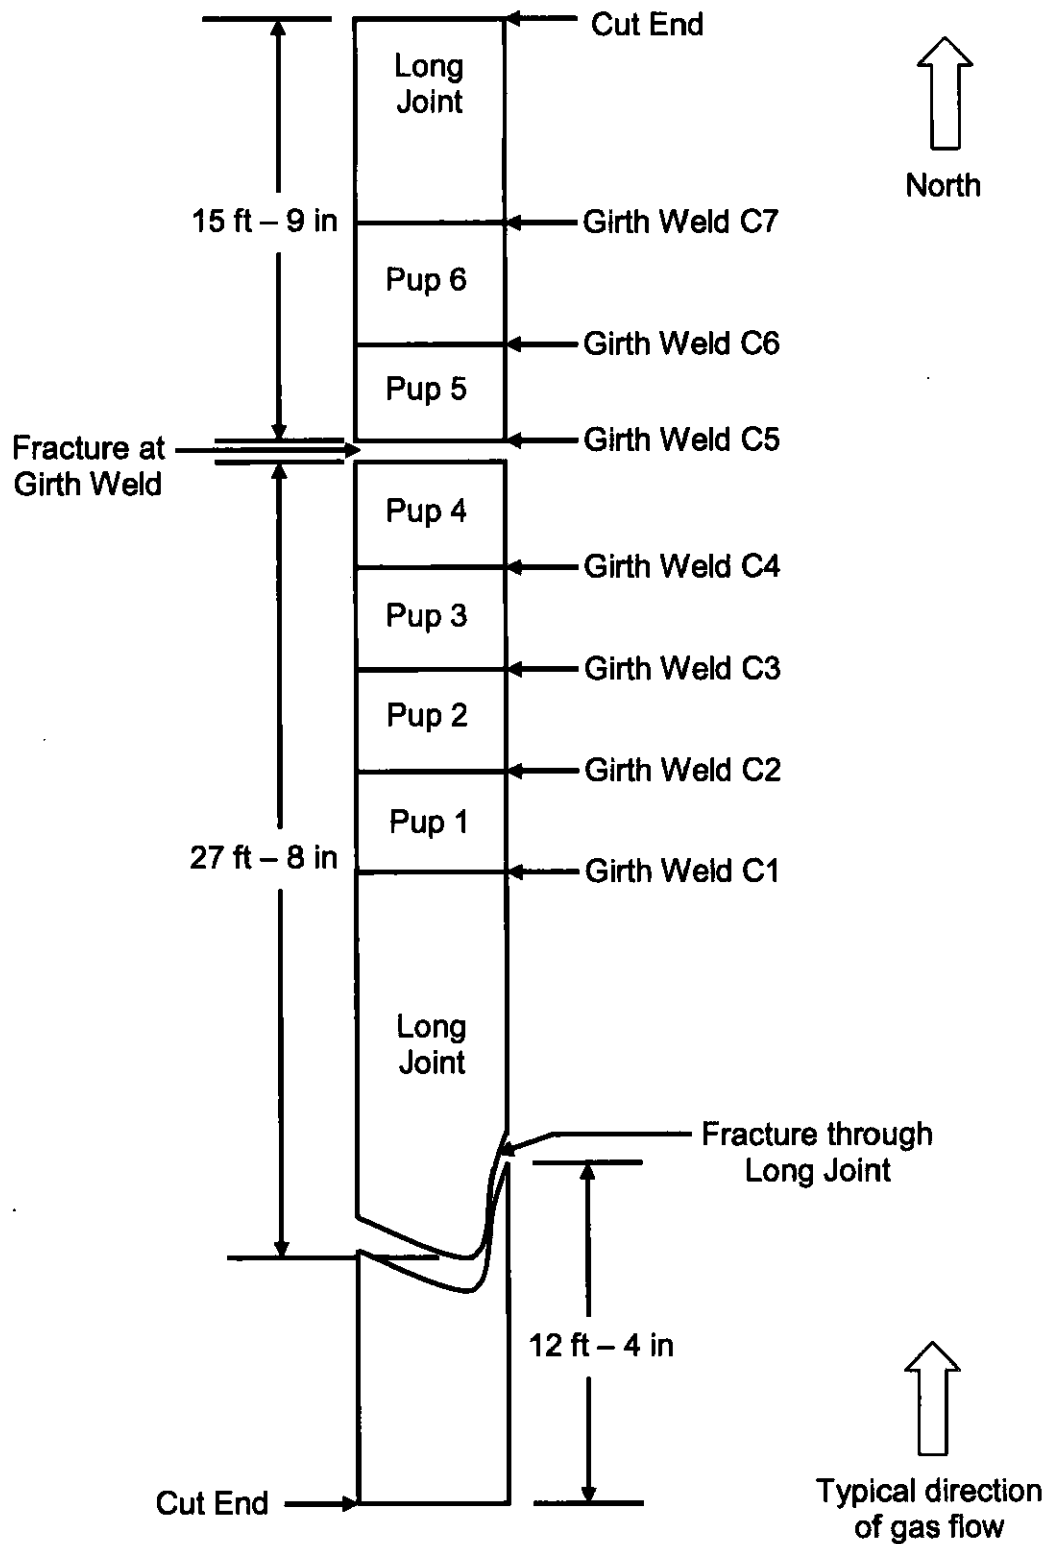
**Figure 1:** Schematic of pipe showing location of girth welds and fractures. Longitudinal fracture not depicted.

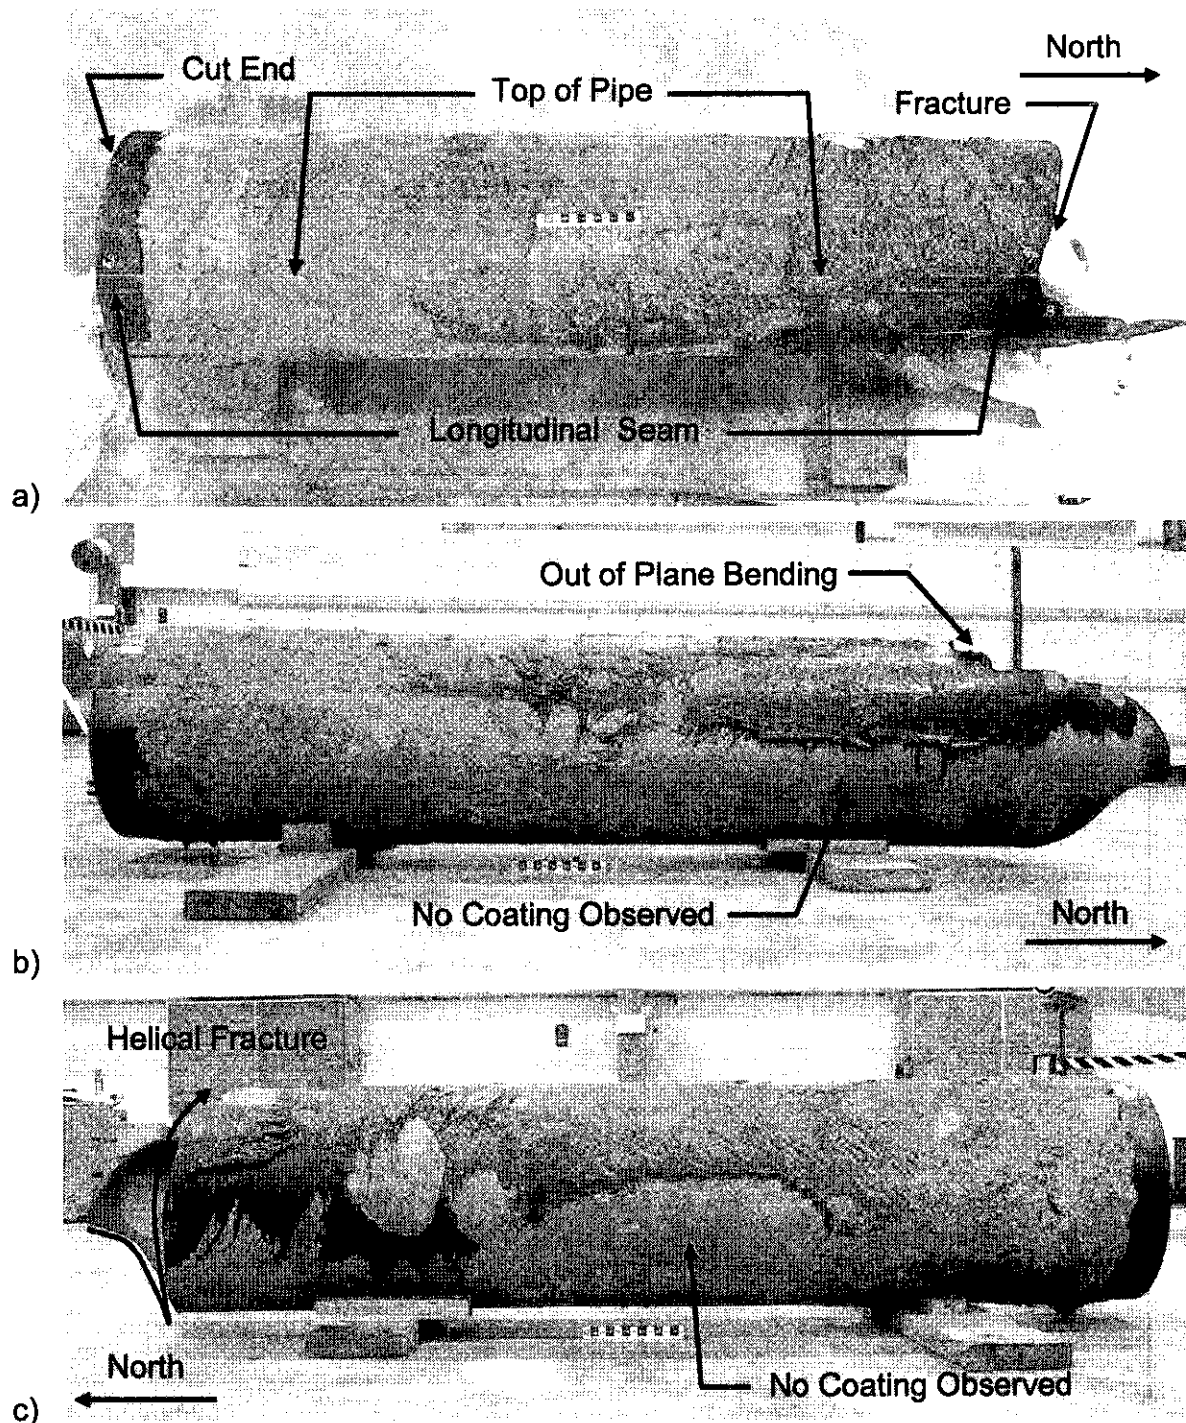
The southern section had a helical fracture at its north end as shown in figure 2c. Out of plane bending was observed along a 5 inch length along the top of the pipe, consistent with the point of final fracture. The bending deformation started at the longitudinal seam as shown in figures 2b and 8 and continued north and clockwise from this point. The fracture ran along the west side of the seam for approximately 1.5 inch, transitioned across the seam and continued on the east side of the seam. A circumferential crack was observed from the inside of the pipe where the main fracture intersected the seam. The crack propagated through the seam and continued for approximately 1.25 inch along the east side of the seam.

**Figure 2:** Southern section of pipe as received; a) Top side of pipe; b) East side of pipe; c) West side of pipe.

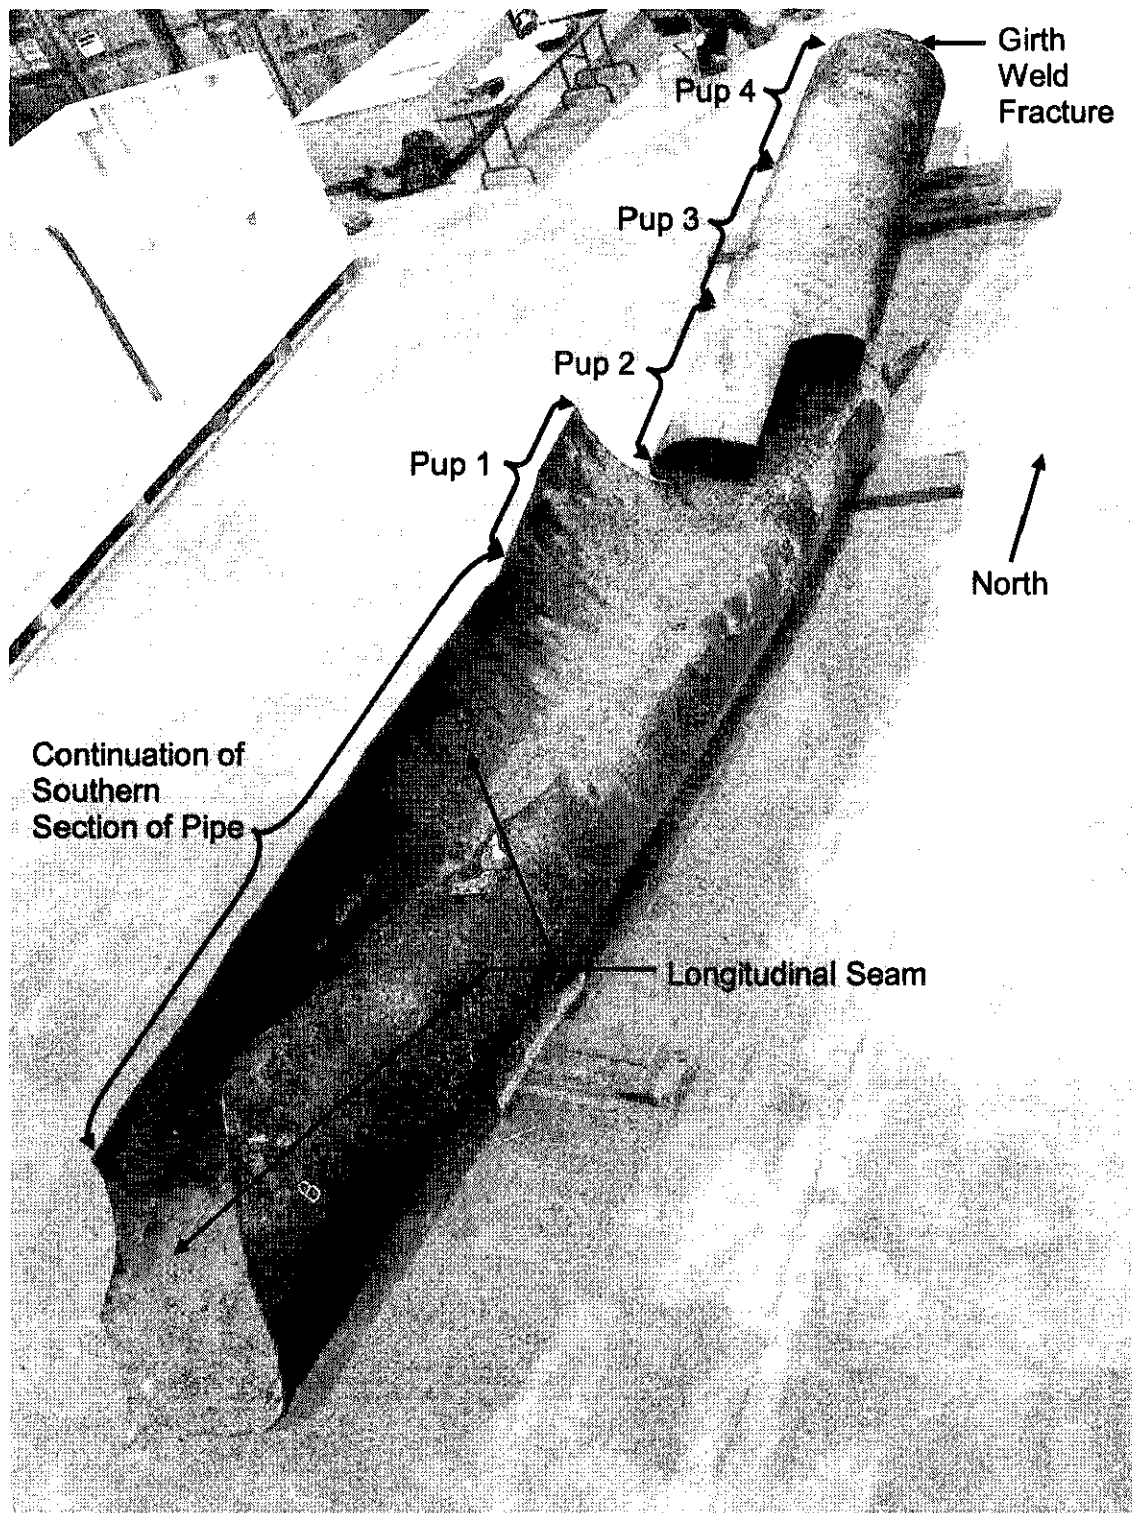
**Figure 3:** Center section of pipe.

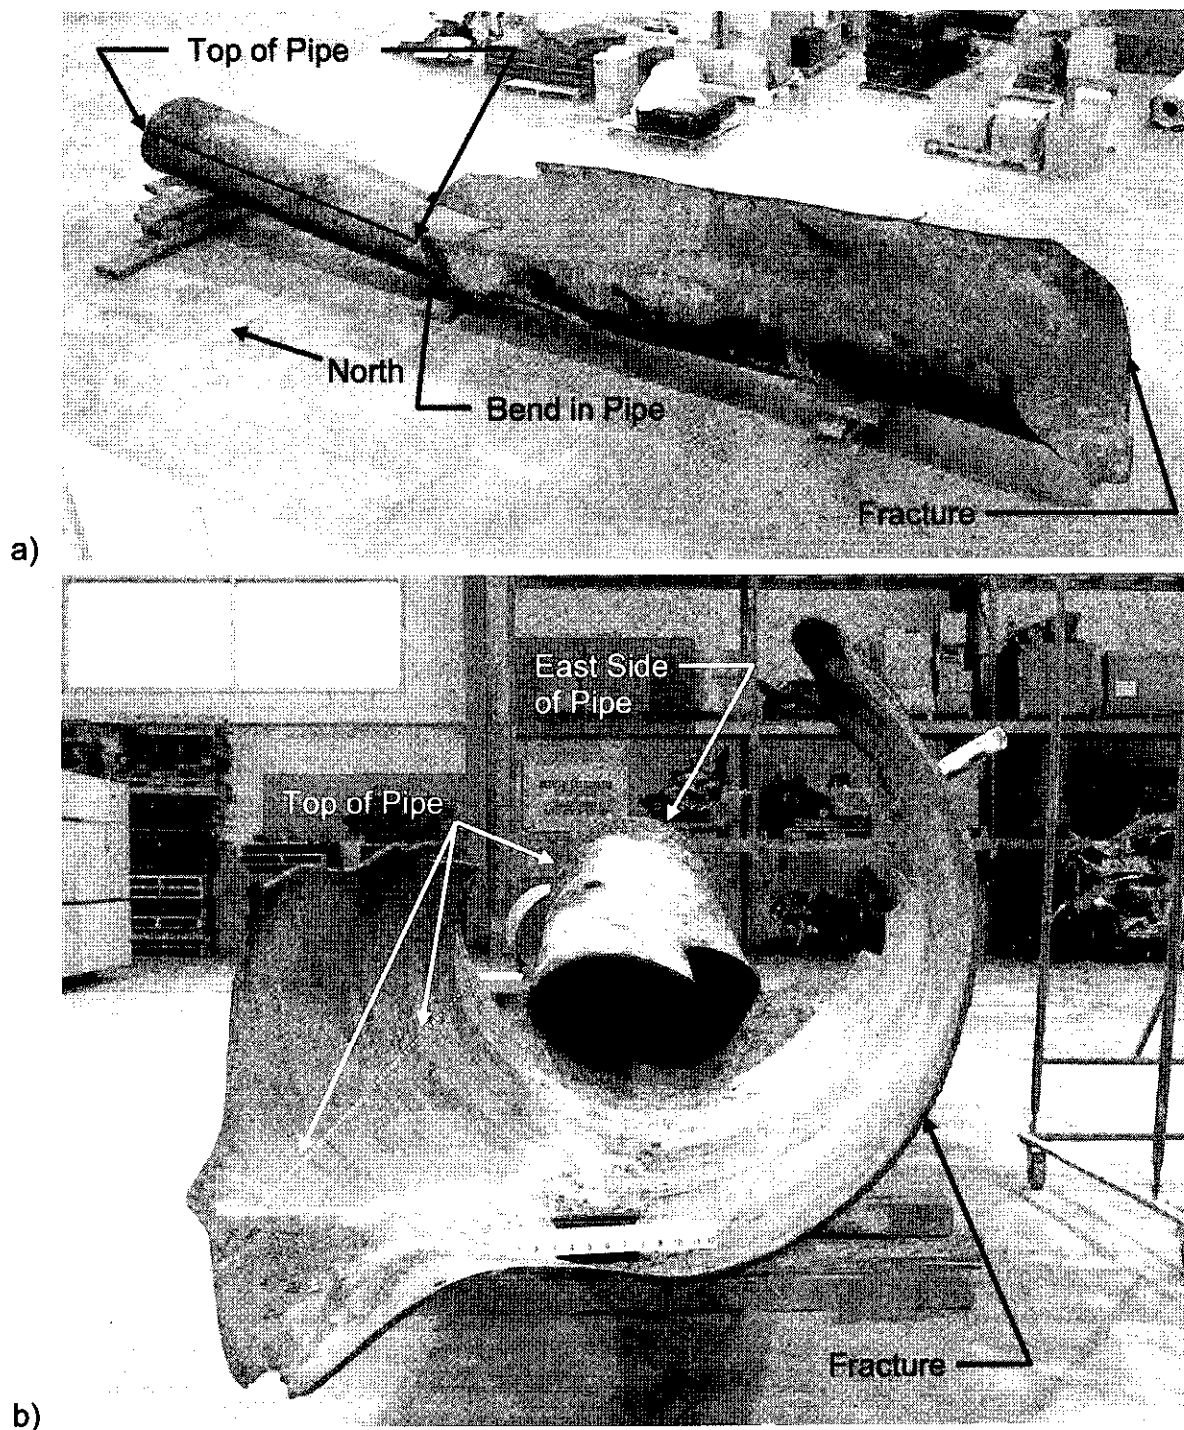
There was a 10° deformation bend in the pipe in the vicinity of pup 2 that caused the section to lie partly on its western side as shown in figure 4. The pipe showed continuously varying ovalization from pup 2 through pup 4, visible in figure 6. The minor radius, measured from inner wall to inner wall varied from 16.0 inch at the south end of pup 2 to 26.2 inch at the north end of pup 4. By comparison, the inner radius of an undeformed nominal 30 inch diameter 0.375 inch wall pipe is 29.2 inch. The southern and northern sections each had a fractured end that mated with one of the fractures on the center section. The true top of the center section was located by mating fracture features and

**Figure 4:** Center section of pipe; a) Orientation of the “true” top of the pipe at the north end; b) Orientation of the true top of the pipe and the east side of the pipe viewed along an axial direction.

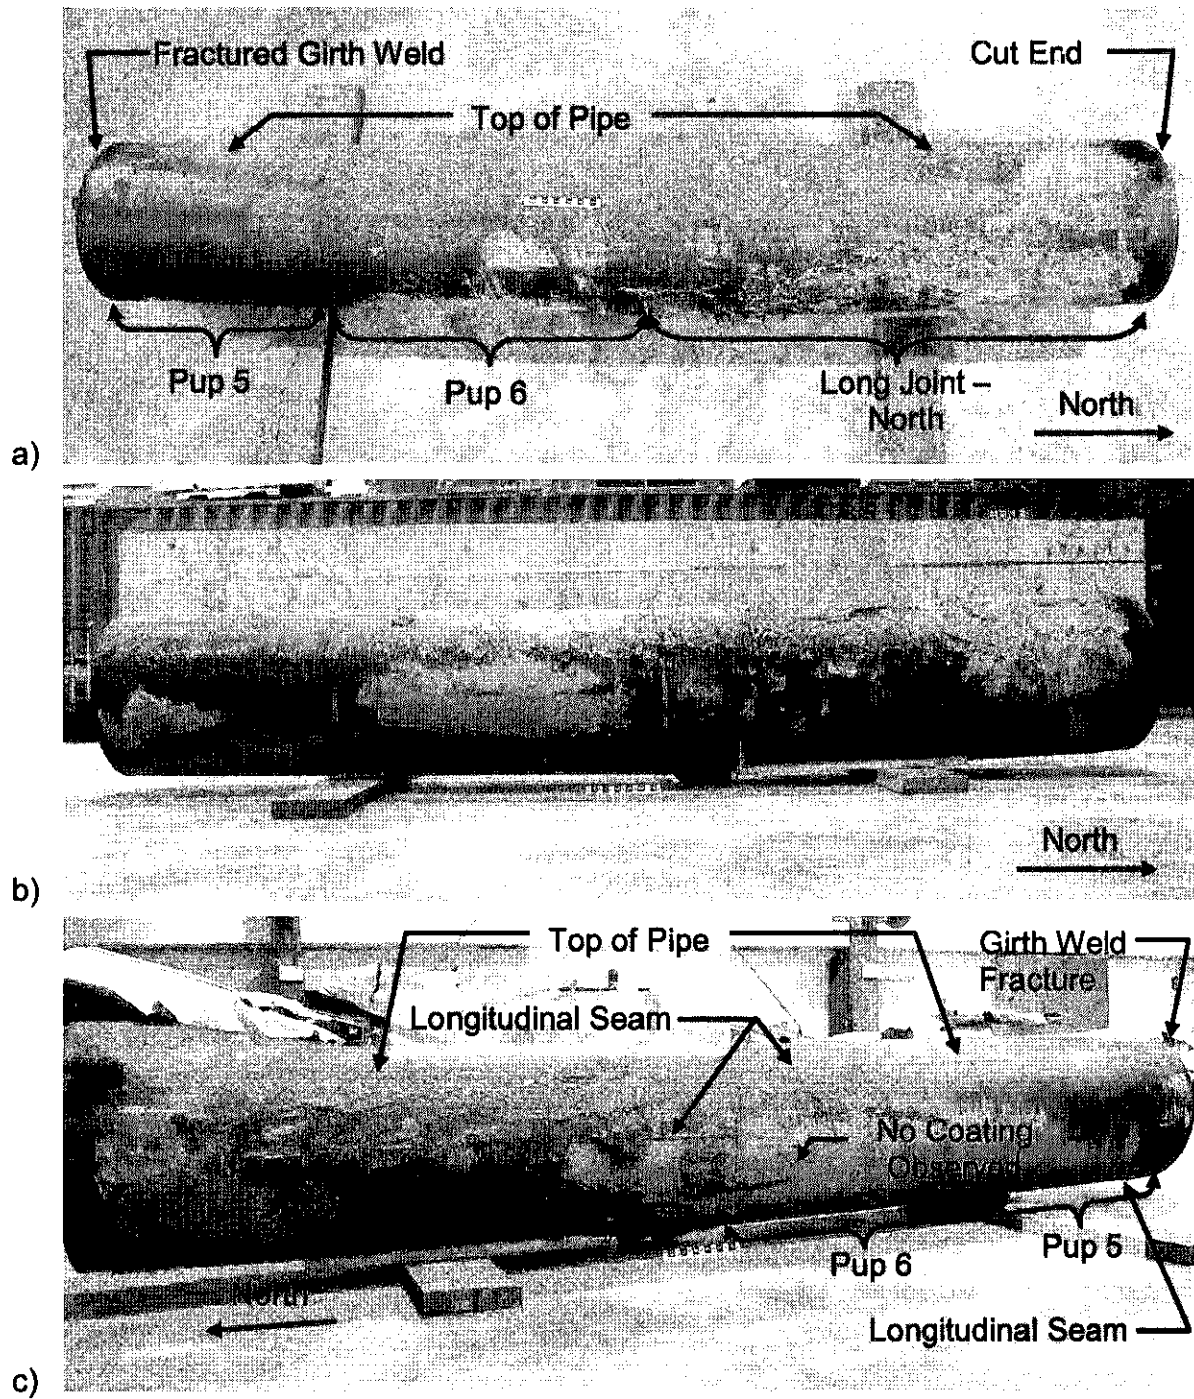
**Figure 5:** Northern section of pipe as received; a) Top side of pipe; b) East side of pipe; c) West side of pipe.

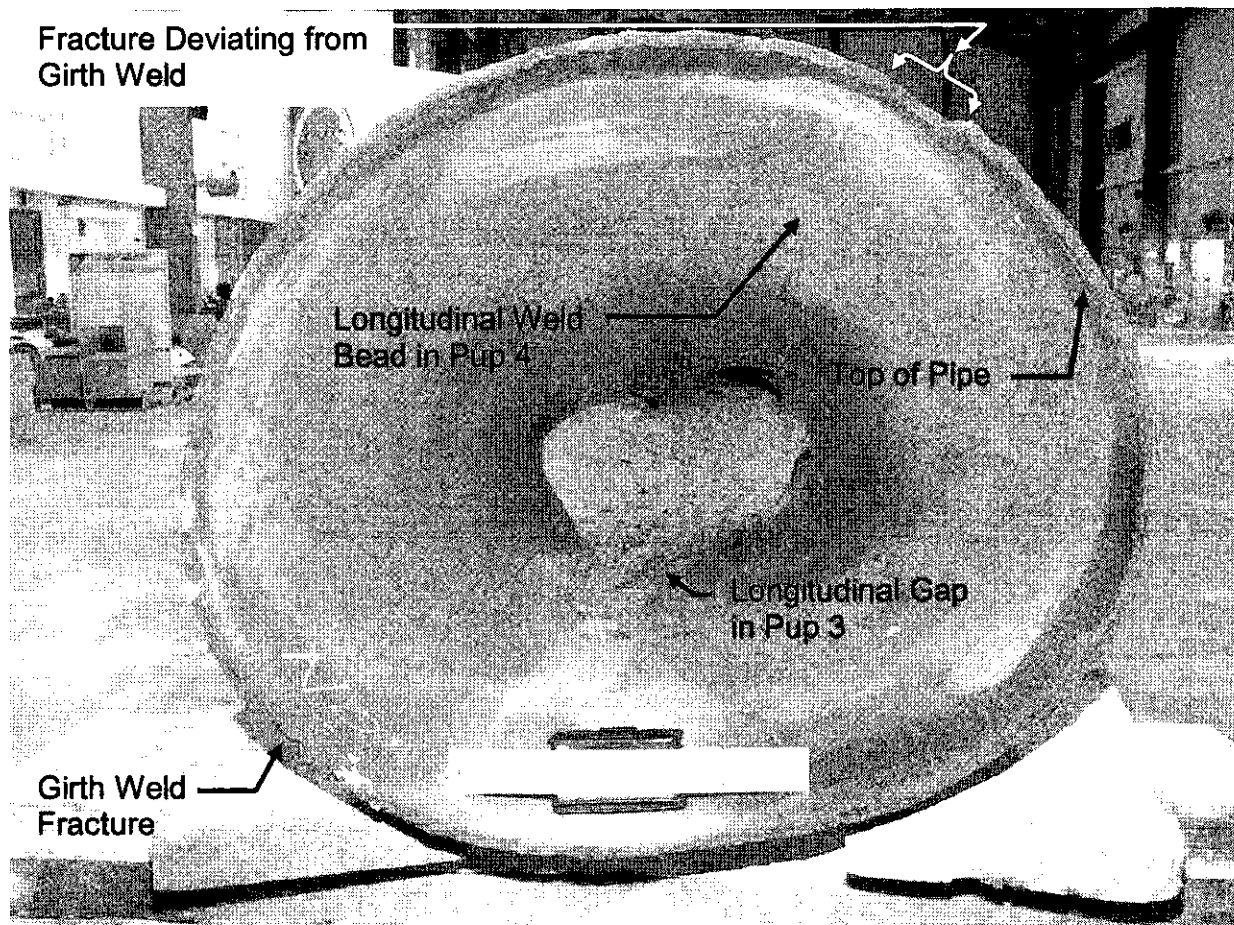
The center section had circumferential fractures at both ends. One fracture was through the long joint to the south of pup 1 as shown in figure 4. The other fracture was at the girth weld between pup 4 and pup 5 (girth weld C5 in figure 1) as shown in figures 3 and 6. There was a longitudinal fracture in pup 1 that continued in the long joint south of pup 1 to the circumferential fracture at the south end of the center section, visible in figure 3. There were circumferential fractures in girth weld C2 between pup 1 and pup 2 on both sides of the pup 1 longitudinal fracture as shown in figures 7a and b. In the counterclockwise direction, the circumferential fracture measured 27 inch (Note: Clockwise and counterclockwise directions are assigned as a rotation about the longitudinal axis of the pipeline looking north). At the end of the fracture there was a 10 inch diameter circular depression in the pipe. In the clockwise direction, the circumferential fracture measured 6.25 inch, at which point it intersected with a longitudinal fracture in pup 2 as shown in figure 7b. The longitudinal fracture in pup 2 extended 29.25 inch from girth weld C2 at which point it branched in two, visible in figure 7a and 7c. One branch continued in the longitudinal direction to within 3 inch of girth weld C3 (Note: This was only visible after removal of the coating as shown in figure 7c). The other branch was angled 66° to the longitudinal direction and measured 18 inch. The circumferential fracture at the north end of the center section deviated from girth weld C5 along a 3.5 inch circumferential length up to 1 inch longitudinally in pup 4 at the location shown in figure 6.

**Figure 6:** Fracture through the girth weld between pup 4 and pup 5 at the north end of the center section. The view is looking south. Pup 3 and pup 2 are also visible.

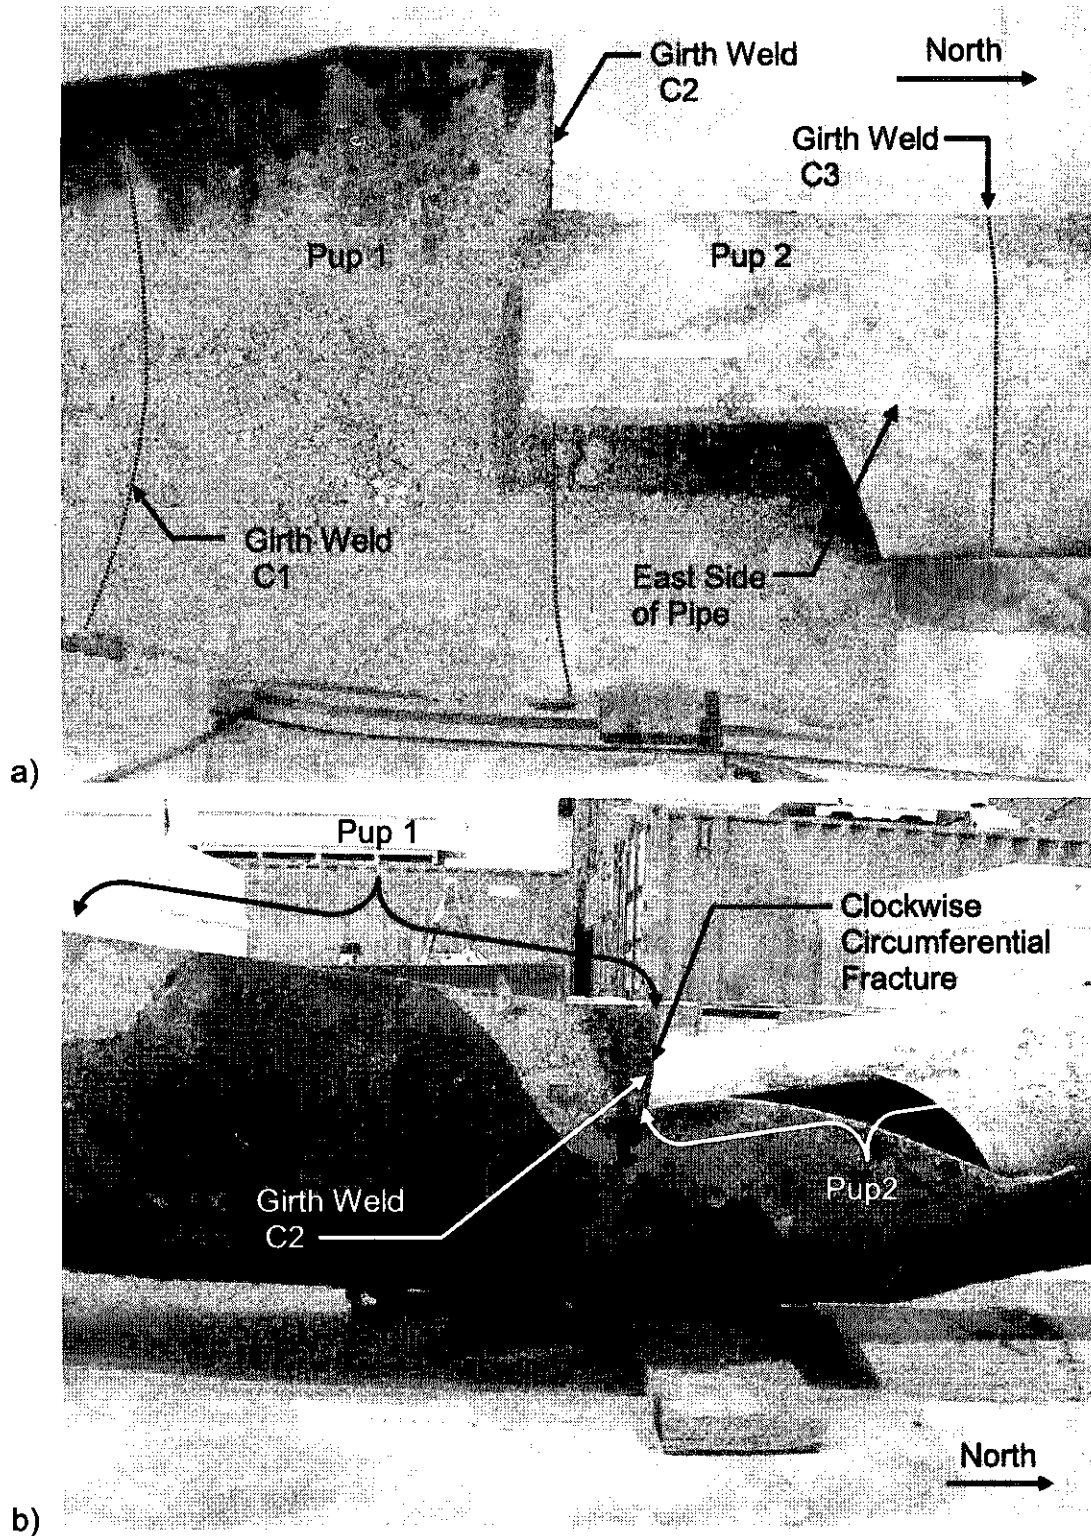
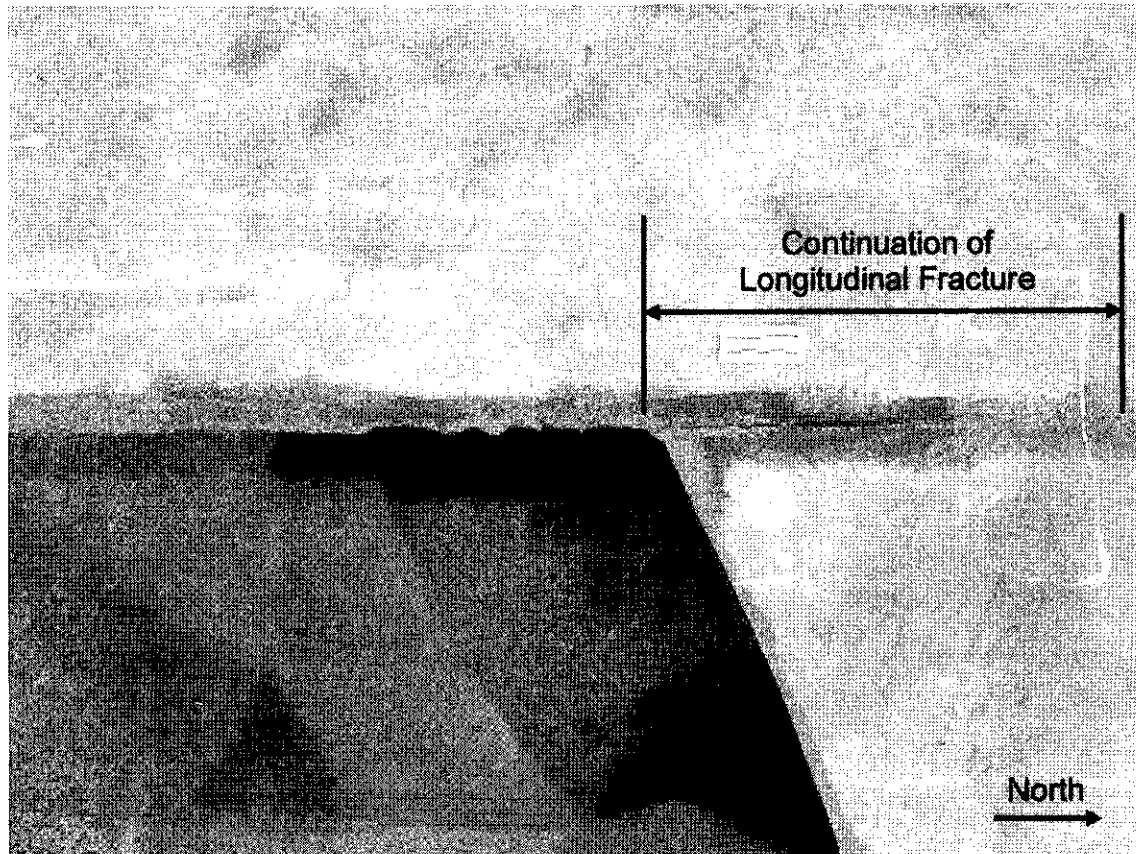
**Figure 7:** The longitudinal and circumferential fractures in pup 1 and pup 2; a) overhead view of the east side of the pipe; b) side view of east and bottom sides of the pipe.

**Figure 7 (cont.):** c) Continuation of the longitudinal fracture in pup 2 past the branching point was visible after removal of the coating.

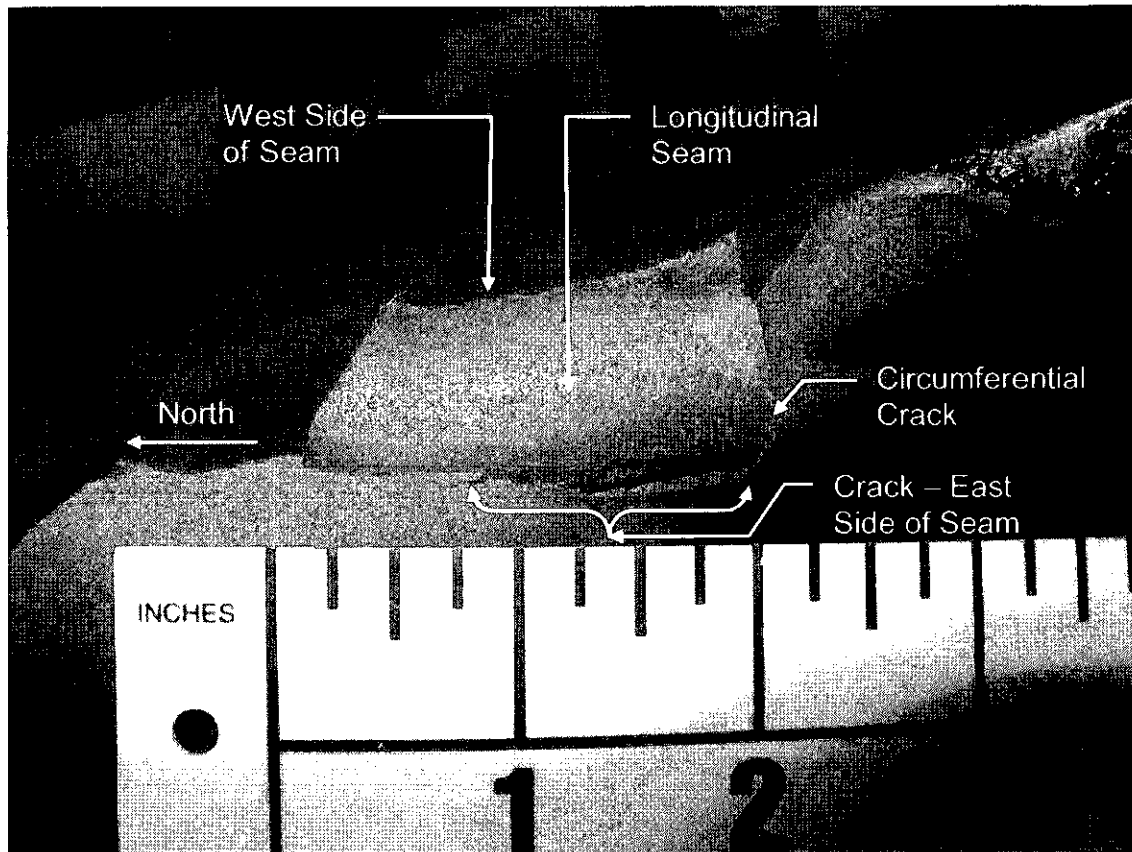
**Figure 8:** Fracture, a crack, and out of plane bending at a longitudinal seam on the southern section.

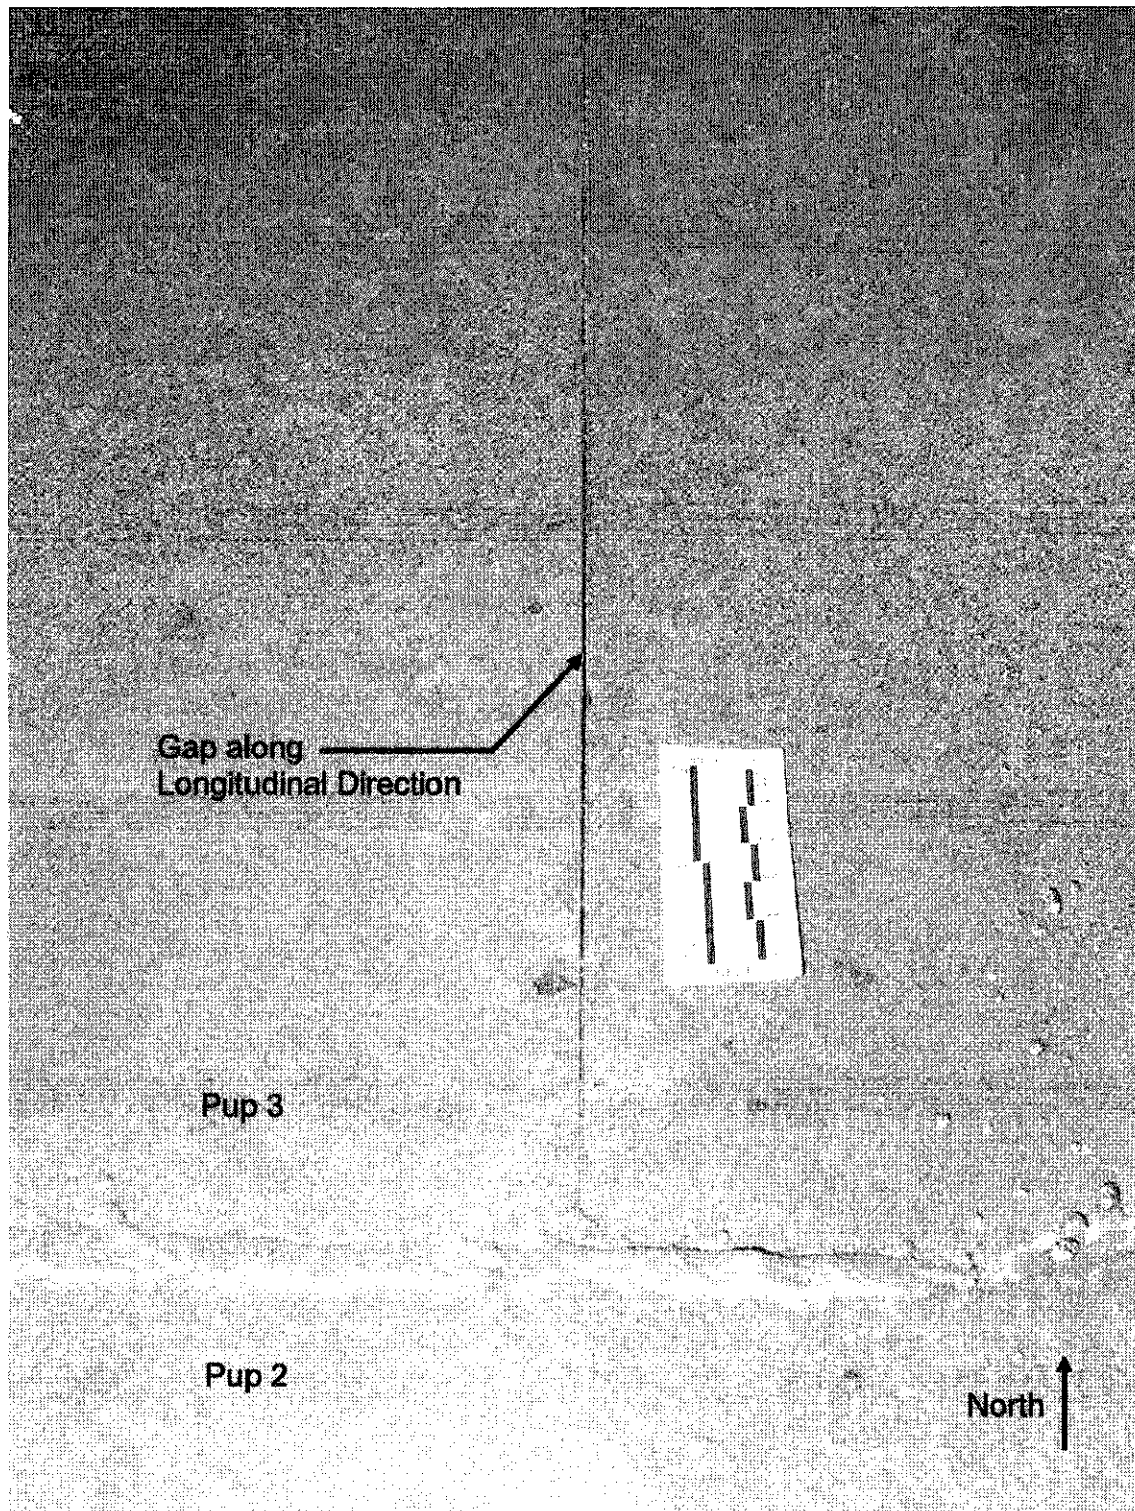
**Figure 9:** Inside wall of pup 3 showing a longitudinal gap that extended the length of the pup.

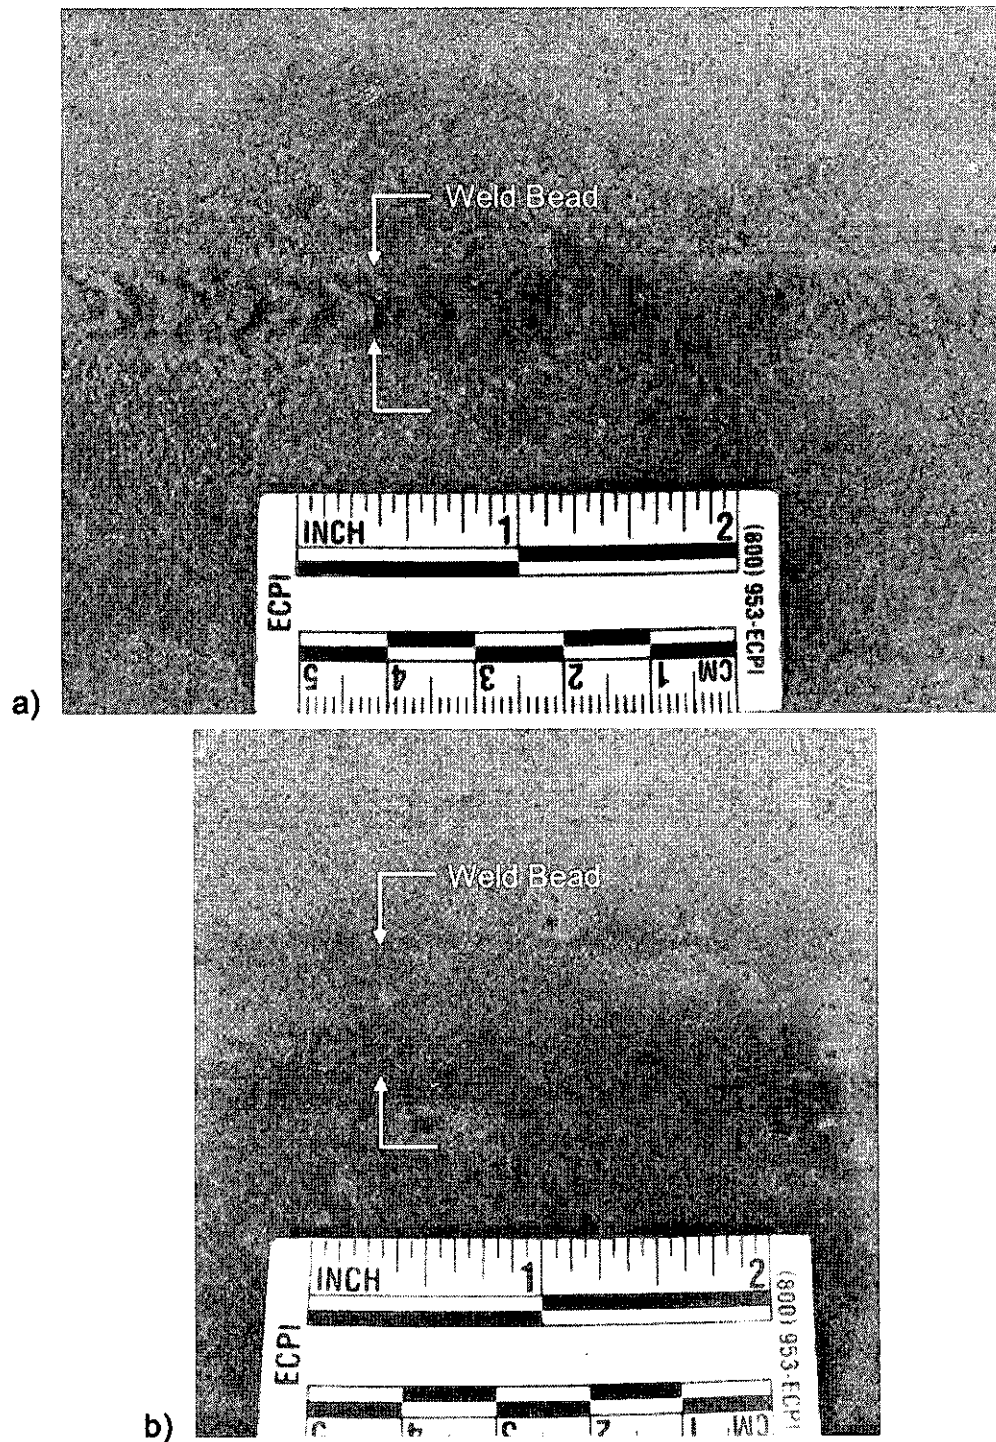
**Figure 10:** a) Longitudinal weld bead observed on the inside of pup 5; b) Longitudinal weld bead observed on the inside of pup 6.

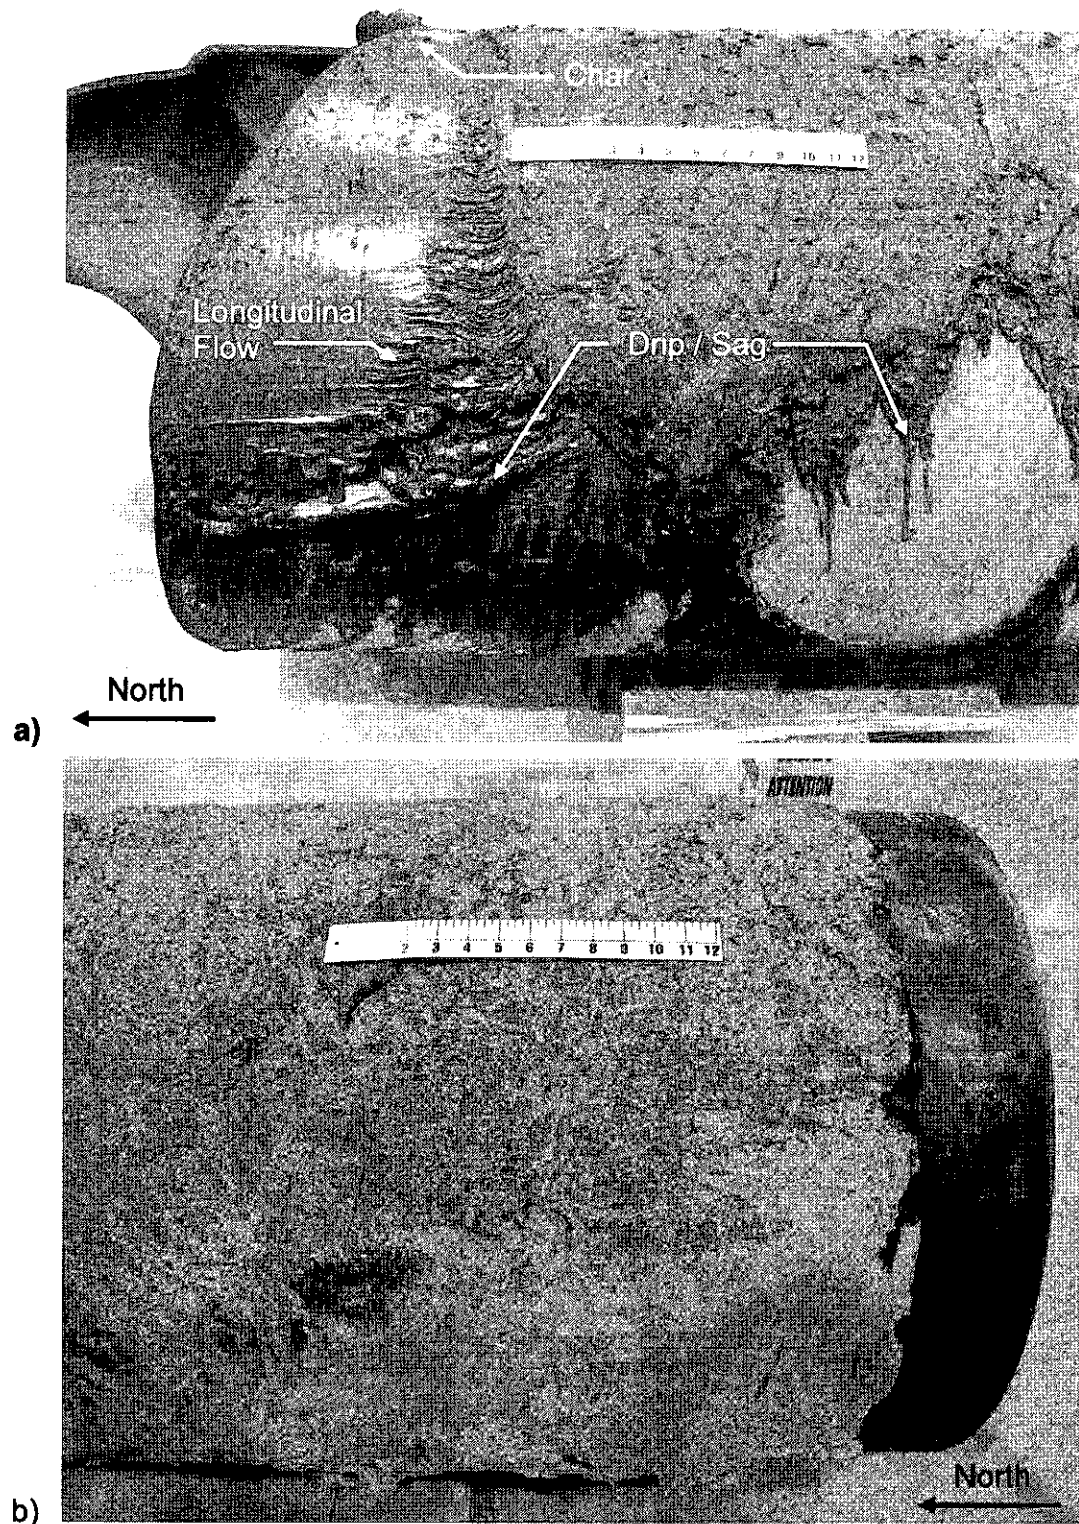
**Figure 11:** Condition of the asphalt coating on the southern section; a) Adjacent to the circumferential fracture; b) Away from the fracture close to the cut end.

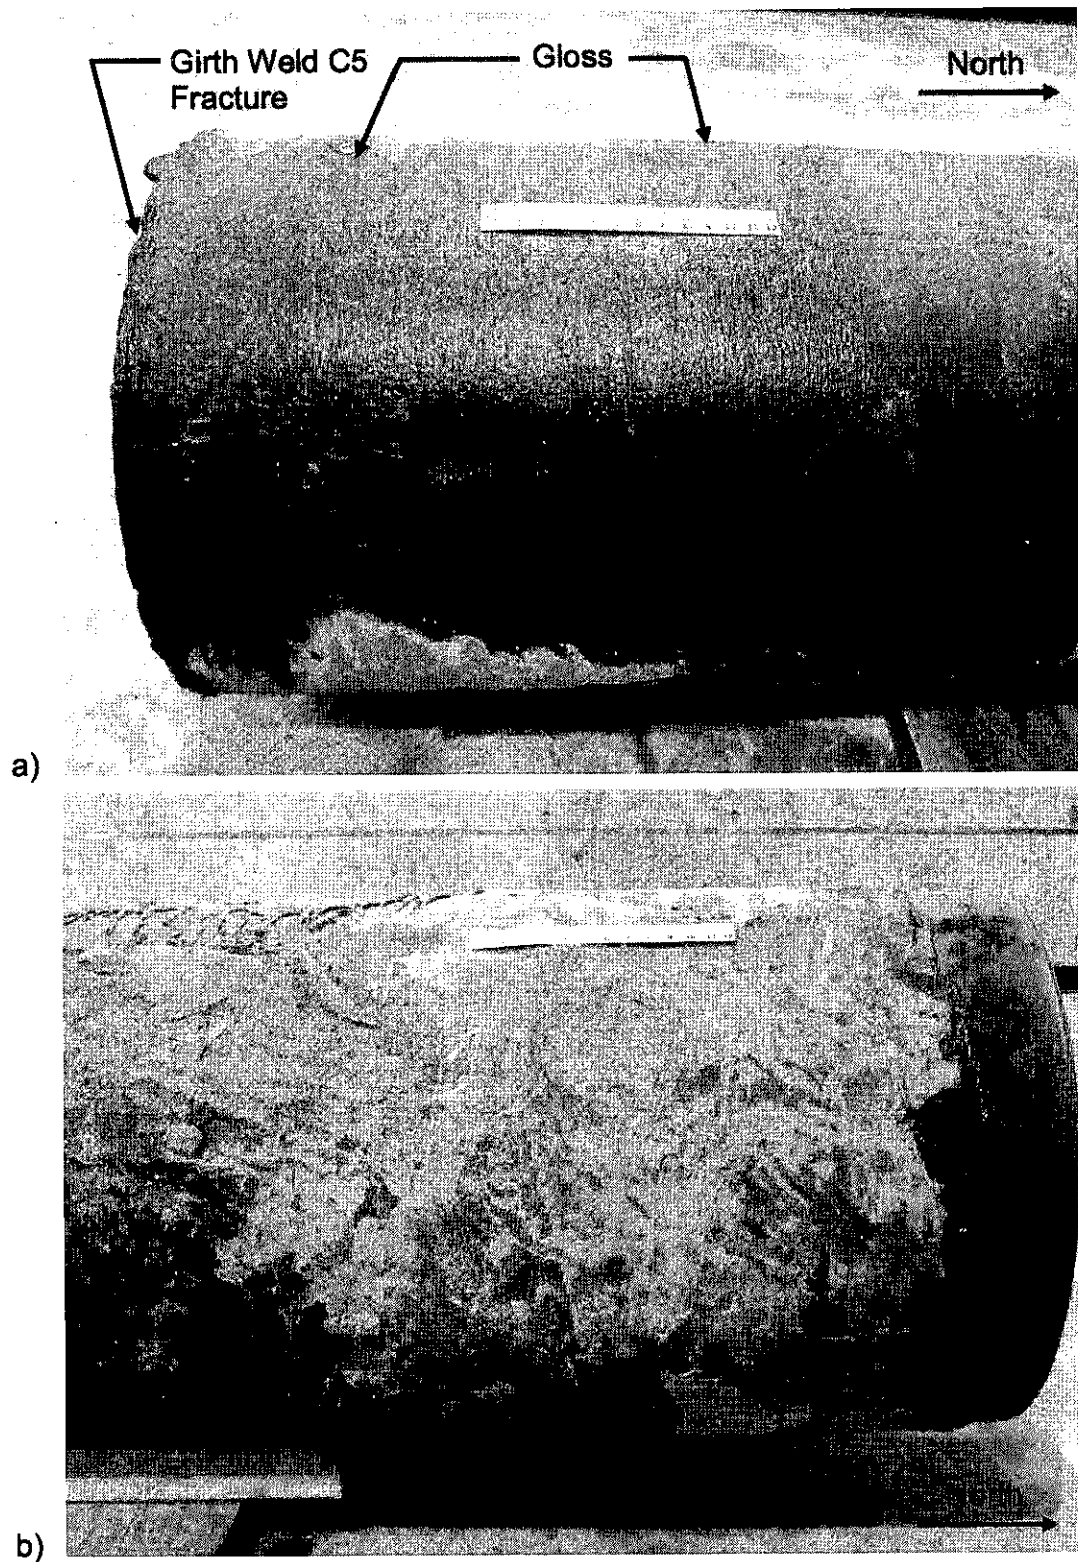
**Figure 12:** Condition of the asphalt coating on the northern section; a) Top of pup 5 adjacent to the girth weld fracture; b) Away from the fracture close to the cut end.

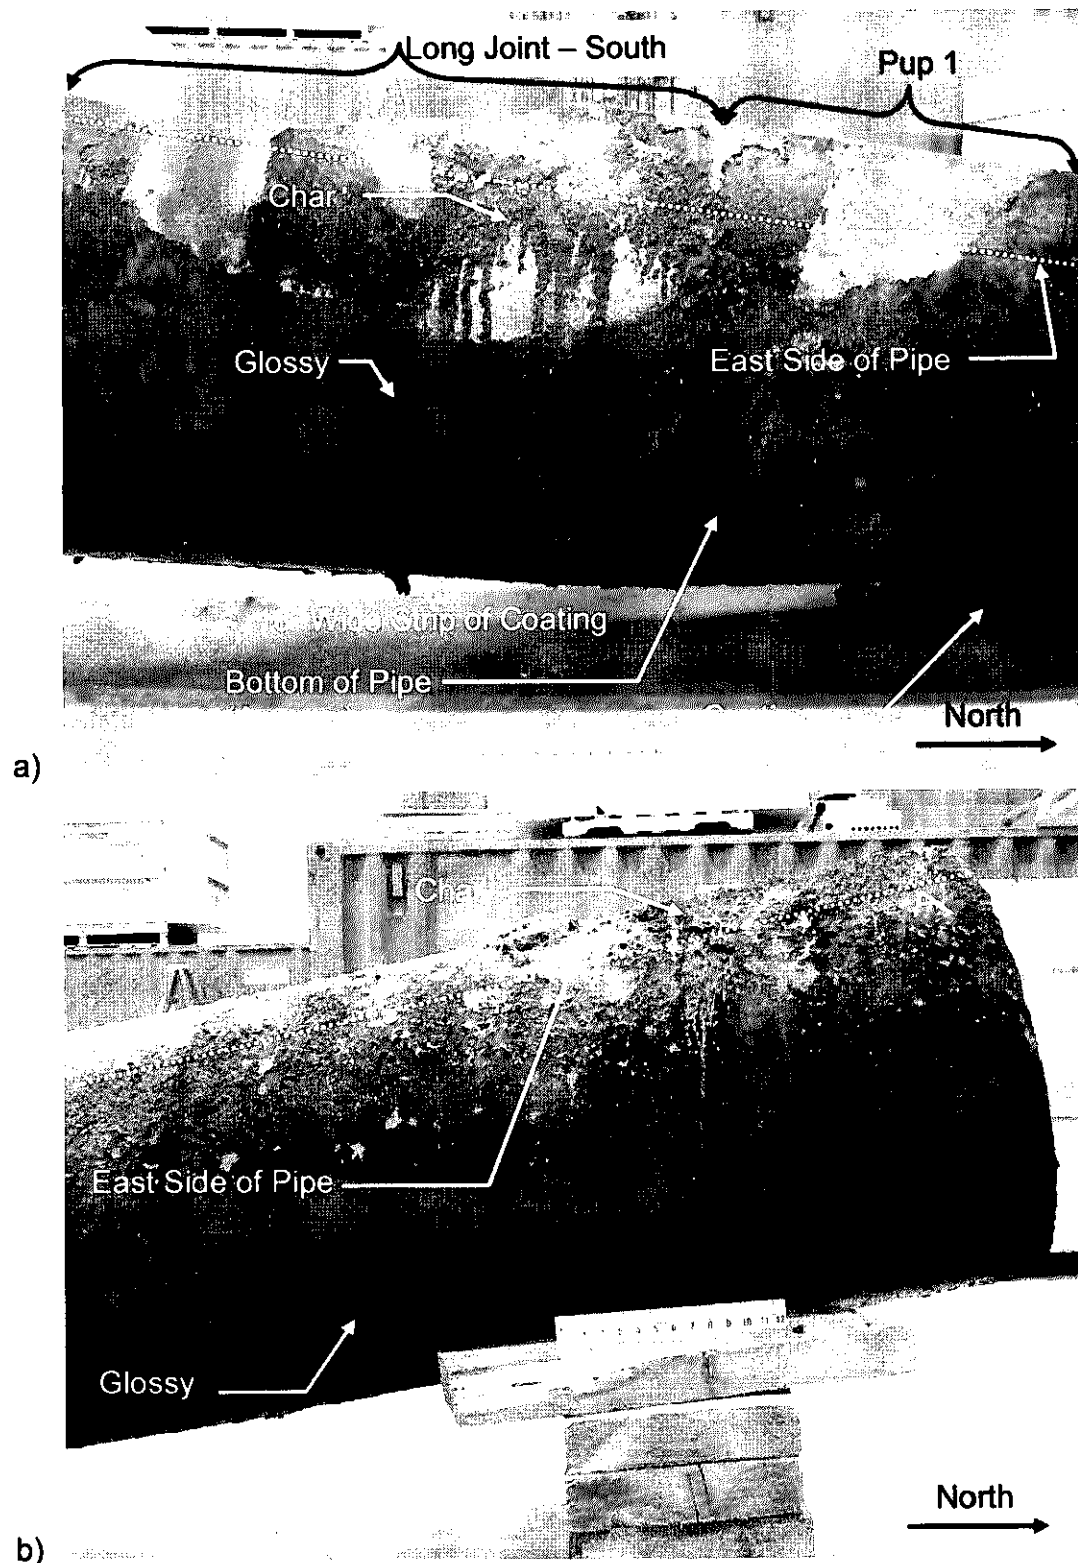
**Figure 13:** Condition of the asphalt coating on the center section; a) East side / bottom of long joint and pup 1; b) East side / bottom of pup 4 adjacent to girth weld fracture.
