### Preliminary Report

- Accident No.: DCA10MP008
- Type of System: 30-inch natural gas transmission pipeline
- Accident Type: Pipeline rupture
- Location: San Bruno, CA
- Date: September 9, 2010
- Time: About 6:11 p.m., Pacific Daylight Time
- Owner/Operator: Pacific Gas & Electric Company
- Fatalities/Injuries: Eight fatalities, multiple injuries
- Pipeline Pressure: 386 pounds per square inch gauge (psig) at the time of rupture
- Quantity Released: Approximately 47.6 million standard cubic feet (MMSCF)

From September 30, 2010 through October 8, 2010, a Metallurgical Group was convened at a facility in Ashburn, VA for the purpose of documenting and examining the ruptured pipeline pieces and determining which portions of the pipe should be removed for further examination at the Materials Laboratory in Washington, DC. Members of the group included:

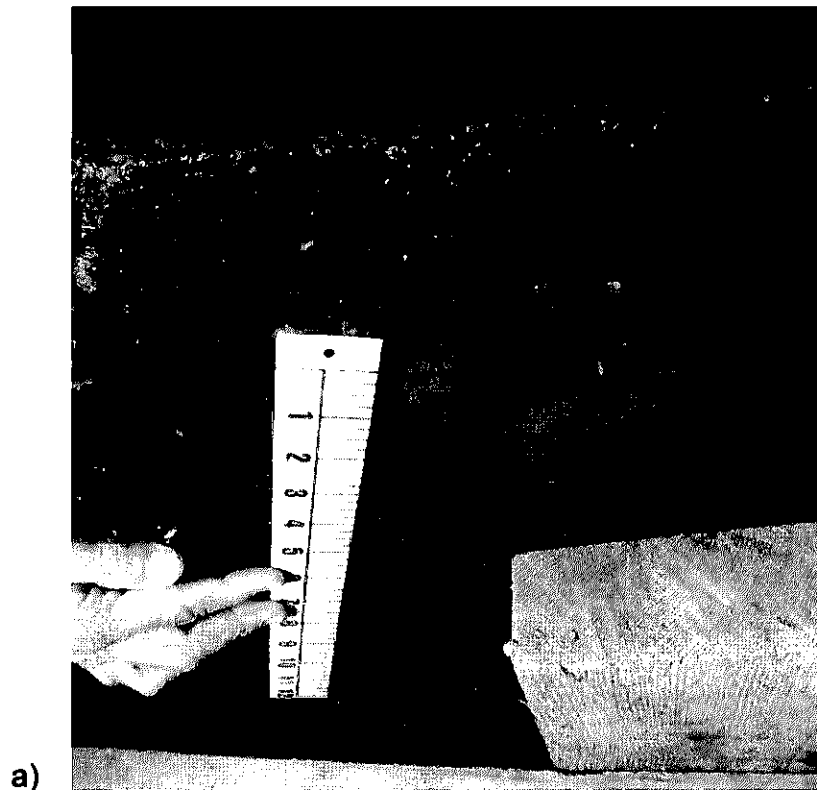
**Figure 14:** Examples on the underside of the center section where no coating was observed;  
a) Underside of pup 4 near the girth weld fracture; b) Underside of long joint to the south of  
pup 1.

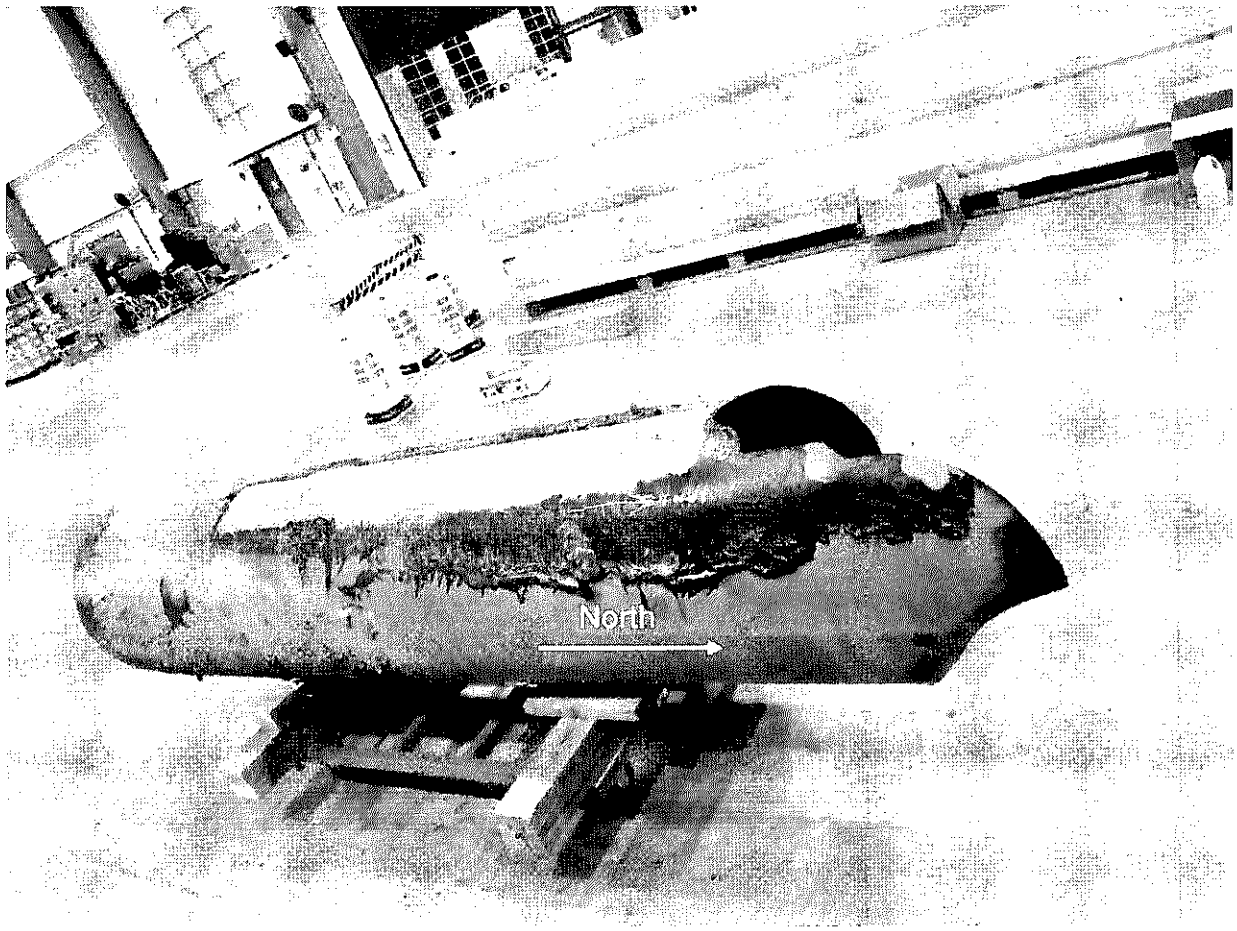
**Figure 15:** Condition of the southern section of pipe after grit blasting and magnetic particle inspection.

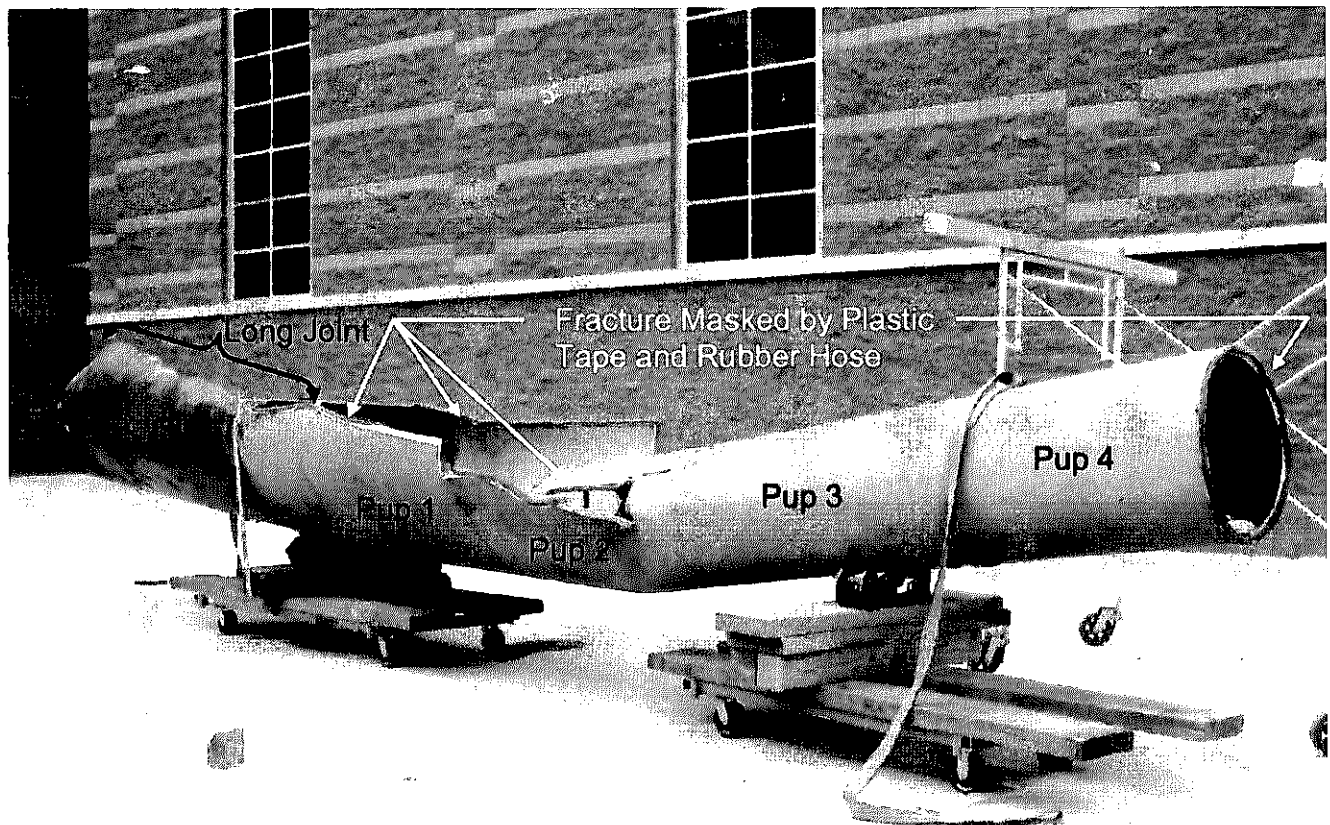
**Figure 16:** Condition of the center section of pipe after grit blasting.

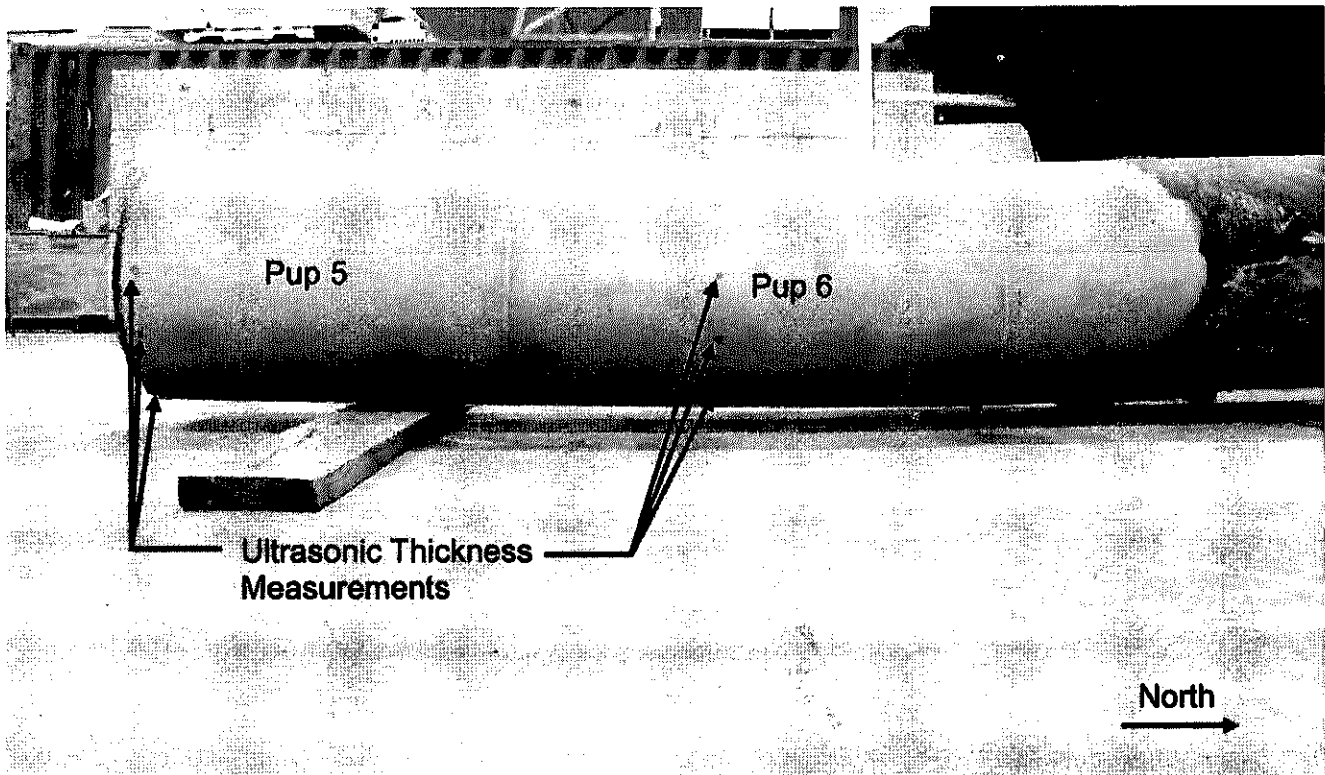
**Figure 17:** Condition of the northern section of pipe after grit blasting. Dots of gel from the ultrasonic thickness measurements are visible on pup 5 and pup 6.

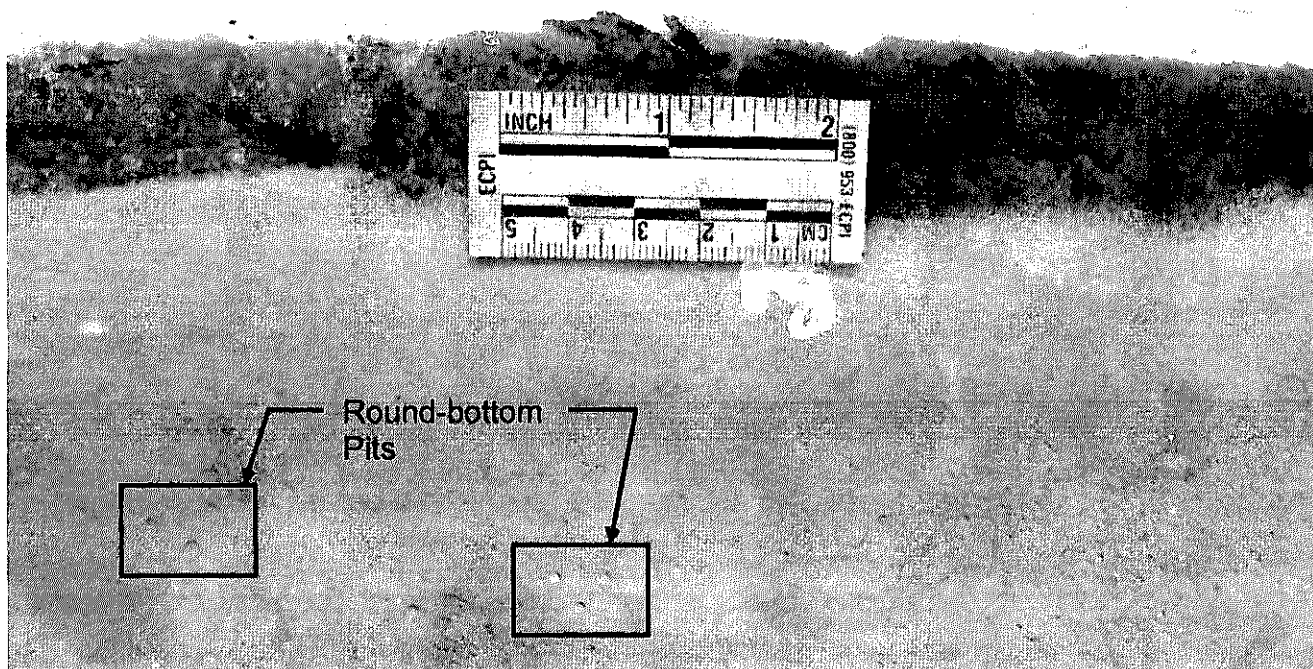
**Figure 18:** Photograph of pup 2 on the outer diameter adjacent to the longitudinal fracture after grit blasting, magnetic particle inspection, and manual laboratory cleaning of the surface.

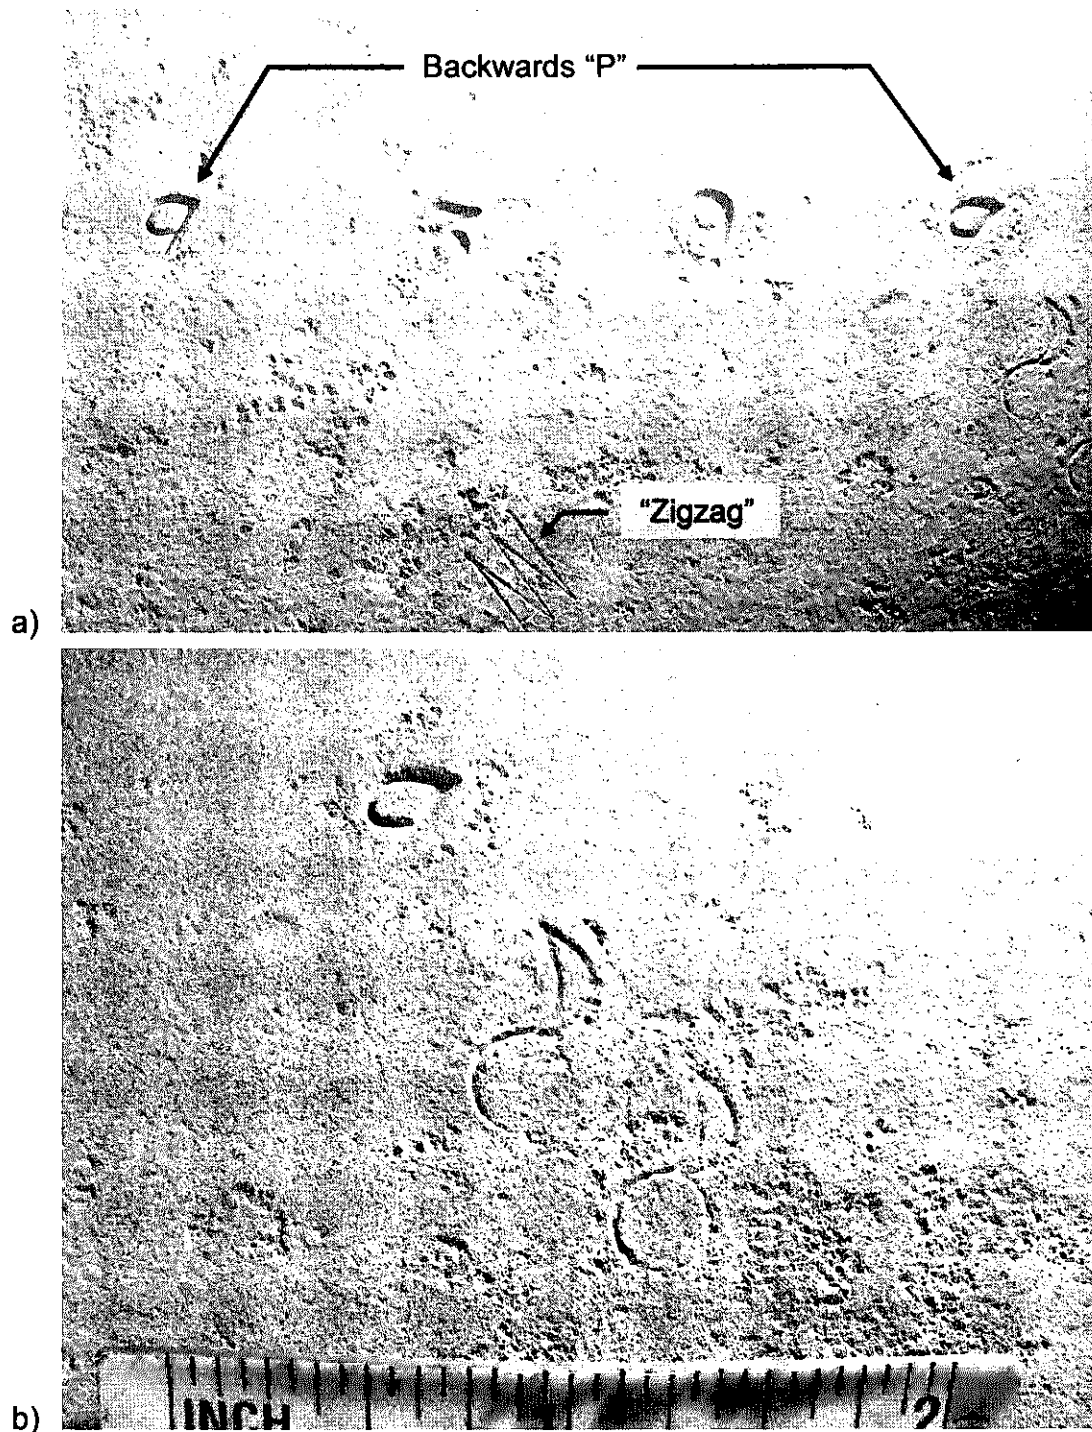
**Figure 19:** Pipe markings found on pup 4; a) The number "30", backwards "P" and five lines forming a "Zigzag"; b) Marking forming a circle and half-moon.

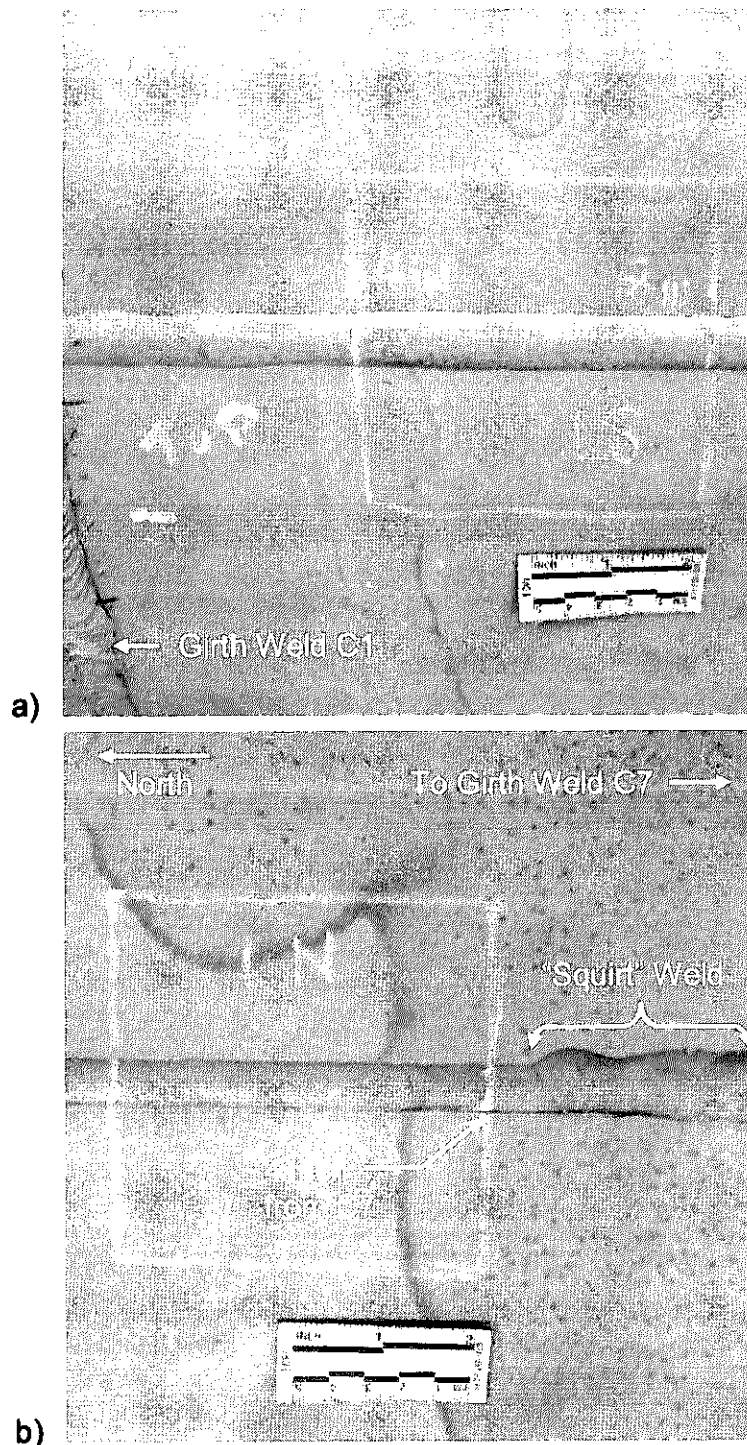
**Figure 20:** a) Outer weld bead on the long joint south of pup 1. There was no apparent “squirt” weld adjacent to girth weld C1; b) Outer weld bead on the long joint north of pup 6. There was an apparent “squirt” weld adjacent to girth weld C7. The photographs are taken after grit blasting and magnetic particle inspection and prior to sample removal for cross-section metallography.

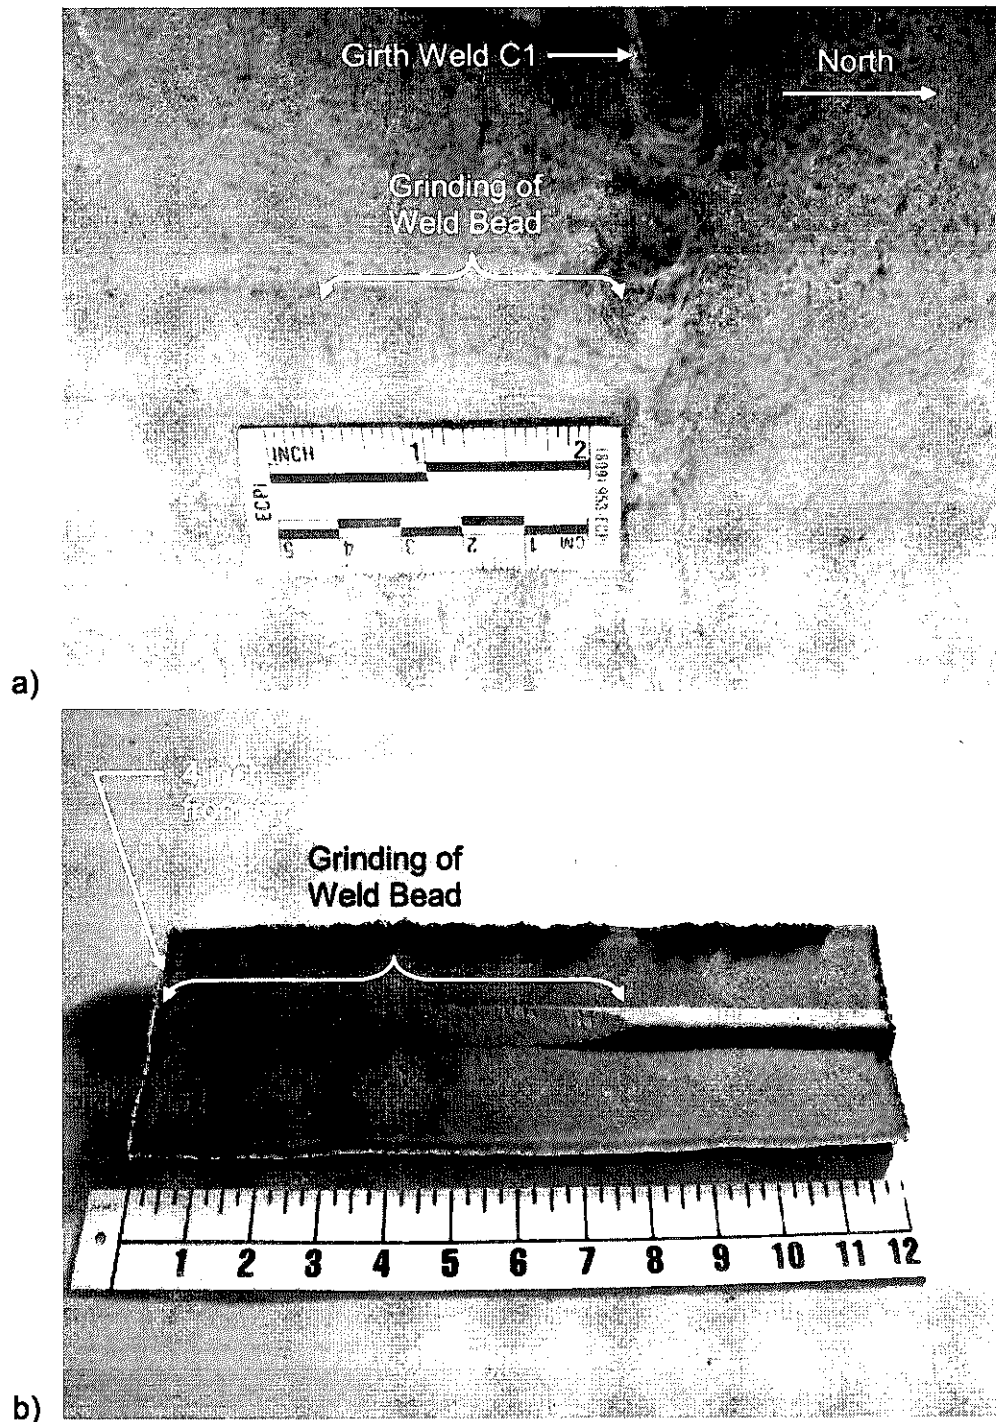
**Figure 21:** a) Inner weld bead on the long joint south of pup 1. The weld bead was ground over 1.75 inch. The photograph was taken after grit blasting and magnetic particle inspection;  
b) Inner weld bead on the long joint north of pup 6. The weld bead was ground over approximately 12 inch. The photograph was taken in the laboratory after the section of pipe was removed using a plasma cutter.

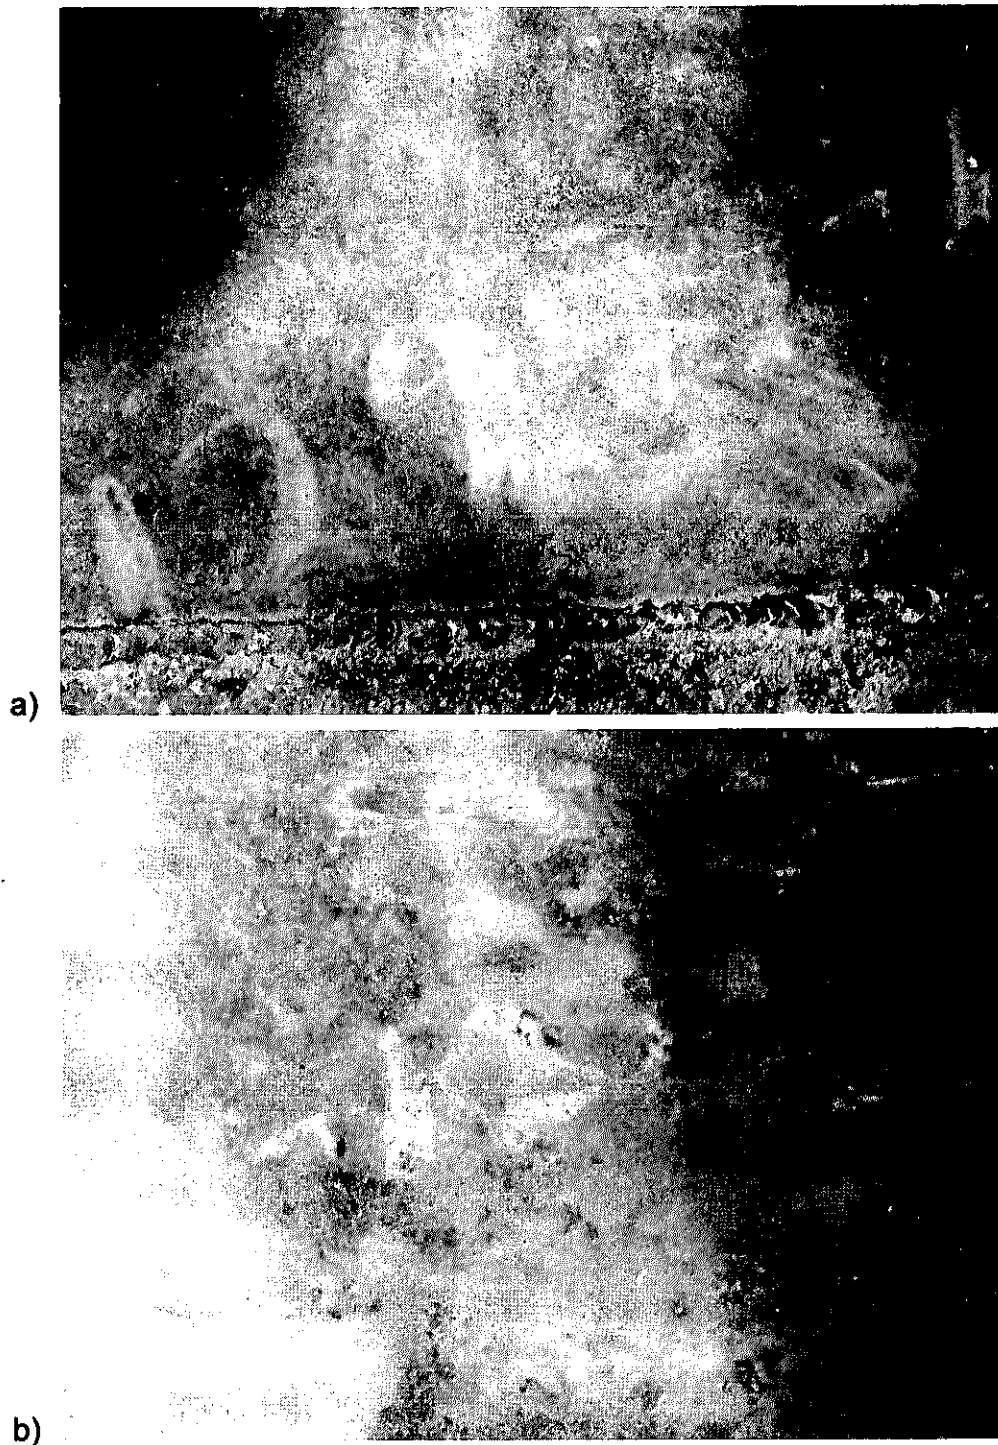
**Figure 22:** Photographs of number painted on the inside of the long joint south of pup 1. The contrast has been altered to enhance the visibility of the numbers.

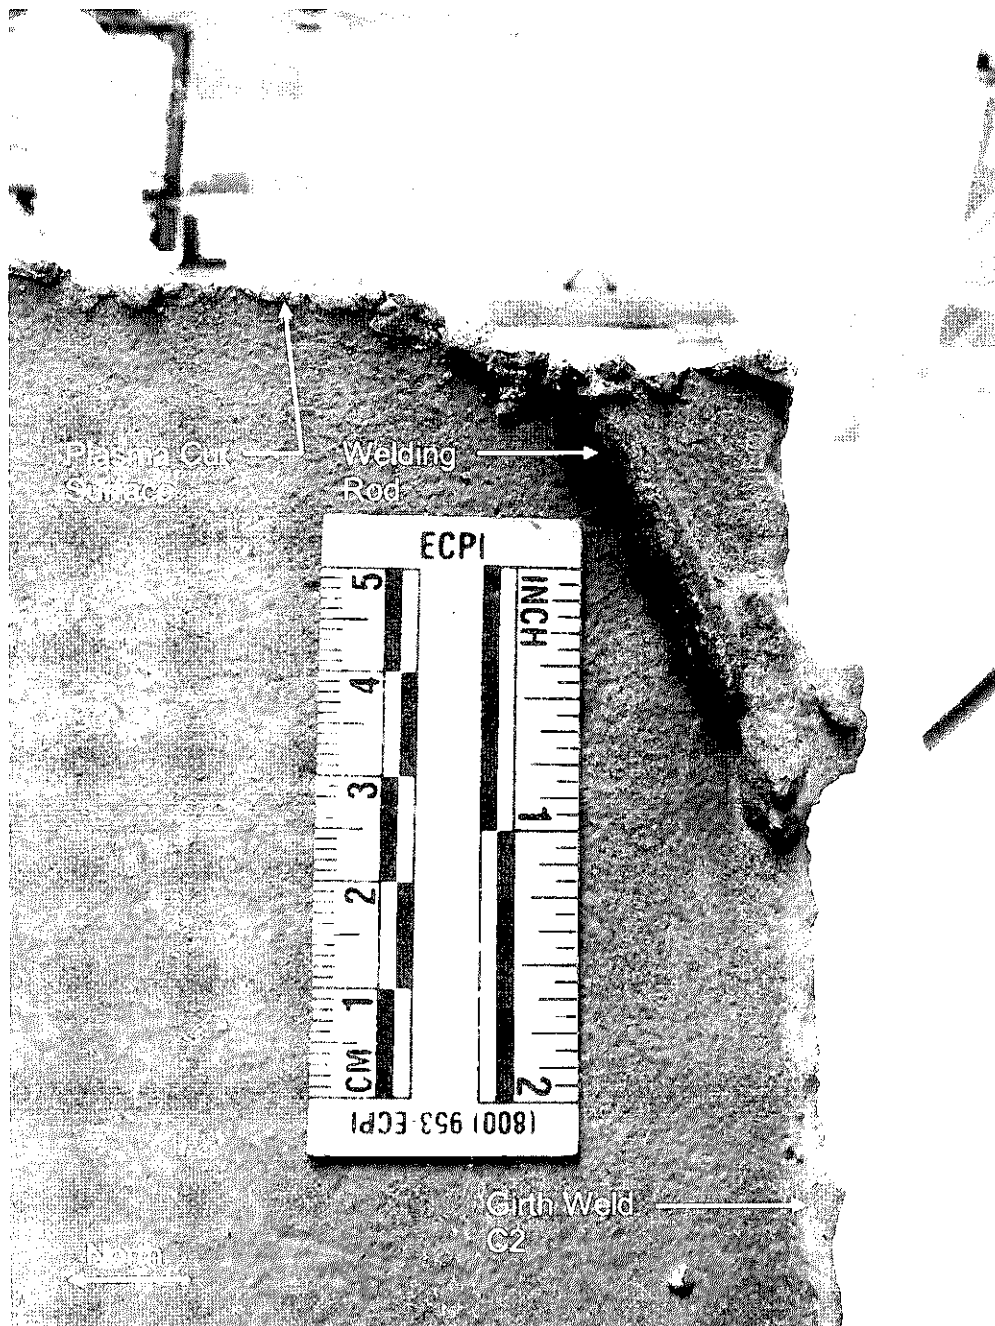
**Figure 23:** Laboratory photo showing length of welding rod fused to the inside of the C2 girth weld on the inner diameter of pup 2.

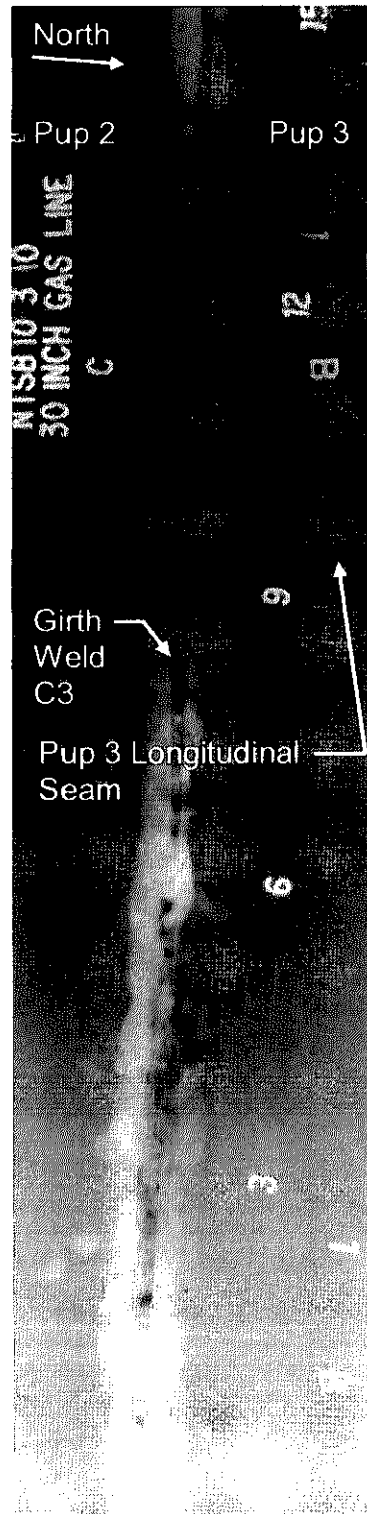
**Figure 24:** Radiograph of girth weld C3 from 0 inch – 15 inch (see Table B2) between pup 2 and pup 3. Part of the pup 3 longitudinal seam is visible.

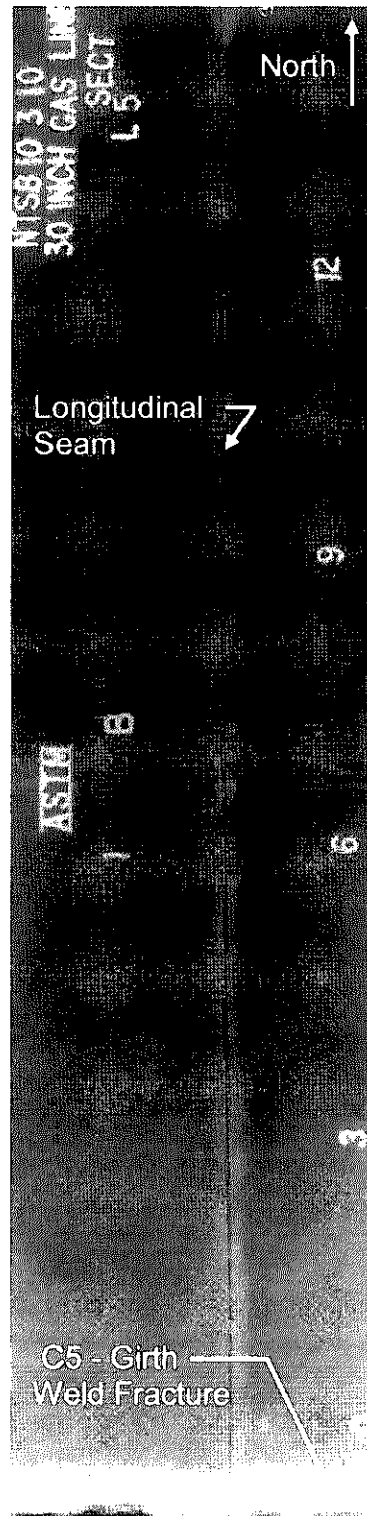
**Figure 25:** Radiograph of the pup 5 longitudinal seam from 0 inch – 12 inch (see Table B1) adjacent to the C5 girth weld fracture.

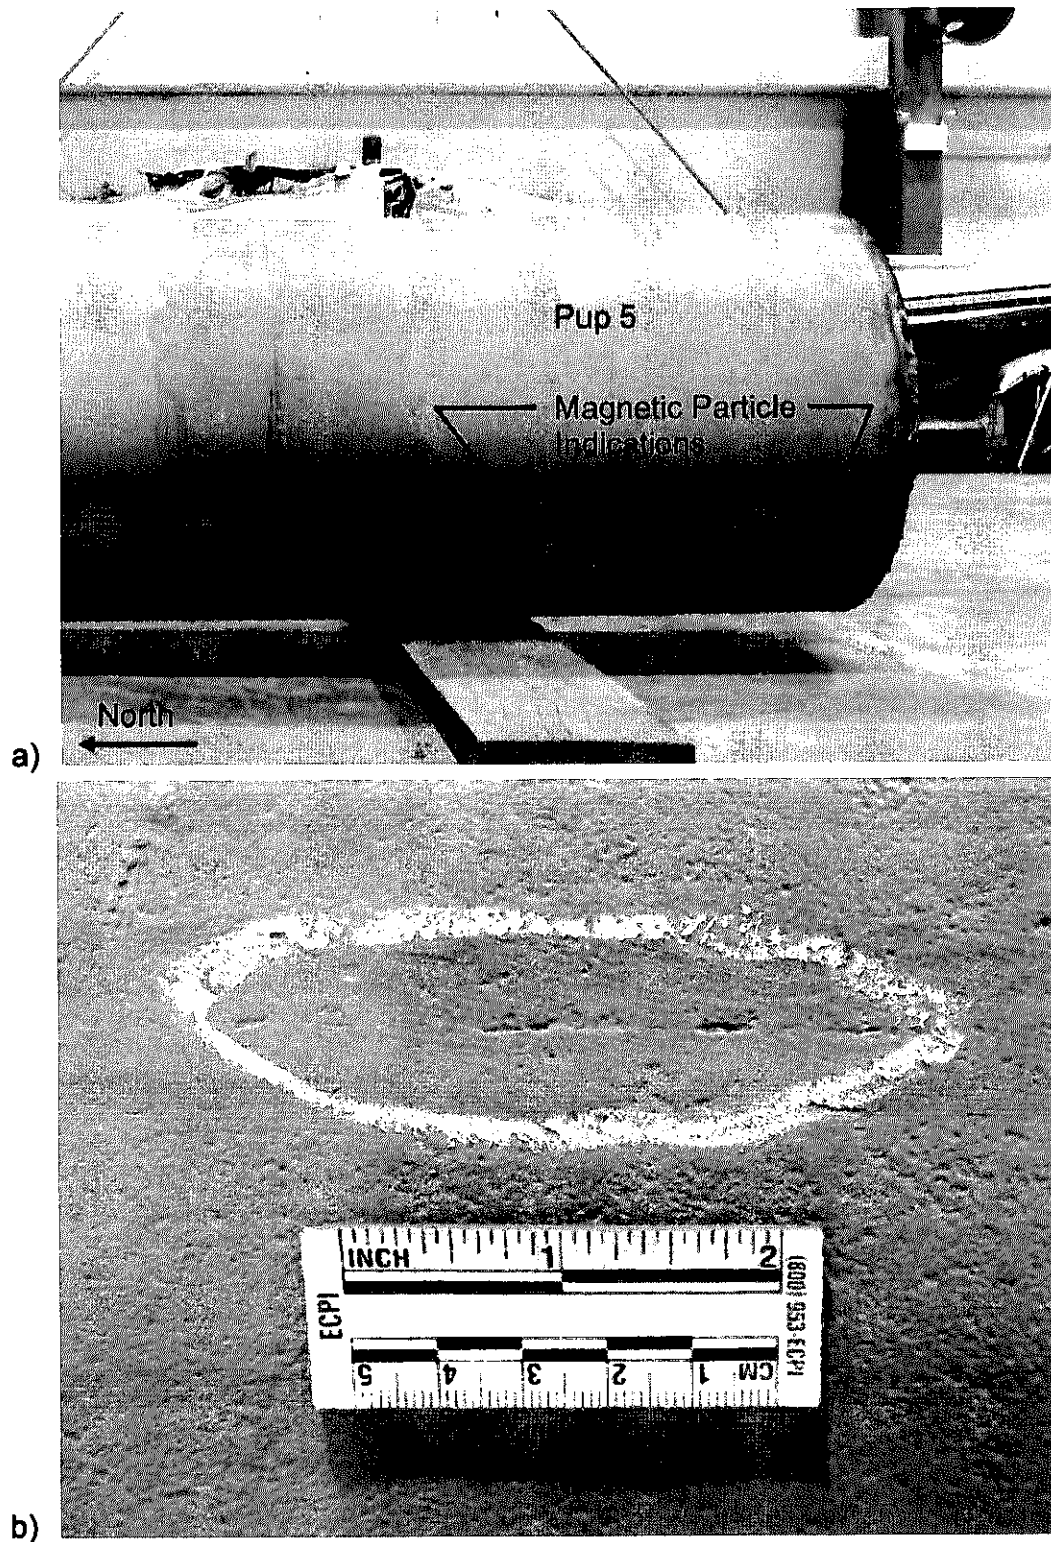
**Figure 26:** a) Pup 5 showing the location of features detected by magnetic particle inspection;  
b) Macrophotograph of the feature 5.5 inch north of the C5 girth weld.

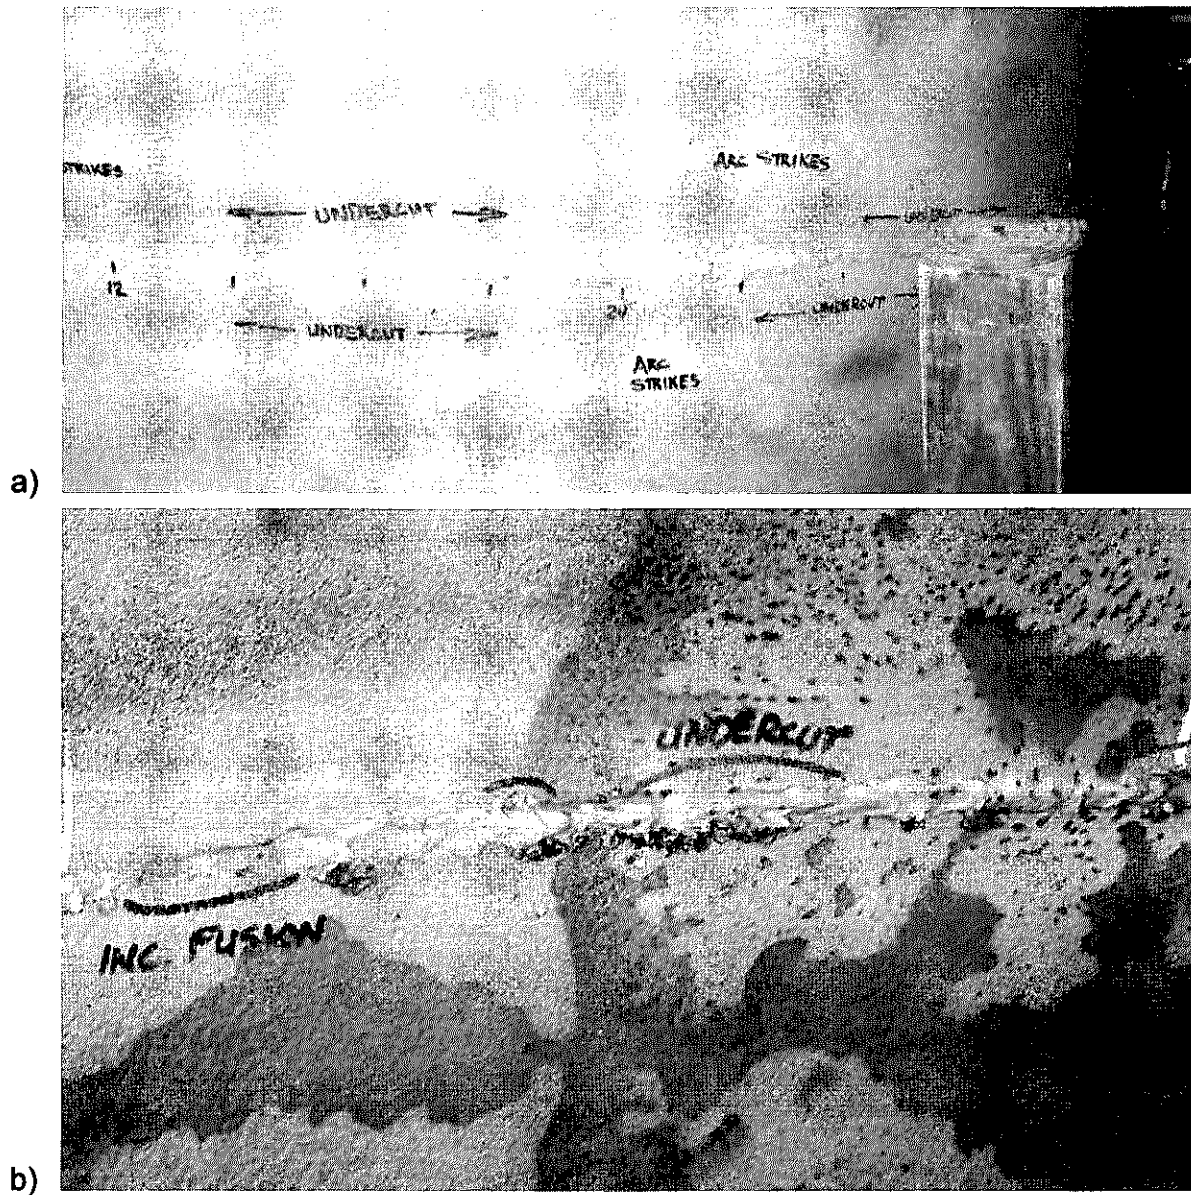
**Figure 27:** a) Weld imperfections indicated by visual examination on the external surface of girth weld C1; b) Weld imperfections indicated by visual examination on the internal surface of girth weld C2. The photograph was taken after magnetic particle inspection.

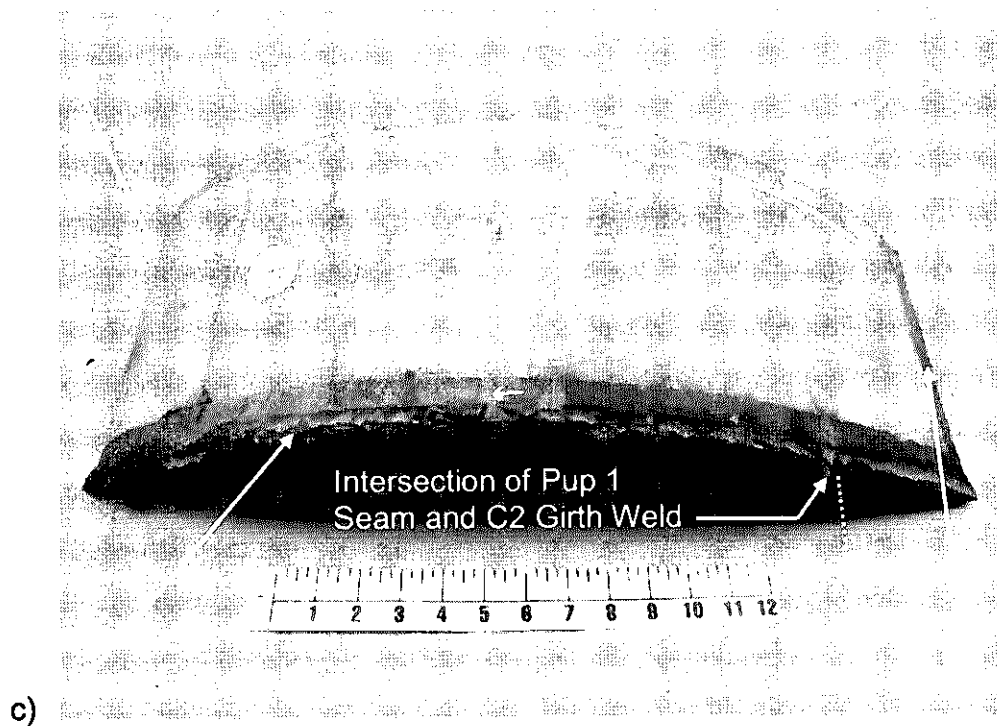
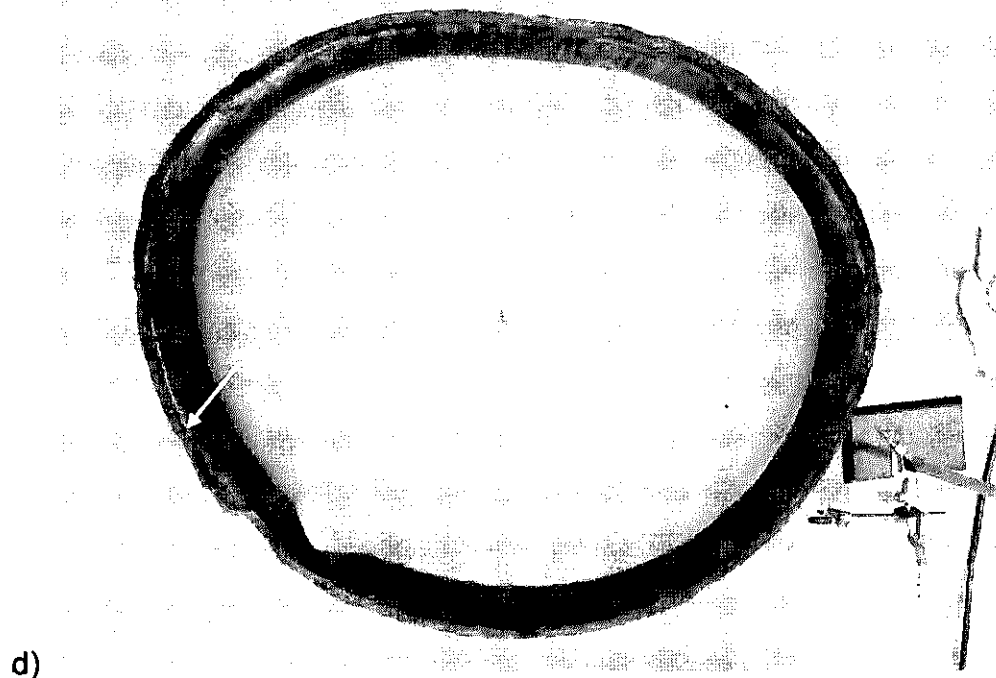
**Figure 28:** Laboratory photos of the sections cut from the pipe for fractographic examination;  
a) Pup 1 counterclockwise fracture surface; b) Pup 1 and pup 2 clockwise fracture surface;

**Figure 28 (cont.):** c) Section taken from pup 2; d) Ring cut from north end of pup 4 containing girth weld C5 fracture.

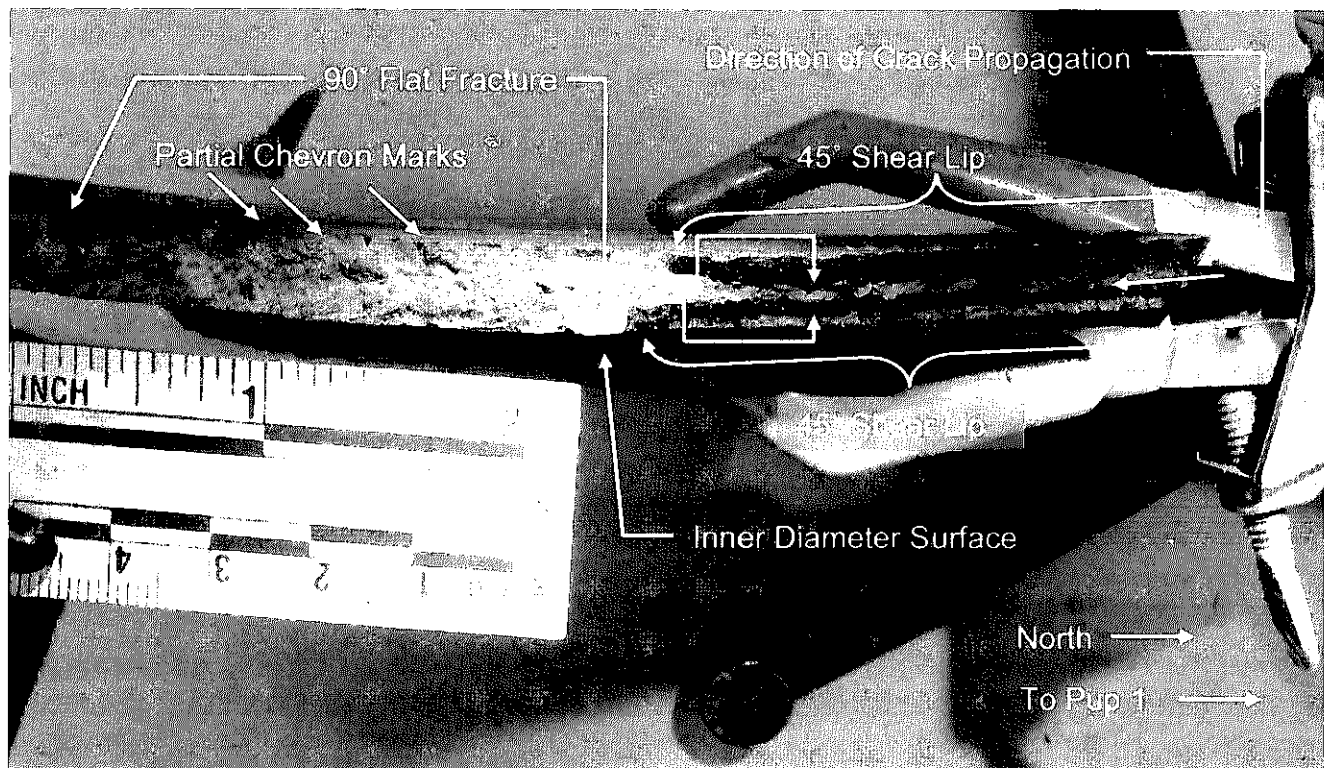
**Figure 29:** Counterclockwise fracture surface on the long joint south of pup 1 (see figure 28a). Partial chevron marks and 45° shear lips on the inner and outer wall were consistent with overstress fracture emanating from pup 1.

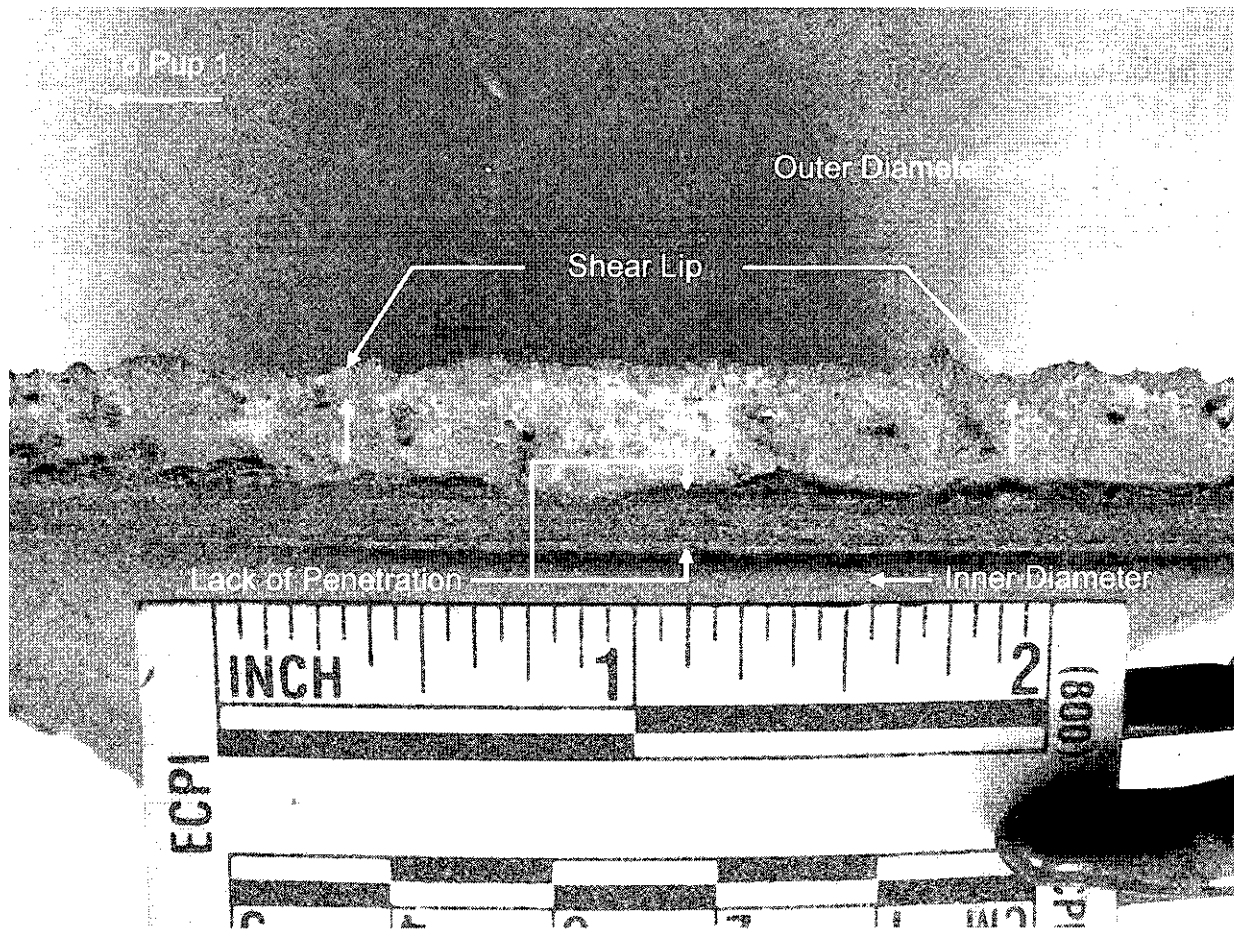
**Figure 30:** Counterclockwise half of longitudinal fracture on pup 2 (see figure 28c). Out of plane shear was observed along the longitudinal seam.

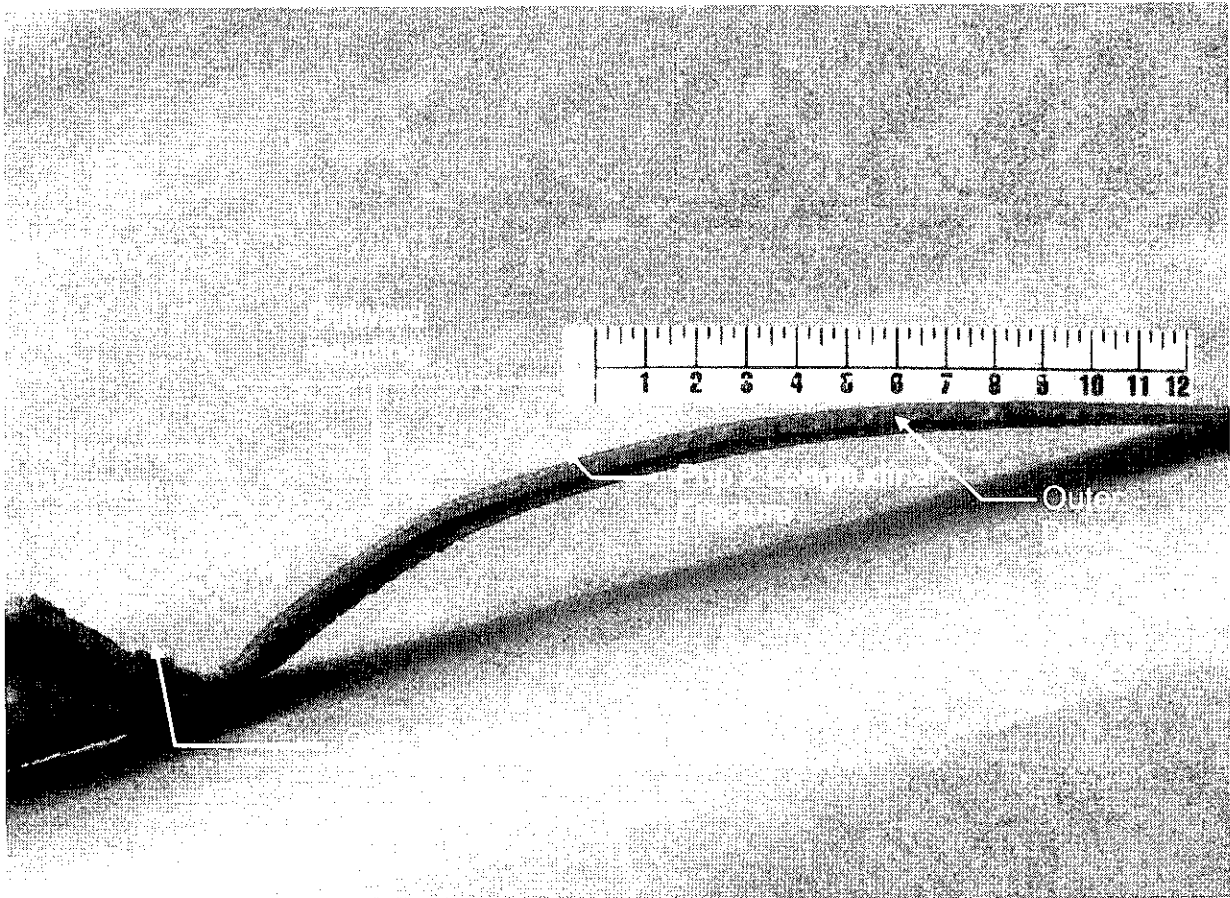
**Figure 31:** Clockwise half of pup 2 fracture viewed in the transverse direction. The wall was bent radially outward with the highest curvature at girth weld C2 and decreased continuously to a straight wall at mid length.

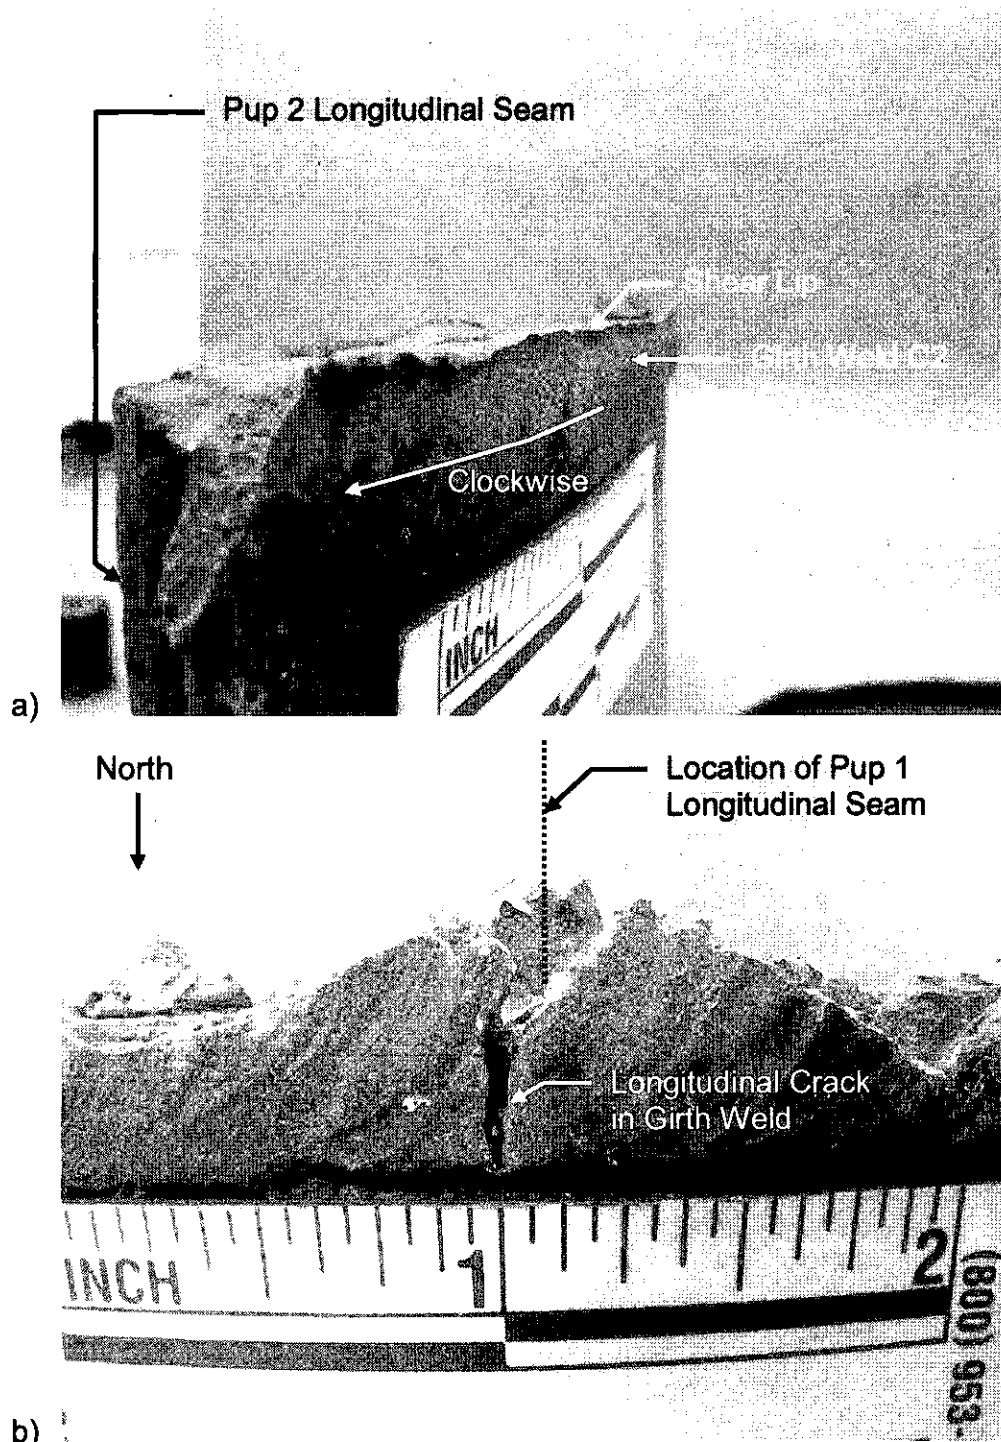
**Figure 32:** a) Shear lip on girth weld C2 fracture surface approaching the pup 2 longitudinal seam; b) Longitudinal crack in girth weld C2 in line with the longitudinal seam in pup 1.
