### Preliminary Report

- Accident No.: DCA10MP008
- Type of System: 30-inch natural gas transmission pipeline
- Accident Type: Pipeline rupture
- Location: San Bruno, CA
- Date: September 9, 2010
- Time: About 6:11 p.m., Pacific Daylight Time
- Owner/Operator: Pacific Gas & Electric Company
- Fatalities/Injuries: Eight fatalities, multiple injuries
- Pipeline Pressure: 386 pounds per square inch gauge (psig) at the time of rupture
- Quantity Released: Approximately 47.6 million standard cubic feet (MMSCF)

From September 30, 2010 through October 8, 2010, a Metallurgical Group was convened at a facility in Ashburn, VA for the purpose of documenting and examining the ruptured pipeline pieces and determining which portions of the pipe should be removed for further examination at the Materials Laboratory in Washington, DC. Members of the group included:

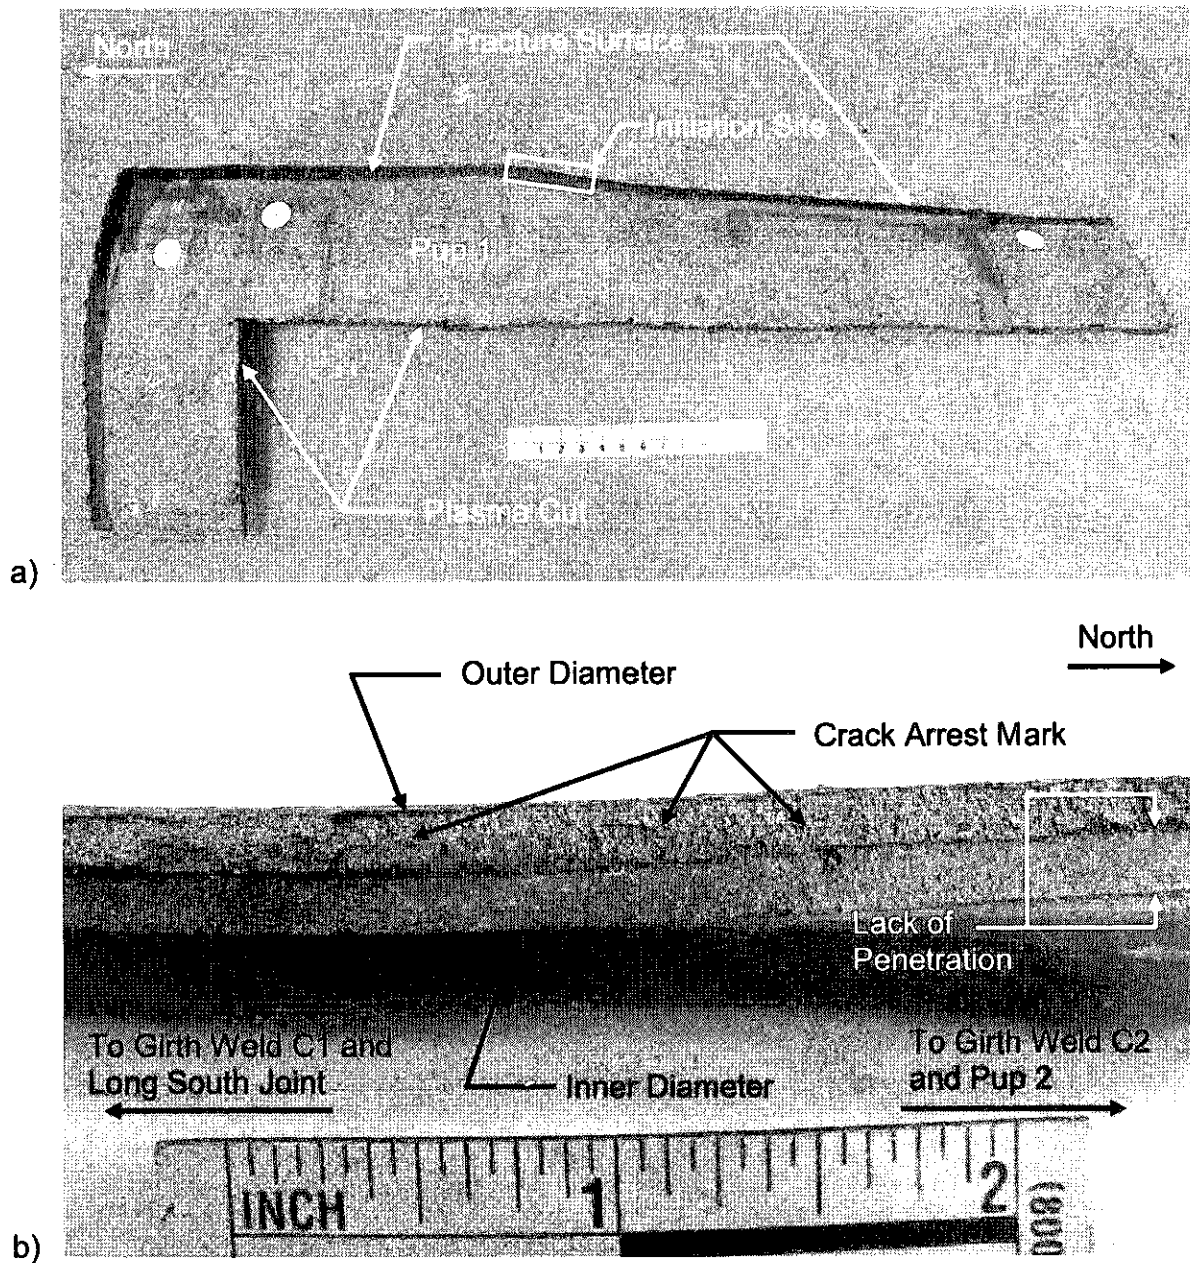
**Figure 33:** a) Counterclockwise half of pup 1 longitudinal fracture with the location of the crack initiation site indicated; b) cross section view of the longitudinal seam at the initiation site.

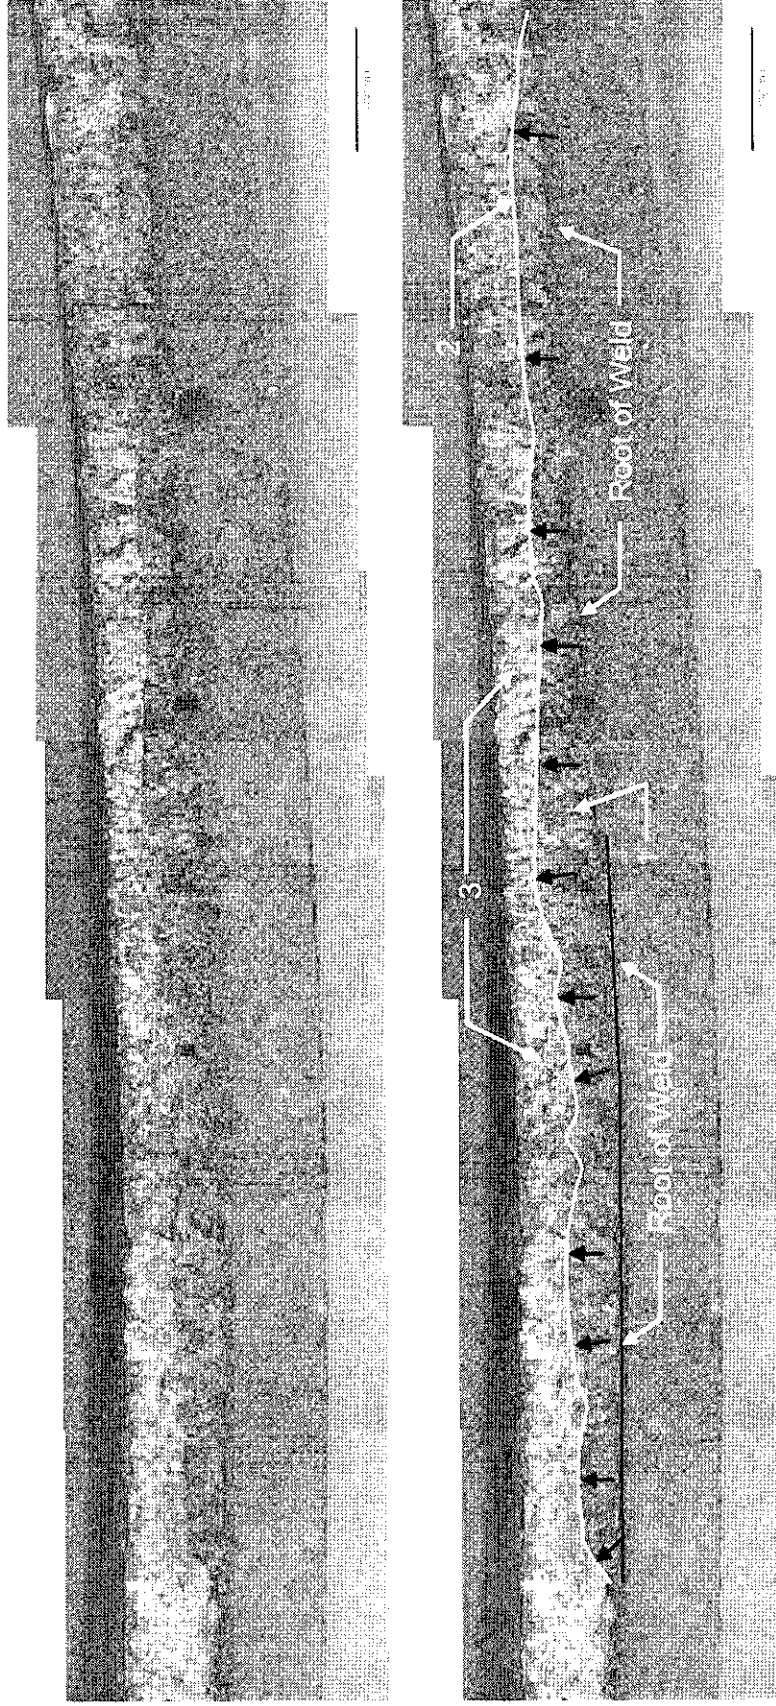
**Figure 34:** Optical micrographs of the fracture initiation site in pup 1. Top: Unlabelled micrograph, Bottom: Same micrograph with a crack arrest mark indicated by a yellow dotted line and the three fracture surface morphologies identified by scanning electron microscopy, 1 - ductile overstress (dimple rupture), 2 - progressive fracture, 3 - quasicleavage. The black arrows indicate the approximate direction of crack propagation. Note: The micrographs were taken after an inhibited acid solution was used to remove iron oxides.

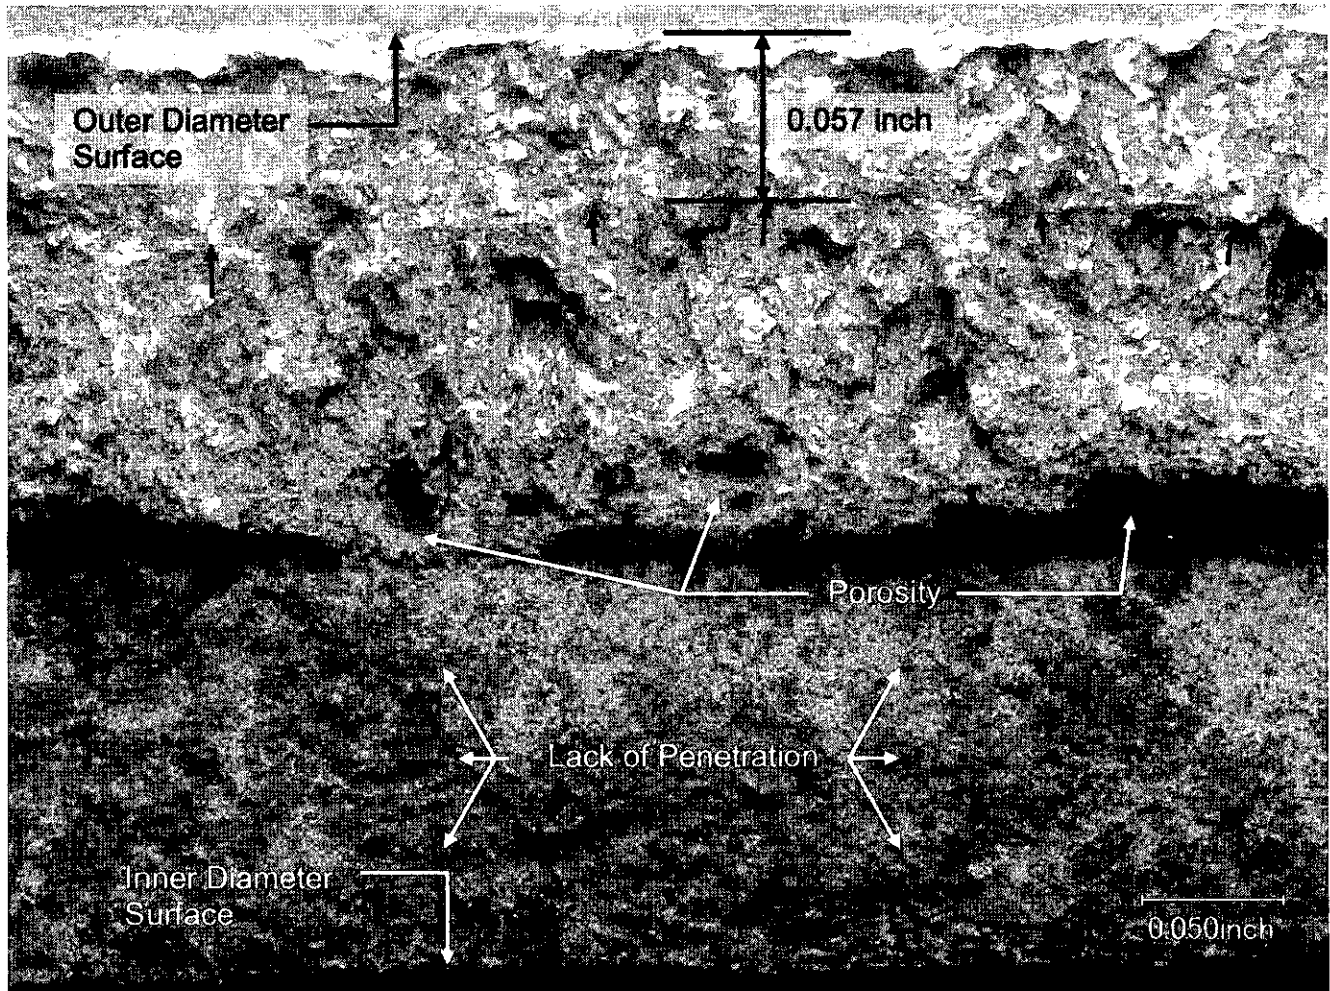
**Figure 35:** Micrograph of the initiation site in pup 1 at the 21.4 inch mark, the deepest point of the crack arrest mark. The profile of the arrest mark is indicated by the black arrows.

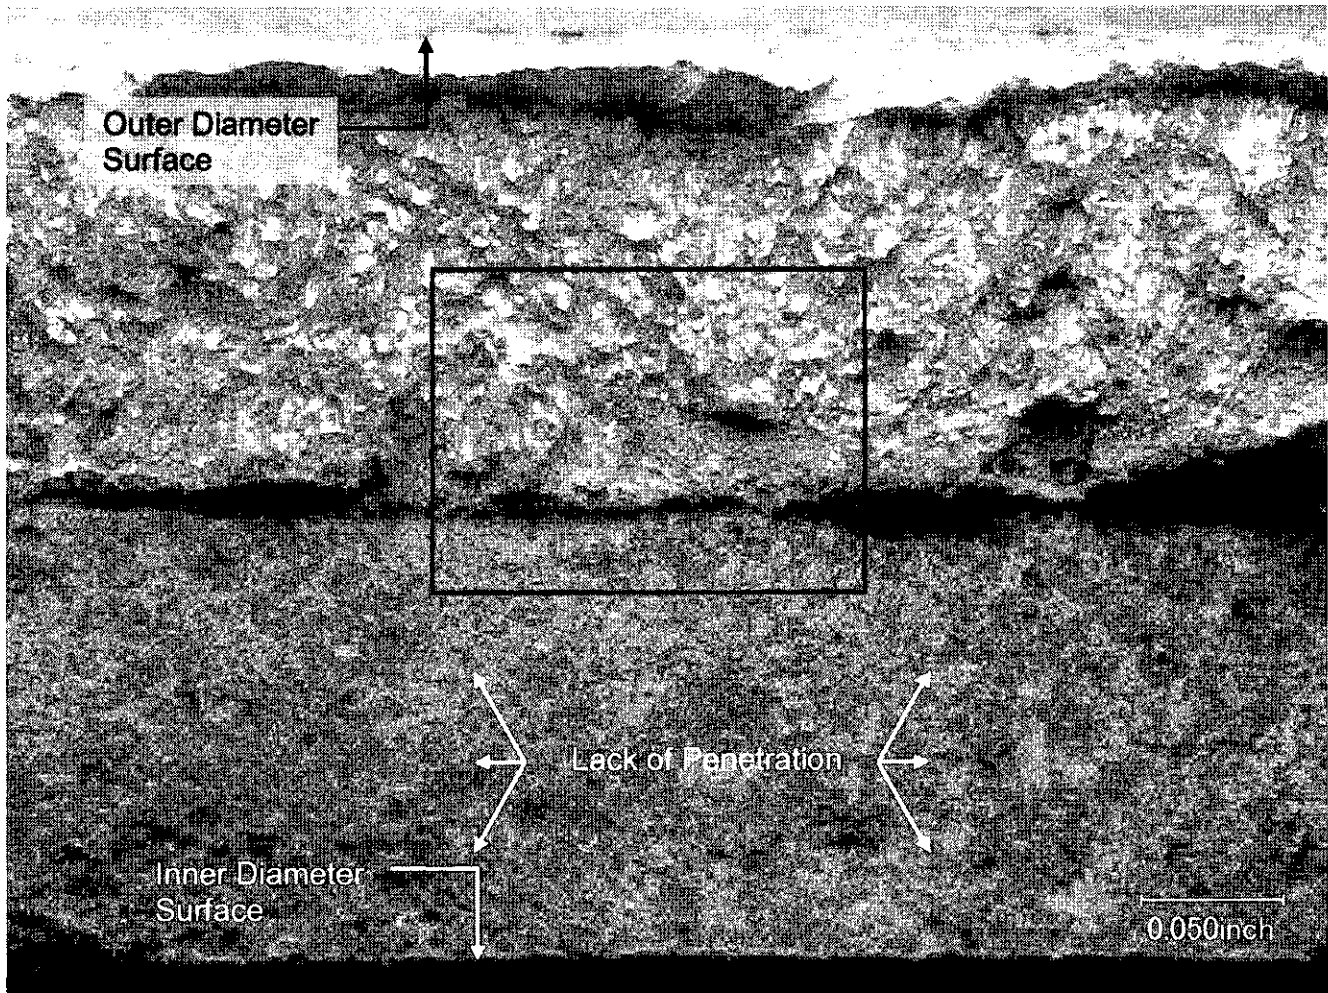
**Figure 36:** Micrograph of the north end of the initiation site at the 22.7 inch mark. A higher magnification view of the fracture surface in the black box is shown in figure 37.

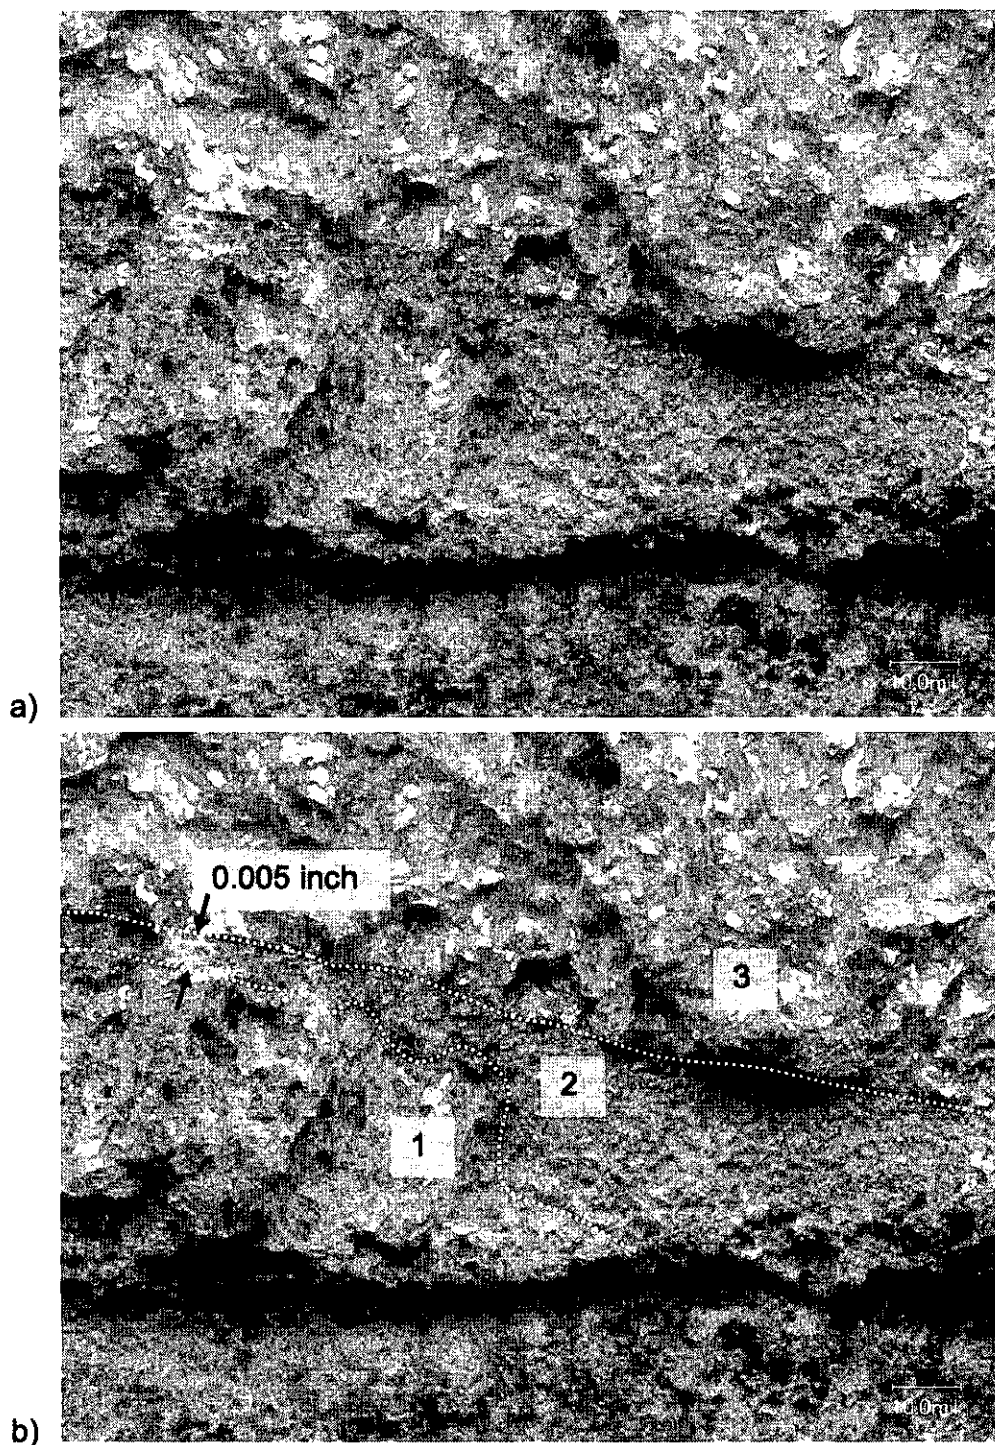
**Figure 37:** Photomicrograph of the north end of the fracture surface at the 22.7 inch mark. A flat fracture surface region at the crack arrest mark was observed between the yellow dashed lines in the bottom micrograph; a) micrograph without annotations; b) micrograph with annotations.

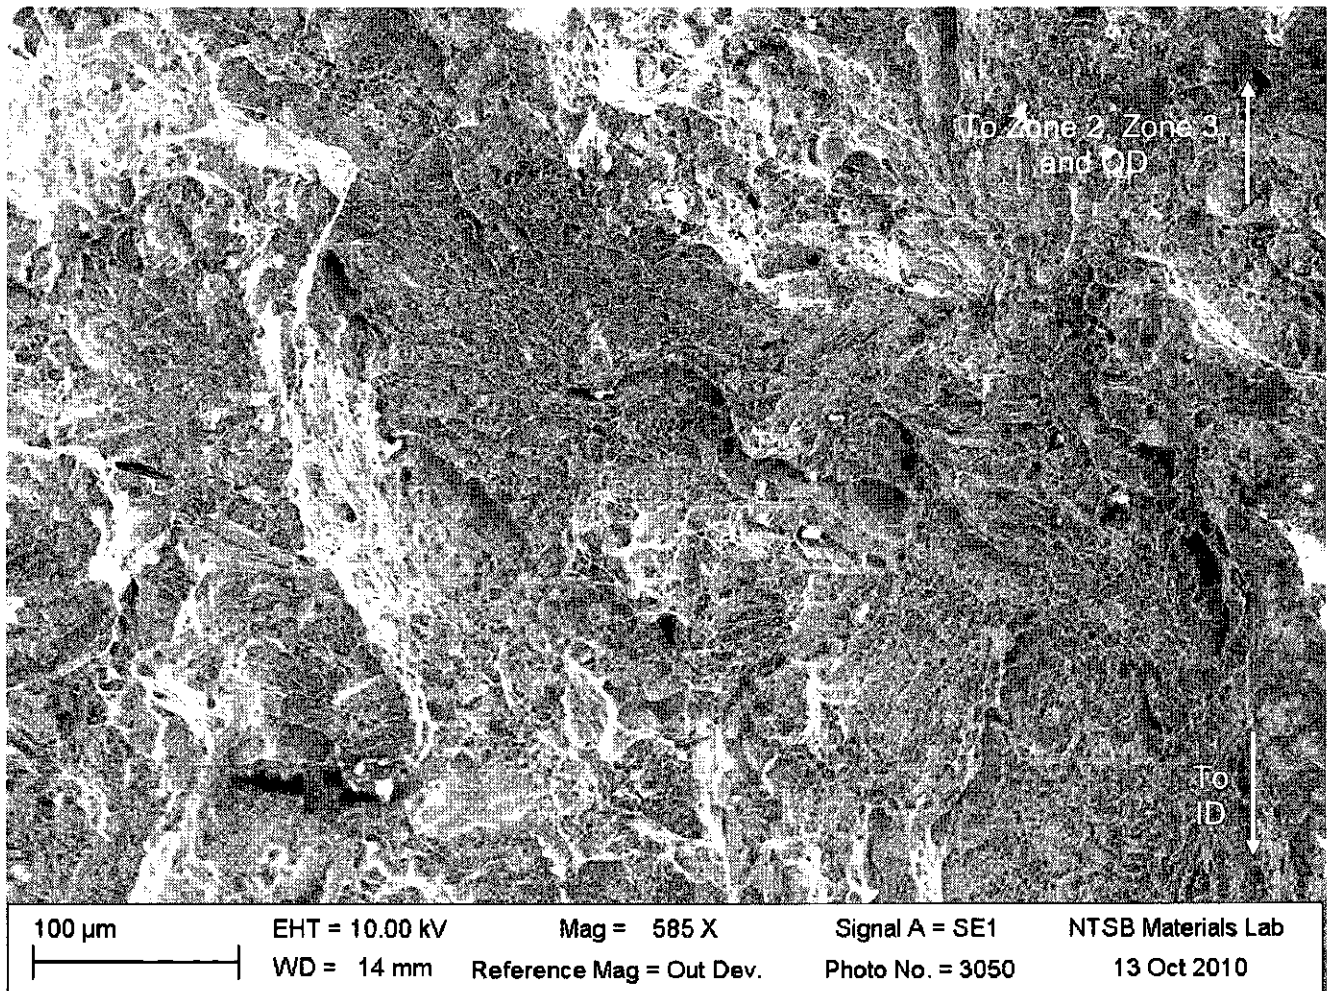
**Figure 38:** Scanning electron micrograph from zone 1 of the initiation site. Dimples were observed on the fracture surface consistent with ductile fracture.

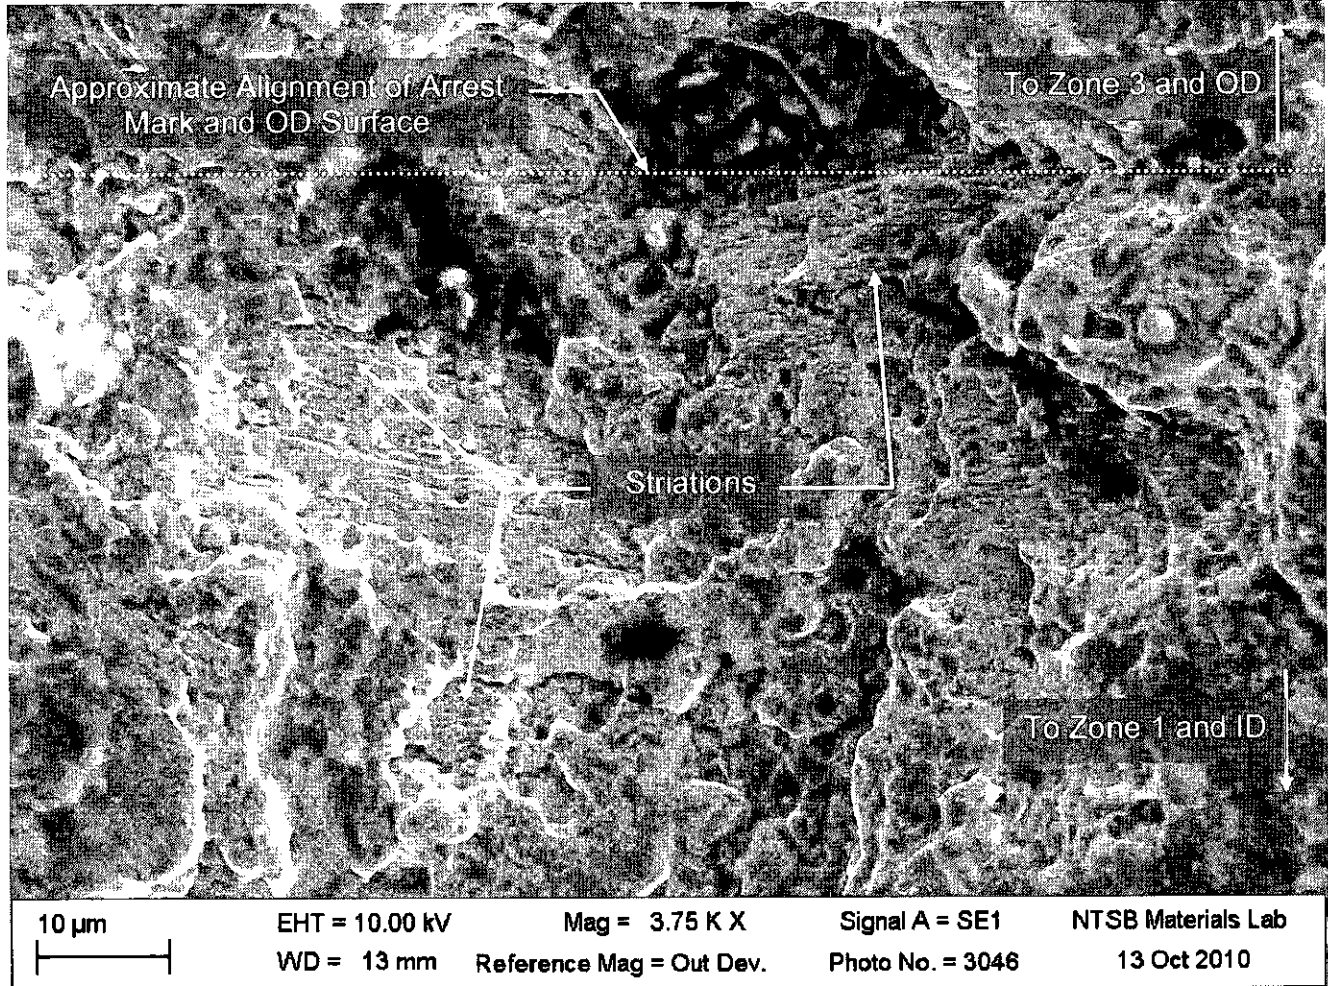
**Figure 39:** Scanning electron micrograph from zone 2 of the initiation site near the 22 inch mark. Striated features were observed on the fracture surface.

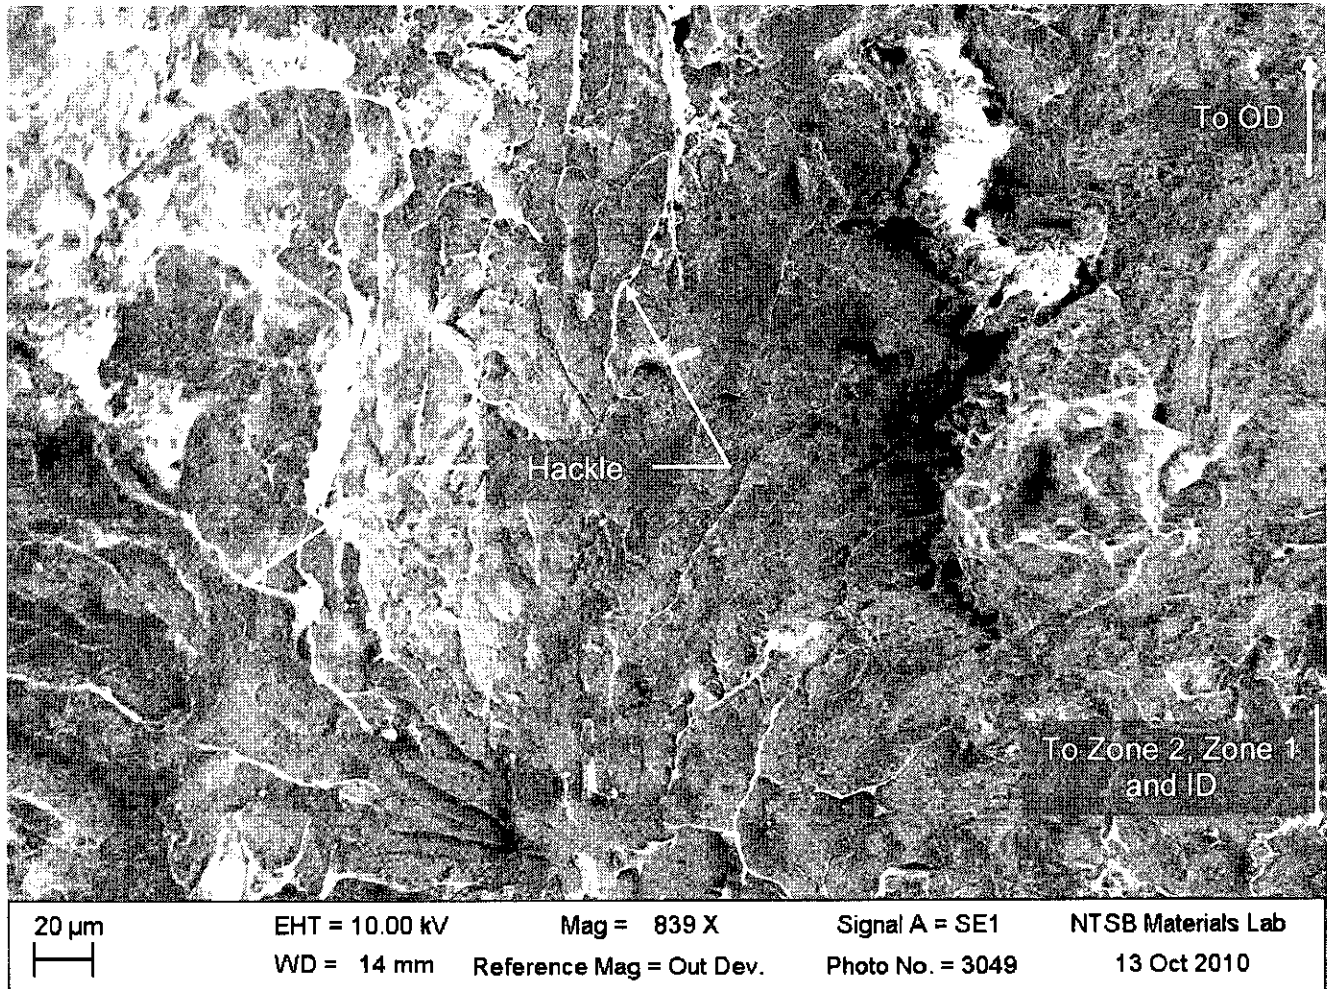
**Figure 40:** Scanning electron micrograph from zone 3 of the initiation site. The fracture surface had a smooth appearance with hackle marks propagating across the surface consistent with quasicleavage fracture.

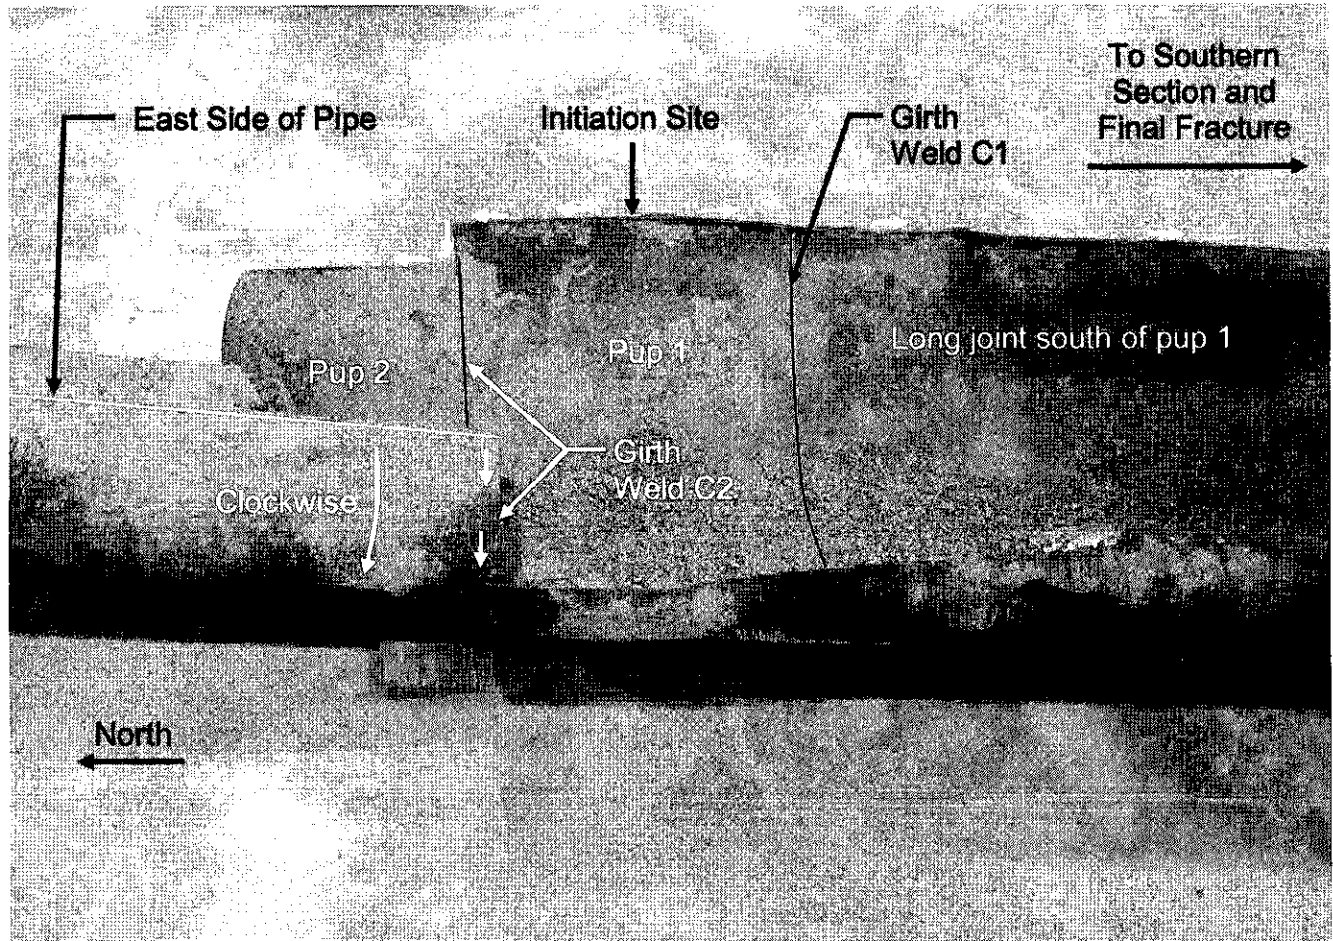
**Figure 41:** Photograph of center section showing the location of the initiation site in pup 1 and white arrows indicating the direction of crack propagation consistent with the observed fracture features.

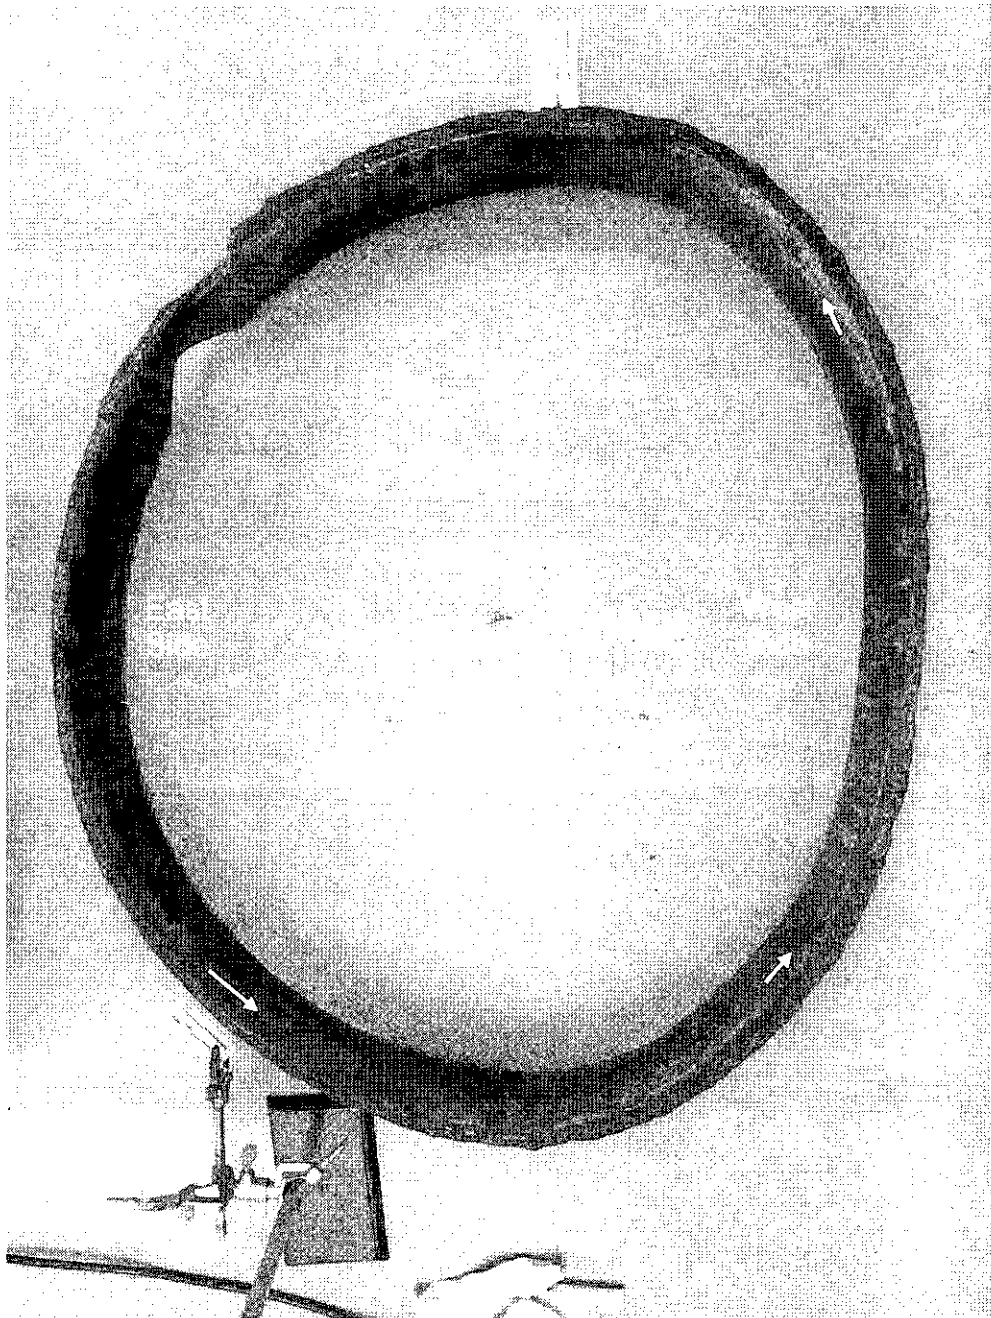
**Figure 42:** Photograph of the south half of the girth weld fracture at C5 between pup 4 and pup 5. The view is of the half associated with pup 4 viewed in the south direction (north out of the page). Yellow arrows in the figure indicate where the location and direction of crack propagation could be determined.

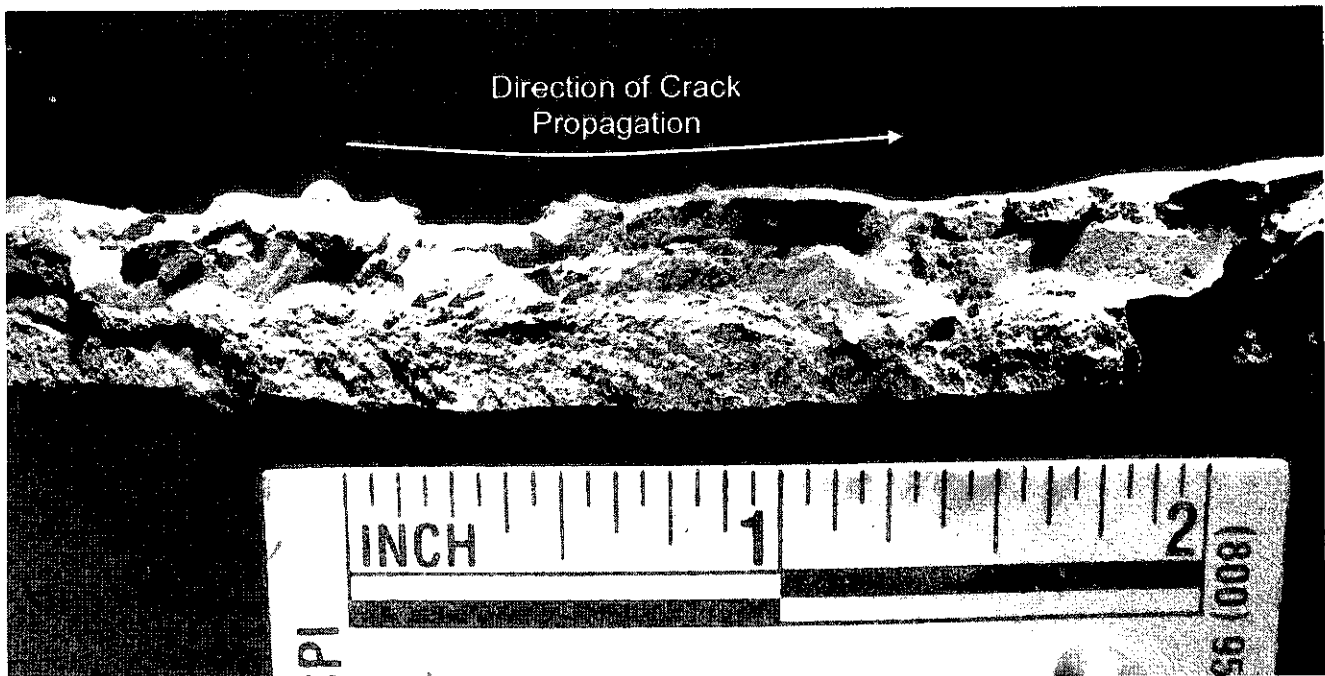
**Figure 43:** Example macrophotograph of the girth weld fracture surface approximately 150° clockwise from the true top of the pipe. The red arrows indicate lines on the fracture surface that point back in the direction of the crack origin.

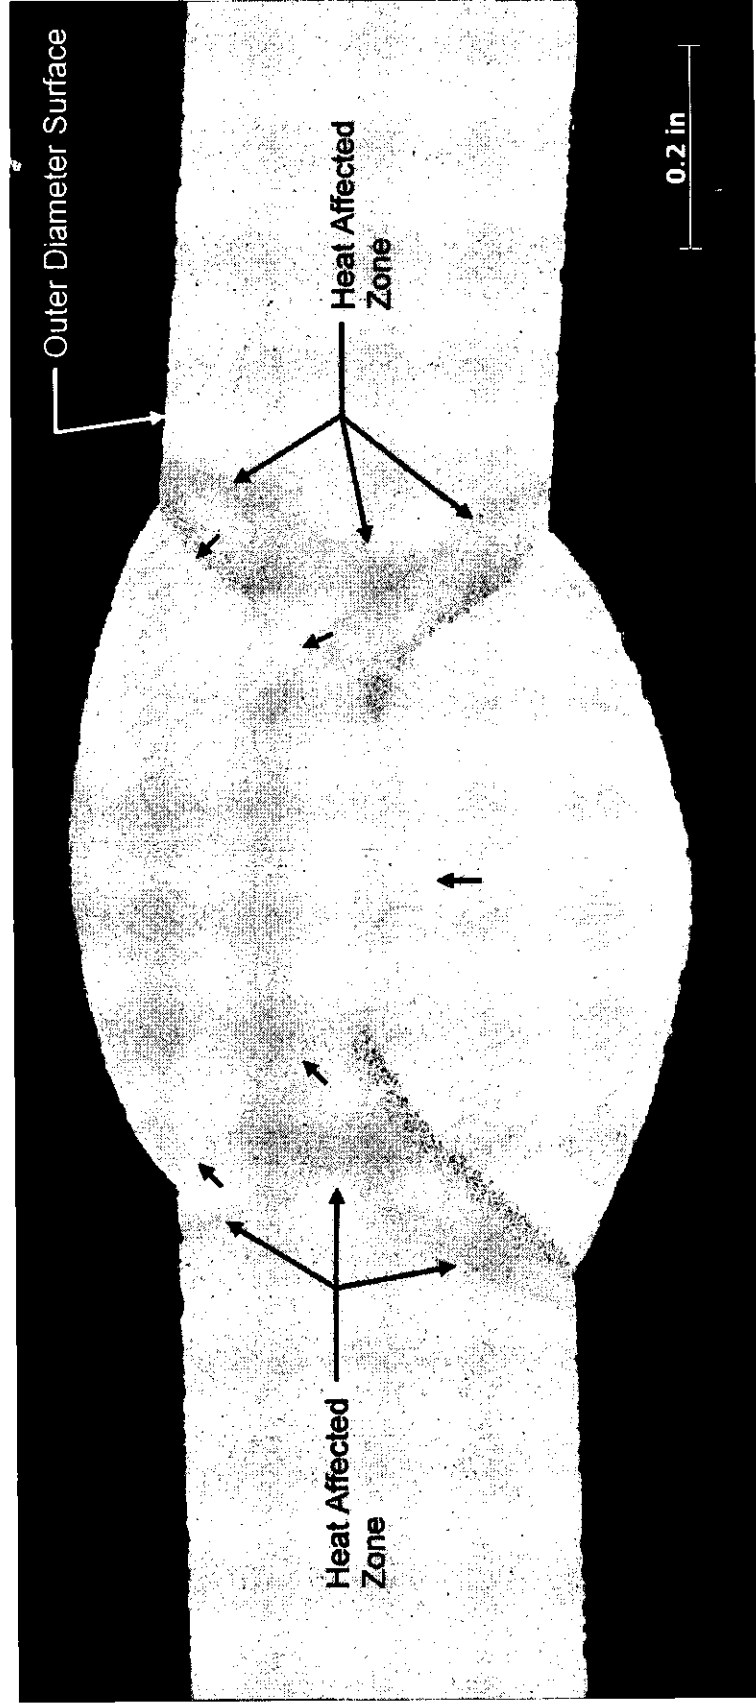
**Figure 44:** Etched metallographic cross section of the longitudinal seam in the long joint south of pup 1 taken 6 inch south of girth weld C1. The microstructure of the weld was consistent with a double submerged arc welding process. Blue arrows – weld pool from first pass along outer diameter surface. Orange arrows – weld pool from second pass along inner diameter surface.

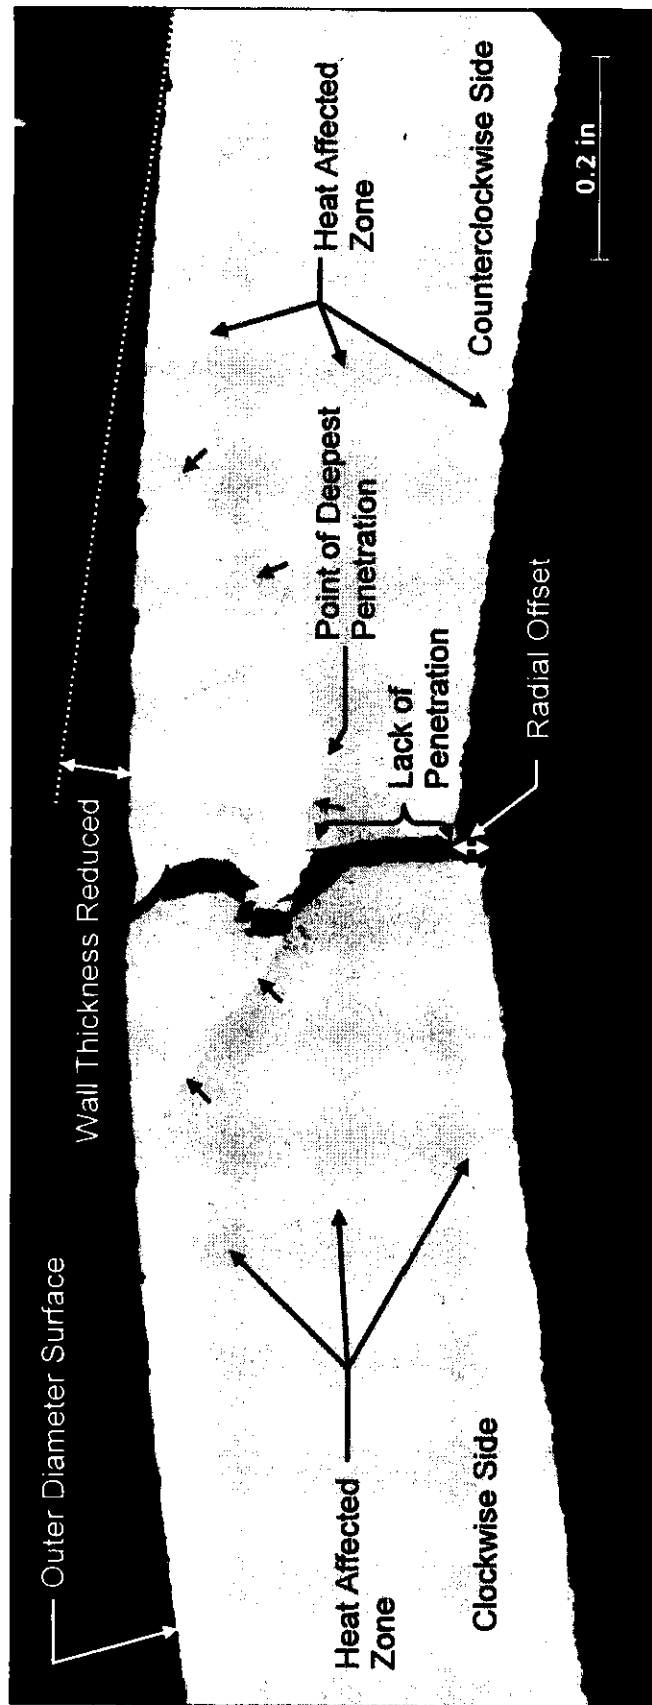
**Figure 45:** Etched metallographic mating fracture cross section of the longitudinal seam in pup 1 taken 9 inch north of girth weld C1. The two sides of the seam are aligned to within 0.005 inch in the longitudinal direction. The microstructure of the weld was consistent with a fusion welding process along the outer diameter surface of the seam. Blue arrows – weld pool boundary along outer diameter surface seam.

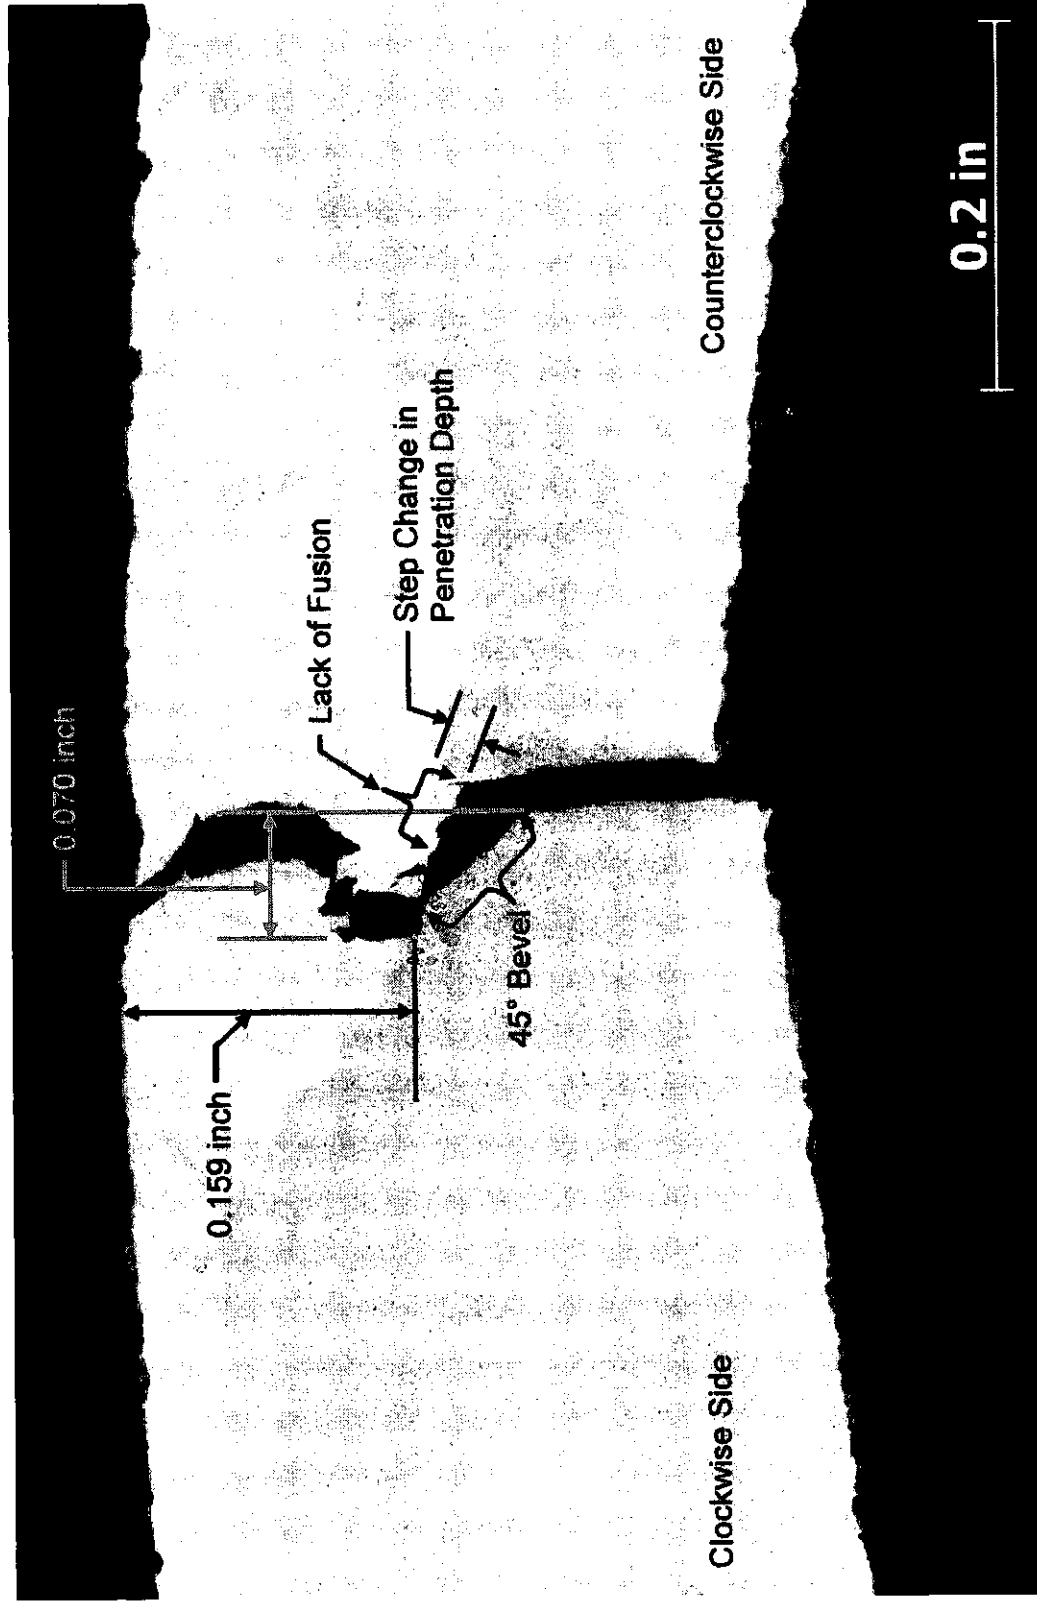
**Figure 46:** Higher magnification view of the seam in pup 1 (see figure 44) showing the offset from the seam and depth of penetration at the plane of fracture.

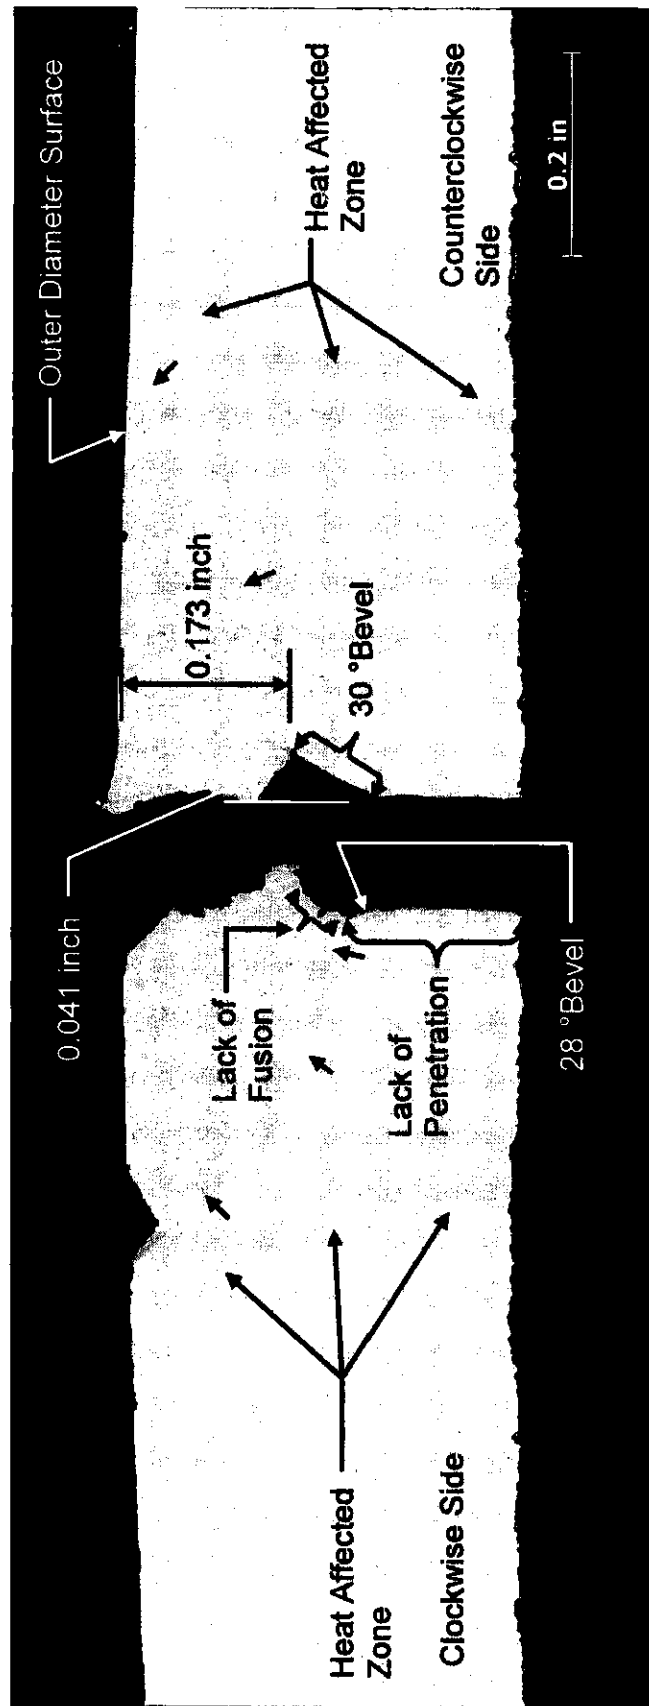
**Figure 47:** Etched metallographic mating faces cross section of the longitudinal seam in pup 2 taken 9 inch south of girth weld C3. Lineup in the longitudinal direction is within 0.05 inch. The microstructure of the weld was consistent with a fusion welding process along the outer diameter surface of the seam. Blue arrows – weld pool boundary along outer diameter surface seam.

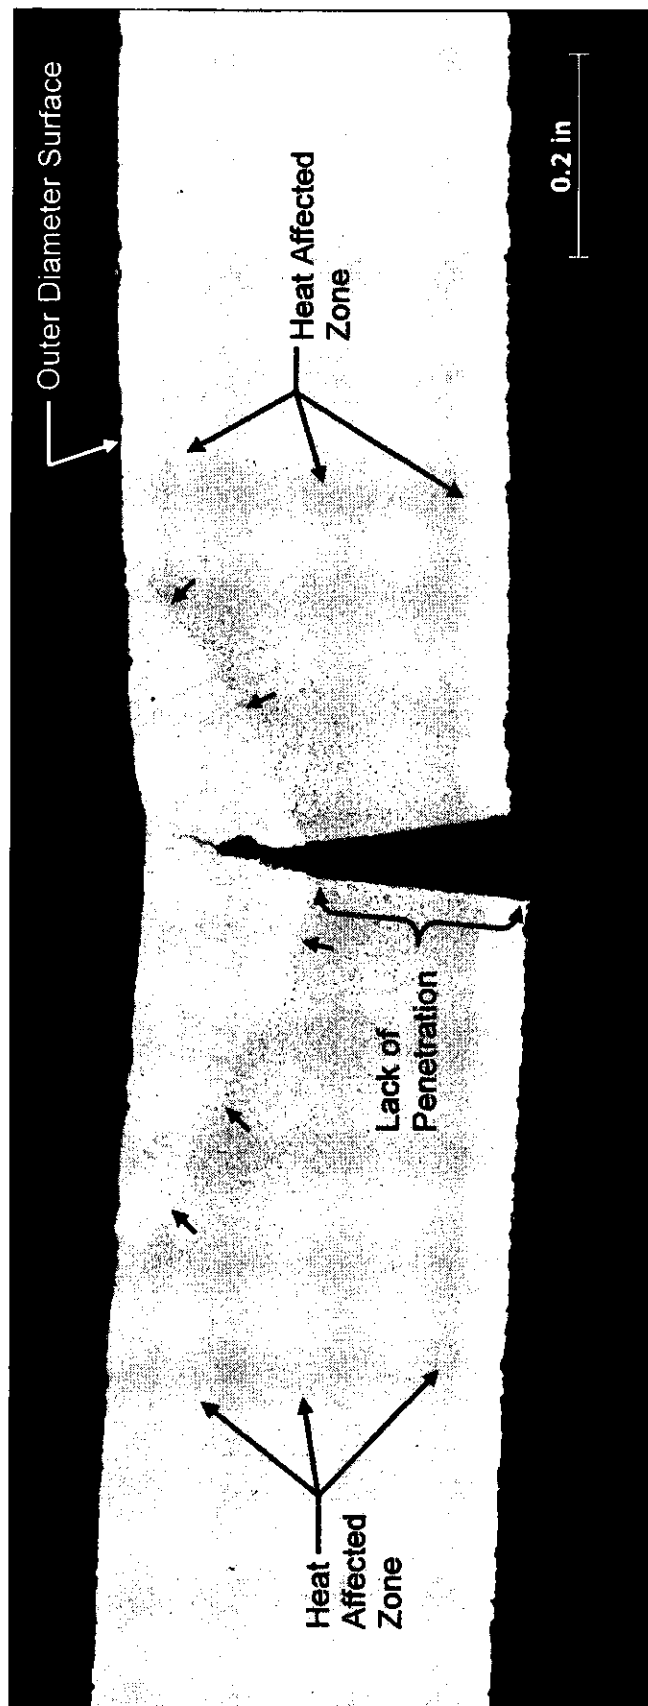
**Figure 48:** Etched metallographic cross section of the longitudinal seam in pup 3 taken 10 inch north of girth weld C3. The microstructure of the weld was consistent with a fusion welding process along the outer diameter surface of the seam.  
Blue arrows – weld pool boundary along outer diameter surface seam.

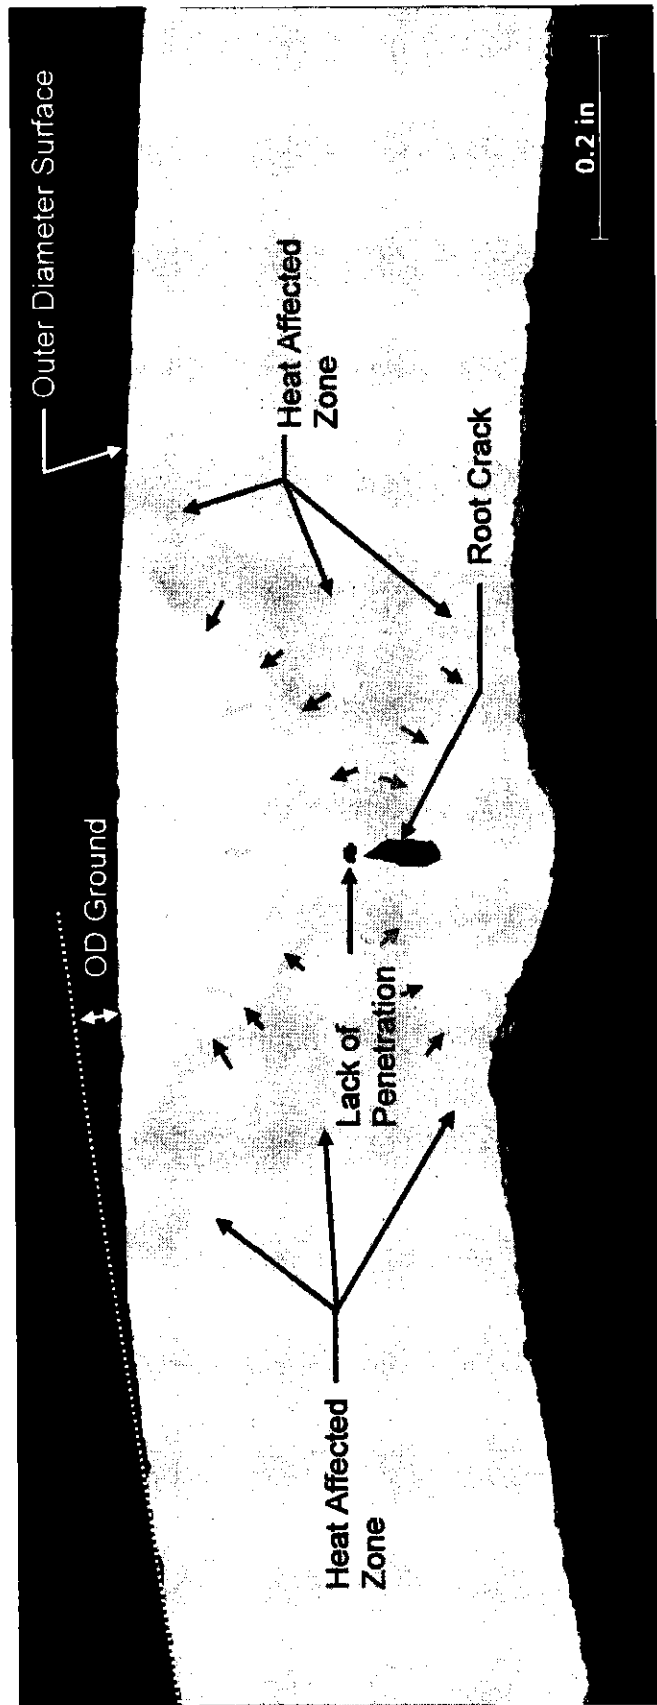
**Figure 49:** Etched metallographic cross section of the longitudinal seam in pup 4 taken 8 inch south of girth weld C5. The microstructure of the weld was consistent with a multi-pass fusion welding process along the outer diameter surface of the seam and a fusion welding process along the inner diameter surface of the seam. Blue arrows – weld pool boundary from first pass along outer diameter surface. Orange arrows – weld pool boundary from second pass along inner diameter surface. Red arrows – weld pool boundary from pass along inner diameter surface.
