### Preliminary Report

- Accident No.: DCA10MP008
- Type of System: 30-inch natural gas transmission pipeline
- Accident Type: Pipeline rupture
- Location: San Bruno, CA
- Date: September 9, 2010
- Time: About 6:11 p.m., Pacific Daylight Time
- Owner/Operator: Pacific Gas & Electric Company
- Fatalities/Injuries: Eight fatalities, multiple injuries
- Pipeline Pressure: 386 pounds per square inch gauge (psig) at the time of rupture
- Quantity Released: Approximately 47.6 million standard cubic feet (MMSCF)

From September 30, 2010 through October 8, 2010, a Metallurgical Group was convened at a facility in Ashburn, VA for the purpose of documenting and examining the ruptured pipeline pieces and determining which portions of the pipe should be removed for further examination at the Materials Laboratory in Washington, DC. Members of the group included:

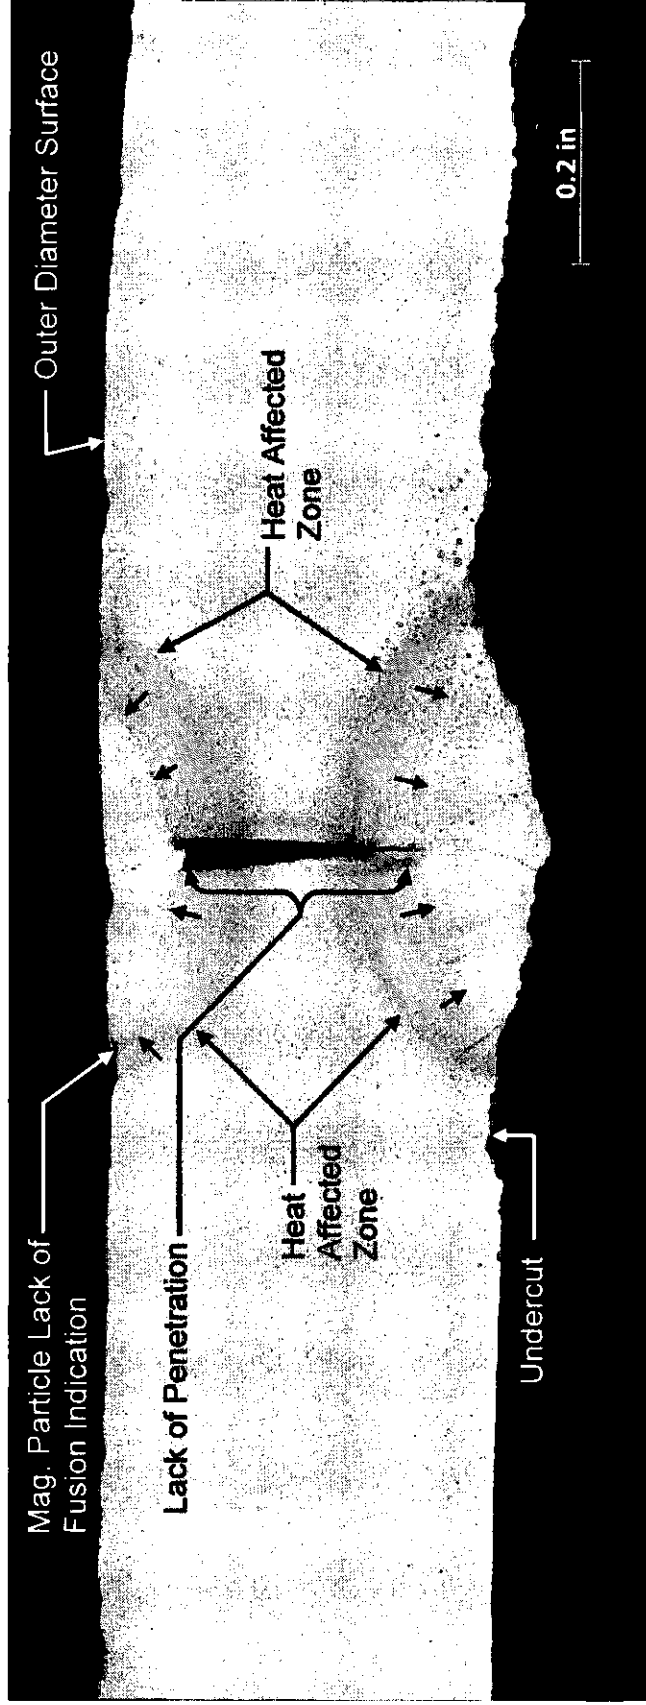
**Figure 50:** Etched metallographic cross section of the longitudinal seam in pup 5 taken 5.5 inch north of girth weld C5 where magnetic particle inspection indicated lack of fusion. The microstructure of the weld was consistent with a fusion welding process along the outer diameter surface of the seam and a fusion welding process along the inner diameter surface of the seam. Blue arrows – weld pool boundaries along outer and inner diameter surface seams.

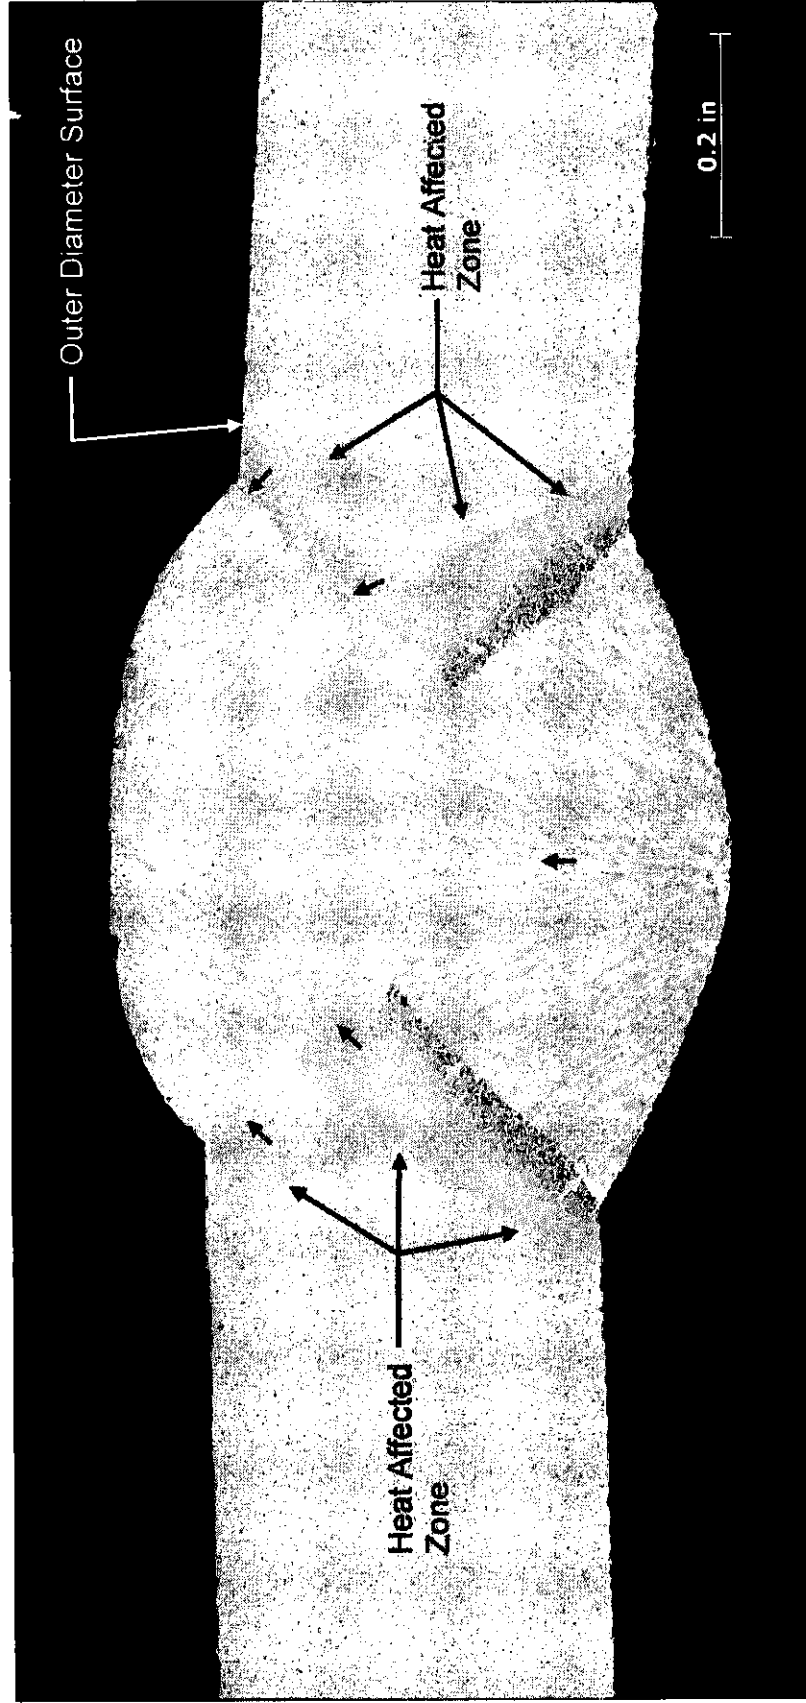
**Figure 51:** Etched metallographic cross section of the longitudinal seam in the pup 6 taken 6 inch north of girth weld C6. The microstructure of the weld was consistent with a double submerged arc welding process. Blue arrows – weld pool from first pass along outer diameter surface. Orange arrows – weld pool from second pass along inner diameter surface.

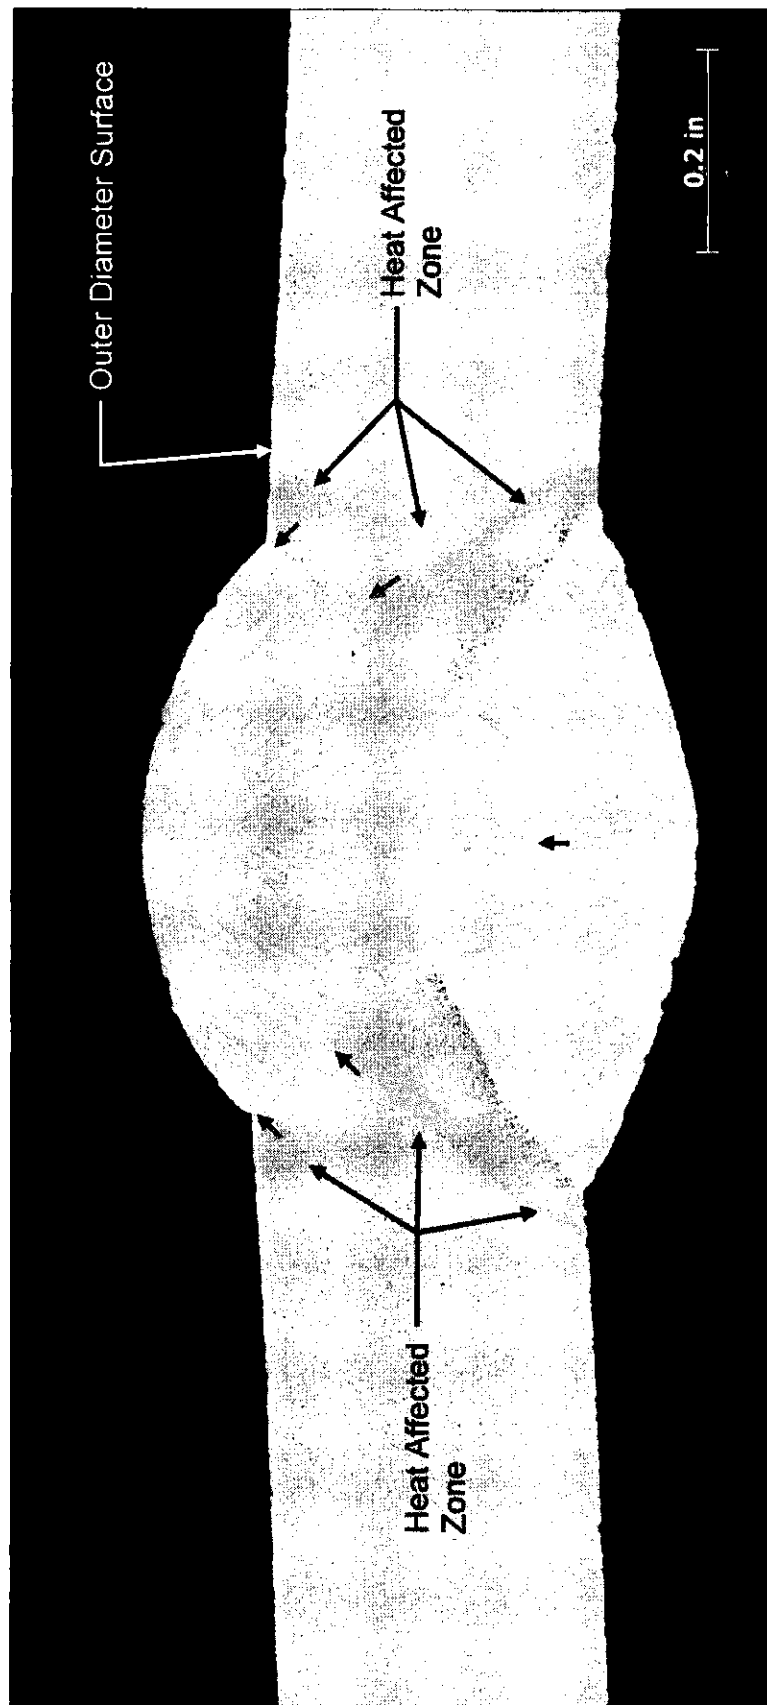
**Figure 52:** Etched metallographic cross section of the longitudinal seam in the long joint north of pup 6 taken 14 inch north of girth weld C7. The microstructure of the weld was consistent with a double submerged arc welding process. Blue arrows – weld pool from first pass along outer diameter surface. Orange arrows – weld pool from second pass along inner diameter surface.
