**INVESTIGATION REPORT
OF THE
SEPTEMBER 30, 2013 SUBCONTRACTOR
FATALITY AT A SOUTHERN CALIFORNIA
EDISON COMPANY UNDERGROUND
VAULT IN HUNTINGTON BEACH**

PUBLIC REPORT

**SAFETY AND ENFORCEMENT DIVISION
ELECTRIC SAFETY AND RELIABILITY BRANCH**

**LOS ANGELES
OCTOBER 2015**

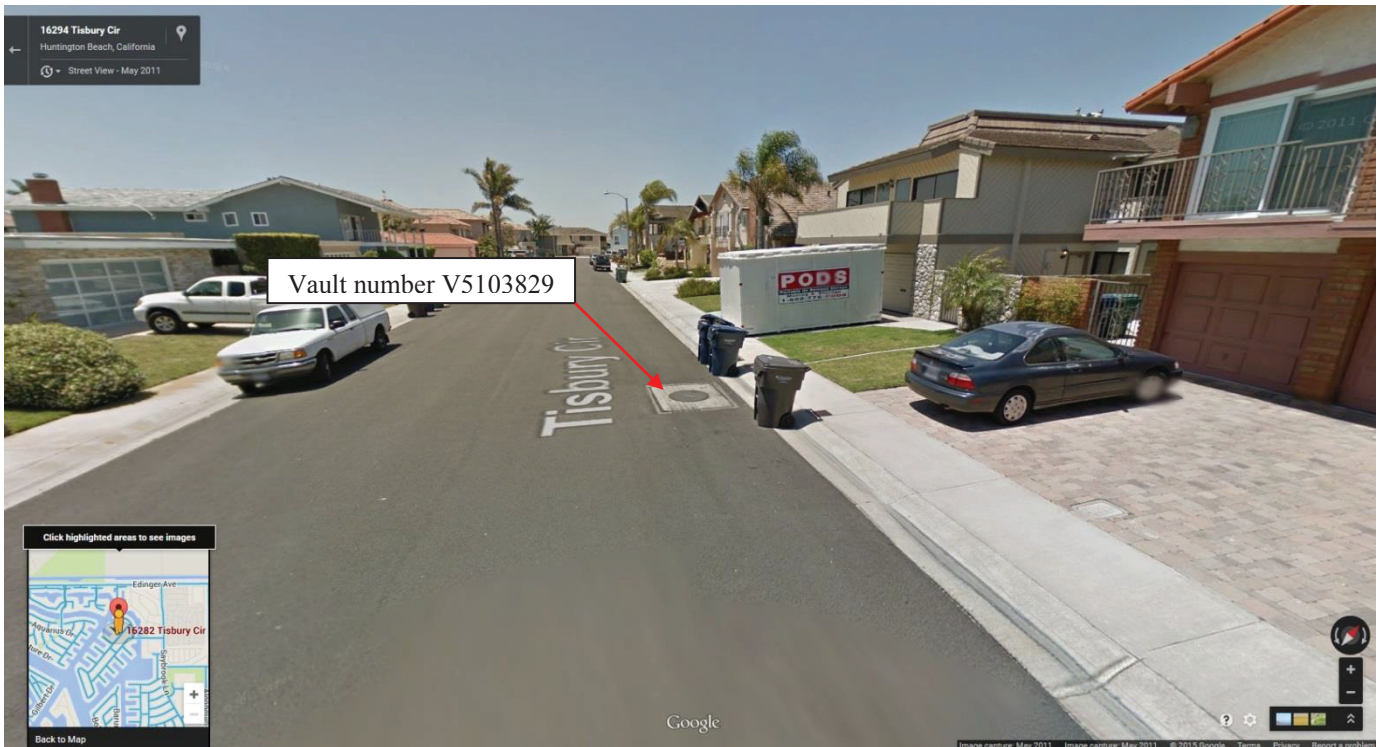
Figure 2: View of the vault as seen from Tisbury Circle. *Source: Google Maps.*

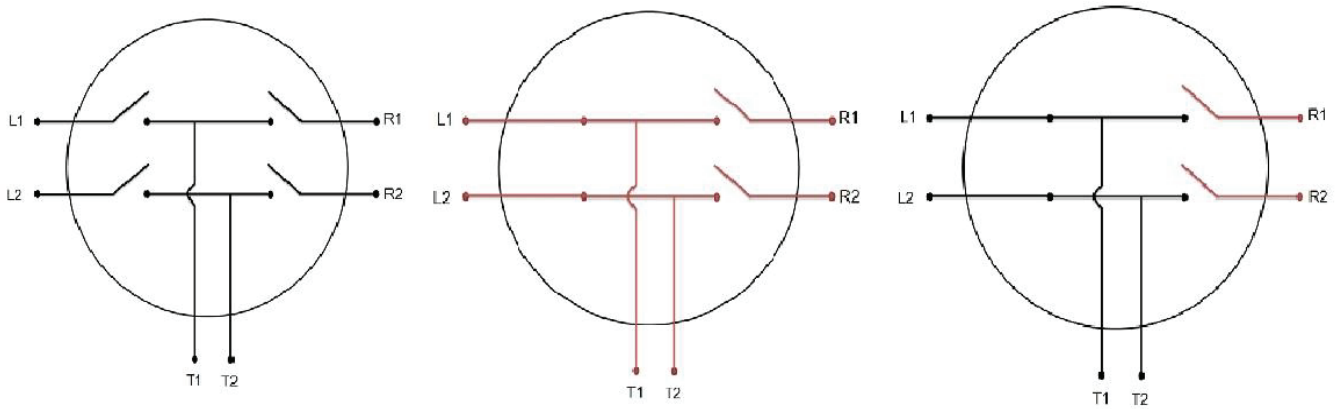
Figure 3: Schematics of switch number BS 0885. Red lines in the center and right schematics indicate an energized component. The schematic on the left is a general schematic of BS 0885. L1, L2, R1, and R2 are switchable, whereas T1 and T2 are permanently closed and, thus, are non-switchable and cannot be opened. L1 and L2 open and close in conjunction; similarly, R1 and R2 also open and close in conjunction. Conductors from switch number GS 0643 located in vault number V5103812 are connected to L1 and L2 (see Appendix A). Conductors from switch number OS 0646 located in vault number V5103759 are connected to R1 and R2 (see Appendix A).

The schematic in the center shows the switching configuration of switch number BS 0885 on the day of the incident prior to field switching. L1 and L2 are energized by the conductors connected to them and are the “source” that feeds (i.e., energizes) T1 and T2. R1 and R2 are not connected to T1 or T2, but are energized by the conductors connected to them. The schematic on the right shows the switching configuration of switch number BS 0885 after SCE performed field switching at switch number GS 0643 to de-energize L1 and L2. T1 and T2 were also de-energized since they were connected to L1 and L2 and had no other energized source. However, R1 and R2 remained energized since they continued to be connected to energized conductors.

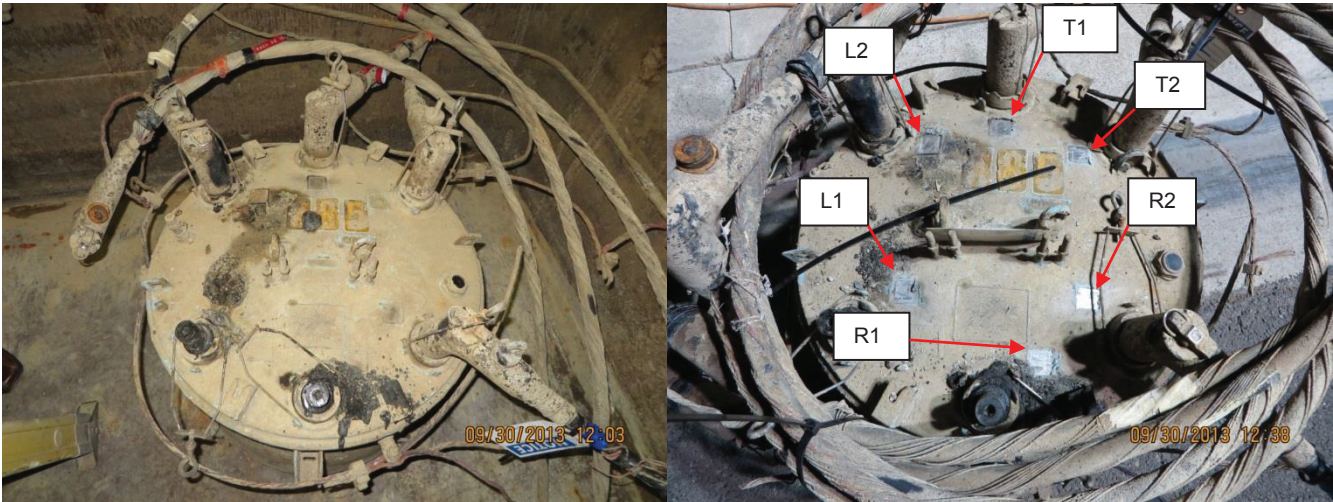
Upon entering the vault, the engineer noted the following equipment: a transformer, conductors, and a switch with connection points for six dead-break elbows. The engineer also made the following observations regarding the switch: 1) only four of the six dead-break elbows were attached to the switch; 2) there were two plugs where a dead-break elbow had been removed: one of the plugs had a black charred substance emanating from it that indicated that an arc flash had occurred at the plug (such a substance is usually the result of an electric arc), while the other plug did not show any evidence of an arc flash; 3) the surface of the switch was covered with a crusty, hard buildup, making it unreadable; and 4) each point where the elbow connected to the switch had a small square outline in front of it (see Figure 6).

At some time after the incident, SCE personnel scrubbed the outlines next to the elbows with a stiff bristle wire brush (see Figure 6). This revealed that the identification of the elbow was embossed within the outline in front of each elbow. It also revealed that the plug with the black substance was located at R1. The other exposed plug was revealed to be located at L1. Removal of the dead-break elbow at L1 would not have caused a flash because it was de-energized (see explanation in Figure 3 above); however, removal of the dead-break elbow at R1 would have caused a flash because R1 was energized.

Figure 6: Top face of BS 0885, before and after scrubbing the labels for R1, R2, L1, L2, T1, and T2. *Source: CPUC*
