CALIFORNIA PUBLIC UTILITIES COMMISSION
Safety and Enforcement Division
Electric Safety and Reliability Branch

Incident Investigation Report

Incident Number: E20191024-01

Regulated Entity Facilities Involved: Geysers #9 Lakeville 230 kV Line

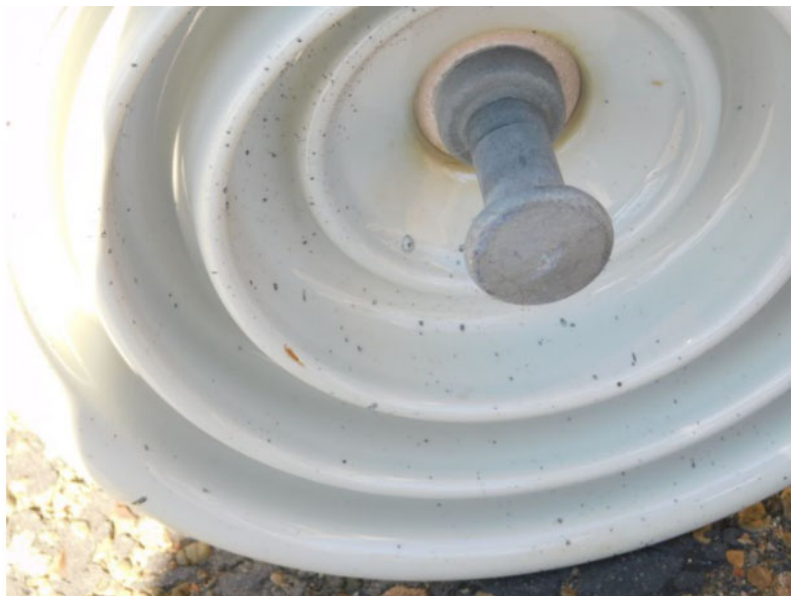
When PG&E removed the insulators from the topmost arm of the Incident Tower on November 1, 2019, the insulators were in good condition. The insulators, which are shown in Figure 18, appeared to have arcing residue, presumably from the incident.⁶⁰

Figure 18: Insulator string that was attached to incident Jumper Cable. The grey spots on the ceramic “skirt” are the arcing residue.
