Safety and Enforcement Division

**Resolution SED-13
August 13, 2026**

**RESOLUTION SED-13 APPROVING ADMINISTRATIVE CONSENT
ORDER AND AGREEMENT OF THE SAFETY AND ENFORCEMENT
DIVISION AND PACIFIC GAS AND ELECTRIC COMPANY REGARDING
THE 2022 MOSQUITO FIRE PURSUANT TO RESOLUTION M-4846**

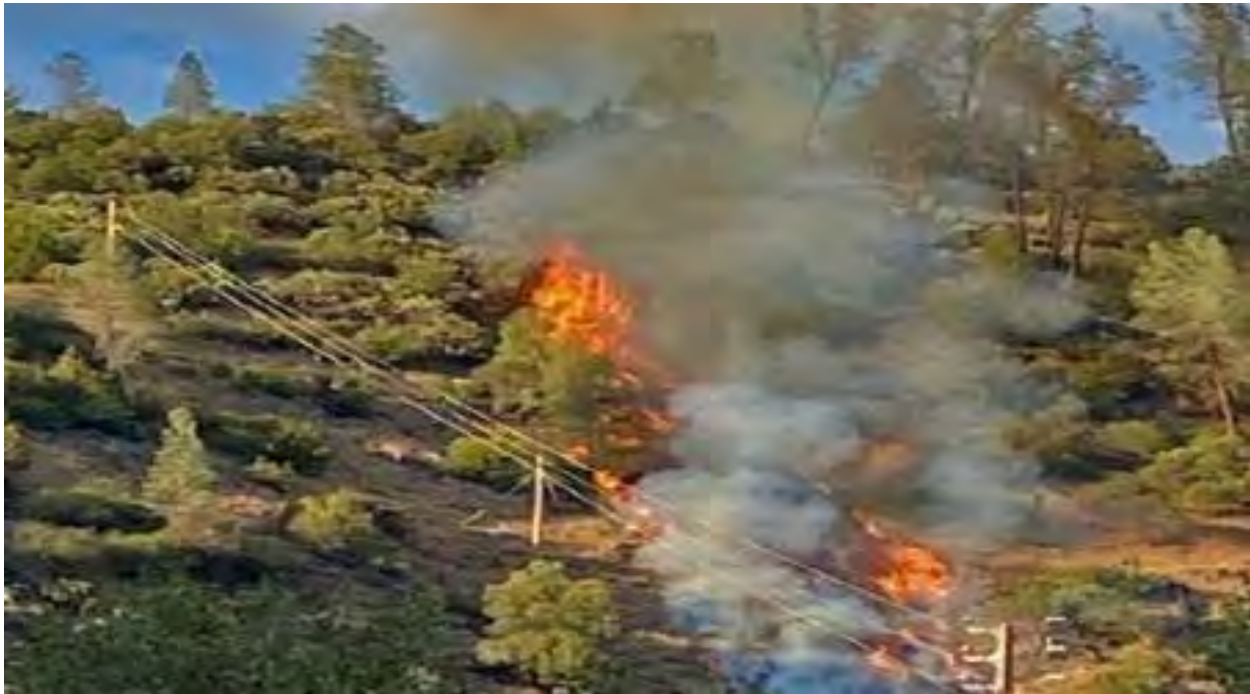
The Mosquito Fire ignited on September 6, 2022, at approximately 1800 hours (see Figure 1 below). A nearby PG&E weather station measured a temperature of 102 degrees Fahrenheit² but PG&E stated that the conditions did not meet the criteria for a Public Safety Power Shut-off event.³

Figure 1: Mosquito Fire ignition near Oxbow Junction Pole (shown near lower right side of photo).⁴

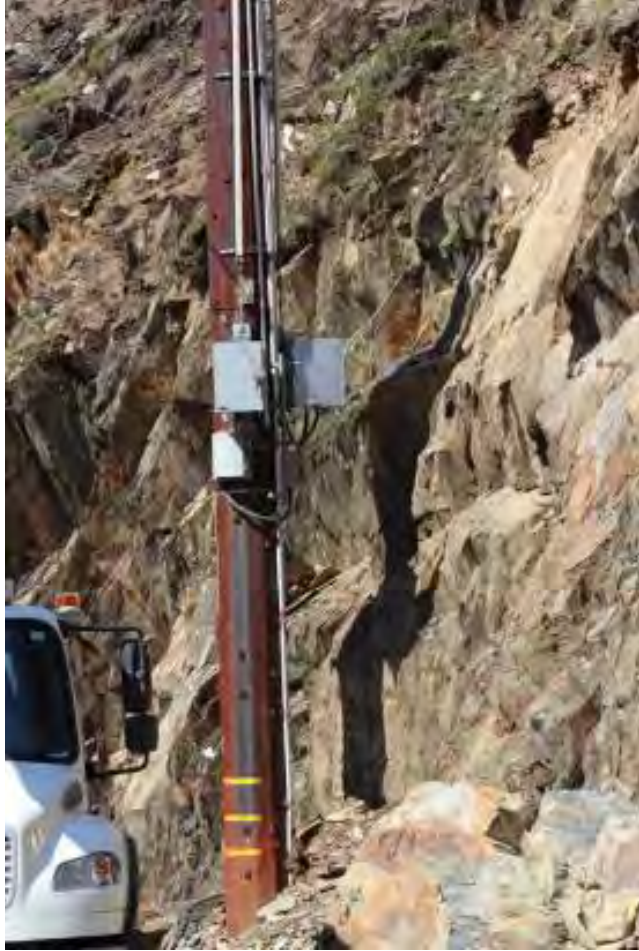
Figure 3: View of Oxbow Junction Pole (14/191) and grey rectangular switch control boxes, with steep terrain to the right (north) of the pole.³¹

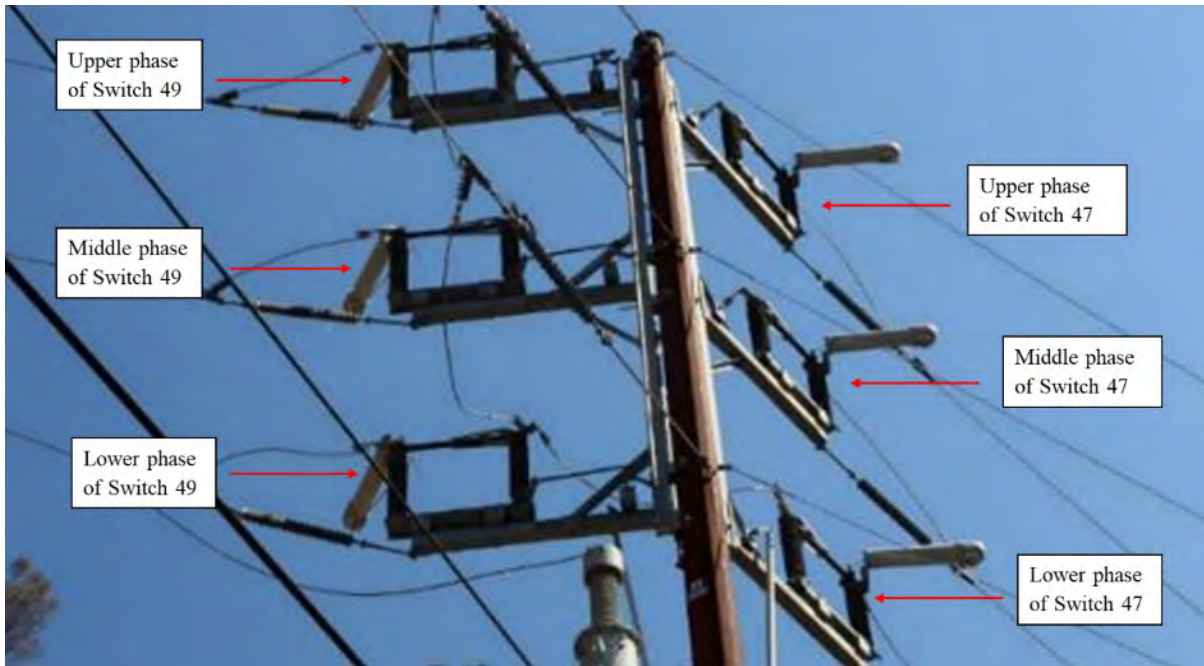
PG&E staff informed SED investigators that Switch 47 controls the connection of the Middle Fork #1 60 kV circuit to the Oxbow Junction Pole and is normally open, preventing the flow of power between this circuit and the pole.³² Switch 49 controlling the Weimar #1 circuit is normally closed. Both switches can be opened and closed either manually or remotely. Each circuit and switch includes three phases (i.e. top, middle, and lower phase based on the respective location on the pole) for a total of six phases between the two switches as shown below in Figure 4.

Figure 4: Switches 47 and 49 on Oxbow Junction Pole³³

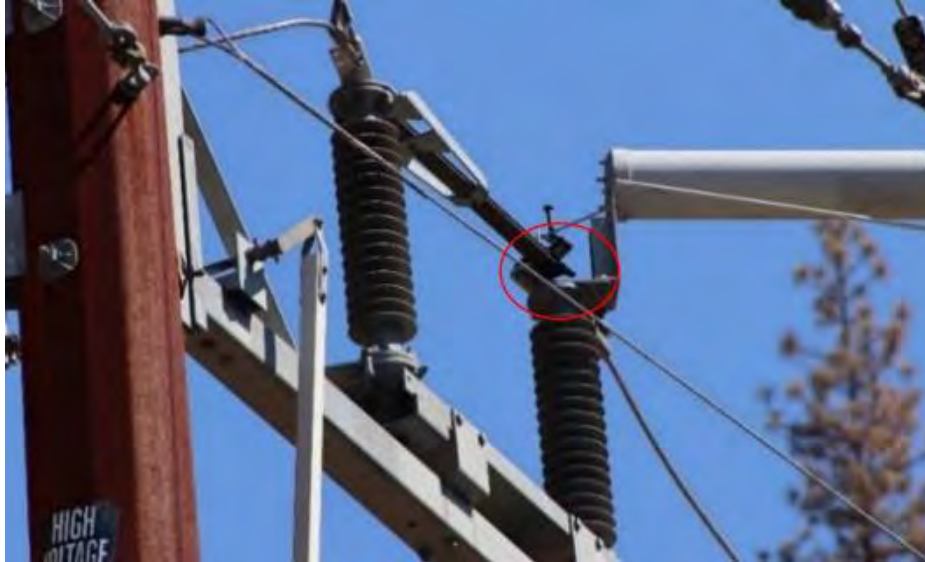
Figure 5: Switch 47 bottom phase in closed position. Red circle shows rotating end of blade within jaws.³⁴

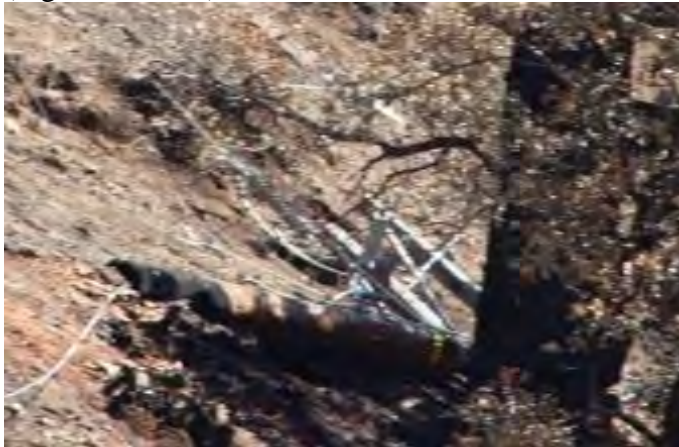
SED investigators saw Pole 09/131 on the ground (Figure 6 below) two poles east of Oxbow Junction. SED investigators were unable to access the pole due to its location on a steep hillside (Figure 7 below).

Figure 6: Partially burned pole 09/131 on Middle Fork #1 line.³⁵

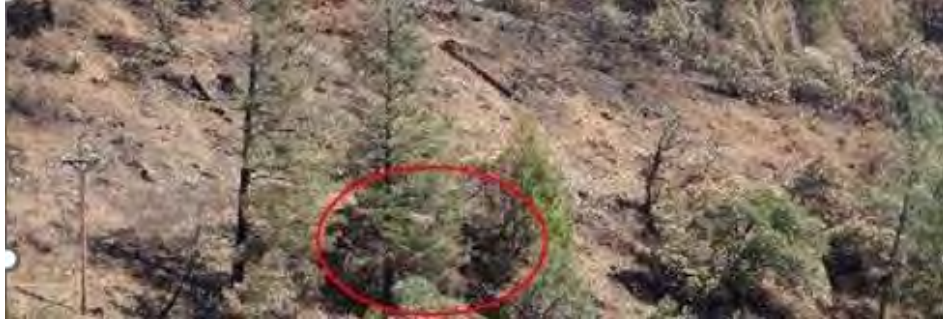
Figure 7: Terrain near fallen Pole 09/131 - east of Oxbow Junction³⁶

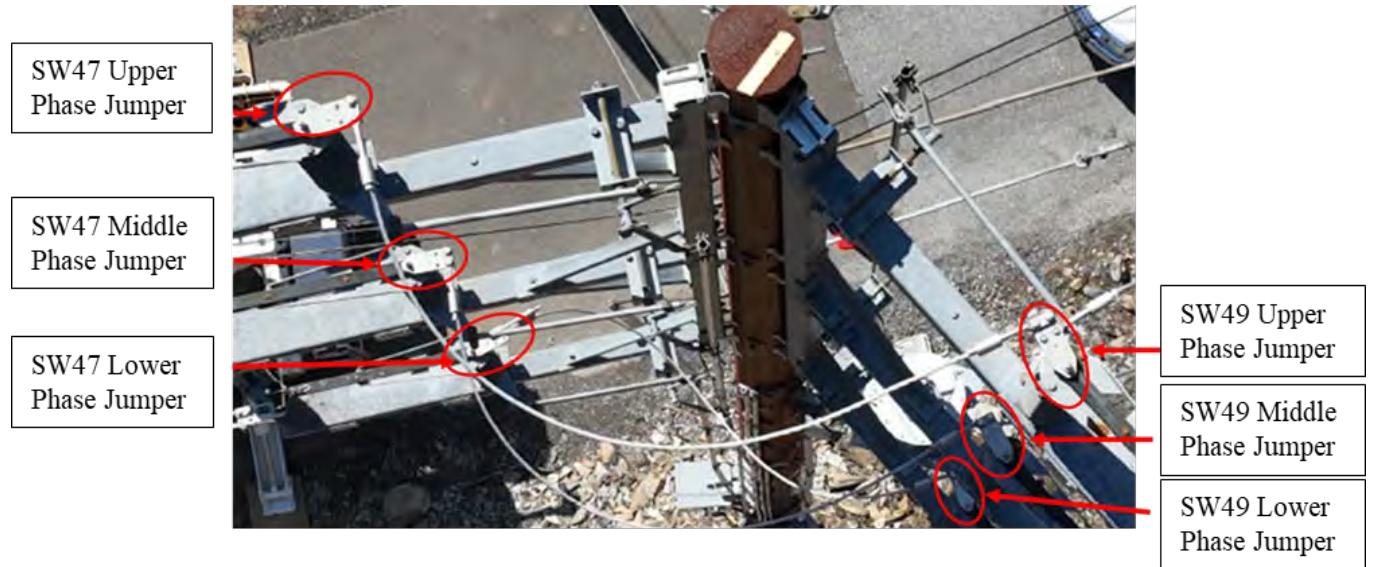
Figure 8: Oxbow Junction Pole on September 22, 2022, with jumper connector pads circled.³⁸

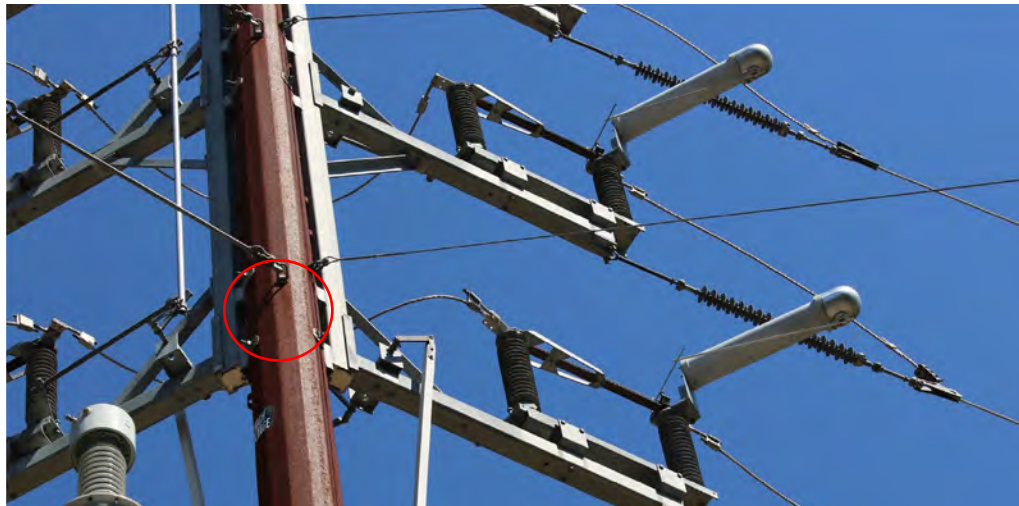
Figure 9: Left side of photo shows Switch 49 and right side shows Switch 47. Red circle shows jumper connecting to lowest phase of Switches 47 and 49.³⁹

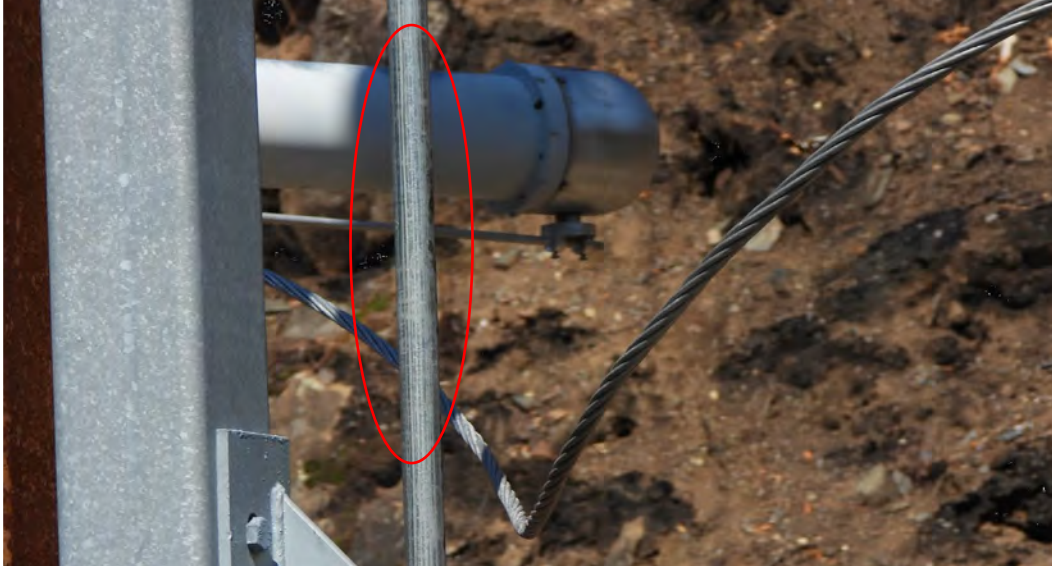
from the pole. PG&E photographs also show the lower jumper contacting or essentially contacting the control rod (Figure 10) and evidence of scorch marks on the rod (Figure 11).

Figure 10: Jumper wire kinked on lowest phase of Switch 47.
Red circle indicates damaged section of control rod.⁴⁰

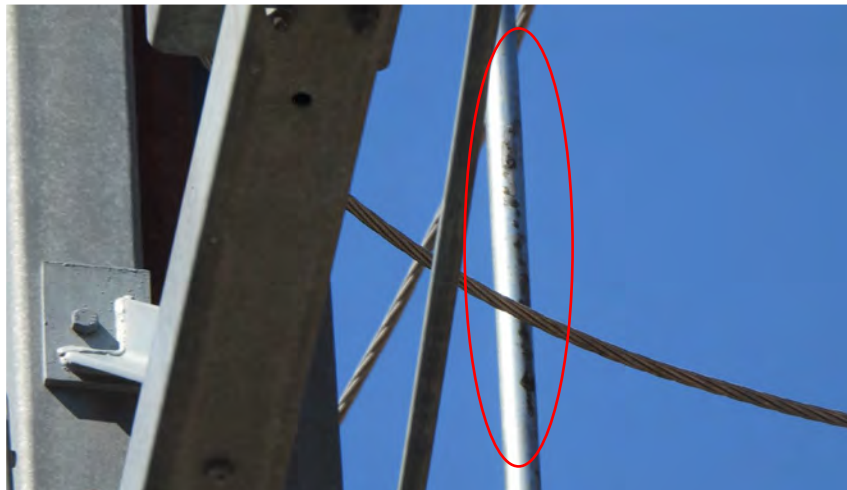
Figure 11: Control rod next to Switch 47 jumper.
Red indicates damaged section of control rod.⁴¹

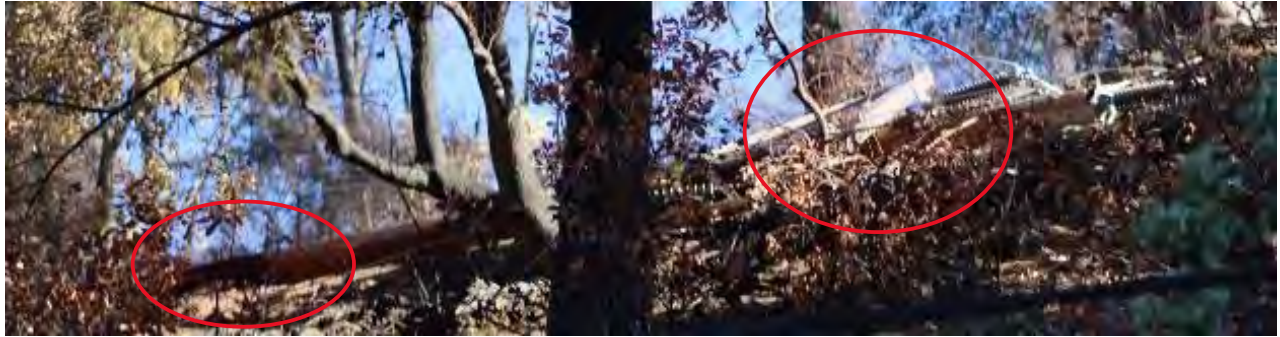
Figure 12: Pole 09/131 on ground two poles east of the Oxbow Junction Pole location, showing burned base (circled at left) and the unburned crossarm (circled at right)⁴²

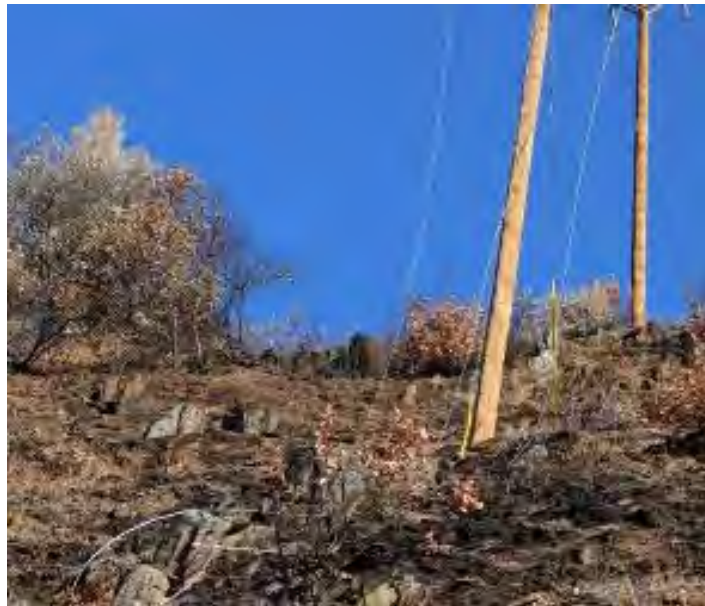
Figure 13: Weimar #1 circuit conductors on the ground north of former Oxbow Junction Pole location.⁴⁴

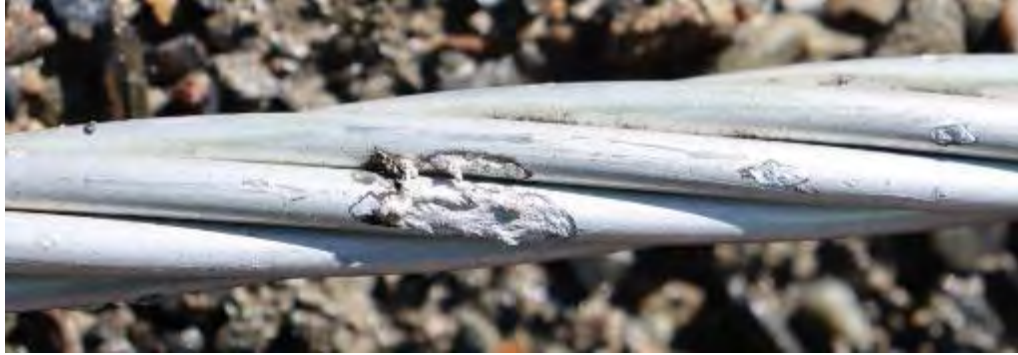
Figure 15: Surface damage to south phase of conductor formerly attached to Pole 09/132.⁵⁰

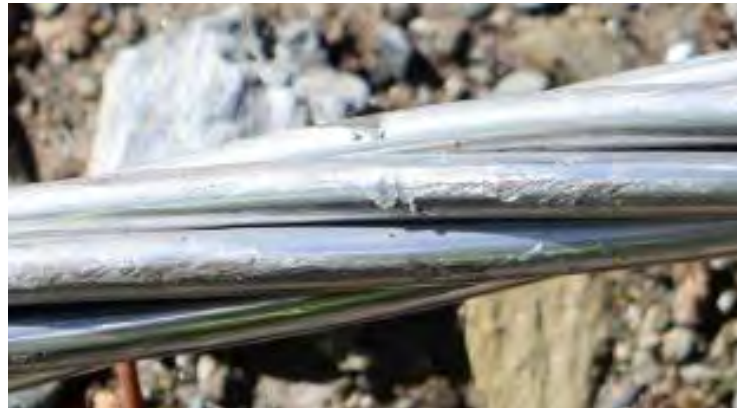
SED investigators also observed marks on the ends of the Oxbow Junction conductor. Based on SED's observations of these marks, abrasion could have caused these marks when USFS cut and dropped the conductor on September 24, 2022, or when PG&E collected the conductor on November 3, 2022.

Figure 16: Marks on conductor section formerly attached to south side of Pole 14/190.⁵¹

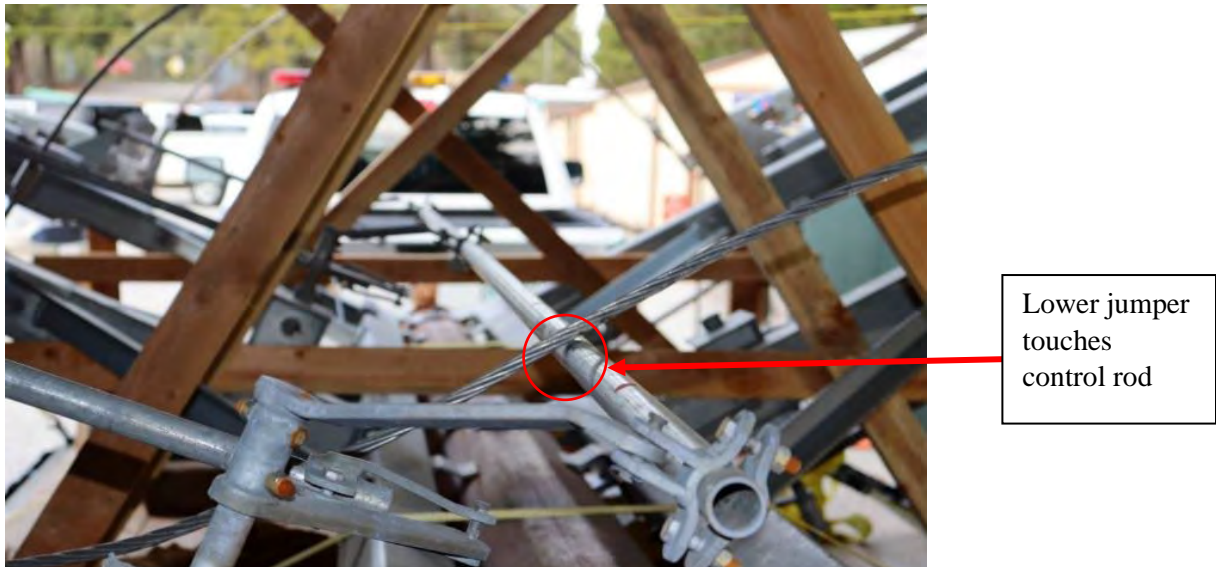
SED staff observed and photographed the position of the lower phase jumper between Switches 47 and 49, which matched photos taken by PG&E on September 22, 2022. The lower jumper curves from Switch 47 into the upper section of the Switch 47 control rod, contacting the rod as shown below in Figure 17. The curve of the jumper changes where it contacts the control rod, indicating that the control rod exerts pressure on the jumper and causes an inflection point. Unlike the lower jumper, the upper and middle jumpers curve around the pole.

Figure 17: SED staff observed lower phase jumper touching control rod⁵⁴

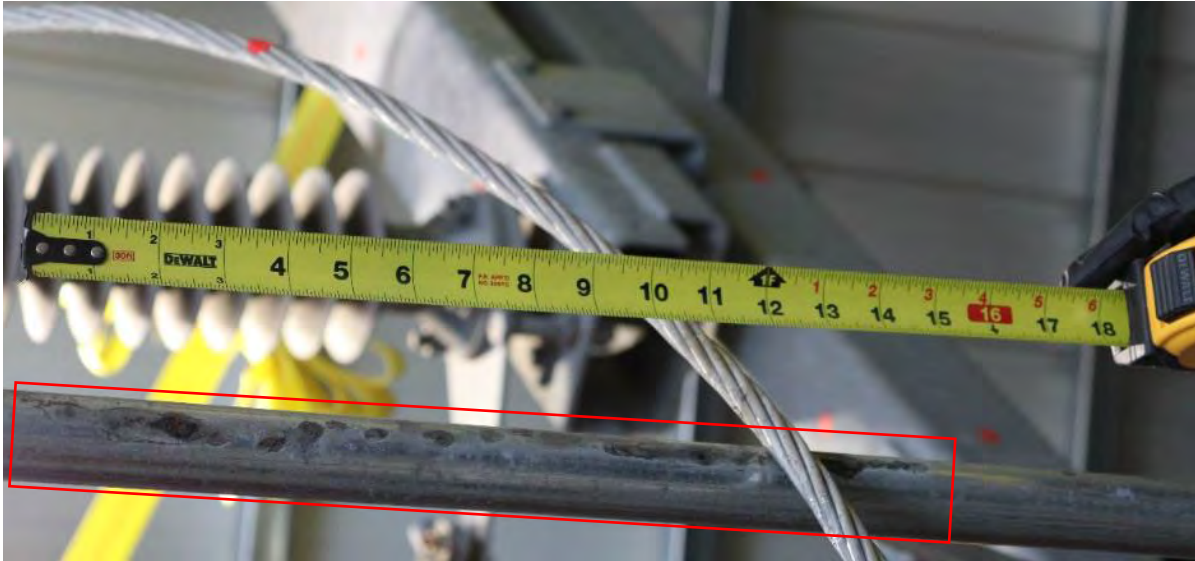
SED staff observed unusual black marks on the upper control rod and sections of the rod where the top layer of metal had apparently flaked off the rod (see Figure 17 and Figure 18). SED staff also observed dark marks on the rectangular lower section of the control rod that appeared consistent with scorching damage. In addition, SED staff observed pitting and discoloration on the jumper near where it contacted the control rod.

Figure 18: Control rod scorch marks and flaking near contact with lower jumper.⁵⁵

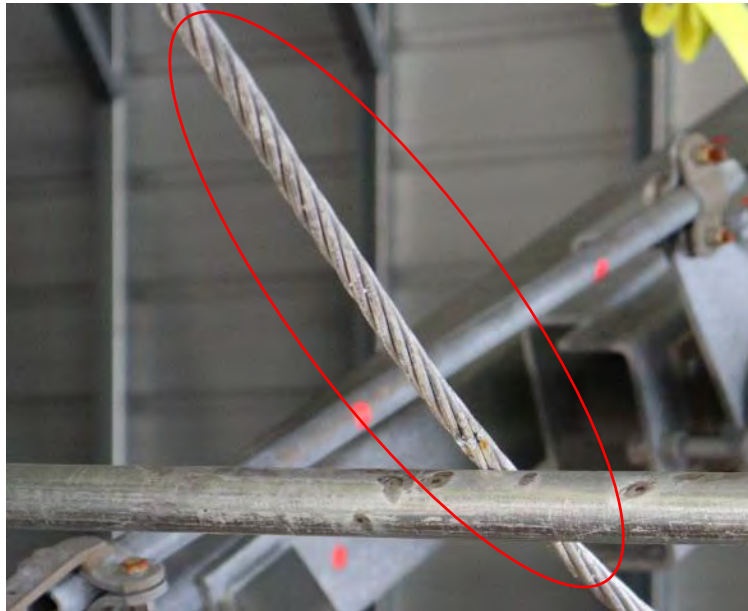
Figure 19: Pitting on lower phase jumper.⁵⁶

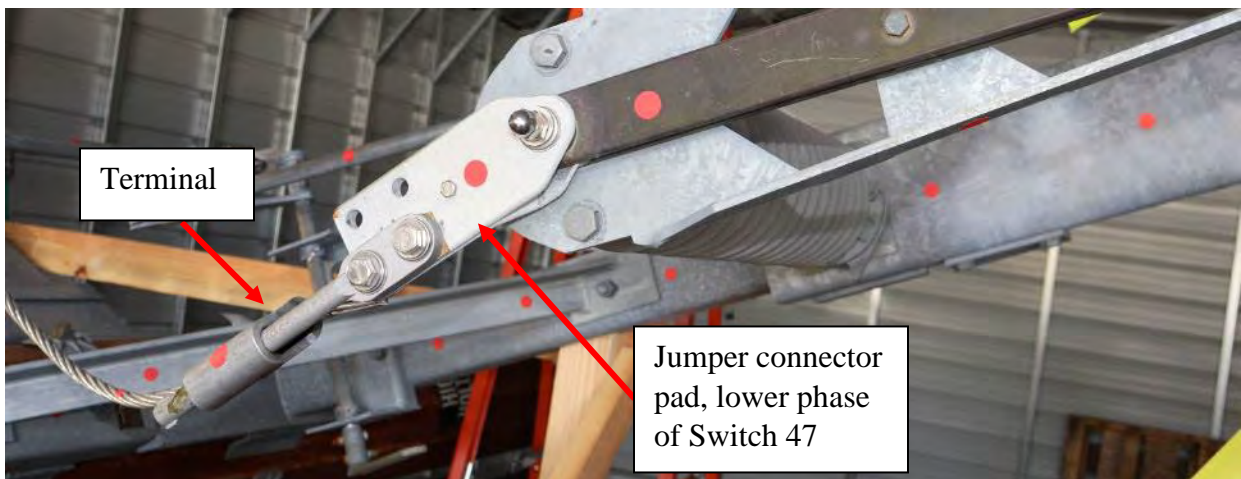
SED observed the connection of the Switch 47 lower phase to a four-hole jumper connector pad or "jumper connector pad." Figure 20 below shows the jumper connector pad and the terminal attached to the jumper cable to the left of the terminal.

Figure 20: Jumper connector pad, which connects to lower phase of Switch 47 and terminal (left of jumper connector pad), which connects to lower phase jumper.⁵⁷

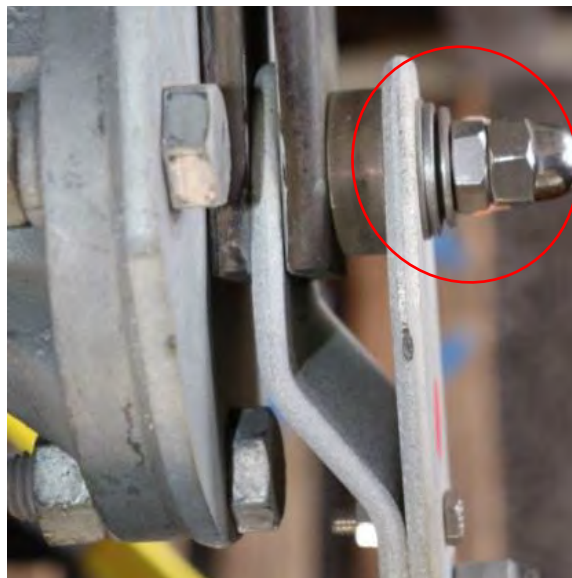
SED did not observe any signs of damage or deterioration to the visible sections of the nut and other hardware connecting the jumper connector pad to the switch shown in Figure 21 below. SED could not observe the bolt holding the jumper connector pad because the bolt was covered by attached equipment.

Figure 21: Hardware connecting jumper connector pad to lower Switch 47; SED circled visible hardware in red.⁵⁸

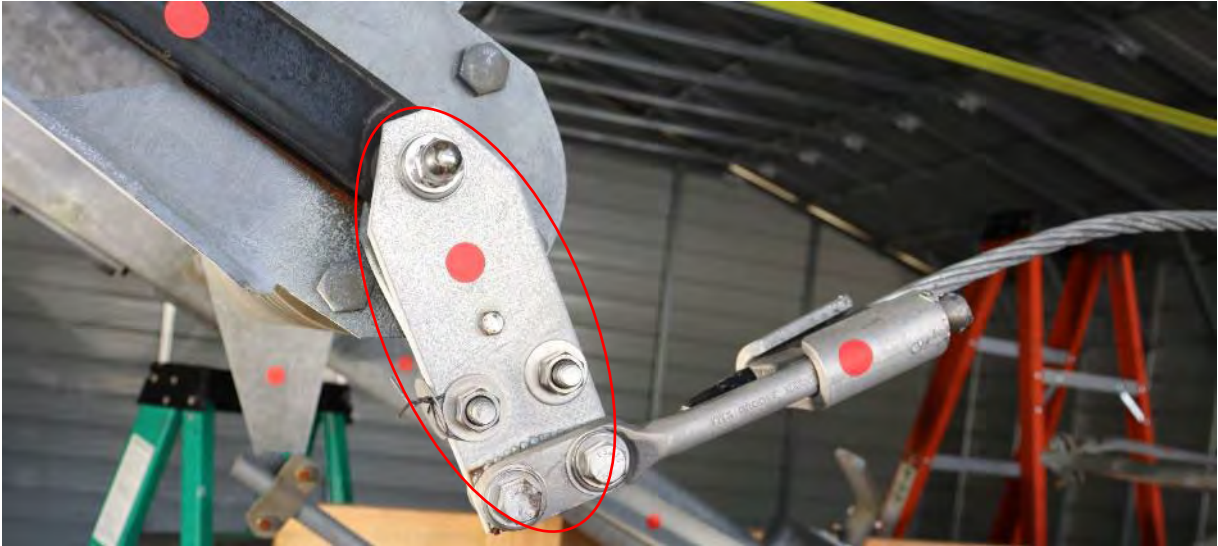
Switch 49 lower jumper connector pad appeared to contribute to the position of the lower jumper allowing contact with the control rod.

Figure 22: Jumper connector pad which connects the lower jumper to lower phase of Switch 49.⁶²

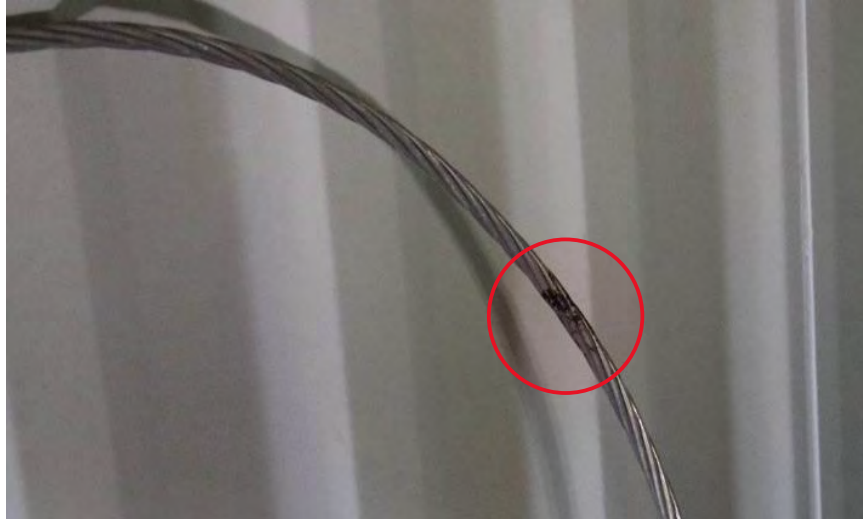
Figure 23 below shows scorch marks on a conductor section that connected to the Switch 49 bottom phase.⁶³

Figure 23: Scorch mark on conductor collected by USFS from Switch 49 bottom phase.⁶⁴

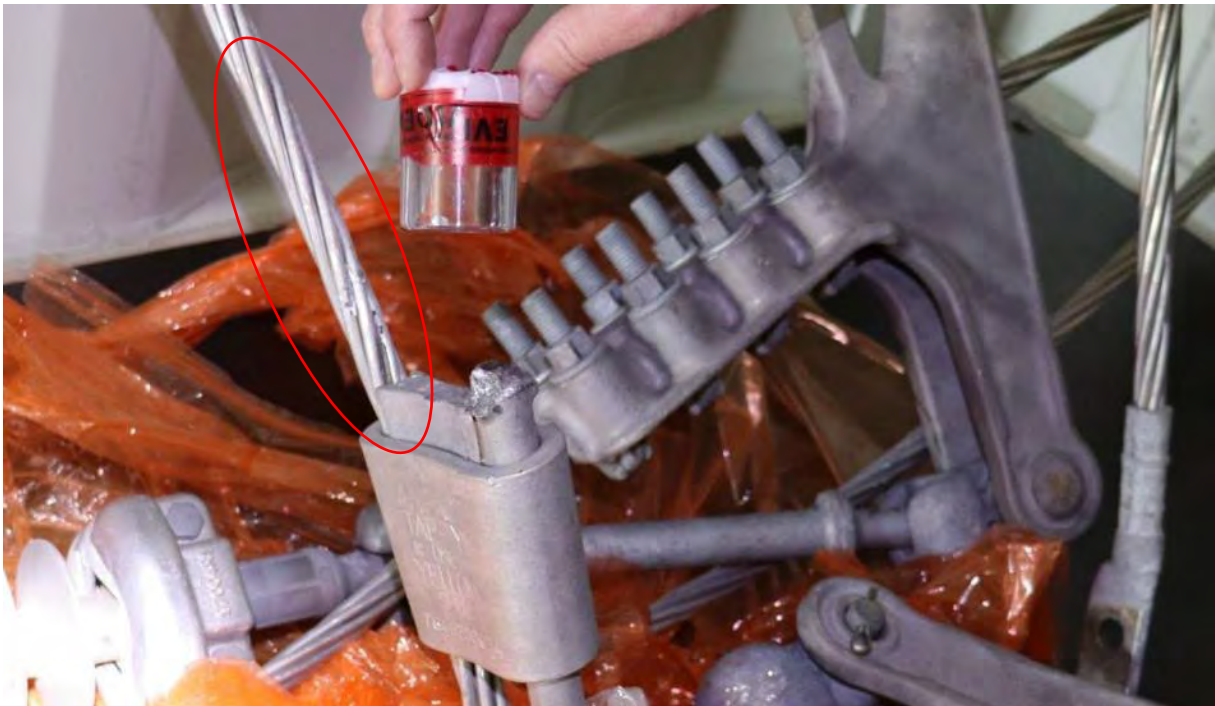
As shown in Figure 24, an evidence container (sealed with red tape) contains a small silver-colored bead that detached from the lower phase of Switch 49 after USFS collected this equipment, including the pitted section noted above.

Figure 24: Switch 49 lower phase conductor section pitting.⁶⁷

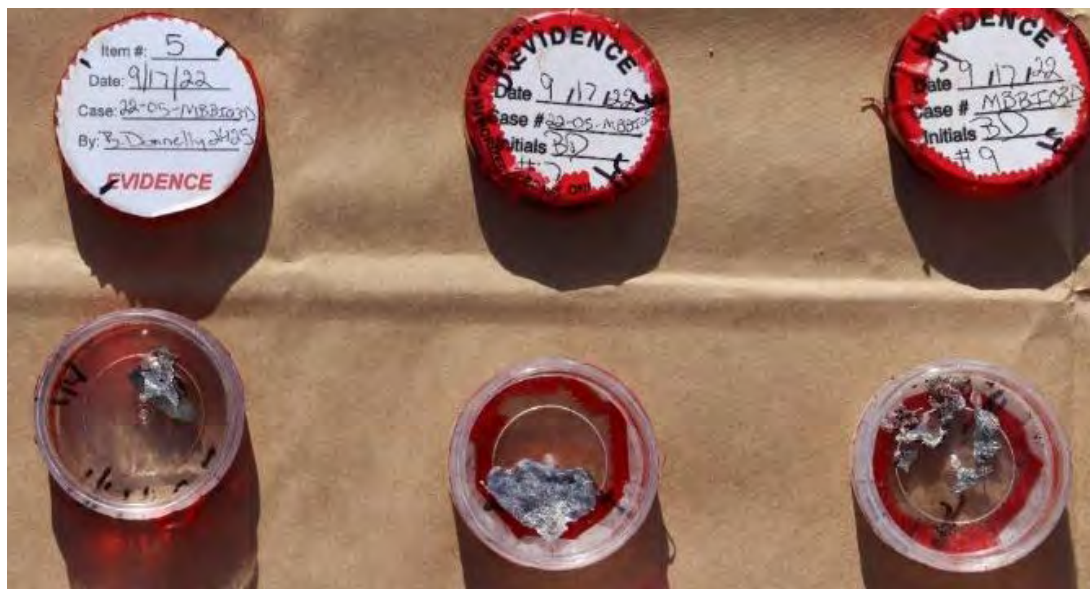
USFS collected several metallic flakes from the ground near the Oxbow Junction Pole on September 17, 2022, as shown in Figure 25 below.⁶⁸ The color of these flakes (steel or a similar silver colored metal) matches the upper section of the control rod shown earlier. As noted earlier, Figure 18 shows damage to the control rod, including areas where the top layer of metal apparently flaked off and was later collected by USFS as evidence. This evidence indicates that the lower jumper touched the upper control rod on September 6, 2022, causing an electrical fault that flaked these small pieces of metal from the upper control rod.

Figure 25: Examples of metallic flakes collected by USFS.⁶⁹

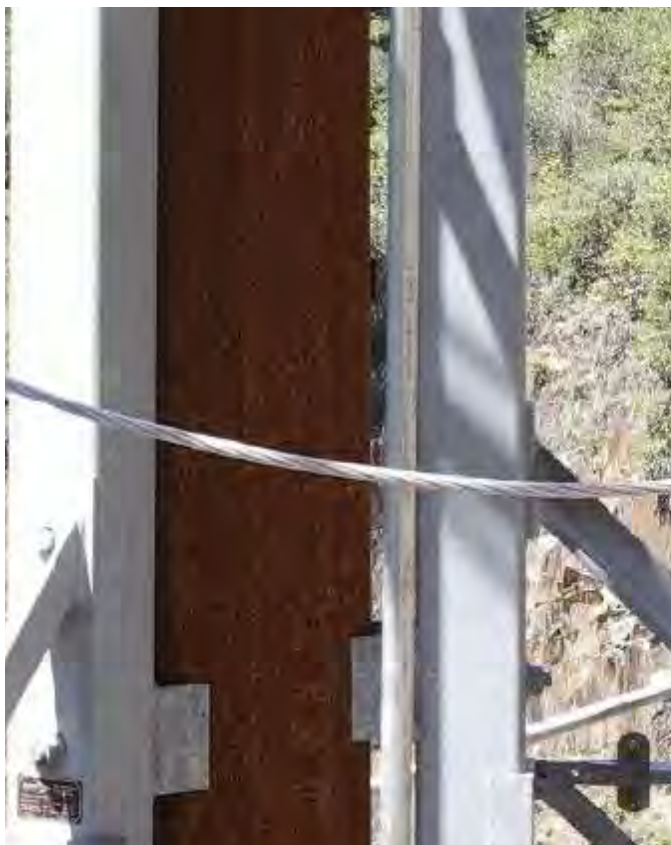
Figure 27: Switch 47 upper control rod and lower jumper on May 16, 2022, showing no visible damage.²⁷

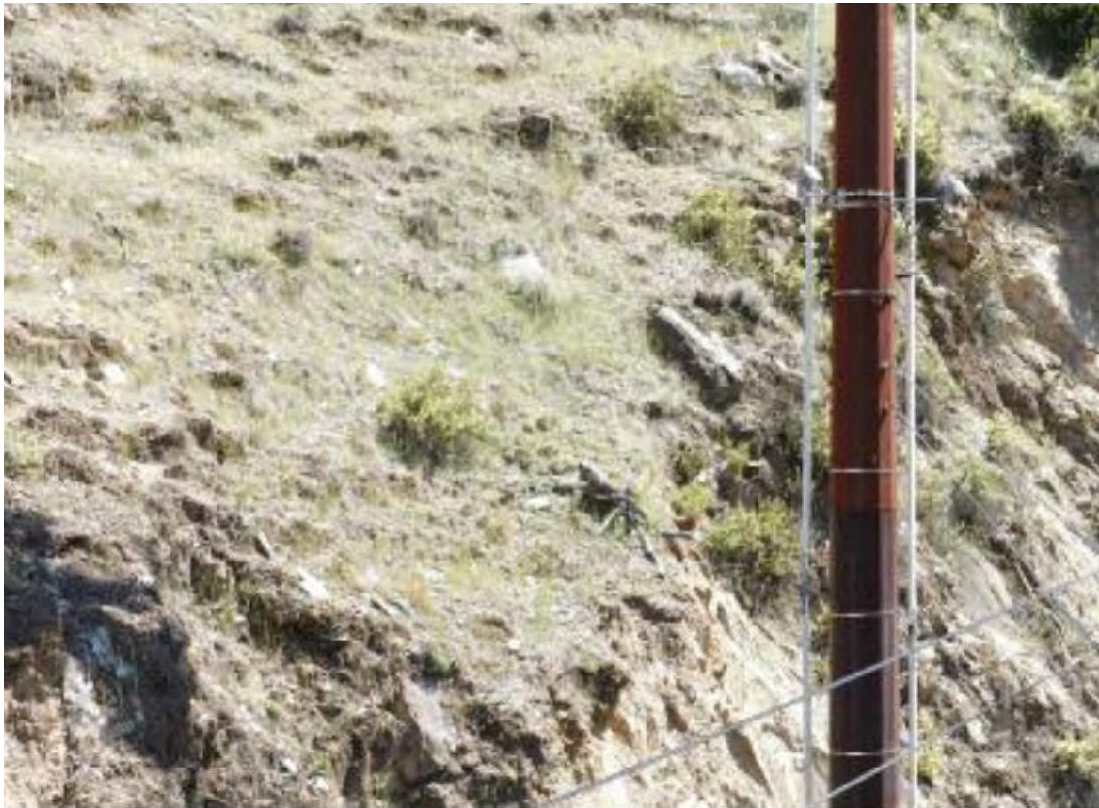
Figure 29 below shows vegetation on the grassy slope. This slope is north of the Oxbow Junction Pole and extends to the west and east.¹⁰⁸

Figure 29: Vegetation near Oxbow Junction Pole on June 11, 2022¹⁰⁹

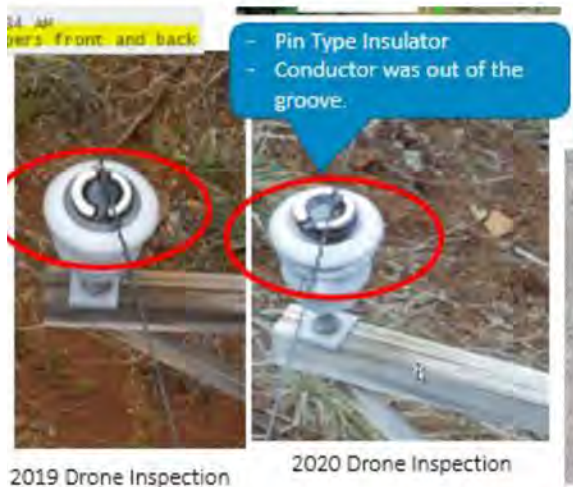
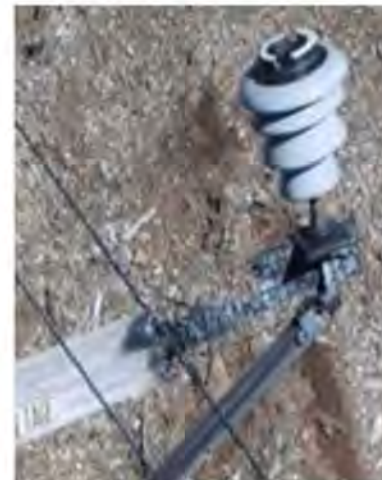
Figure 33: Loose tie wire (left) and resulting pole fire (right)¹²³

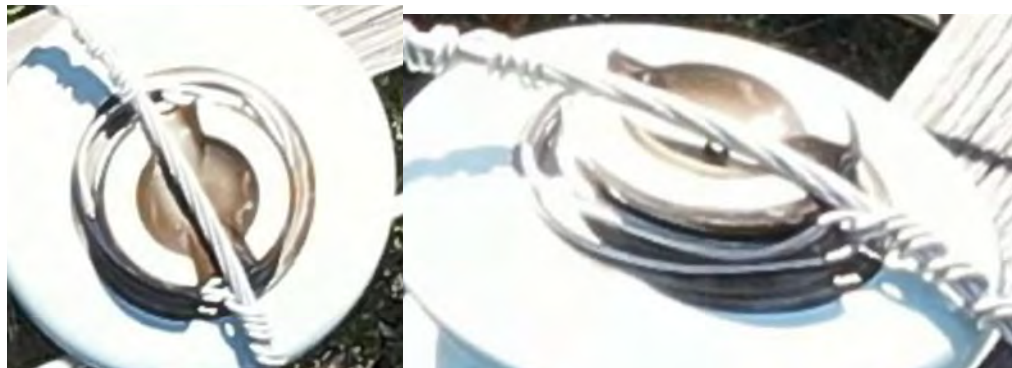
PG&E's May 25, 2022, Pole 000/003 inspection summary, noted that sections of tie wire were not secured to the center phase insulator (see Figure 34 below).¹²⁵ Because the pole is in a Tier 3 HFTD, PG&E's inspector and SME reviewer set a 90-day deadline for repairs consistent with PG&E policies. Rule 18 requires correcting this Level 2 priority hazard within 6 months (i.e., by November 25, 2022) based on the inspection finding that the tie wire required correction but not immediately.

Figure 34: Pole 000/003 center phase loose tie wire May 25, 2022¹²⁶

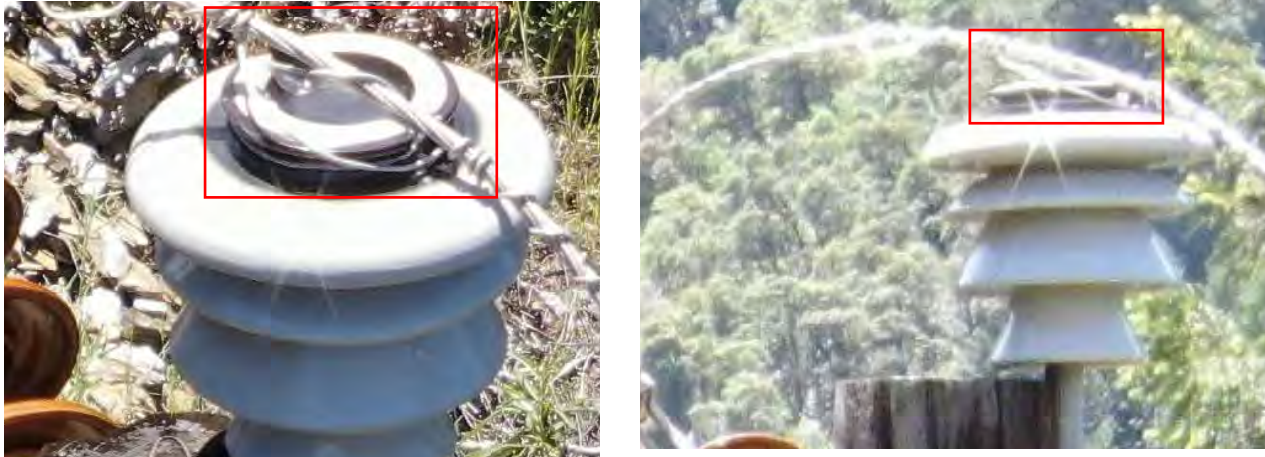
PG&E's June 9, 2022, Transmission notification 123833466 for Pole 14/186 states "LEFT POLE TIE WIRE NOT TO STANDARD."¹²⁸ PG&E also refers to the left pole as Pole 14/186(A), and the right pole as Pole 14/186(C).¹²⁹ Figure 35 below shows this loose tie wire.

**Figure 35: PG&E photos of loose tie wire, Pole 014/186(A), May 26, 2022¹³⁰
(SED outlined in red the loose tie wires)**

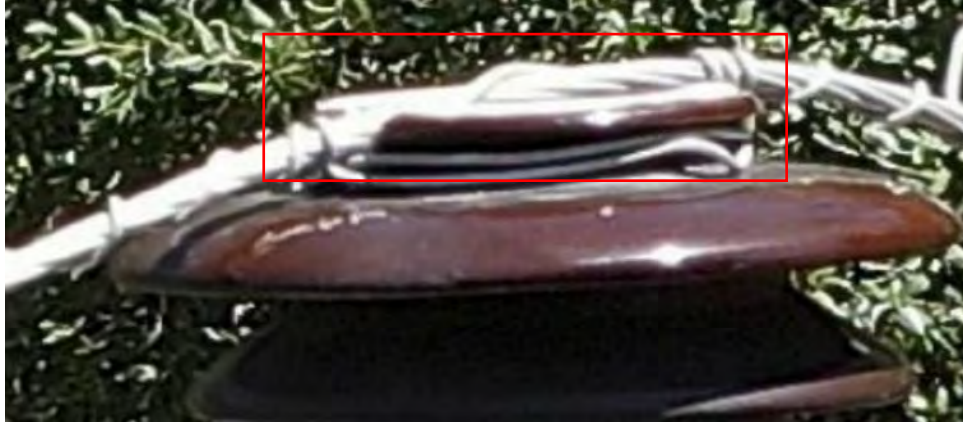
**Figure 38: Loose tie wire at Pole 009/132 (middle phase)¹⁴⁶
(SED outlined in red the loose tie wire)**

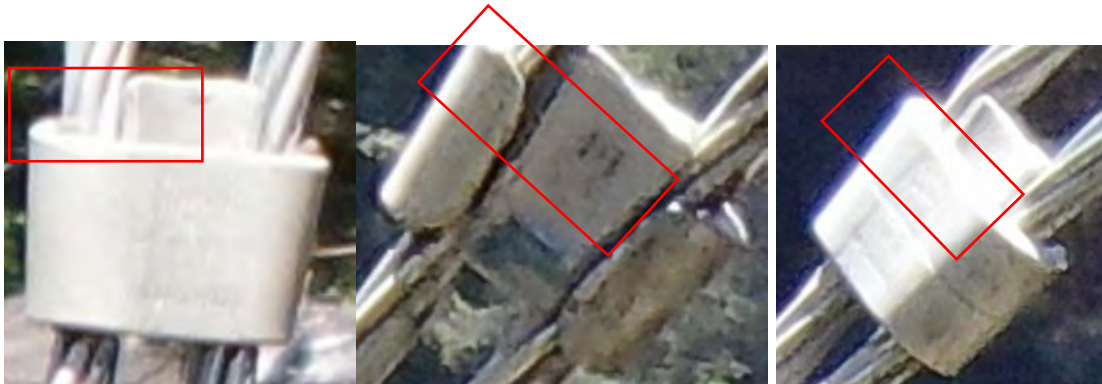
Figure 39: Wedge connectors at Pole 014/187
(SED outlined in red area of wedge not fully seated)

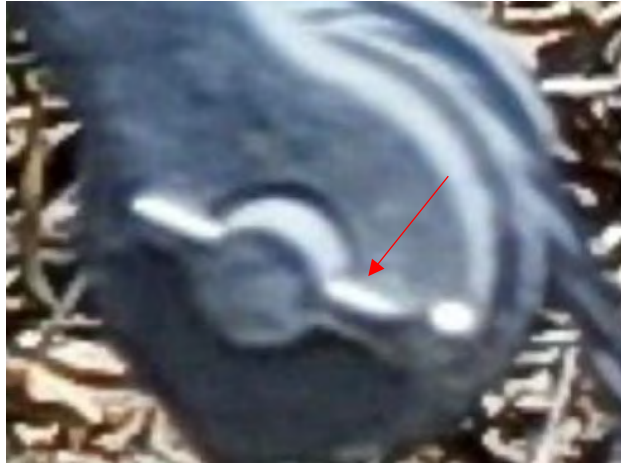
Figure 42: Partially seated cotter key at Pole 009/131 on May 26, 2022¹⁸⁷ (red arrow shows unseated section)

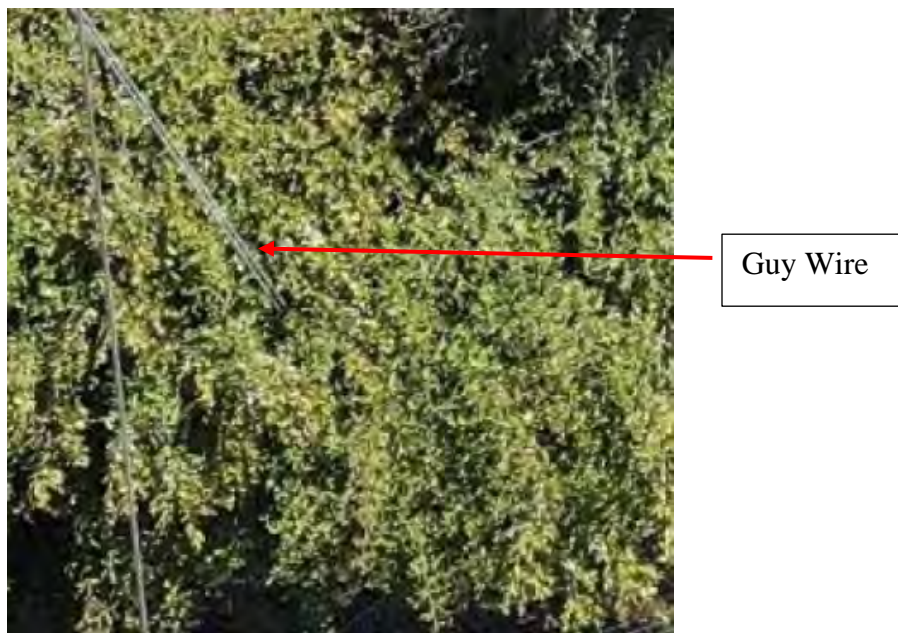
consistent with EPTM guy and anchor inspection requirements.¹⁹¹

Figure 43: Vegetation obscuring guy wires at Pole 000/003¹⁹²

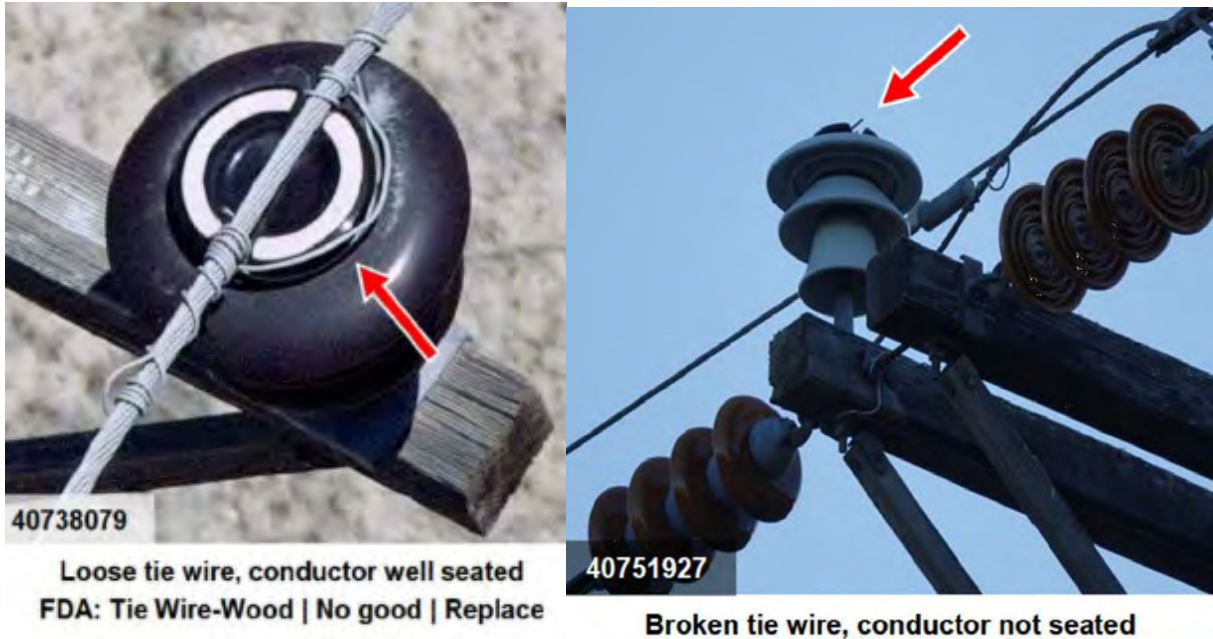
Figure 48: Photos of loose tie wires from Identifying Conductor and Clearance Conditions²³⁹
