**PUBLIC UTILITIES COMMISSION OF THE STATE OF CALIFORNIA**

**Resolution SED-13  
August 13, 2026**

**RESOLUTION SED-13 APPROVING ADMINISTRATIVE CONSENT  
ORDER AND AGREEMENT OF THE SAFETY AND ENFORCEMENT  
DIVISION AND PACIFIC GAS AND ELECTRIC COMPANY REGARDING  
THE 2022 MOSQUITO FIRE PURSUANT TO RESOLUTION M-4846**

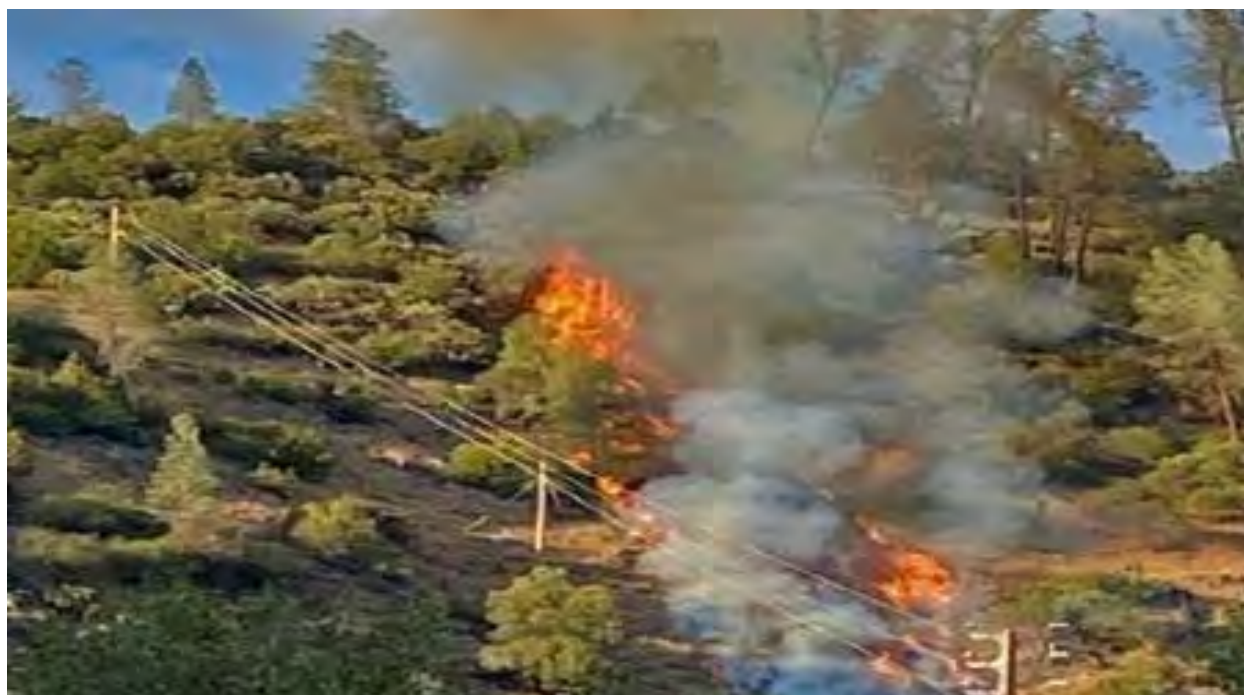
The Mosquito Fire ignited on September 6, 2022, at approximately 1800 hours (see Figure 1 below). A nearby PG&E weather station measured a temperature of 102 degrees Fahrenheit<sup>2</sup> but PG&E stated that the conditions did not meet the criteria for a Public Safety Power Shut-off event.<sup>3</sup>

**Figure 1: Mosquito Fire ignition near Oxbow Junction Pole (shown near lower right side of photo).<sup>4</sup>**

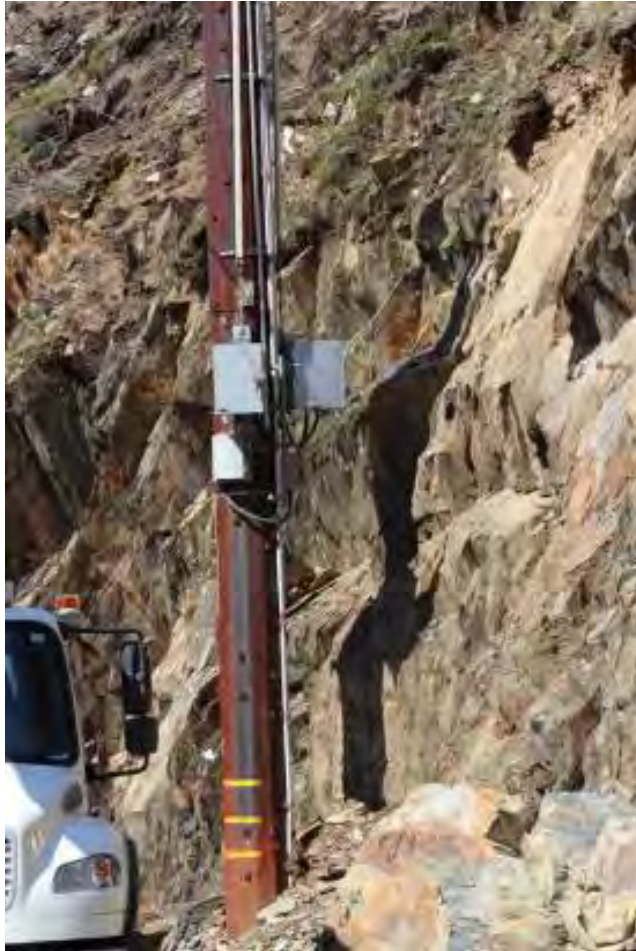
Figure 3: View of Oxbow Junction Pole (14/191) and grey rectangular switch control boxes, with steep terrain to the right (north) of the pole.<sup>31</sup>

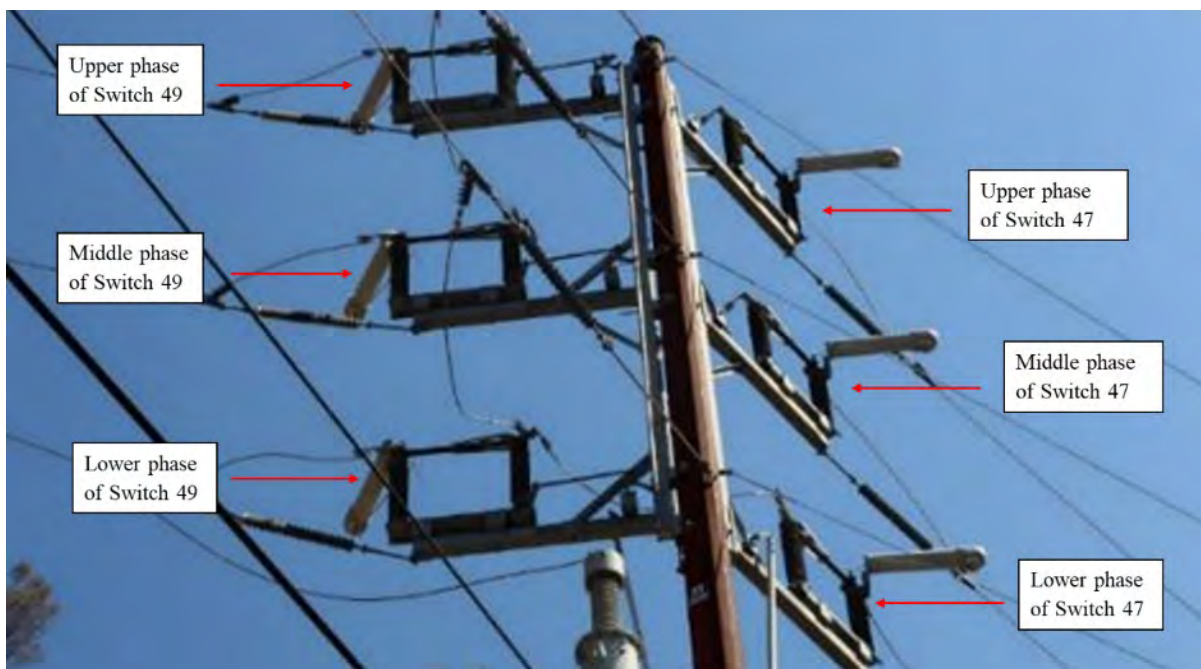
PG&E staff informed SED investigators that Switch 47 controls the connection of the Middle Fork #1 60 kV circuit to the Oxbow Junction Pole and is normally open, preventing the flow of power between this circuit and the pole.<sup>32</sup> Switch 49 controlling the Weimar #1 circuit is normally closed. Both switches can be opened and closed either manually or remotely. Each circuit and switch includes three phases (i.e. top, middle, and lower phase based on the respective location on the pole) for a total of six phases between the two switches as shown below in Figure 4.

Figure 4: Switches 47 and 49 on Oxbow Junction Pole<sup>33</sup>

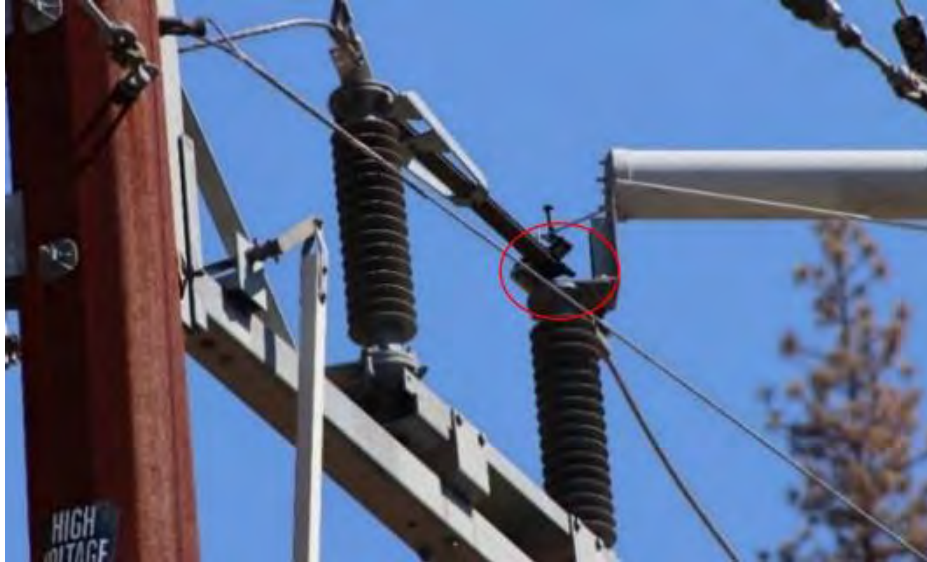
Figure 5: Switch 47 bottom phase in closed position. Red circle shows rotating end of blade within jaws.<sup>34</sup>

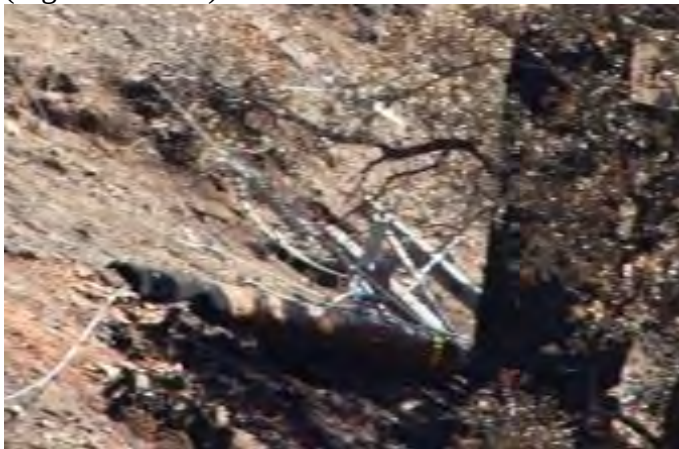
SED investigators saw Pole 09/131 on the ground (Figure 6 below) two poles east of Oxbow Junction. SED investigators were unable to access the pole due to its location on a steep hillside (Figure 7 below).

Figure 6: Partially burned pole 09/131 on Middle Fork #1 line.<sup>35</sup>

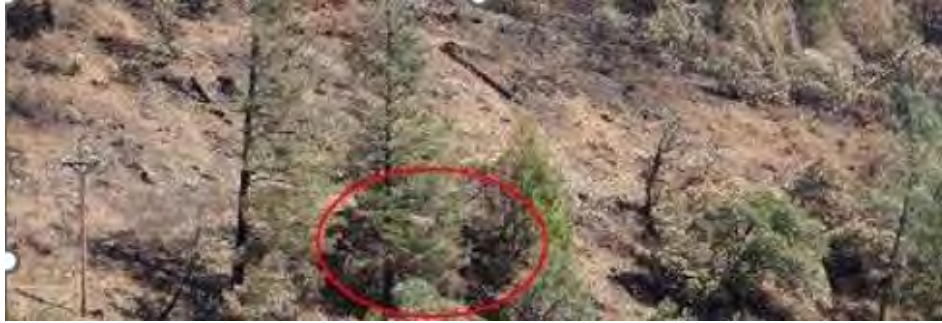
Figure 7: Terrain near fallen Pole 09/131 - east of Oxbow Junction<sup>36</sup>

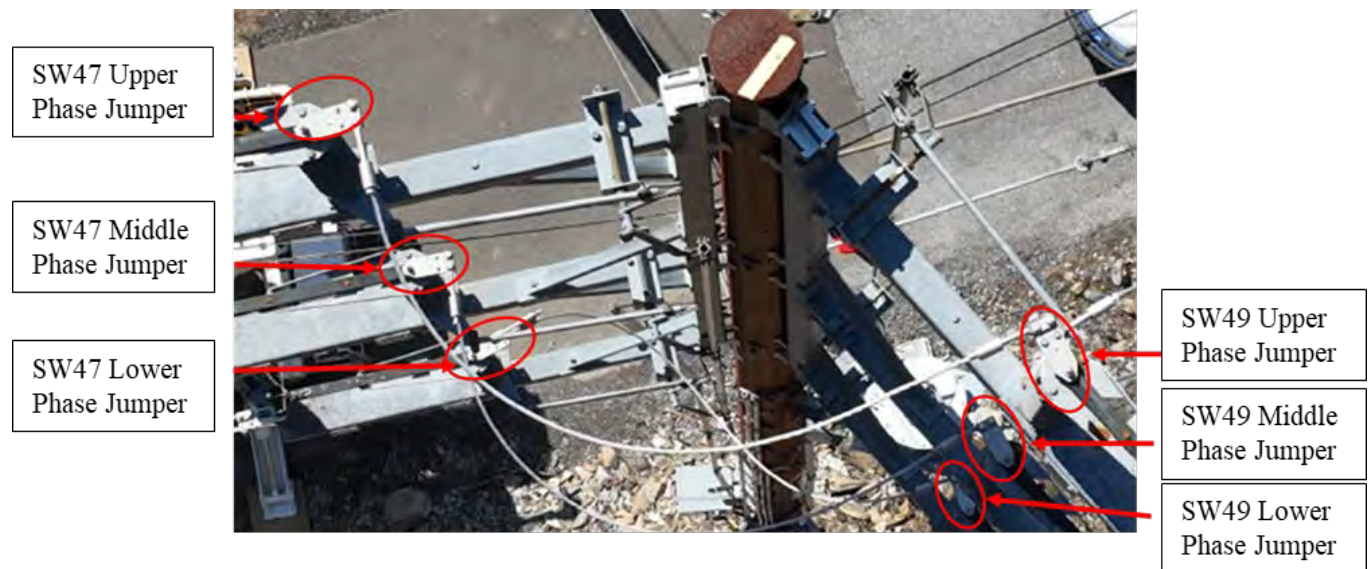
Figure 8: Oxbow Junction Pole on September 22, 2022, with jumper connector pads circled.<sup>38</sup>

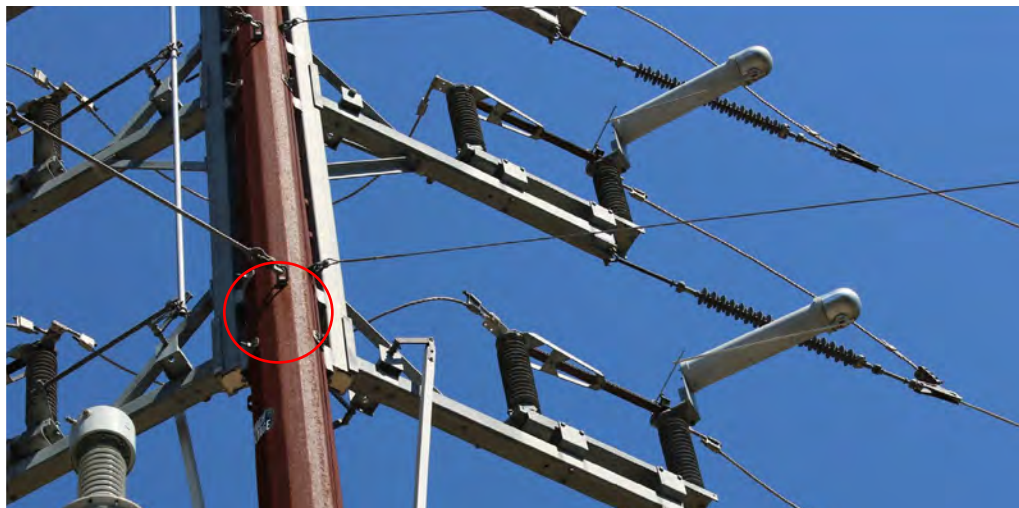
Figure 9: Left side of photo shows Switch 49 and right side shows Switch 47. Red circle shows jumper connecting to lowest phase of Switches 47 and 49.<sup>39</sup>

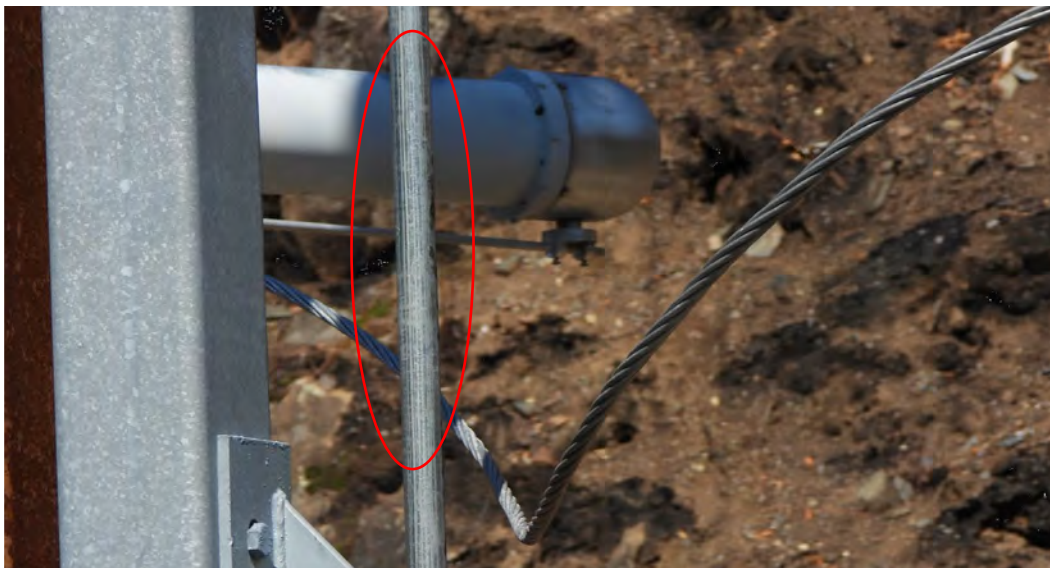
from the pole. PG&E photographs also show the lower jumper contacting or essentially contacting the control rod (Figure 10) and evidence of scorch marks on the rod (Figure 11).

Figure 10: Jumper wire kinked on lowest phase of Switch 47.  
Red circle indicates damaged section of control rod.<sup>40</sup>

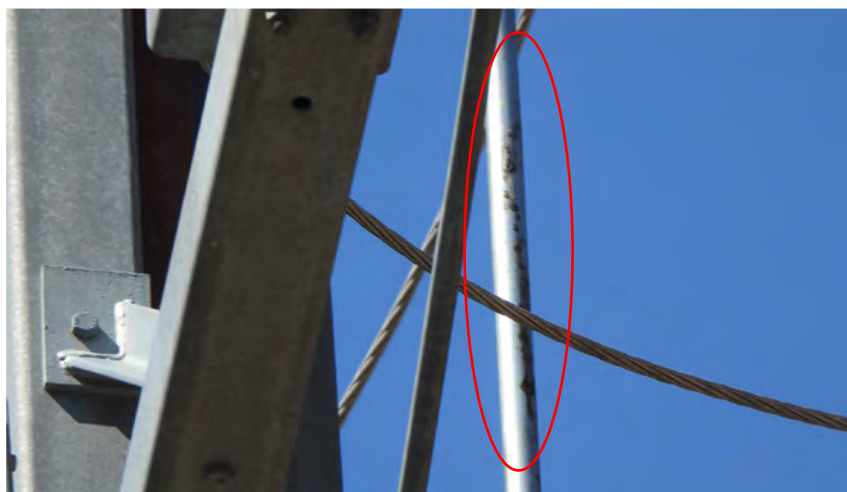
Figure 11: Control rod next to Switch 47 jumper.  
Red indicates damaged section of control rod.<sup>41</sup>

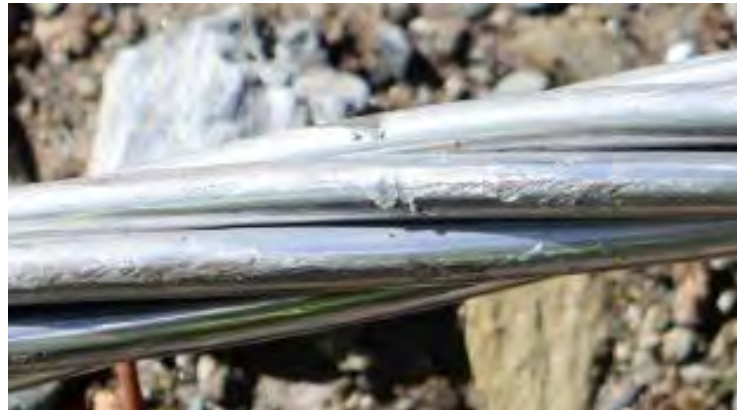
SED investigators also observed marks on the ends of the Oxbow Junction conductor. Based on SED's observations of these marks, abrasion could have caused these marks when USFS cut and dropped the conductor on September 24, 2022, or when PG&E collected the conductor on November 3, 2022.

**Figure 16: Marks on conductor section formerly attached to south side of Pole 14/190.<sup>51</sup>**

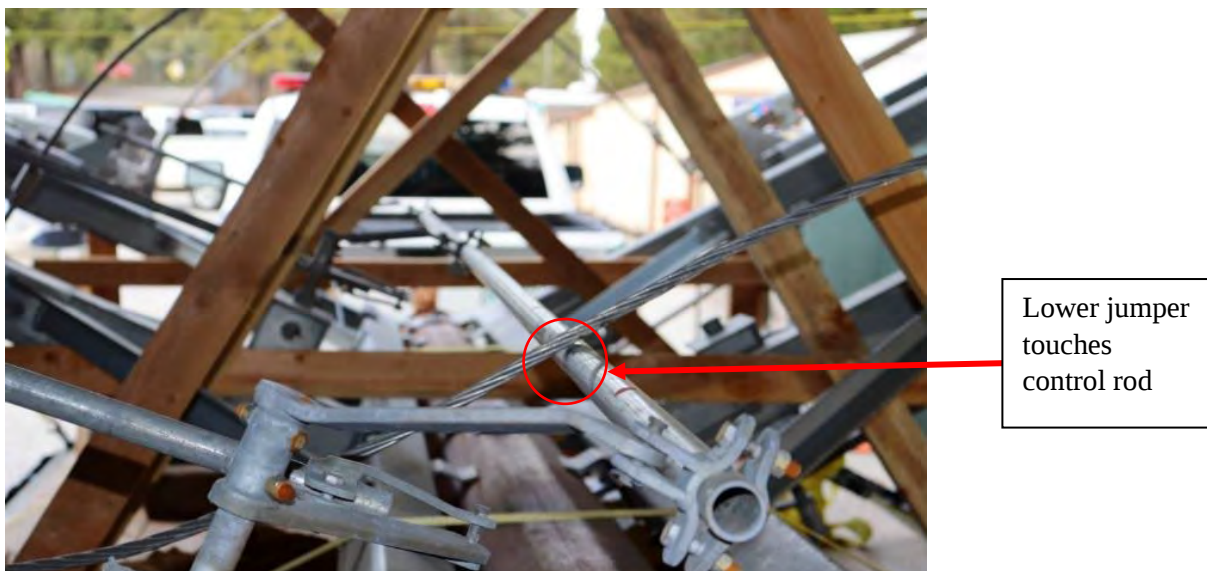
SED staff observed and photographed the position of the lower phase jumper between Switches 47 and 49, which matched photos taken by PG&E on September 22, 2022. The lower jumper curves from Switch 47 into the upper section of the Switch 47 control rod, contacting the rod as shown below in Figure 17. The curve of the jumper changes where it contacts the control rod, indicating that the control rod exerts pressure on the jumper and causes an inflection point. Unlike the lower jumper, the upper and middle jumpers curve around the pole.

**Figure 17: SED staff observed lower phase jumper touching control rod<sup>54</sup>**

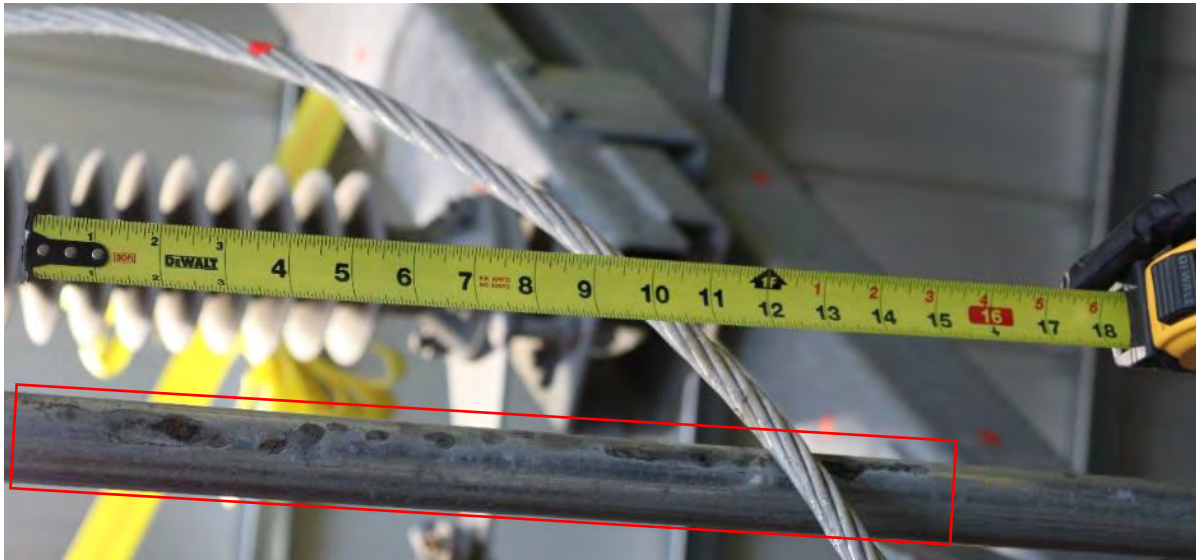
SED staff observed unusual black marks on the upper control rod and sections of the rod where the top layer of metal had apparently flaked off the rod (see Figure 17 and Figure 18). SED staff also observed dark marks on the rectangular lower section of the control rod that appeared consistent with scorching damage. In addition, SED staff observed pitting and discoloration on the jumper near where it contacted the control rod.

**Figure 18: Control rod scorch marks and flaking near contact with lower jumper.<sup>55</sup>**

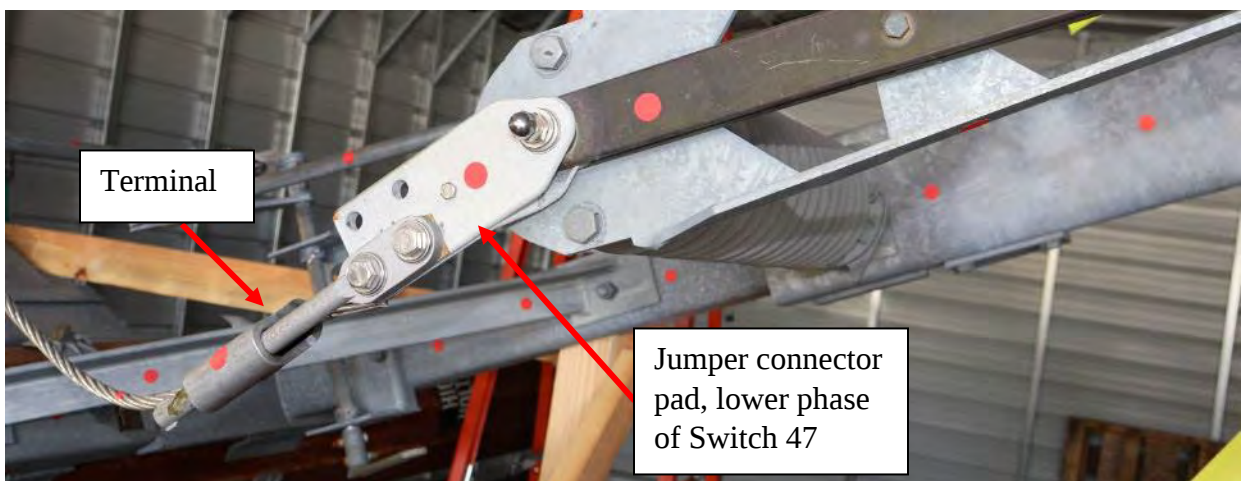
SED observed the connection of the Switch 47 lower phase to a four-hole jumper connector pad or "jumper connector pad." Figure 20 below shows the jumper connector pad and the terminal attached to the jumper cable to the left of the terminal.

**Figure 20: Jumper connector pad, which connects to lower phase of Switch 47 and terminal (left of jumper connector pad), which connects to lower phase jumper.<sup>57</sup>**

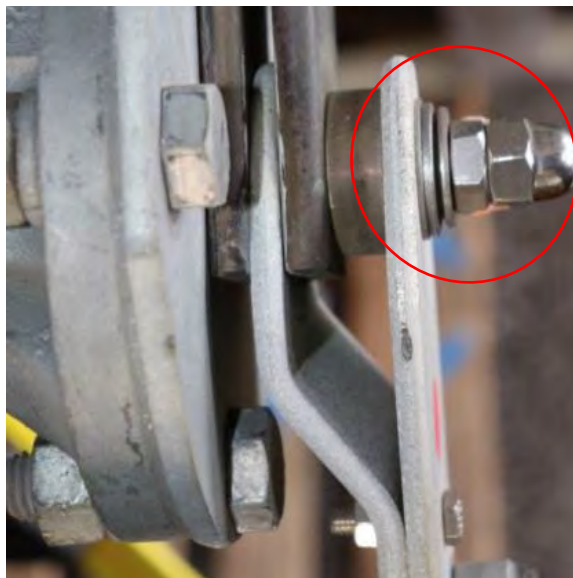
SED did not observe any signs of damage or deterioration to the visible sections of the nut and other hardware connecting the jumper connector pad to the switch shown in Figure 21 below. SED could not observe the bolt holding the jumper connector pad because the bolt was covered by attached equipment.

Figure 21: Hardware connecting jumper connector pad to lower Switch 47; SED circled visible hardware in red.<sup>58</sup>

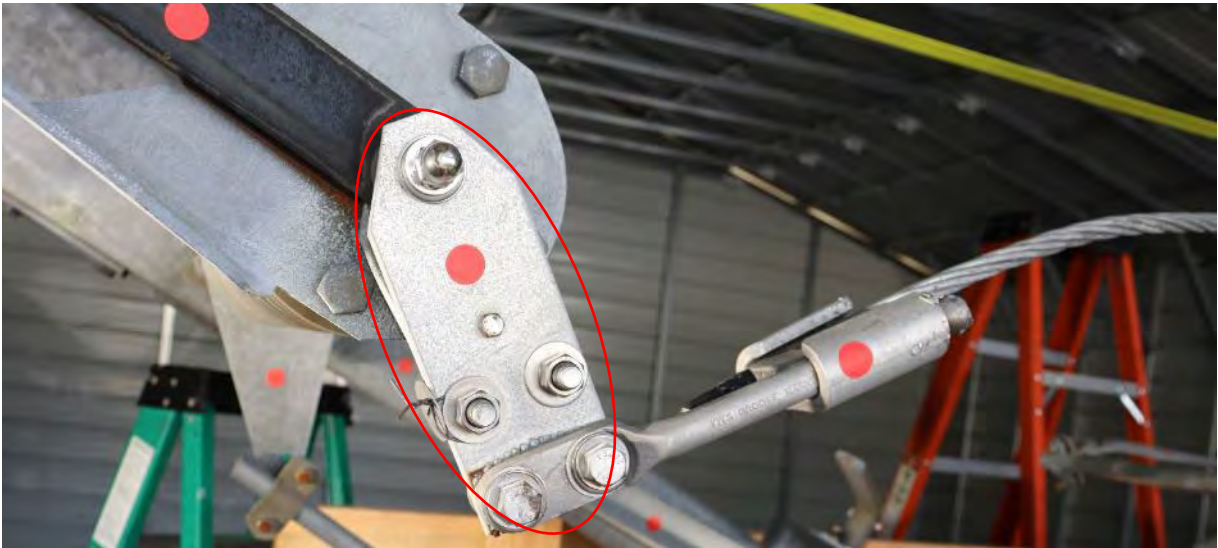
Switch 49 lower jumper connector pad appeared to contribute to the position of the lower jumper allowing contact with the control rod.

Figure 22: Jumper connector pad which connects the lower jumper to lower phase of Switch 49.<sup>62</sup>

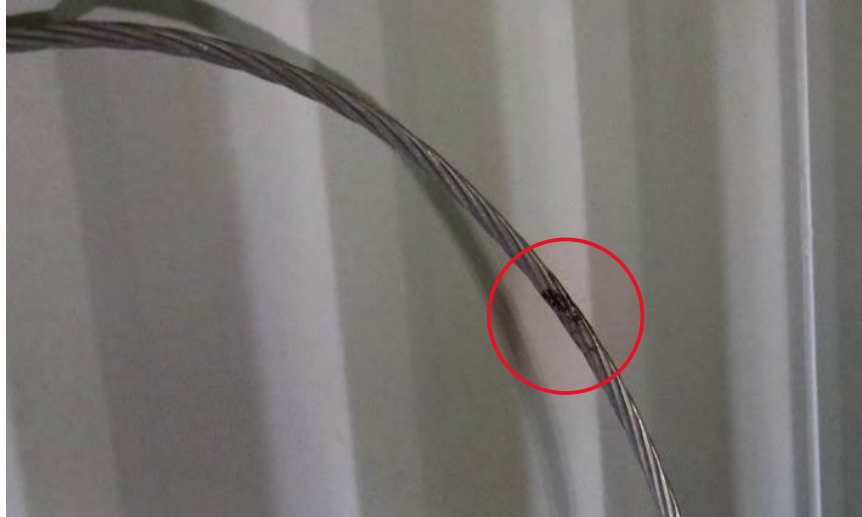
Figure 23 below shows scorch marks on a conductor section that connected to the Switch 49 bottom phase.<sup>63</sup>

**Figure 23: Scorch mark on conductor collected by USFS from Switch 49 bottom phase.<sup>64</sup>**

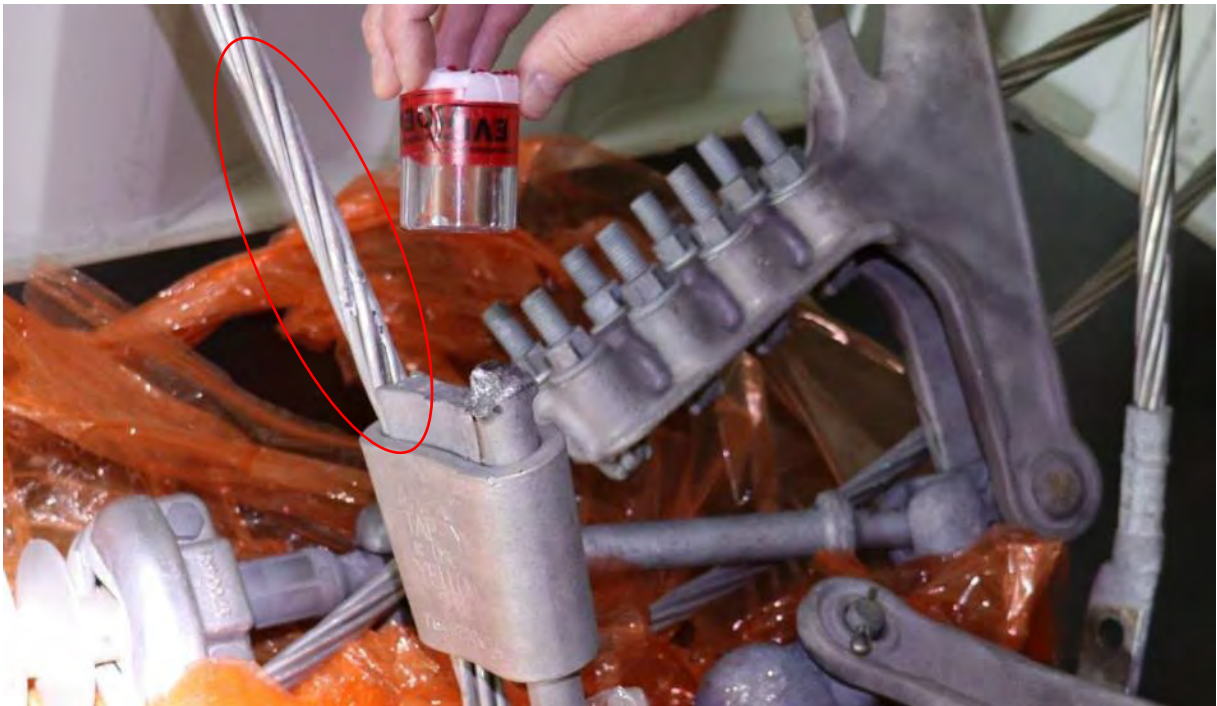
As shown in Figure 24, an evidence container (sealed with red tape) contains a small silver-colored bead that detached from the lower phase of Switch 49 after USFS collected this equipment, including the pitted section noted above.

Figure 24: Switch 49 lower phase conductor section pitting.<sup>67</sup>

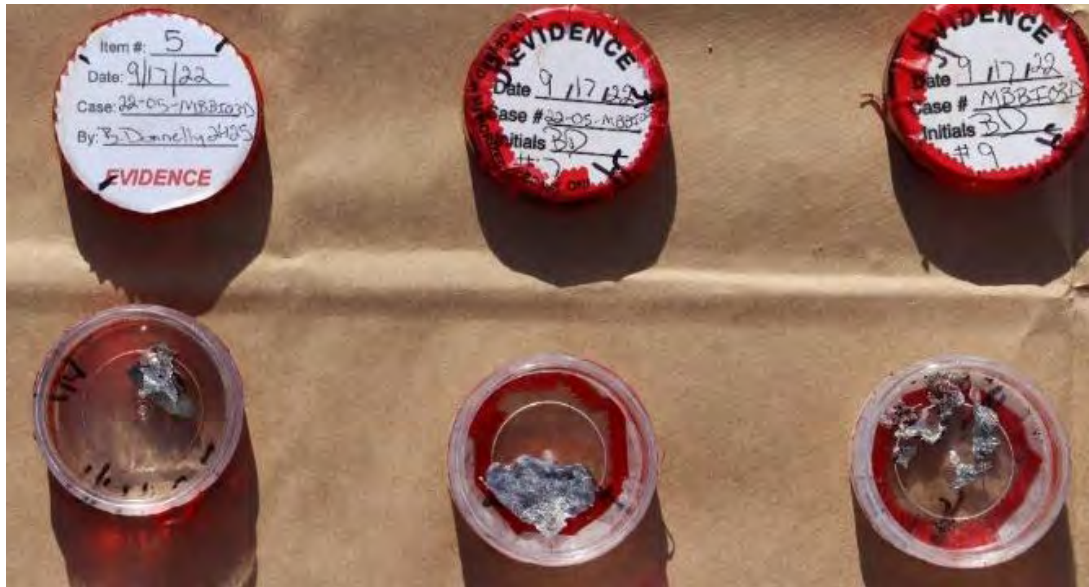
USFS collected several metallic flakes from the ground near the Oxbow Junction Pole on September 17, 2022, as shown in Figure 25 below.<sup>68</sup> The color of these flakes (steel or a similar silver colored metal) matches the upper section of the control rod shown earlier. As noted earlier, Figure 18 shows damage to the control rod, including areas where the top layer of metal apparently flaked off and was later collected by USFS as evidence. This evidence indicates that the lower jumper touched the upper control rod on September 6, 2022, causing an electrical fault that flaked these small pieces of metal from the upper control rod.

**Figure 25: Examples of metallic flakes collected by USFS.<sup>69</sup>**

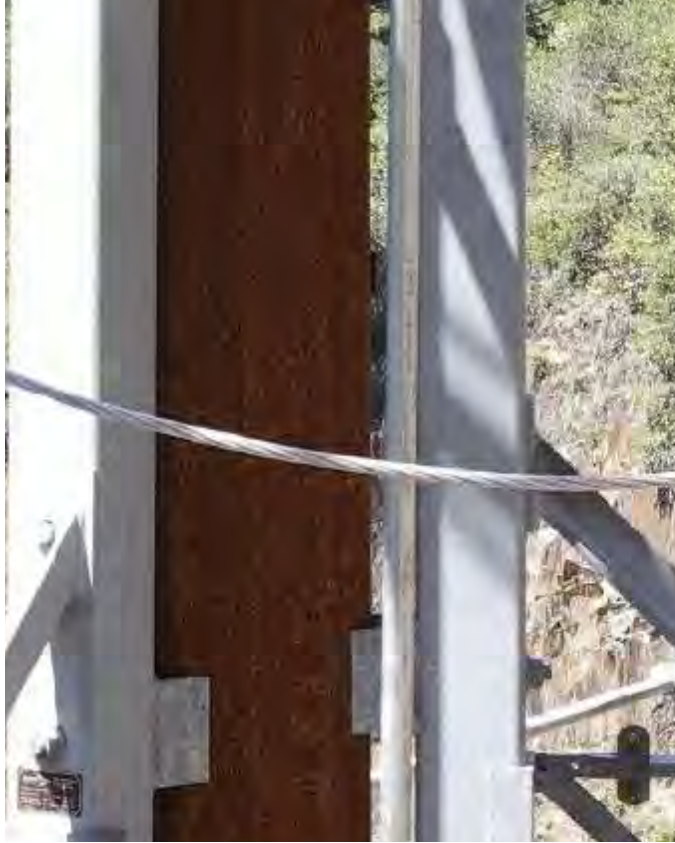
**Figure 27: Switch 47 upper control rod and lower jumper on May 16, 2022, showing no visible damage.<sup>97</sup>**

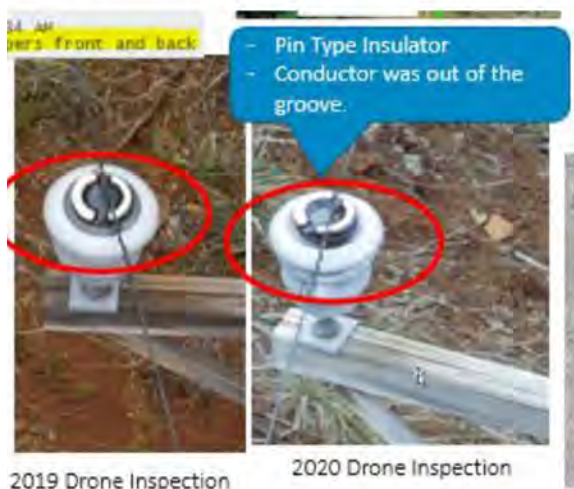
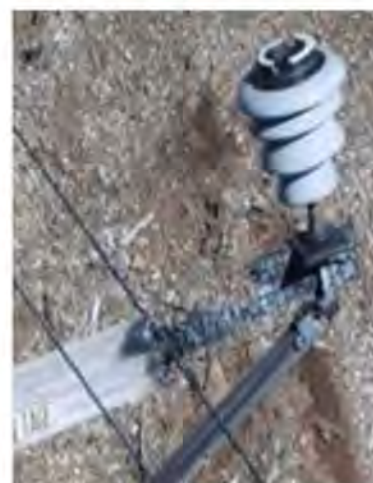
Figure 33: Loose tie wire (left) and resulting pole fire (right)<sup>123</sup>

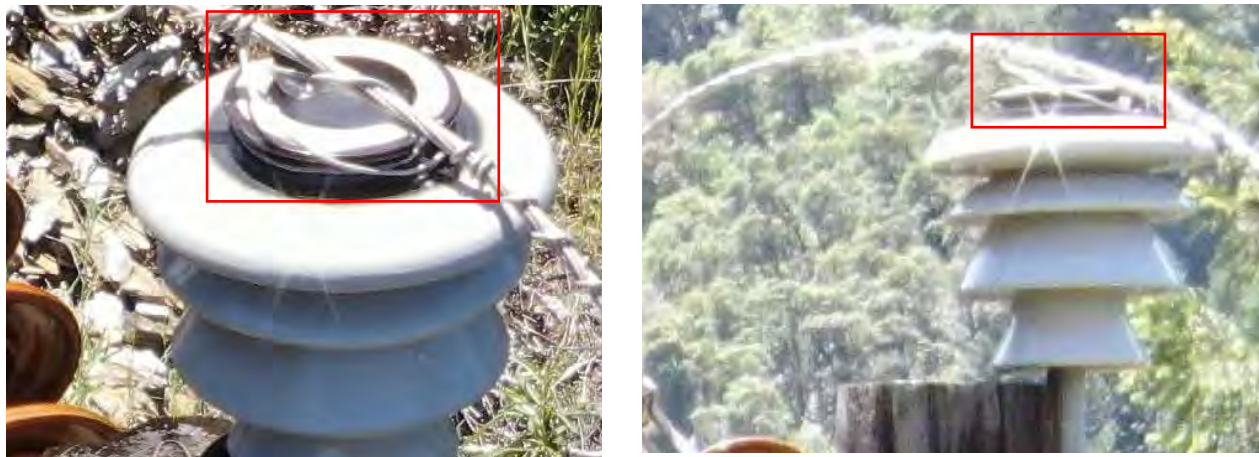
PG&E's June 9, 2022, Transmission notification 123833466 for Pole 14/186 states "LEFT POLE TIE WIRE NOT TO STANDARD."<sup>128</sup> PG&E also refers to the left pole as Pole 14/186(A), and the right pole as Pole 14/186(C).<sup>129</sup> Figure 35 below shows this loose tie wire.

**Figure 35: PG&E photos of loose tie wire, Pole 014/186(A), May 26, 2022<sup>130</sup>  
(SED outlined in red the loose tie wires)**

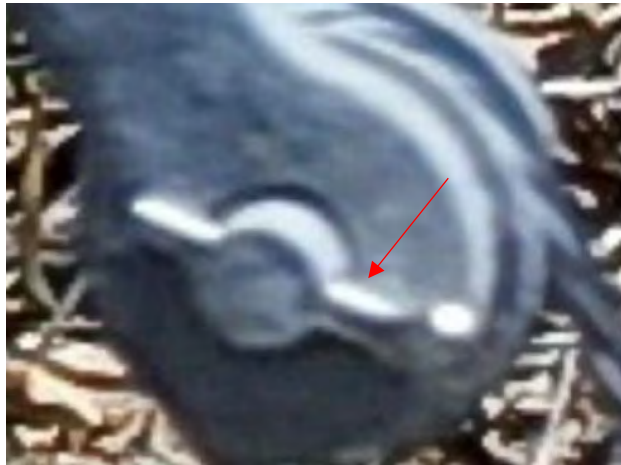
Figure 42: Partially seated cotter key at Pole 009/131 on May 26, 2022<sup>187</sup>  
(red arrow shows unseated section)

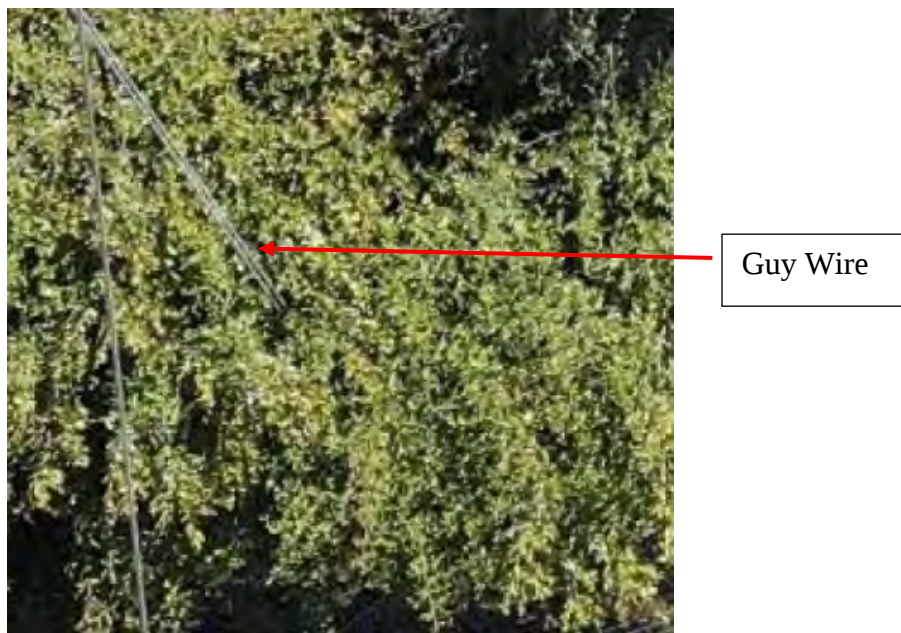
Figure 43: Vegetation obscuring guy wires at Pole 000/003<sup>192</sup>

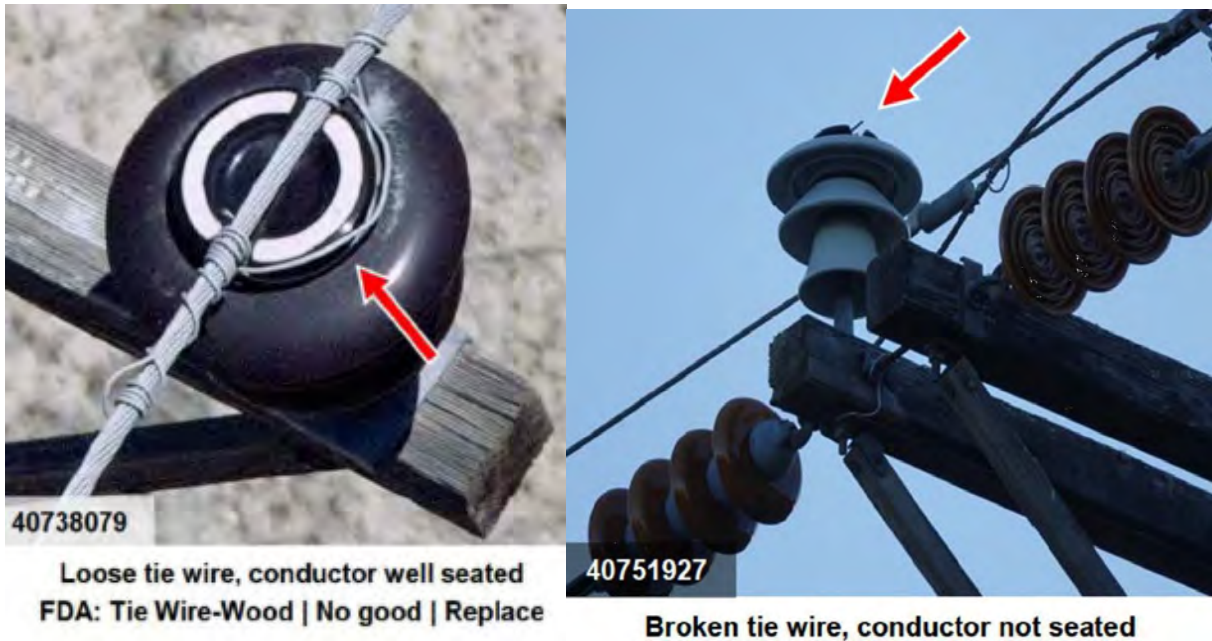
**Figure 48: Photos of loose tie wires from Identifying Conductor and Clearance Conditions<sup>239</sup>**
