Incident Investigation Report

Incident Number: E20220622-01 (Edgewood Fire)

Regulated Utility Involved: Pacific Gas and Electric Company (PG&E)

Regulated Utility Facilities Involved: Jefferson-Stanford 60 Kilovolt (kV) transmission circuit, and Emerald Lake 4.2kV distribution circuit.

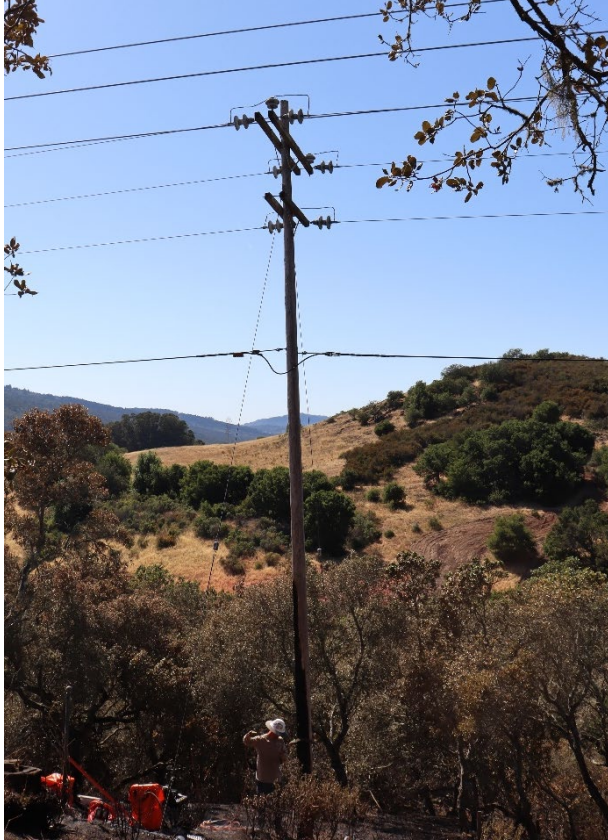
CAL FIRE led SED down the hill to the Incident Pole shown in Figure 2 below. Upon initial inspection of the Incident Pole, SED observed that the transmission line was hanging very low and appeared damaged directly above the high point of the distribution circuit on the Incident Pole (see Figure 3 below). The high point of the distribution line was a jumper cable supported by a vertical insulator on the south phase. SED observed that the jumper cable was broken at the point of the vertical insulator. In addition, visible flashing on the vertical insulator implied that the transmission conductor and distribution jumper cable likely came in close enough contact to cause an electrical arc.

Figure 2: Incident Pole supporting a distribution line with a transmission line visible above.

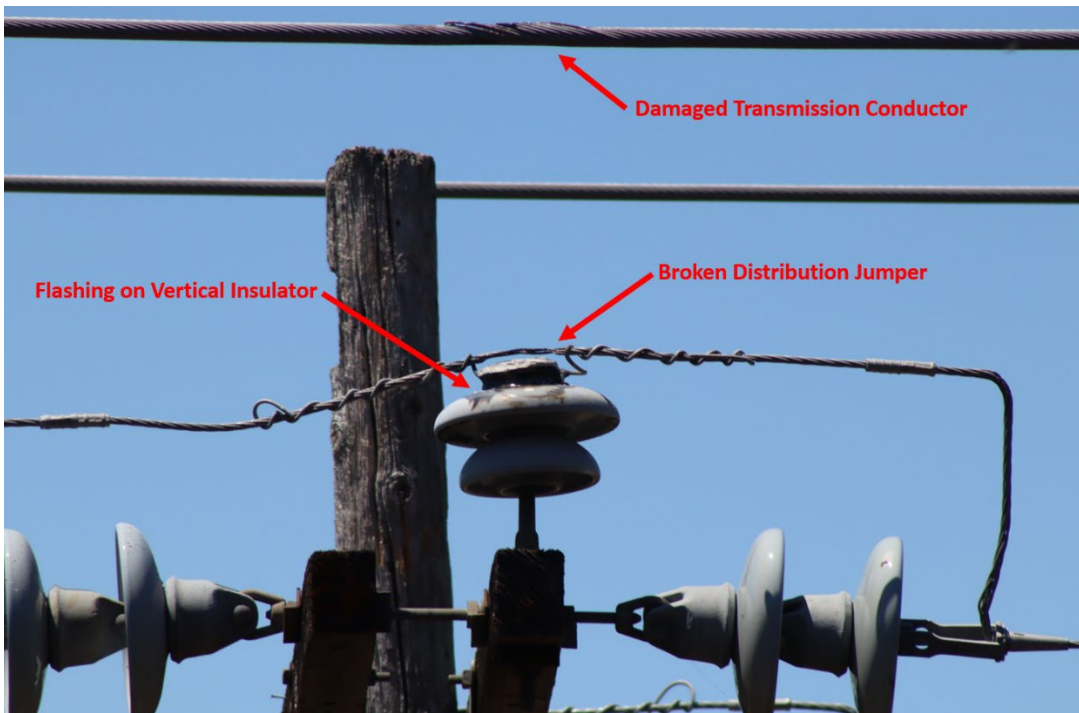
- 1914 hours Troubleman #3 called the DCC again to report a broken primary jumper at the Incident Pole. The troubleman did not observe any downed transmission or distribution conductors but did notice a fiber-optic communication line on the ground between Jefferson Substation and Emerald Lake Substation, which presumably were the downed wires the CAL FIRE Incident Commander requested PG&E investigate.

- 1938 hours A transmission troubleman (Troubleman #4) called the GCC and reported damage to the Subject Transmission Circuit conductor above the Incident Pole, where Troubleman #3 reported the broken distribution jumper. PG&E determined that the damage would require repair and re-sagging of the transmission conductor before it could be reenergized.

Figure 3: Top of the Incident Pole showing a damaged transmission conductor and a broken distribution jumper.

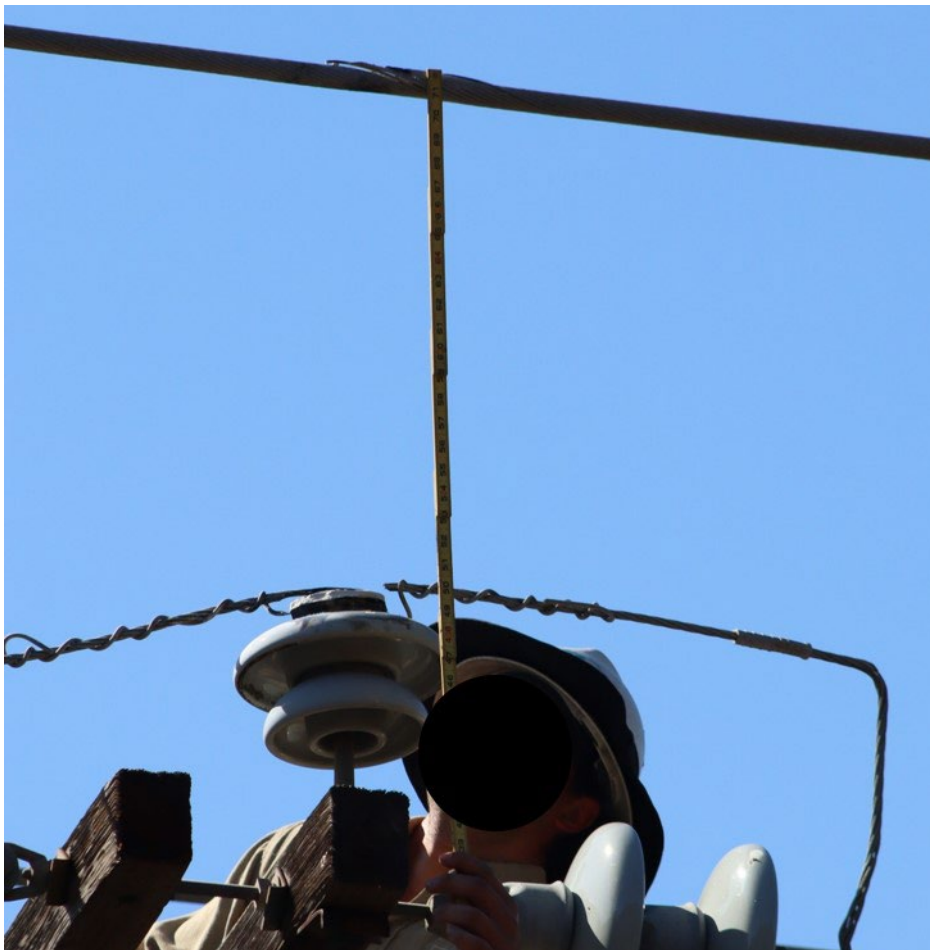
When PG&E joined CAL FIRE and SED, CAL FIRE informed the utility that they would be collecting evidence prior to the utility being able to repair and restore power. PG&E's priority for repair work was to repair the transmission line which served [REDACTED]. Before removing the evidence for CAL FIRE, the utility took measurements of the conductors in place, shown in **Figure 4** below. The distance between the transmission line, and distribution line jumper on the south phase was 23.5 inches. The distance between the transmission line and distribution line jumper on the north phase was 36.5 inches. The PG&E Transmission Foreman acknowledged that GO 95, Rule 38 required a minimum distance of 96 inches between 60kV and 4.2kV power lines. The measurements taken were "in situ." To SED's knowledge, the measurements taken reflect the distances between the lines prior to the fire's ignition. PG&E also measured the distance from the ground to the south phase transmission line at 40 feet 0 inches, and the distance from the ground to the south phase distribution line at 36 feet 5 inches.

Figure 4: PG&E Lineman measuring the distance between a transmission line and a distribution jumper cable, which reportedly measured 23.5 inches.

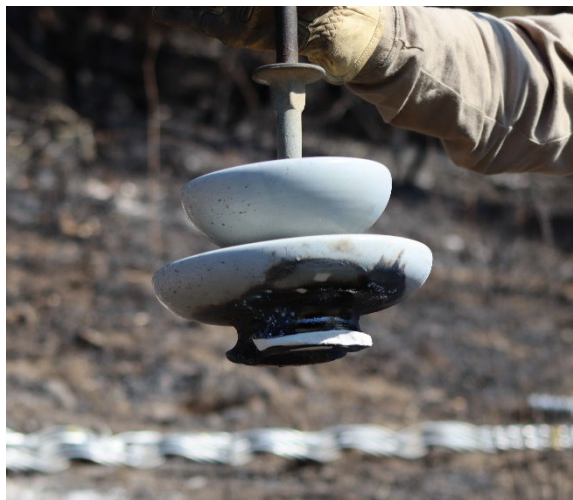
insulator had visible flashing on it, shown in Figure 5 below. The segment of transmission line CAL FIRE collected included the damaged portion, which showed flashing and melted metal. See Figure 6 below.

Figure 5: Flashing on the insulator collected by CAL FIRE.

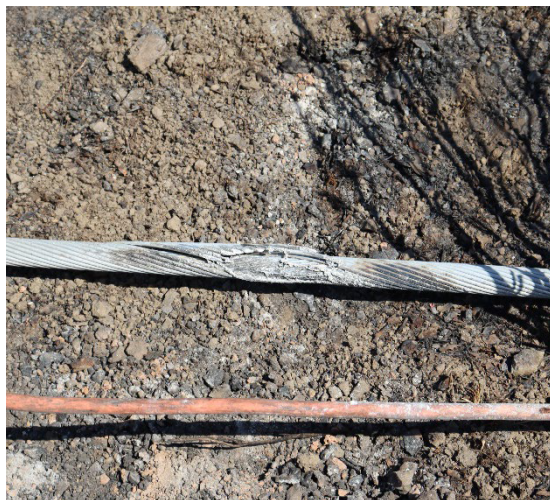
Figure 6: Damaged transmission conductor collected by CAL FIRE.

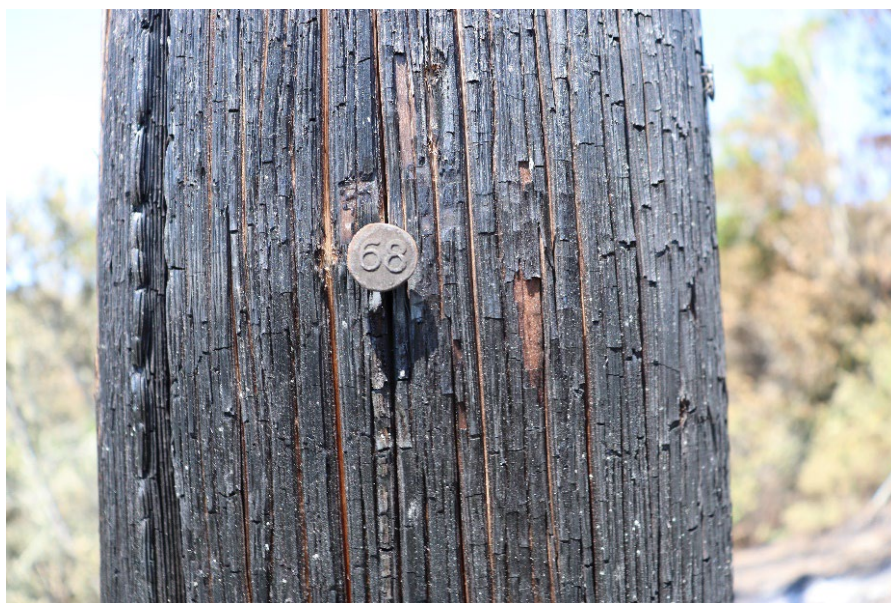
SED observed the poles in the Incident Location. The Incident Pole had no label indicating the equipment number. CAL FIRE confirmed they did not find any sign or label near the pole when they were containing the fire. A tag on the side of the Incident Pole indicated that the pole was installed in 1968, shown in Figure 7 below.

Figure 7: Tag indicating the Incident Pole was installed in 1968.

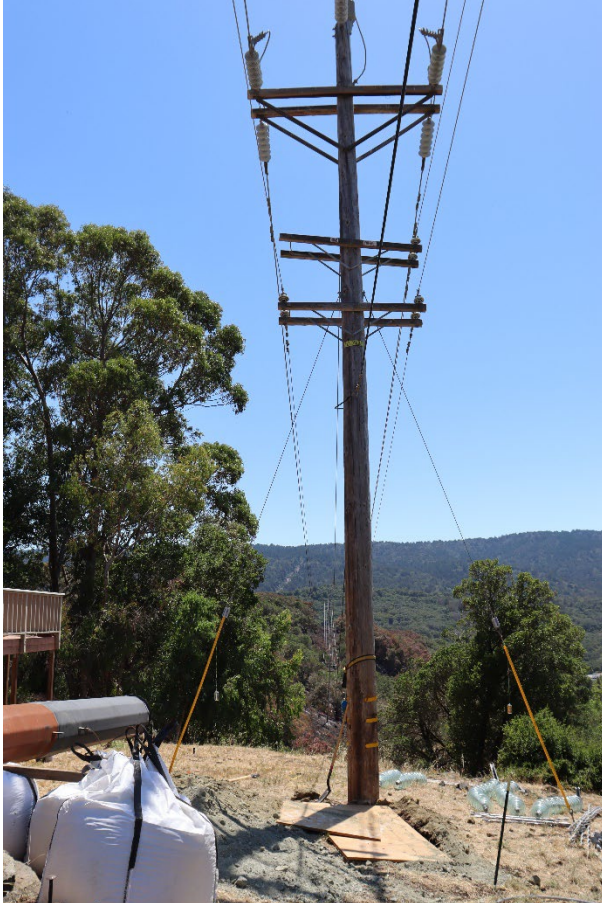
Pole 000/005 was one pole east of the Incident Pole. When SED observed this pole, there was a replacement pole and new insulators visible at the base of the pole, shown in Figure 8 below. At

the time of SED's site visit, a contracting company's trucks and workers were present at the pole. However, the contracting company was not performing any work. PG&E confirmed that this pole had been scheduled to be replaced, and the work had begun, but was placed on hold when the fire broke out.

Figure 8: Pole 000/005, downstream from the Incident Pole. The fire outbreak stopped the work scheduled to replace this pole. The replacement pole can be seen in the lower left corner of the photo.

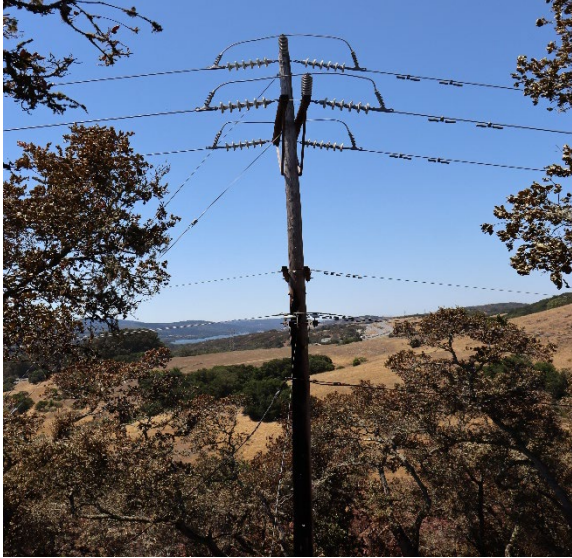
Pole 000/004 was one pole west (towards the Jefferson Substation) from the Incident Pole. This pole supported both the transmission and distribution lines. PG&E's Transmission Electric Foreman confirmed that the naming convention for Pole 000/004 indicates that it is the fourth pole from the Jefferson Substation. Figure 9 shows that this pole noticeably separates the lines further apart than they were above the Incident Pole (see Figure 2).

Figure 9: Pole 000/004 upstream of the Incident Pole, supporting and separating transmission and distribution lines.

SED did not measure the lines at Pole 000/004, but the lines displayed in Figure 9 appeared to be 96 inches apart, in accordance with GO 95, Rule 38. The fire significantly burned the pole, as shown in Figure 10, and PG&E confirmed that it would be replaced, though not on the day of the site visit. SED observed a fiber-optic telecom line, broken and on the ground and extending from this pole to the next pole upstream, Pole 000/003. PG&E later confirmed to SED via email that the utility owned the fiber-optic line, and it would be replaced.

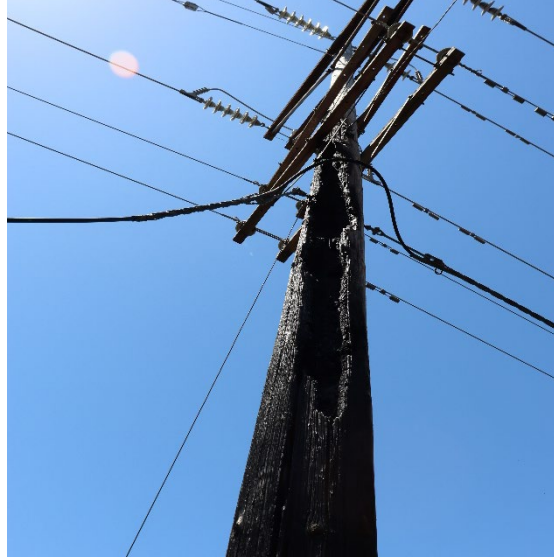
Figure 10: Pole 000/004 damaged by the fire, a telecom line is hanging on the ground.

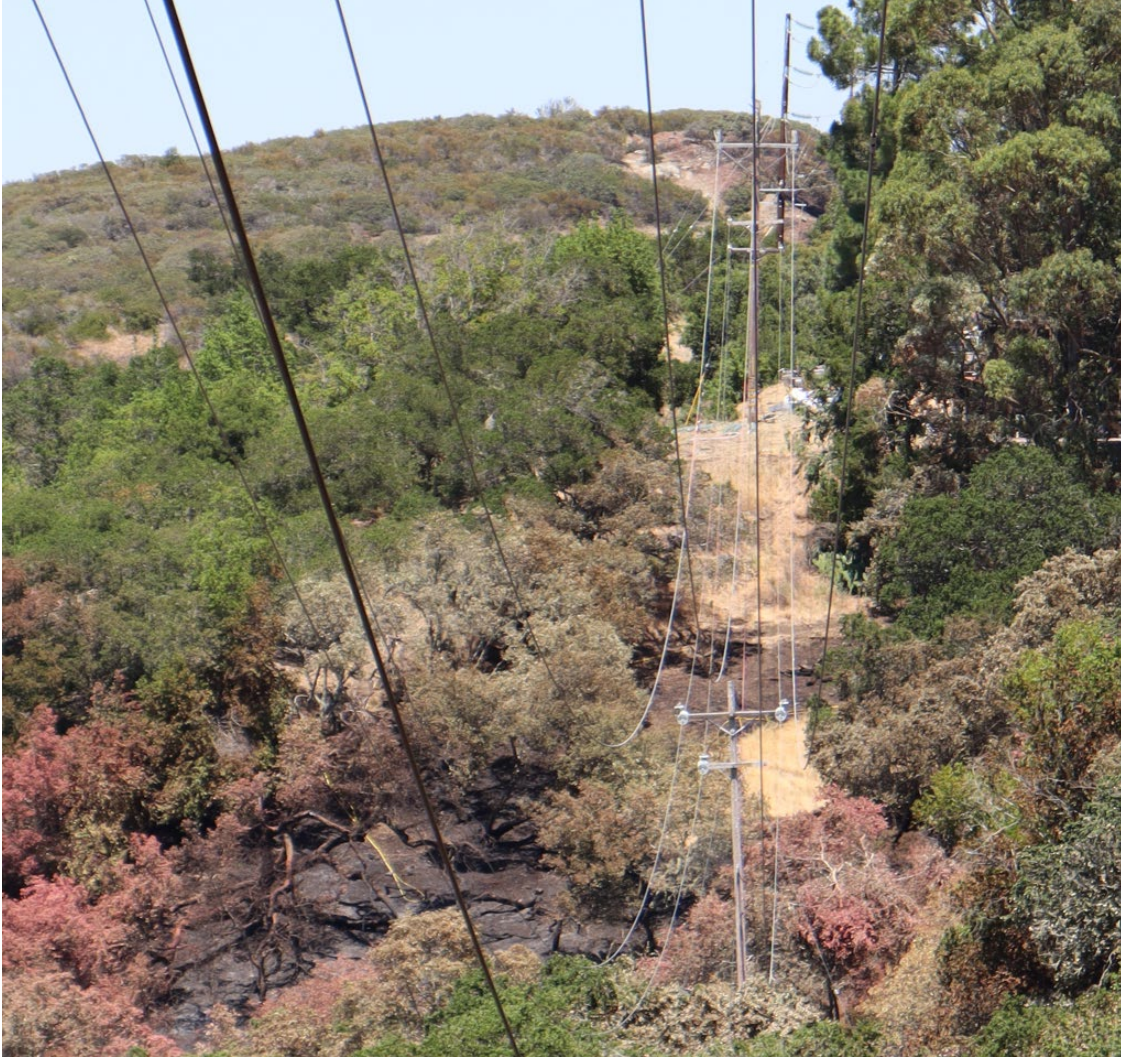
The view from Pole 000/004 looking towards the Incident Pole showed the significant amount of sag the transmission lines had across the Incident Span. See Figure 11 below.

Figure 11: View from Pole 000/004 looking towards the Incident Pole and Pole 000/005.

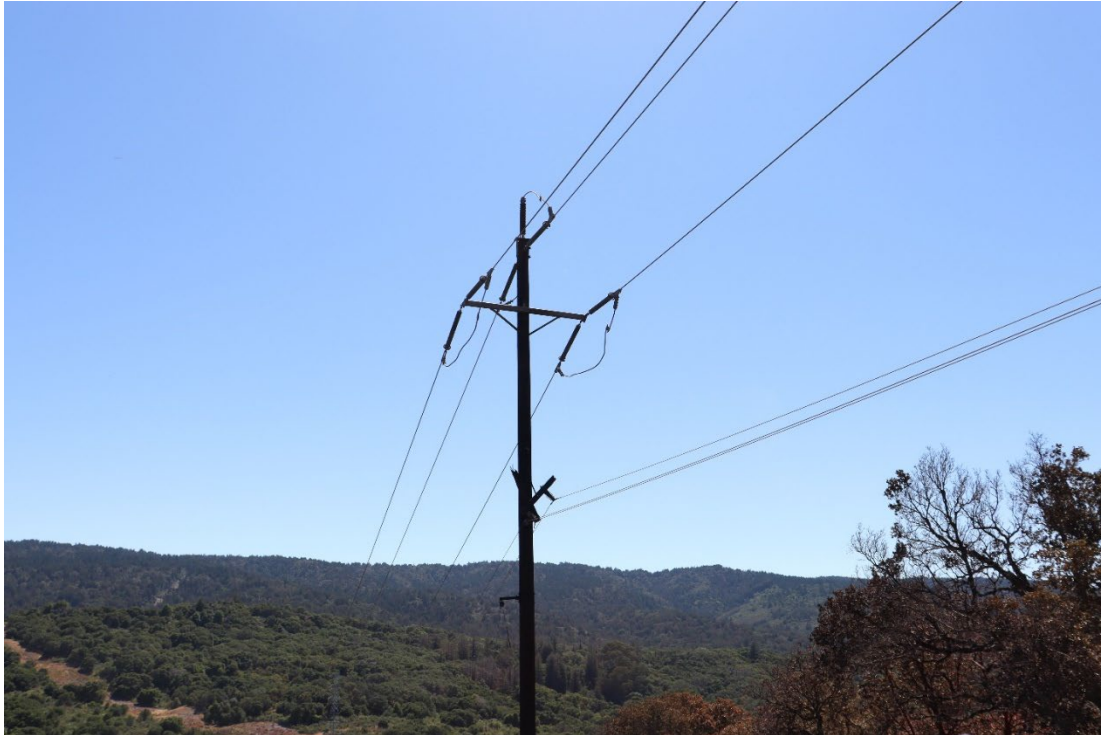
Pole 000/003 was two poles west from the Incident Pole. This naming convention indicates that it is the third pole from the Jefferson Substation. The fire also damaged this pole, and the pole had a broken crossarm supporting the Distribution lines. See Figure 12 below.

Figure 12: Pole 000/003 with a broken crossarm supporting distribution conductors.

SED asked the PG&E construction supervisor about the broken crossarm on Pole 000/003 that SED observed during the June 23, 2022, site visit. He stated that the crossarm was likely damaged from the fire, and then twisted and snapped.

- 1623 hours A third PG&E troubleman (Troubleman #3) was dispatched to the Jefferson Substation and arrived at 1700 hours. At 1806 hours, Troubleman #3 informed the DCC that there was a broken crossarm on Pole 000/003 on the Subject Transmission Circuit. PG&E created a corrective work order to repair the crossarm.

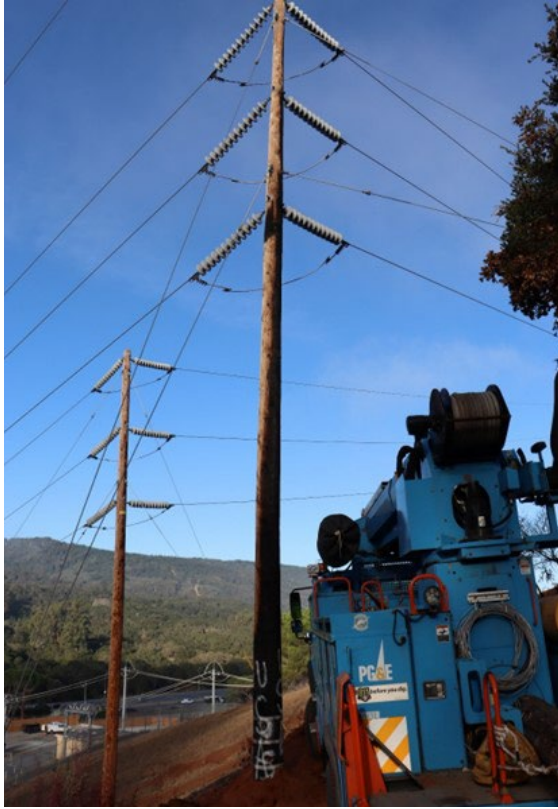
The PG&E construction supervisor confirmed that his crew had replaced Poles 000/002, 000/003, and 000/004 the night before the site visit, and that PG&E scheduled Pole 000/001 to be replaced that night or the next night (September 30, 2022). Figure 14 below shows Pole 000/001 prior to it being replaced.

Figure 14: Wooden Pole 000/001.

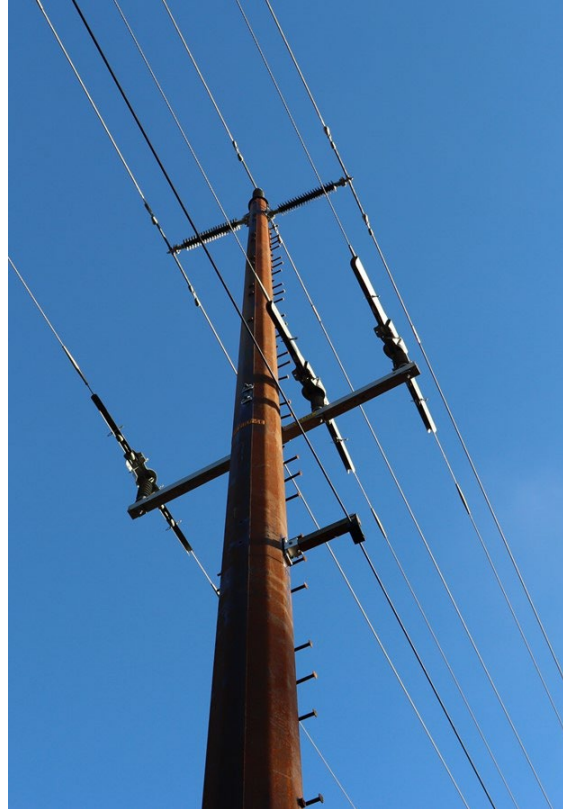
Figure 15: New Metal Pole 000/002.

SED observed that PG&E replaced the other wooden poles that the Edgewood fire damaged, Poles 000/002, 000/003, and 000/004, with metal poles. Figure 15 below shows Pole 000/002 as an example of the newly installed poles.

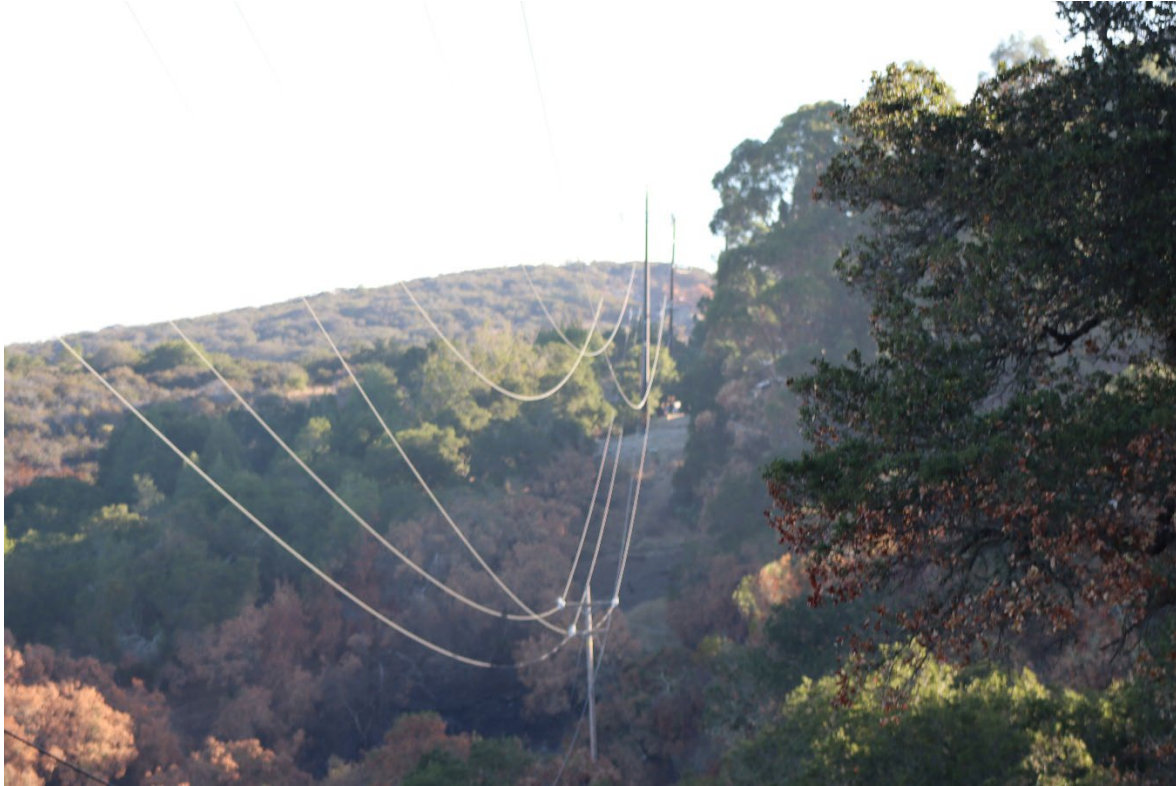
The Incident Span to Pole 000/005 is visible from Pole 000/004. Figure 16 shows this span. SED observed that the sag in the transmission line was substantially less than what SED observed during the June 23, 2022 site visit. On the second site visit, SED observed that the clearance between the 60kV transmission conductors and the 4kV distribution conductors, running parallel below the transmission lines, had substantially increased with the installation of the new poles. Comparing Figure 11 to Figure 16, the clearance appeared to SED to meet the minimum 96-inch clearance required by GO 95, Rule 38, though no measurements were taken during SED's site visit.

Figure 16: Conductor span between Poles 000/004 and 000/005, with the Incident Pole visible below the transmission conductors.

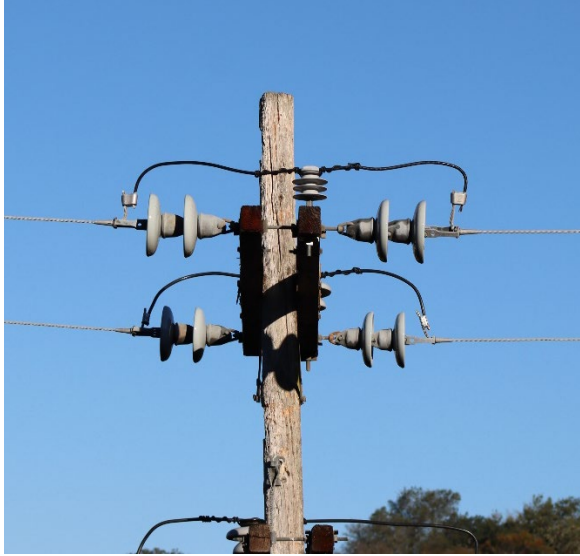
Figure 17: Top of the Incident Pole showing new, insulated jumper lines.

After the SED and PG&E investigators took photos of Poles 000/001, 000/002, 000/003, and 000/004, they descended a steep grade to reach the Incident Pole. SED observed that PG&E had not replaced the Incident Pole, which showed some fire markings around the base. The PG&E construction supervisor remarked to SED during the site visit that he did not know if PG&E would replace this pole, since it was a distribution asset, and he was only knowledgeable about transmission assets. SED observed that the new jumper cables installed on the Incident Pole had insulation wrap around them, as shown in Figure 17 below.

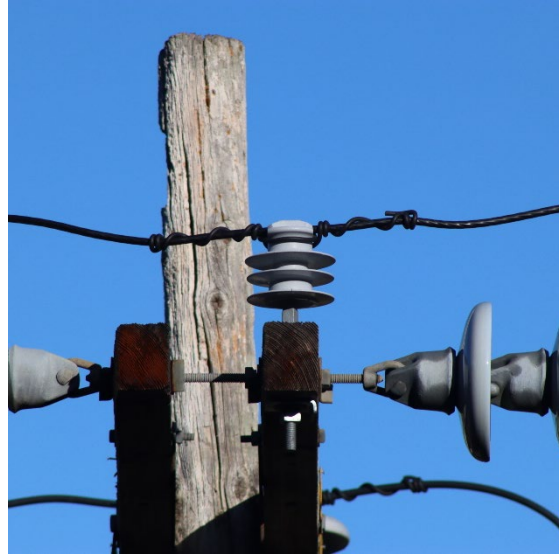
Figure 18: New flying bell insulator and insulated jumper lines on the Incident Pole.

PG&E had replaced the flying bell insulator, shown in Figure 18 below, after CAL FIRE took the old one as evidence. The PG&E construction supervisor pointed out that PG&E had not replaced the transmission conductor. Instead, PG&E installed “compression splices” on the spliced cable after CAL FIRE retained a section of conductor for evidence. Then, PG&E added “shunt splices” on top of the “compression splices.” He explained that a shunt splice looks like a wrap around the shiny tube-like sleeve, which is a compression splice. Both are shown in Figure 19 below. The PG&E construction supervisor added that these splices are commonly installed nowadays for increased electrical and mechanical security.

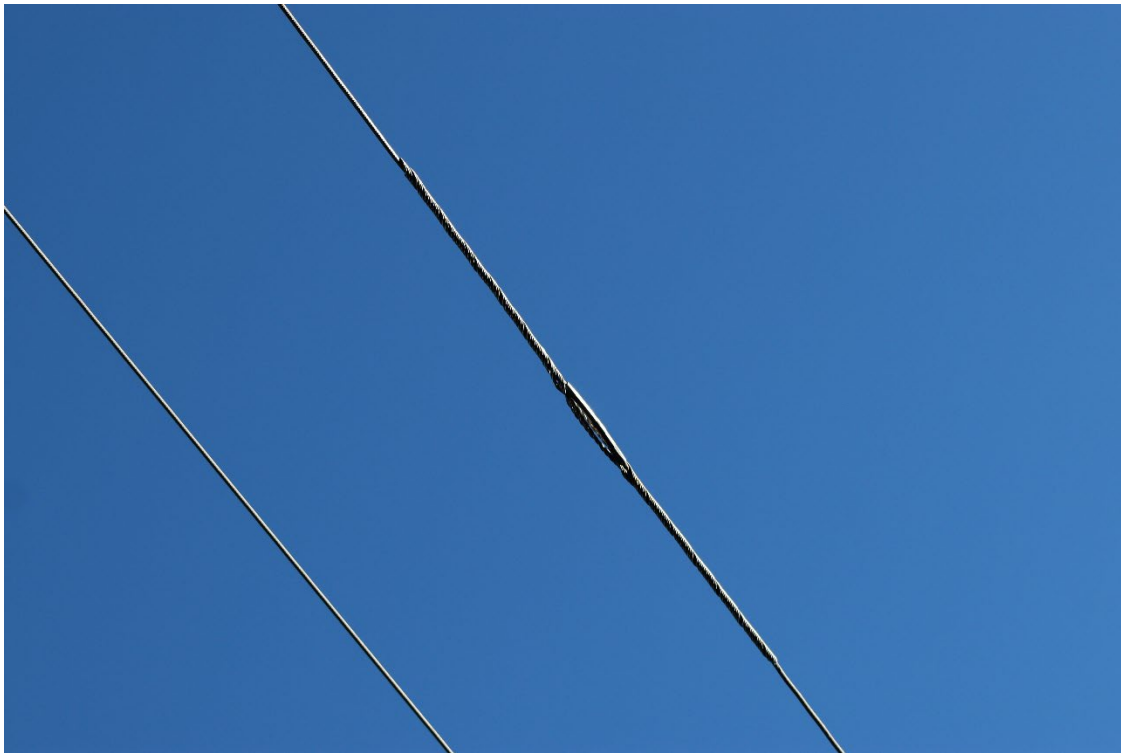
Figure 19: Transmission conductor compression splice and shunt splice above the Incident Pole.

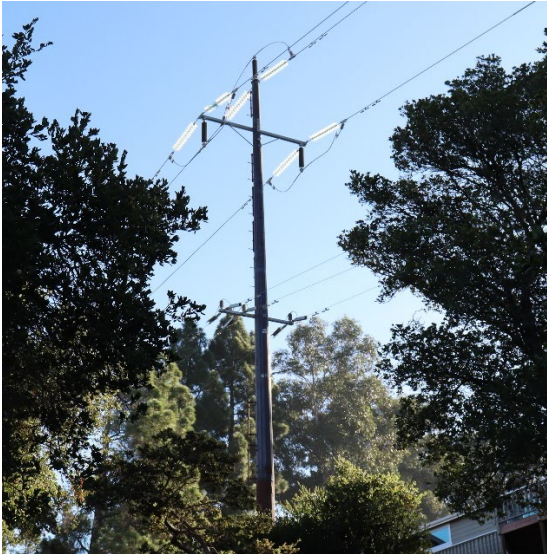
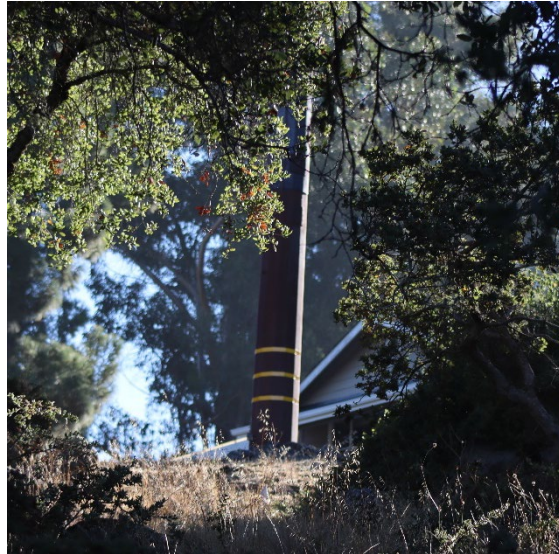
Relatedly, due to the remarked upon ongoing dispute, during the site visit, the PG&E investigator called PG&E corporate security to request permission to access Pole 000/005 during the site visit. In turn, PG&E corporate security recommended that the investigator avoid the owner's property. As a safety measure, SED followed suit and did not access the pole. Rather than access the pole, SED photographed the pole from a distance and did not identify any abnormal conditions. See Figure 20 and Figure 21 for images of Pole 000/005.

Figure 20: Pole 000/005 viewed from down the hill looking north-east.

Figure 21: Bottom of Pole 000/005 viewed from down the hill looking north-east.

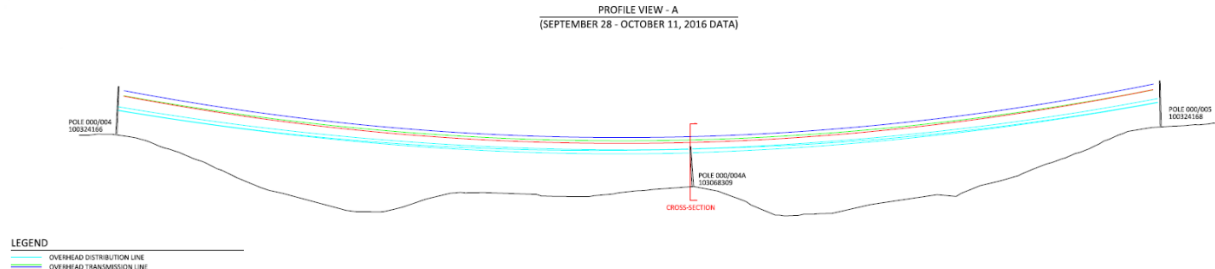
of the Incident Span that PG&E provided based on LIDAR point cloud data from a September 28, 2016 scan of the area. The cross section shown in Figure 23 is based on LIDAR point cloud data at the Incident Pole. Figure 23 shows that on September 28, 2016, the clearance was 69.6 inches between the Subject Distribution Circuit conductors on the Incident Pole, and the Subject Transmission Circuit conductors hanging above the Incident Pole.

Figure 22: Profile Drawing of the Incident Span based on 2016 LIDAR Data.³²

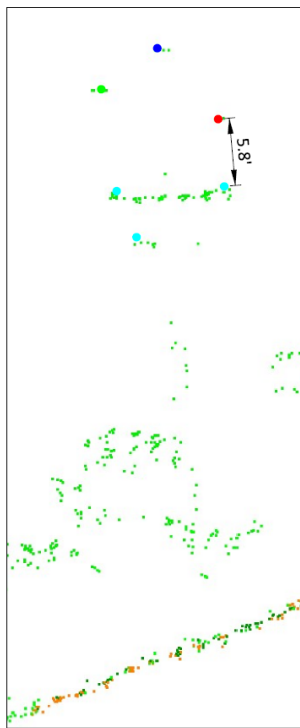
CROSS-SECTION
(SEPTEMBER 28 - OCTOBER 11, 2016 DATA)

Figure 23: A cross section of the clearance at the Incident Pole based on LIDAR Data indicates a 69.6-inch clearance.³³

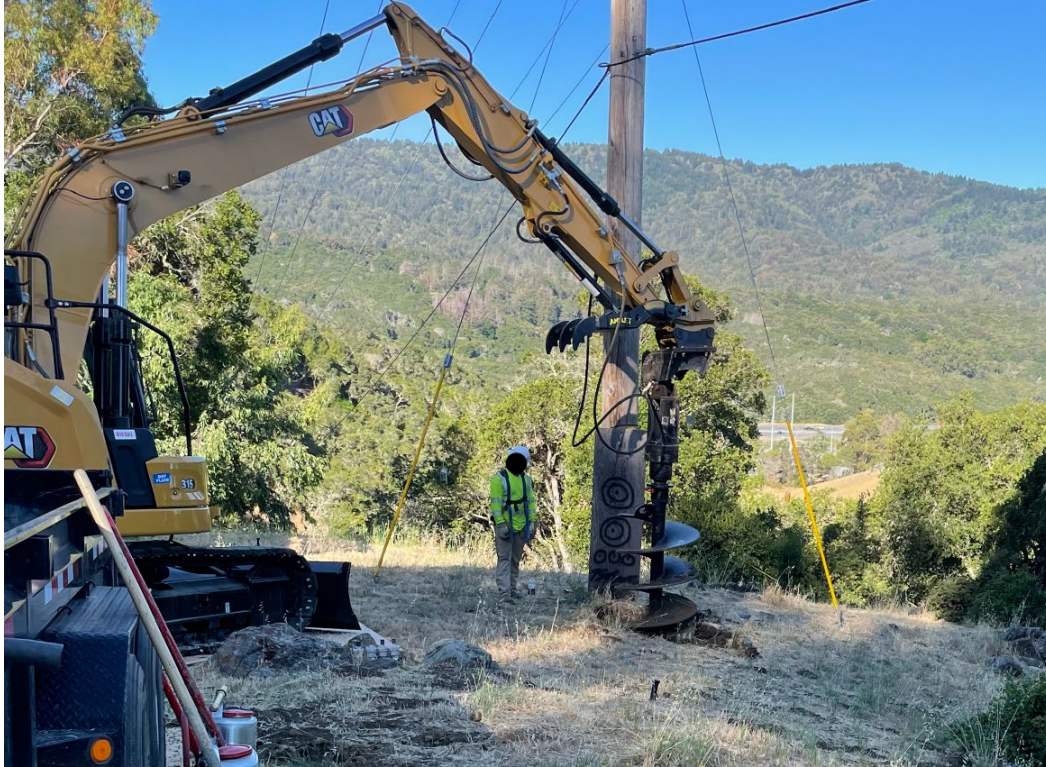
Figure 24: Excavation at Pole 000/005 the morning of June 21, 2022.⁷⁶

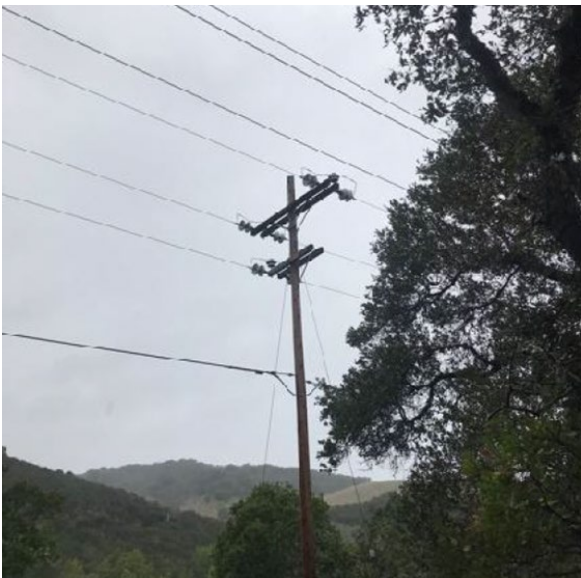
PG&E provided inspection reports for the WSIP inspections of the Incident Span with its 20-Day Report, and the photos below from two separate 2019 inspections show transmission conductors hanging visibly close to the distribution conductors on the Incident Pole. LIDAR data from that year confirms that there was insufficient clearance at the time of this inspection.⁸³ Nonetheless, the inspector failed to identify the condition. PG&E explained to SED that as part of its corrective actions taken in response to the Edgewood Fire, PG&E created a new process to use LIDAR data to identify GO 95, Rules 37 and 38 clearance issues. However, PG&E confirmed that prior to July 21, 2022, the utility did not use LIDAR to identify clearance issues and that those issues, if they were identified at all, were identified via overhead inspections.⁸⁴

Figure 25: Photo of the Incident Pole taken on January 16, 2019 as part of a transmission WSIP inspection. The inspection report does not identify any clearance issues.⁸⁵

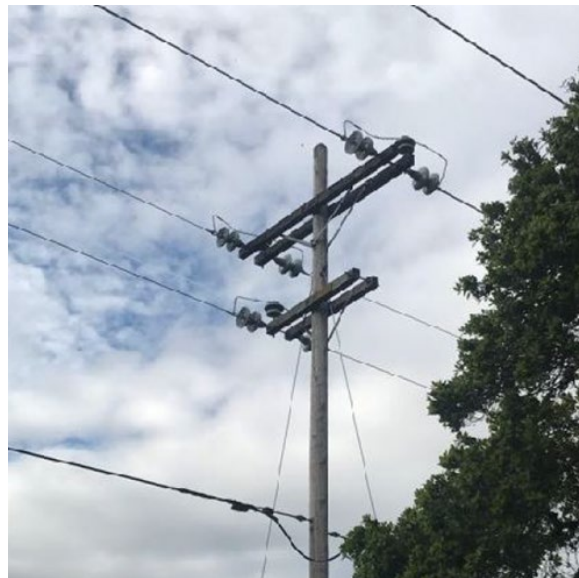
Figure 26: Photo of the Incident Pole taken on April 6, 2019 as part of a Distribution WSIP inspection. The inspection report does not identify any clearance issues.⁸⁶

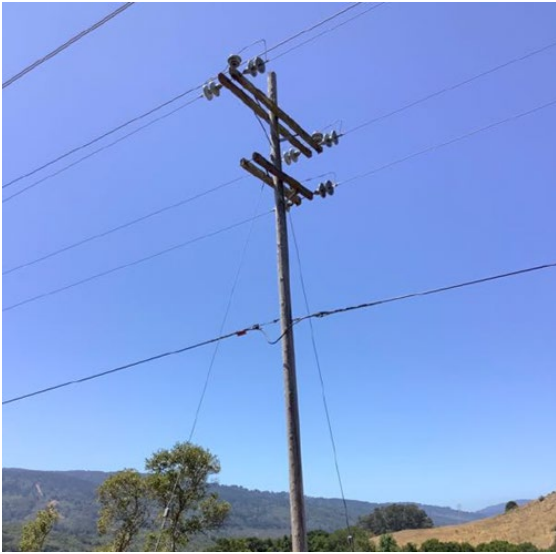
1. The June 2020 Distribution GO 165 Patrol records do not identify conductor clearances issues and notes “no abnormal conditions identified today.”⁸⁷
2. The August 2020 Distribution GO 165 Inspection records do not identify any issues with conductor clearances along the Incident Span, but include photos which show the transmission conductor sagging low and hanging above the Incident Pole.

Figure 27: Photo of the Incident Pole taken by the PG&E Compliance Inspector on August 6, 2020, during a Distribution GO 165 Inspection. Transmission conductors are visible above in the top left corner.⁸⁸

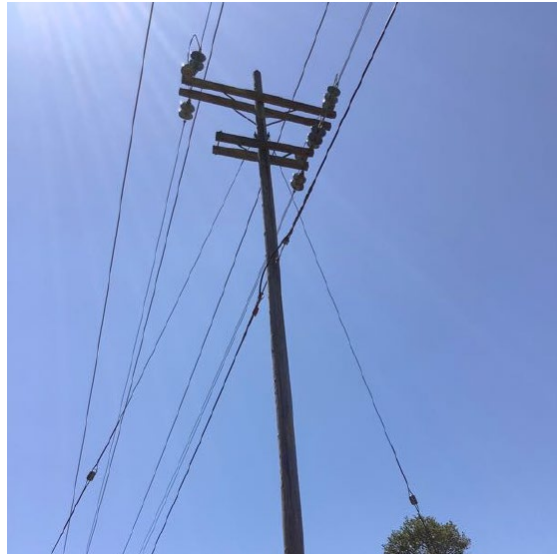
Figure 28: Photo of the Incident Pole taken by the PG&E Compliance Inspector on August 6, 2020, during a Distribution GO 165 Inspection. Transmission conductors are visible above.⁸⁹
