Company: San Diego Gas & Electric Company (U 902 M)
Proceeding: 2024 General Rate Case – Track 3
Application No.: A.22-05-016
Exhibit: SDG&E-T3-WMPMA-14

Investigation Report of the Woolsey Fire

INVESTIGATION REPORT OF THE WOOLSEY FIRE

**SAFETY AND ENFORCEMENT DIVISION
ELECTRIC SAFETY AND RELIABILITY BRANCH
LOS ANGELES**

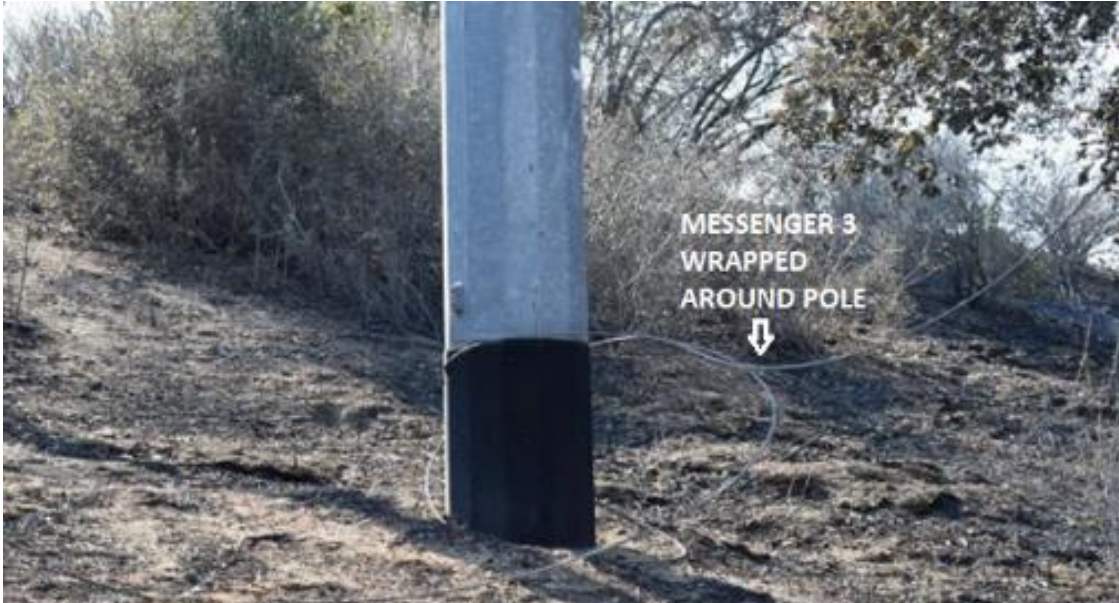
Three of the four communications conductors supported by the Stubbed Pole ran north from the Stubbed Pole and past the Steel Pole. This included the two ECS conductors and one conductor of unknown ownership. These three conductors were deflected by the Steel Pole, but not attached to it. The messenger wire that had previously supported the two ECS conductors running past the steel pole had been broken or cut, and one end of it had been wrapped around the base of the steel pole (this messenger wire will be referred to as "Messenger Wire 3" further in the report; see figure 3). The other end

Figure 3: Messenger Wire 3 broken and wrapped around the base of the Steel Pole.⁷

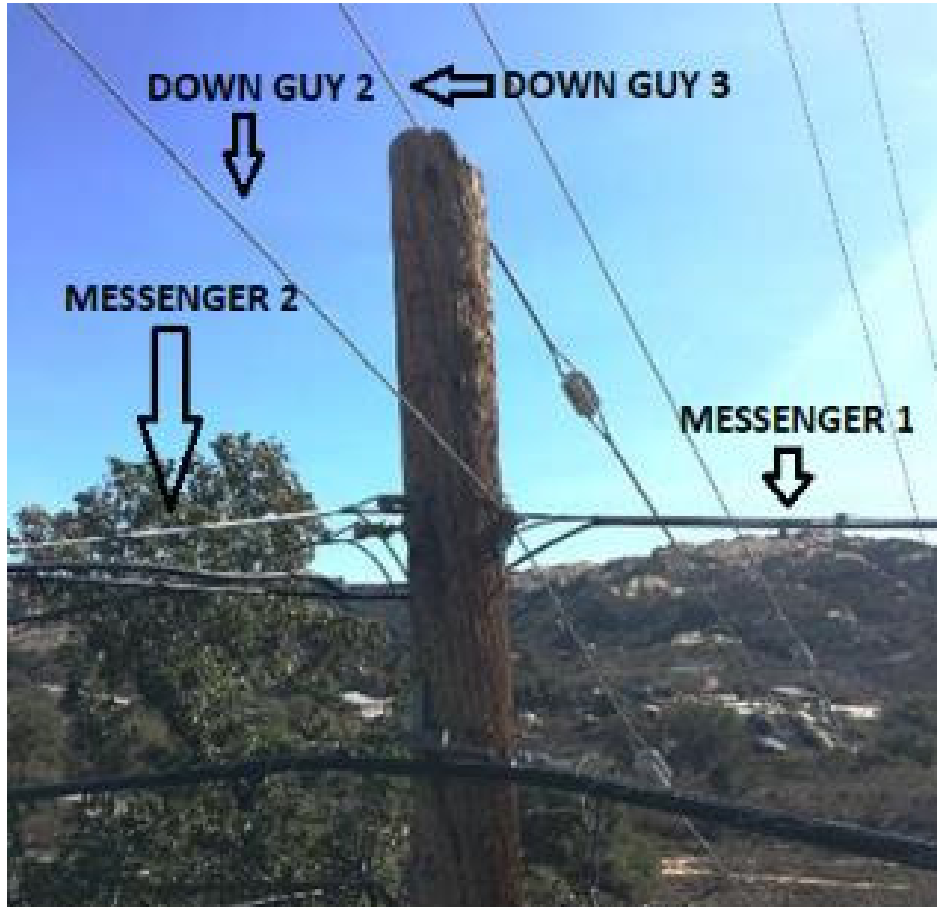
The Stubbed Pole supported communications conductors that ran to the north, east, and west. The communications conductors running east and west from the pole each had their own messenger wires which were connected together via a “through bolt”, a bolt that penetrated all the way through the pole horizontally. One of the northbound communications conductors also had a messenger wire (Messenger Wire 3, which was wrapped around the base of the Steel Pole), but this messenger wire was not electrically linked to the other two messenger wires on the Stubbed Pole. Messenger Wire 1 ran to the west, and Messenger Wire 2 ran to the east toward Site 1. Although the east-and-westbound messenger wires were separate and distinct, they were electrically connected by the through bolt they had in common. One of the loose down guy wires on the Steel Pole was in contact with Messenger Wire 1 at the time the incident occurred. See Figure 5.

Figure 5: The Stubbed Pole as viewed from the northwest. Note the loose down guy in contact with Messenger Wire 1.⁸

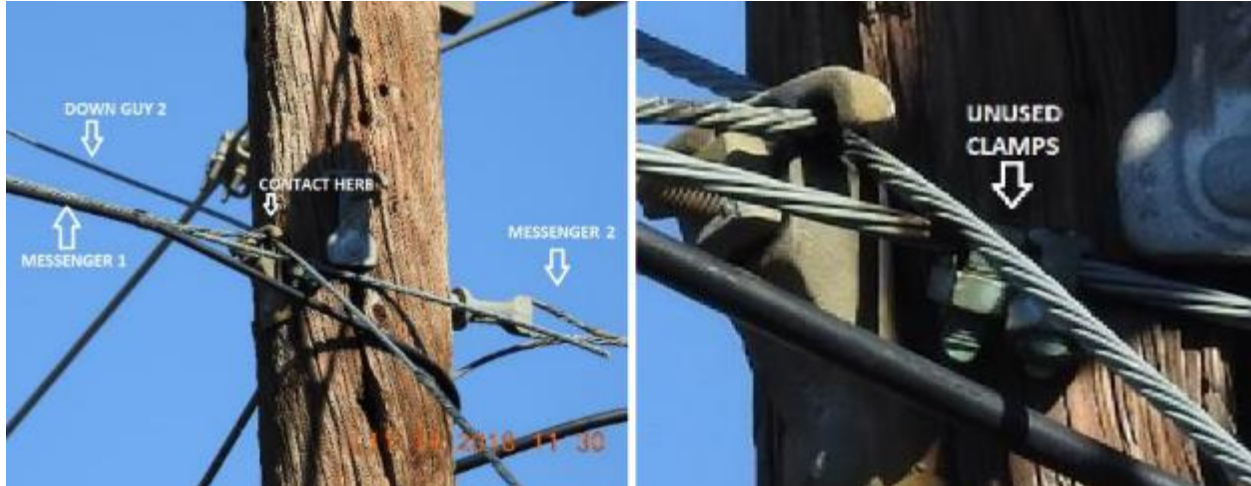
The three messenger wires on the Stubbed Pole had been designed to be bonded together, that is, electrically linked for grounding purposes. Each of the three messenger wires had a wire extension on the end and these ends were designed to be connected to one another by way of bonding clamps, which are small, simple metal clamping devices. However, at the time of the incident, the three messenger wires were not bonded together, although the bonding clamps were present and ineffectually attached to the wire extension on Messenger Wire 1. See Figure 6.

Figure 6: The top of the Stubbed Pole as viewed from the southwest. Note the unattached bonding extension on Messenger Wire 1 in the photograph on the left. On the right is a detail of the extension showing the unused bonding clamps.⁹

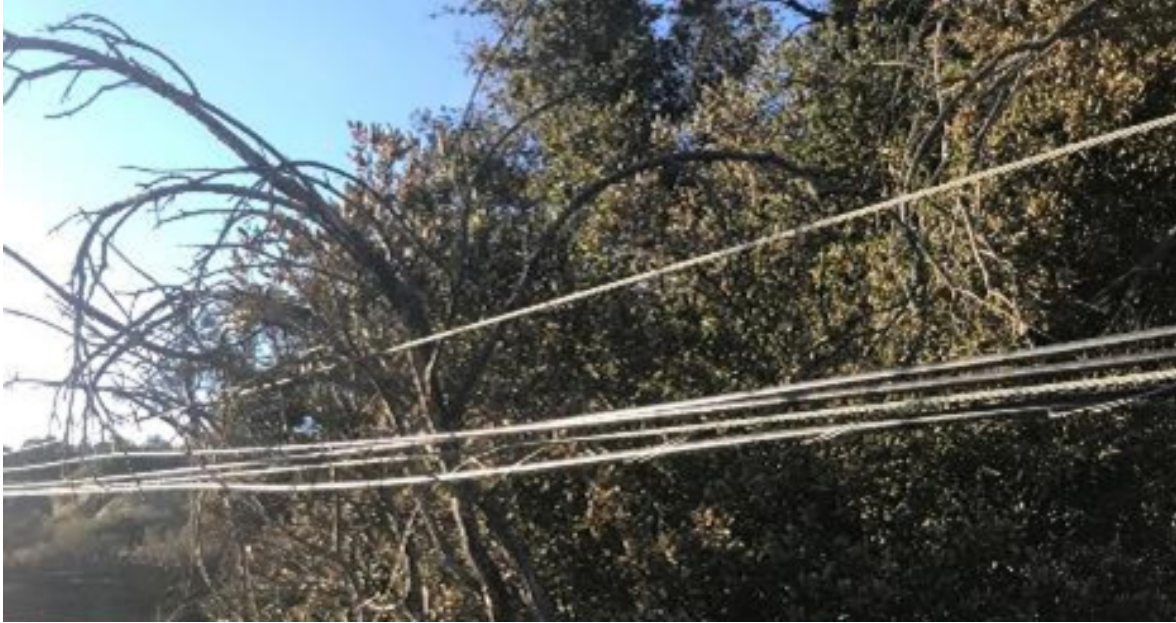
Figure 7: Overgrown tree branches pressing the ECS communications conductor into the third-party communications conductor at Site 1. The communications conductors separated from their messenger guys when their lashing wires melted during the arcing event.¹⁴

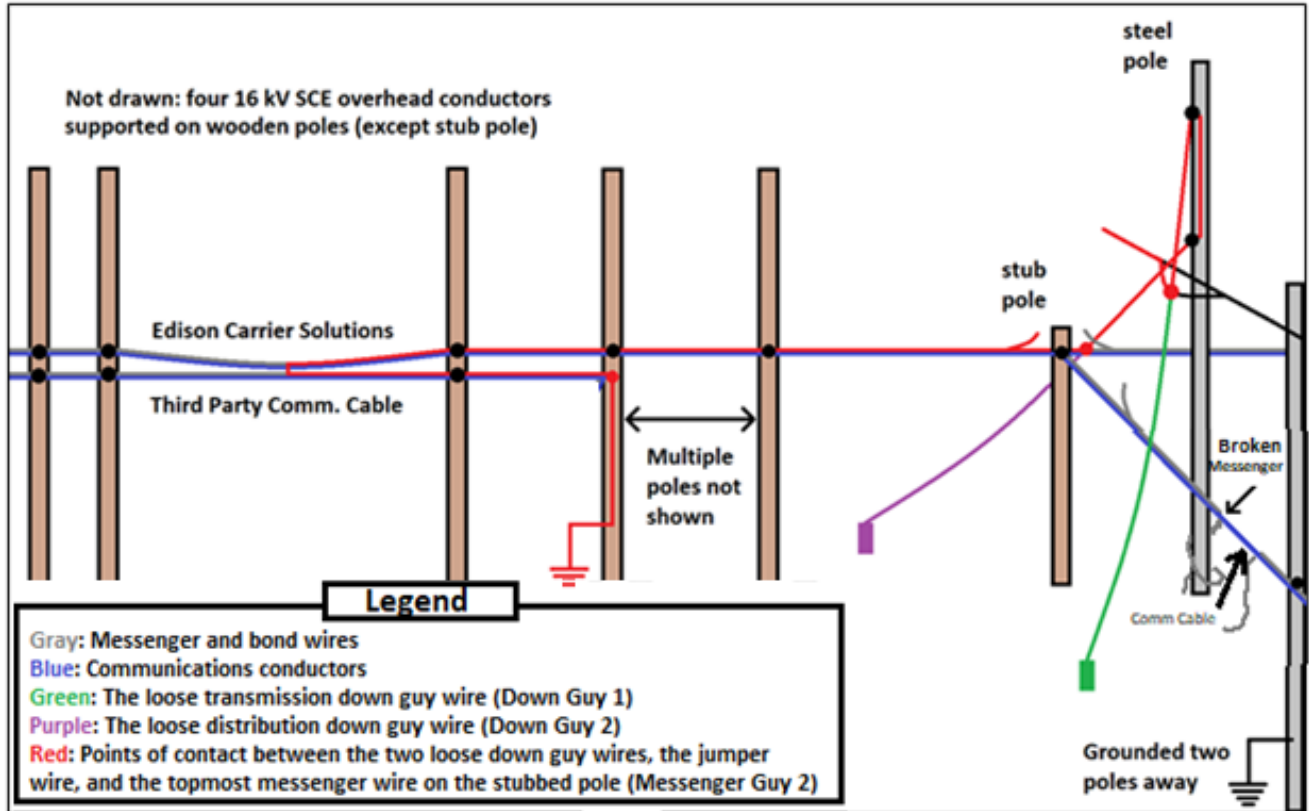
When Down Guy 1 contacted the jumper wire, it became energized, which caused the Steel Pole to become energized as well. As a result, a loose Edison distribution down guy wire (Down Guy 2) attached to the Steel Pole also became energized. Down Guy 2 was also in contact with an ECS messenger wire (Messenger Wire 1) via a steel through-bolt that was supported on the Stubbed Pole. This contact caused Messenger Wires 1 and 2 to become energized along with their respective lashing wires. See Figure 9.

Figure 9: Path of electrical current during the incident. The path of the electric current is represented in red. The loose transmission down guy wire in green made contact with the jumper wire on the Steel Pole, energizing the pole and all its attachments. The loose distribution down guy wire in purple made contact with the messenger wire on the Stubbed Pole. The eastbound messenger wire made contact with the grounded messenger and lashing wires of the third-party communications conductor at Site 1.

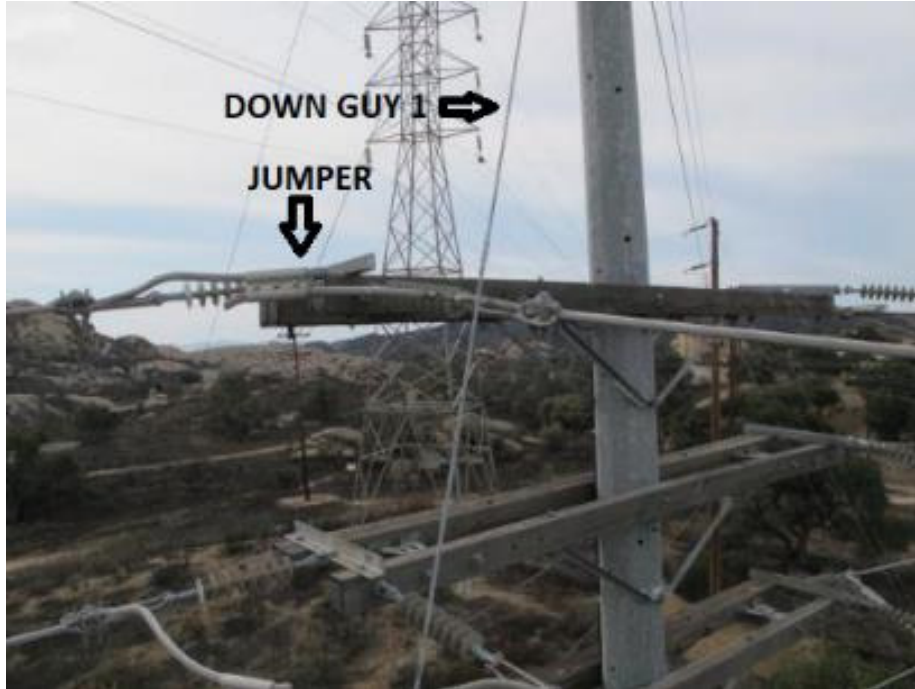
Figure 11: A lateral view of Down Guy 1 and the jumper wire taken from an elevated work platform from the northeast.²³

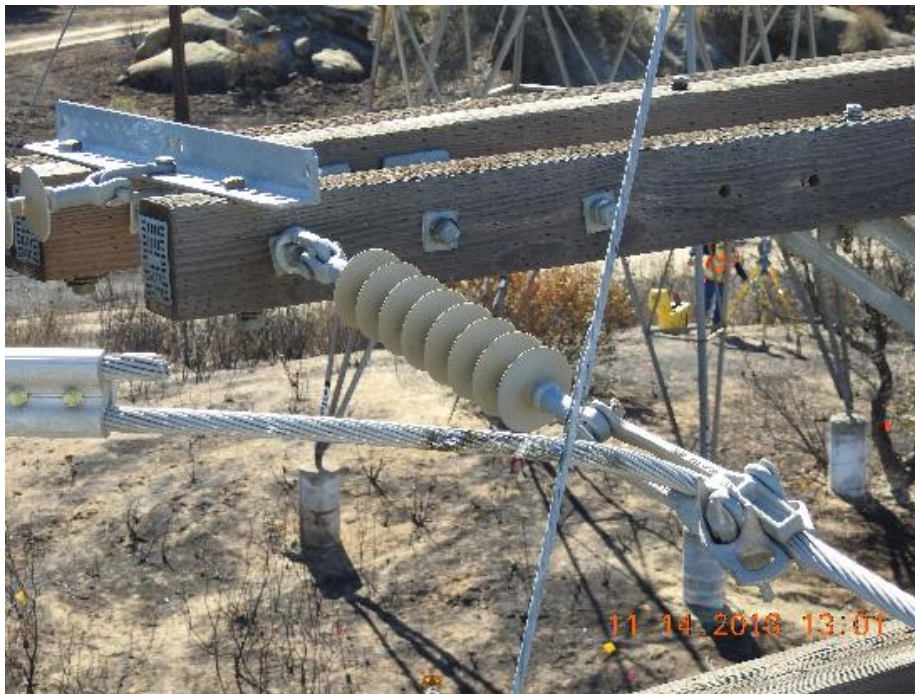
Figure 12: The jumper wire and transmission down guy wire (Down Guy 1) on the Steel Pole. Note the burn marks on the jumper wire and the damage to the down guy wire.²⁴

Staff observed that Down Guy 1 was loose and had sustained damage consistent with contacting the Edison 16 kV jumper wire. Staff noted that two other Edison down guy wires on the south side of the Steel Pole were also loose. The second loose down guy wire, Down Guy 2, was in contact with Messenger Wire 1 on the Stubbed Pole. The third loose down guy wire, Down Guy 3, was in contact with the top of the Stubbed Pole. Staff observed dark discoloration around the contact point between Down Guy 2 and the ECS through-bolt. See Figures 15-18.

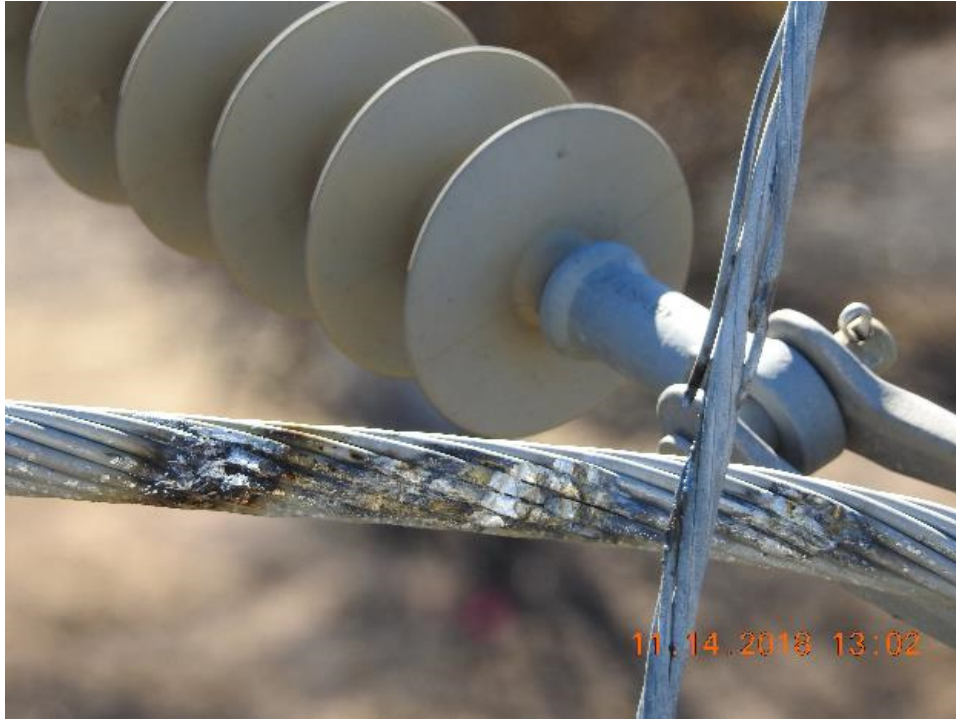
Figure 13: A detail of the damage to the jumper wire on the Steel Pole and the transmission down guy wire, Down Guy 1.²⁵

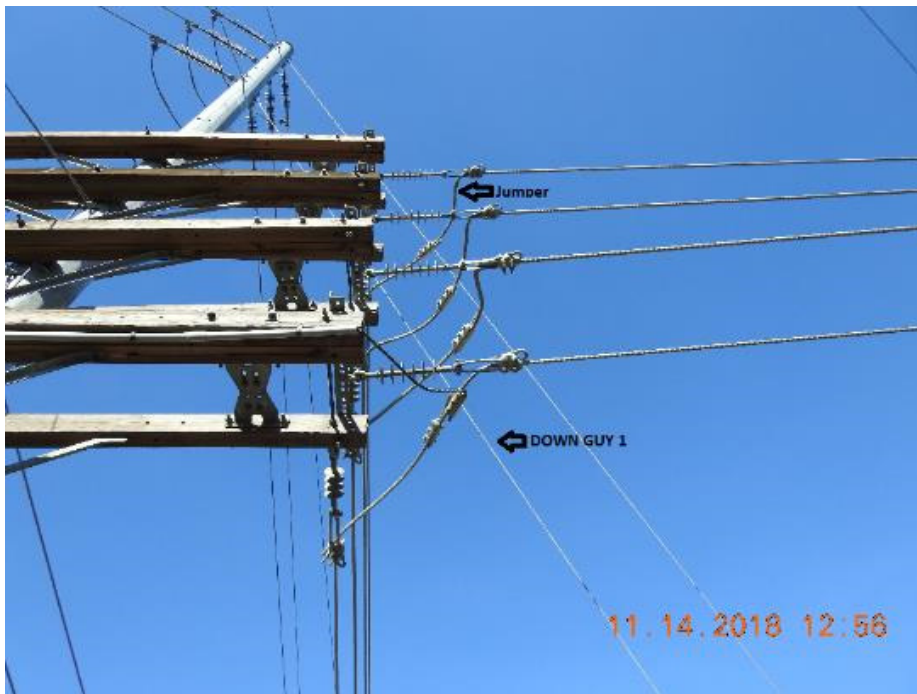
Figure 14: The jumper and down guy that made contact as viewed from the base of the Steel Pole.²⁶

Down Guy 2, at Site 2, was touching the through-bolt supporting Messenger Wire 1, which in turn supported ECS communications conductor No. 06044. As shown in Figure 14, Down Guy 2 passed approximately three (3) inches above the ECS communications conductor. Edison is in violation of the Rule 38 for failing to ensure that Down Guy 2 maintained the minimum required vertical clearance of 24 inches above the ECS communications conductor.

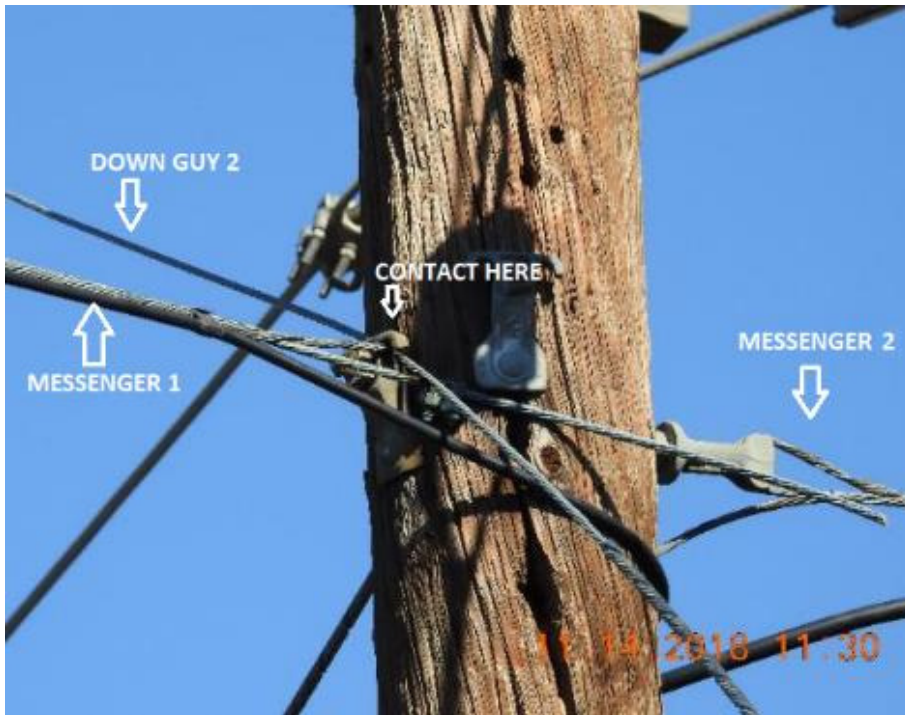
Figure 17: A closeup of the Stubbed Pole. Note that the bonding extension on Messenger Wire 1 is not attached to anything.²⁸

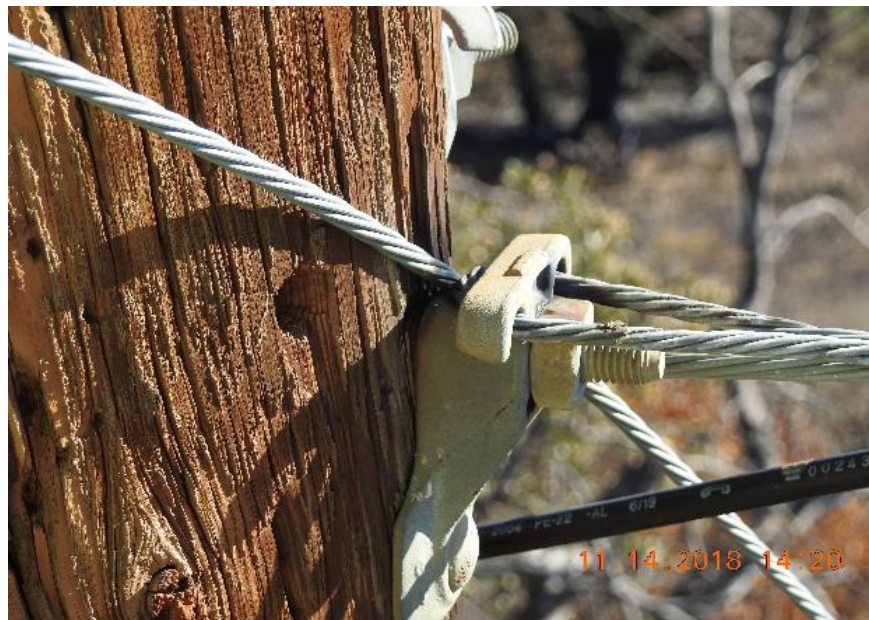
Figure 18: A detail of the distribution down guy, Down Guy 2, in contact with Messenger Wire 1 and the through bolt on the Stubbed Pole. Note the blackened area on the down guy and the Stubbed Pole at the point of contact.²⁹

Down Guy 2 was touching the through-bolt supporting Messenger Wire 1, which in turn supported ECS communications conductor No. 06044 traveling westbound. Edison is in violation of the Rule 38 for failing to ensure that Down Guy 2 maintained the minimum required radial clearance of three (3) inches from the ECS communications conductor.

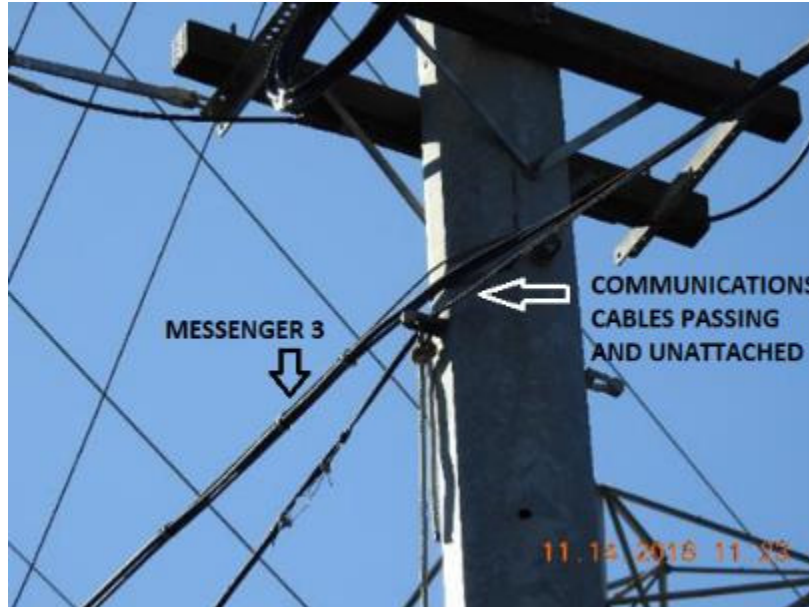
Staff observed that the two ECS communications conductors attached to the Stubby Pole traveled north past the Steel Pole towards Chatsworth substation. The two northbound ECS communications conductors were in contact with the surface of the Steel Pole but not attached to it. See Figure 19.

Figure 19: Communications conductors in contact with the surface of the steel pole, but not attached to it. Viewed from the northeast.³⁰

The two northbound ECS communications conductors were contacting steel Pole 4534353E but were not attached to the pole. Edison is in violation for Rule 84.4-D4 for failing to ensure that the center line clearance between the two northbound ECS communications conductors and Pole 4534353E was at least 22.5 inches.

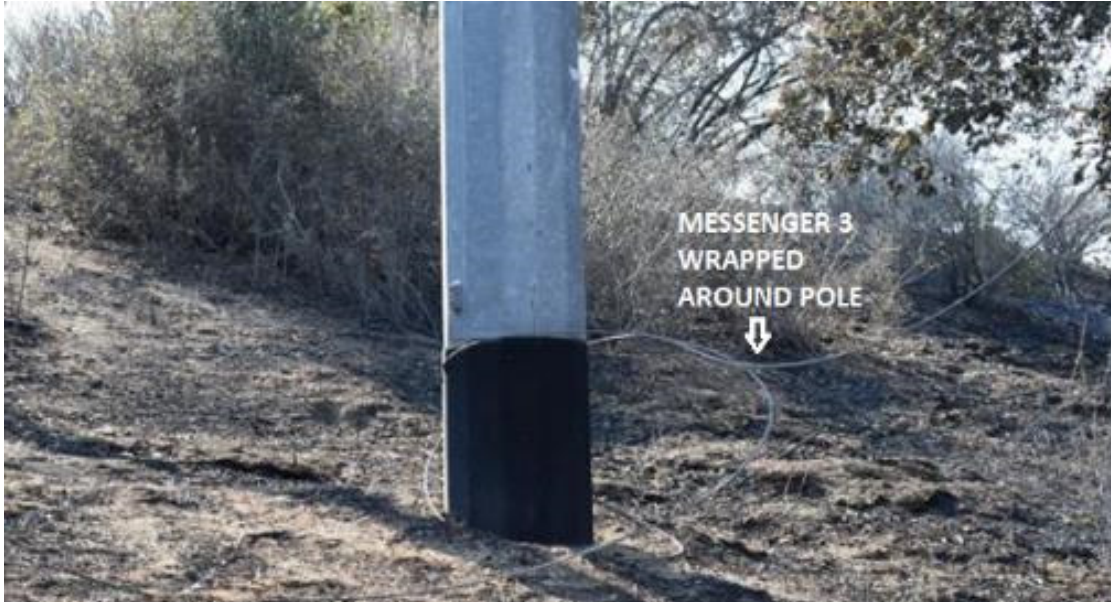
Moreover, Messenger Wire 3 was broken between the Steel Pole and pole number 1258776E/1528776E. One end of Messenger Wire 3 was wrapped around the base of the Steel Pole and the other end of Messenger Wire 3 was lying on the ground between the poles. See Figure 20.

Figure 20: Messenger Wire 3 wrapped around the base of the Steel Pole.³¹

- Messenger Wire 3 was broken. Edison is in violation of Rule 31.1 for failing to maintain Messenger Wire 3 for its intended use. This condition existed since at least May of 2018 when it was discovered during an inspection. This wire also had been in contact with the steel pole without being attached to it since the steel pole had been installed in 2008. Rather than replacing the broken messenger guy wire, an unidentified person had wrapped the south end of the guy wire around the base of the steel pole. Edison could not determine who had wrapped the messenger wire, or even whether or not it was done by an Edison employee.

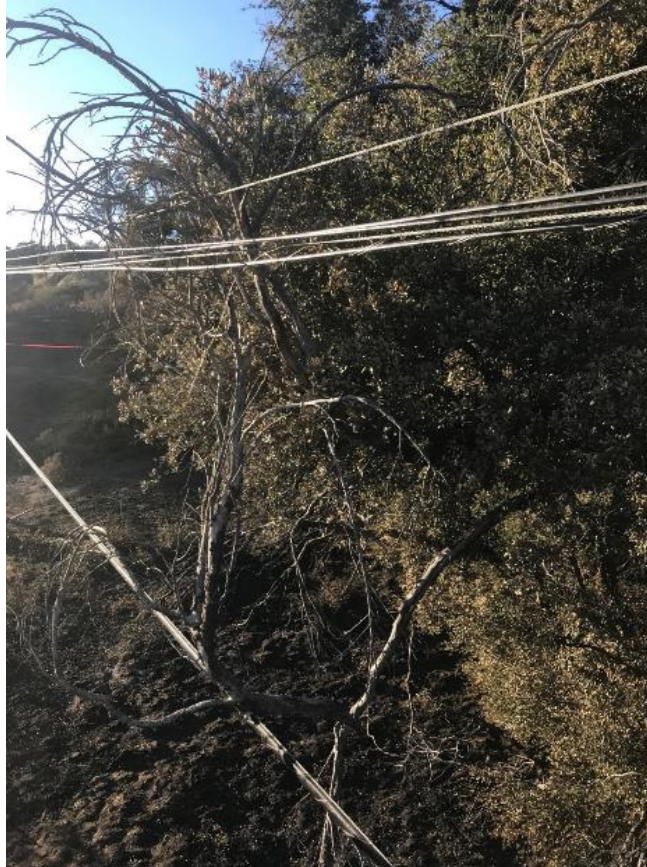
At Site 1, Staff observed tree branches pressing into the communications conductors between poles numbered 4650857E and 4557126E. This caused insufficient clearance between the ECS communications conductor supported on Messenger Wire 2 and a third-party communications conductor on Messenger Wire 4. The lashing wires on both communications conductors were damaged, and the messenger wires had separated from the conductors they supported. See Figures 22-24.

Figure 22: Tree branches pressing the communications facilities together at Site 1. Viewed from the southwest from an elevated position.³³

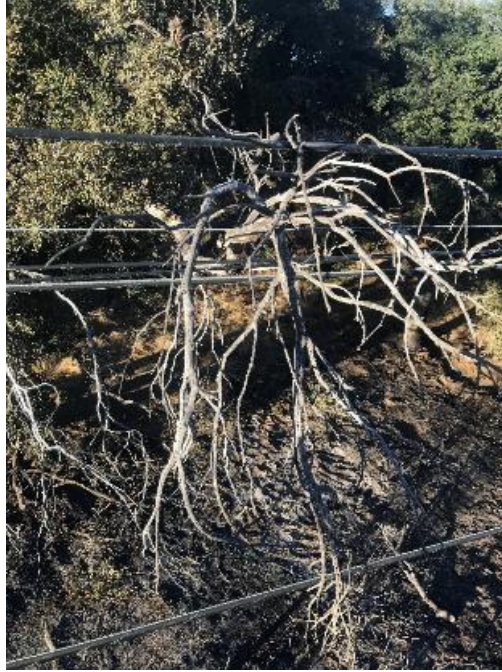
Figure 23: Another view of the overgrown tree branches pressing the communications facilities together. Viewed from an elevated position in the south.³⁴

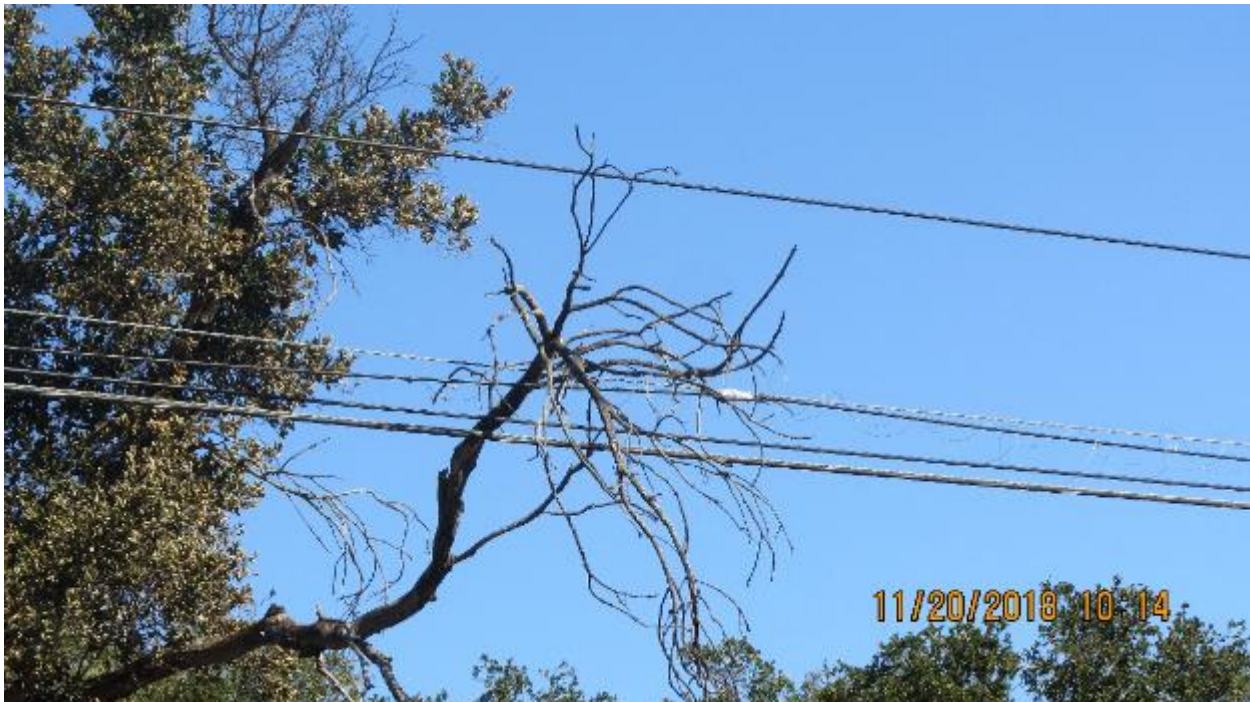
Figure 24: One of the branches pressing the communications conductors together at Site 1.³⁵

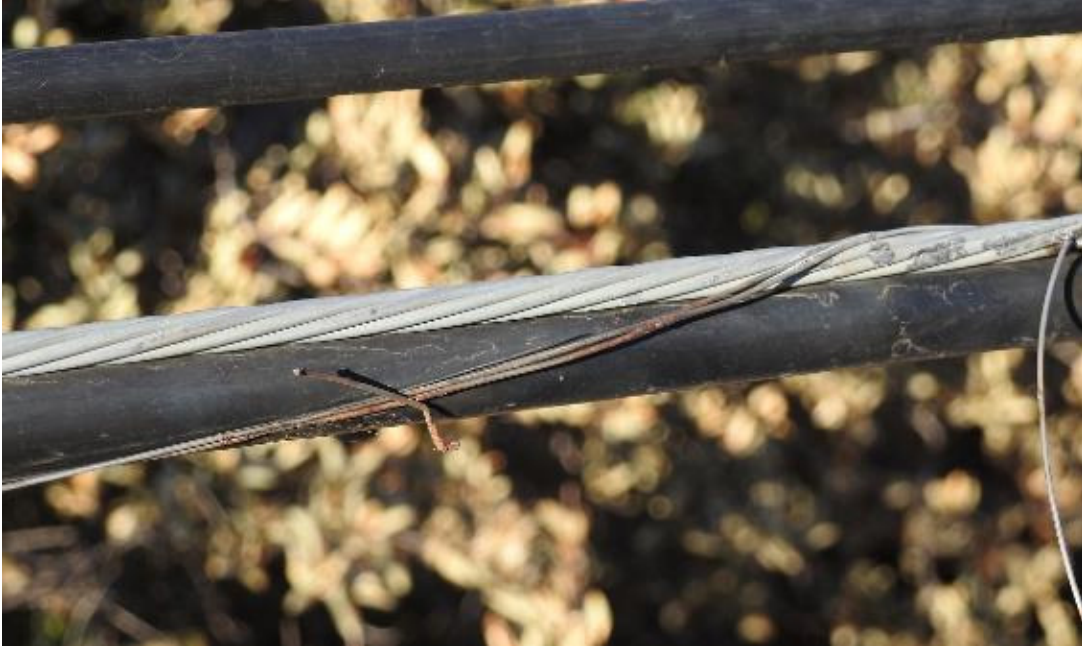
SED Staff used an aerial work platform to observe the damage up close. SED Staff observed burn marks on the messenger wires and found that pieces of lashing wire had been welded onto them. This damage is consistent with electrical arcing between the wires. See Figure 25.

Figure 25: A closeup of damage to a messenger guy and its lashing wire. Pieces of lashing wire were found welded together and also welded to the messenger guy.³⁶

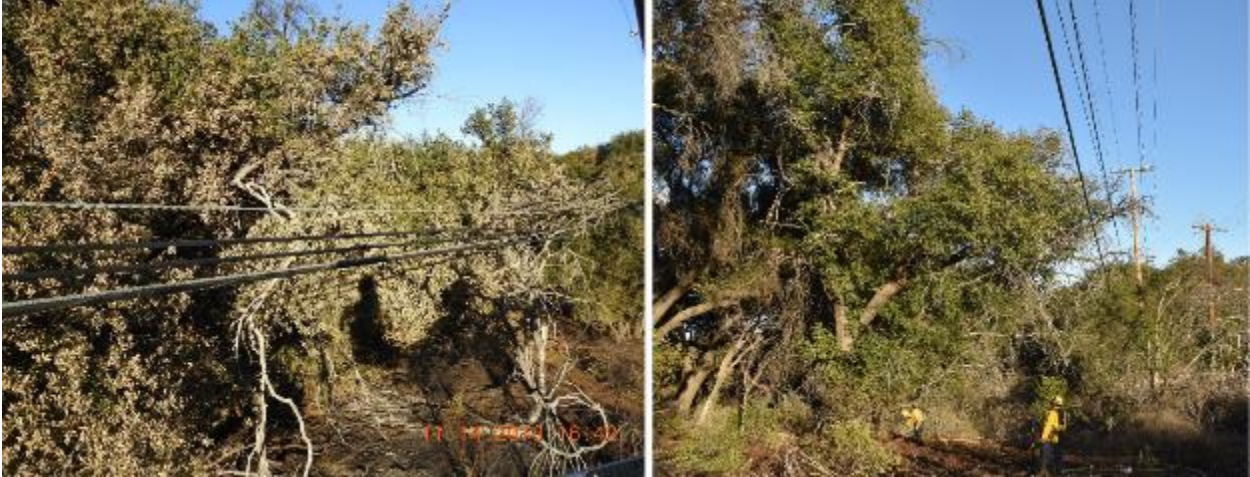
VCFD shared a 2015 fire report with SED that documented a fire that occurred at Site 1 on December 26, 2015.³⁷ VCFD also shared photographs taken on December 26, 2015 that showed overgrown tree branches pushing together the same two communications conductors. CalFire staff reported orally to SED staff that they had found small pieces of lashing wire buried under debris at Site 1 on or around November 14, 2018. It is likely that this 2015 fire occurred in the same manner as the November 8, 2018 fire and that these bits of lashing wire fell there during the 2015 incident. Edison could not provide any evidence of vegetation management taking place between these poles between the dates of November 8, 2008, and November 8, 2018.³⁸ See Figure 26.

Figure 26: On the left are the communications conductors and tree branches as they appeared on November 14, 2018. On the right is a photograph taken by VCFD of the same part of the span in December 2015.³⁹

The ECS communications conductor and the third-party communications conductor supported by poles numbered 4650857E and 4557126E had less than 12 inches of vertical clearance because they were pushed together by vegetation at Site 1. Therefore, Edison is in violation of Rule 38 for failing to ensure that ECS communications conductor No. 06051 maintained a minimum vertical clearance of 12 inches from the third-party communications conductor. This condition most likely existed since at least December of 2015 as shown by photographs taken by VCFD⁴⁹.
