Company: San Diego Gas & Electric Company (U 902 M)
Proceeding: 2024 General Rate Case – Track 3
Application No.: A.22-05-016
Exhibit: SDG&E-T3-WMPMA-15

**Investigation Report of the December 4, 2017 Wildfire in Santa Paula, California Involving
Southern California Edison Facilities That Came to be Known as the Thomas Fire**

**INVESTIGATION REPORT
OF THE DECEMBER 4, 2017 WILDFIRE
IN SANTA PAULA, CALIFORNIA
INVOLVING SOUTHERN CALIFORNIA EDISON FACILITIES
THAT CAME TO BE KNOWN AS THE THOMAS FIRE**

**SAFETY AND ENFORCEMENT DIVISION
ELECTRIC SAFETY AND RELIABILITY BRANCH
LOS ANGELES**

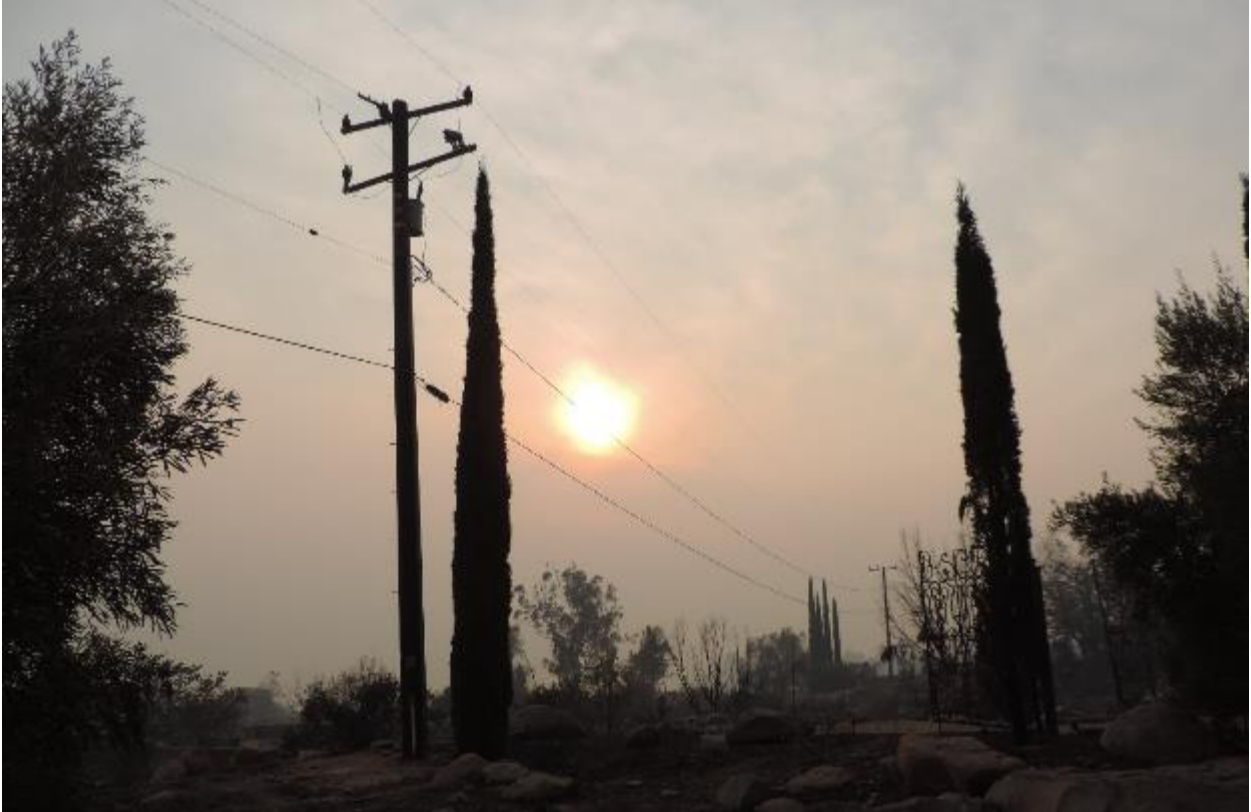
Site photos depict the Koenigstein ignition site, pole 729566E, and pole 729565E. The primary conductor failed towards the 729566E side of the span and remained attached on the 729565E side.

Figure 2: SED photo Koenigstein site, 729566E at the fore, 729565E at the rear.

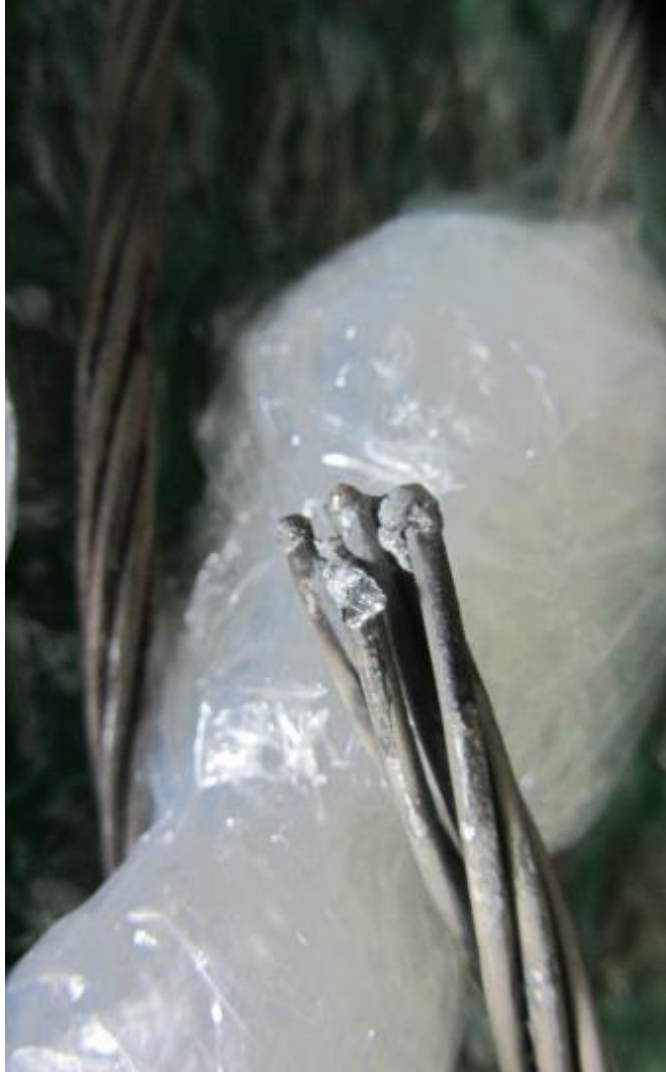
CAL FIRE removed and stored as evidence both ends of the center conductor running between poles numbered 729565E and 729566E. Depicted below in Figure 4 is one end of the failed conductor which appears charred, melted, and is missing material, thereby not appearing as a complete continuous conductor. The other end of the failed conductor shown in Figure 5, is hidden by multiple wraps of black electrical tape. At the time of SED's inspection of the failed conductor, CAL FIRE did not allow SED to remove the electrical tape and examine the other end of the failed conductor. If, at a later date, CAL FIRE conducts a controlled viewing of the end of the conductor covered in electrical tape, then SED investigators will document findings in an updated version of this report.

Figure 4: SED photo of Koenigstein evidence, one end of failed conductor.

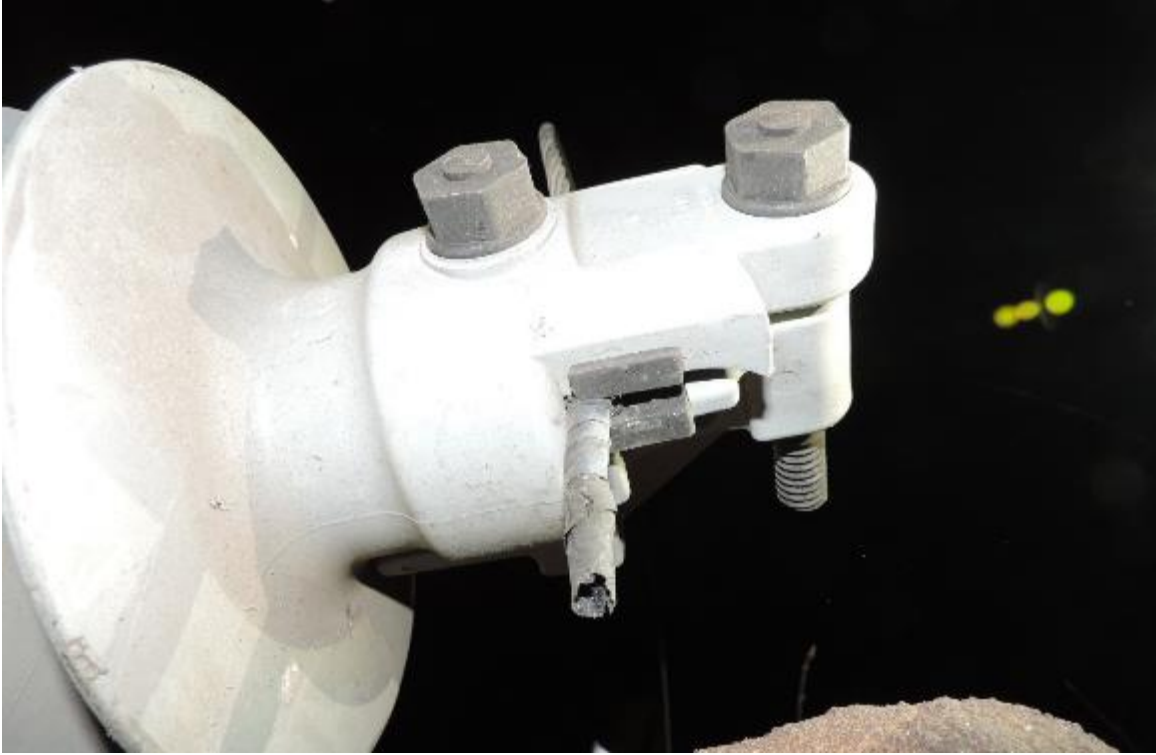
Figure 5: SEM photo of Koenigstein evidence, other end of failed conductor (covered with electrical tape) still attached in the vise of the insulator mounted to 729566E

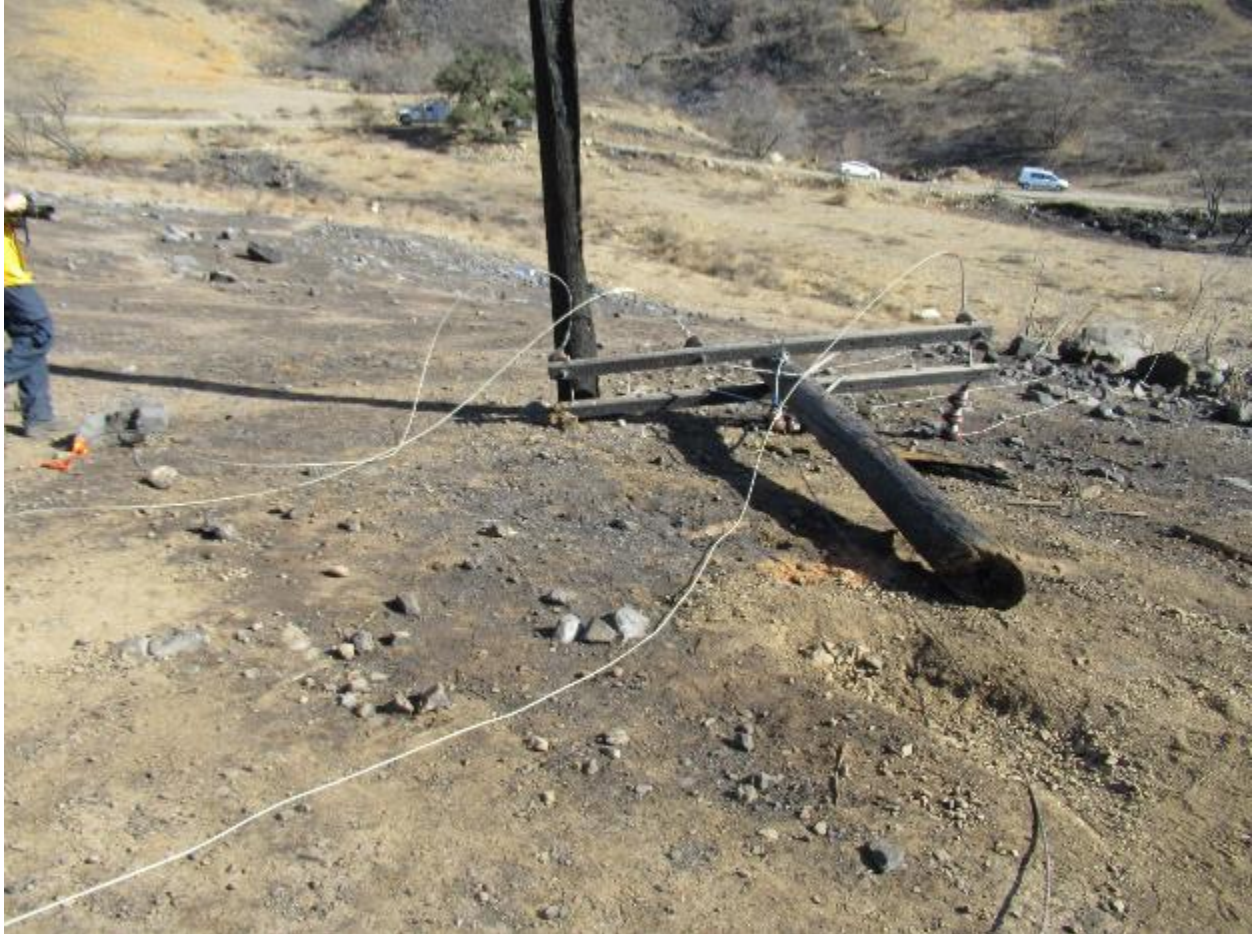
Figure 7: SED photo of Anlauf Canyon site, the top of pole 1202085E removed by Edison.

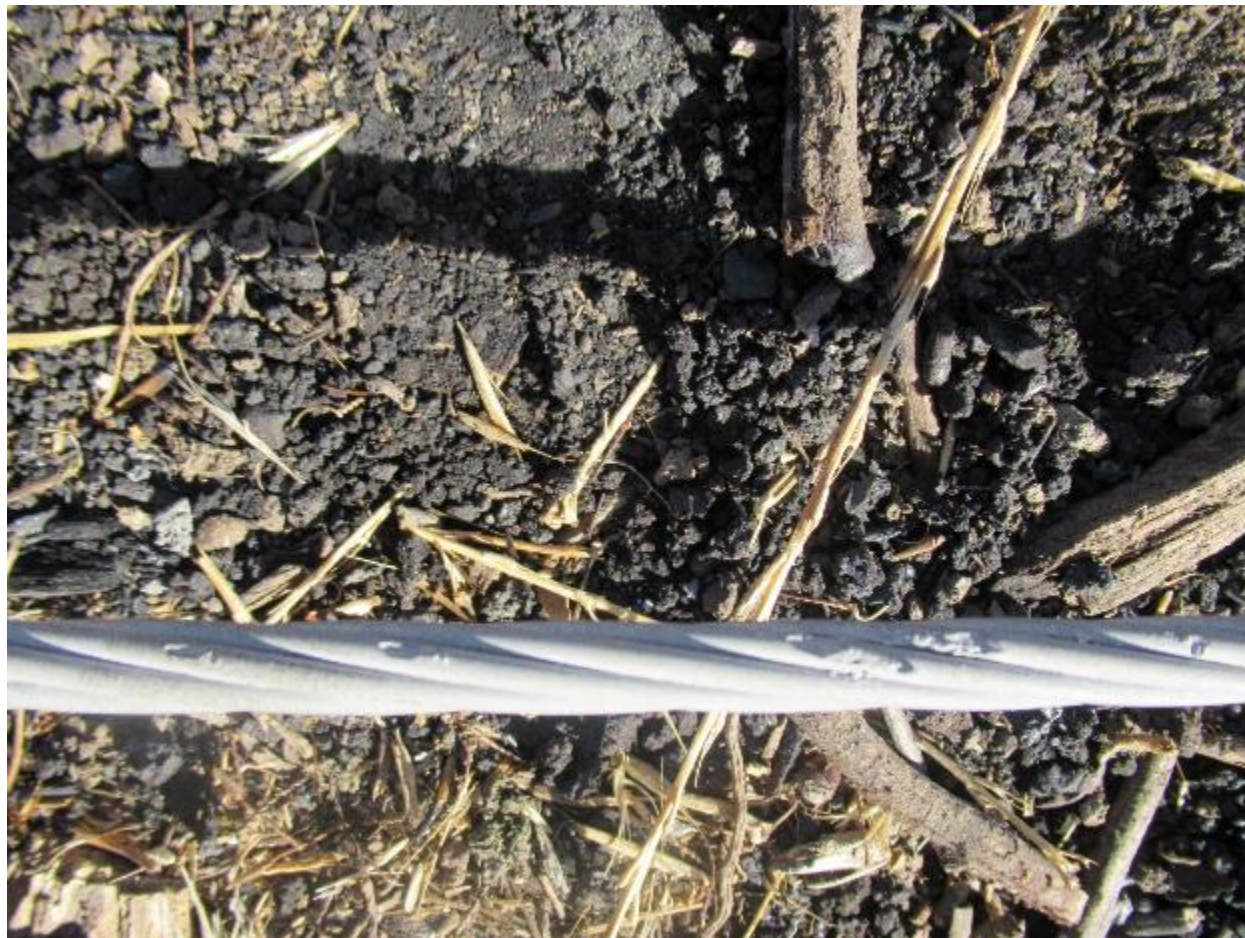
SED observed damage on the east and center conductors including burn marks, arc marks, and loss of material referred to as “pitting” as shown in the figures below. Pitting is an indicator that wire-slap has occurred; however, SED was unable to determine how recently these pitting marks were made. SED examined these same conductors at CAL FIRE’s Fresno facility on February 7, 2017, and found further evidence of damage, including broken strands and bird caging. However, CAL FIRE denied SED’s request to unravel the conductors to examine them more closely. Because SED could not unravel the conductors, SED was unable to take measurements to estimate the location of the damage on the conductors and review the relative locations of the observed damage along the conductors, which would have been useful to confirm whether the damage corresponded in location to similar damage on the adjacent conductor. Corresponding damage would support the conclusion that two or more conductors had made contact.

Figure 10: SED photo of Anlauf Canyon site, pitting on the east conductor between poles numbered 3002114E and 1202085E.

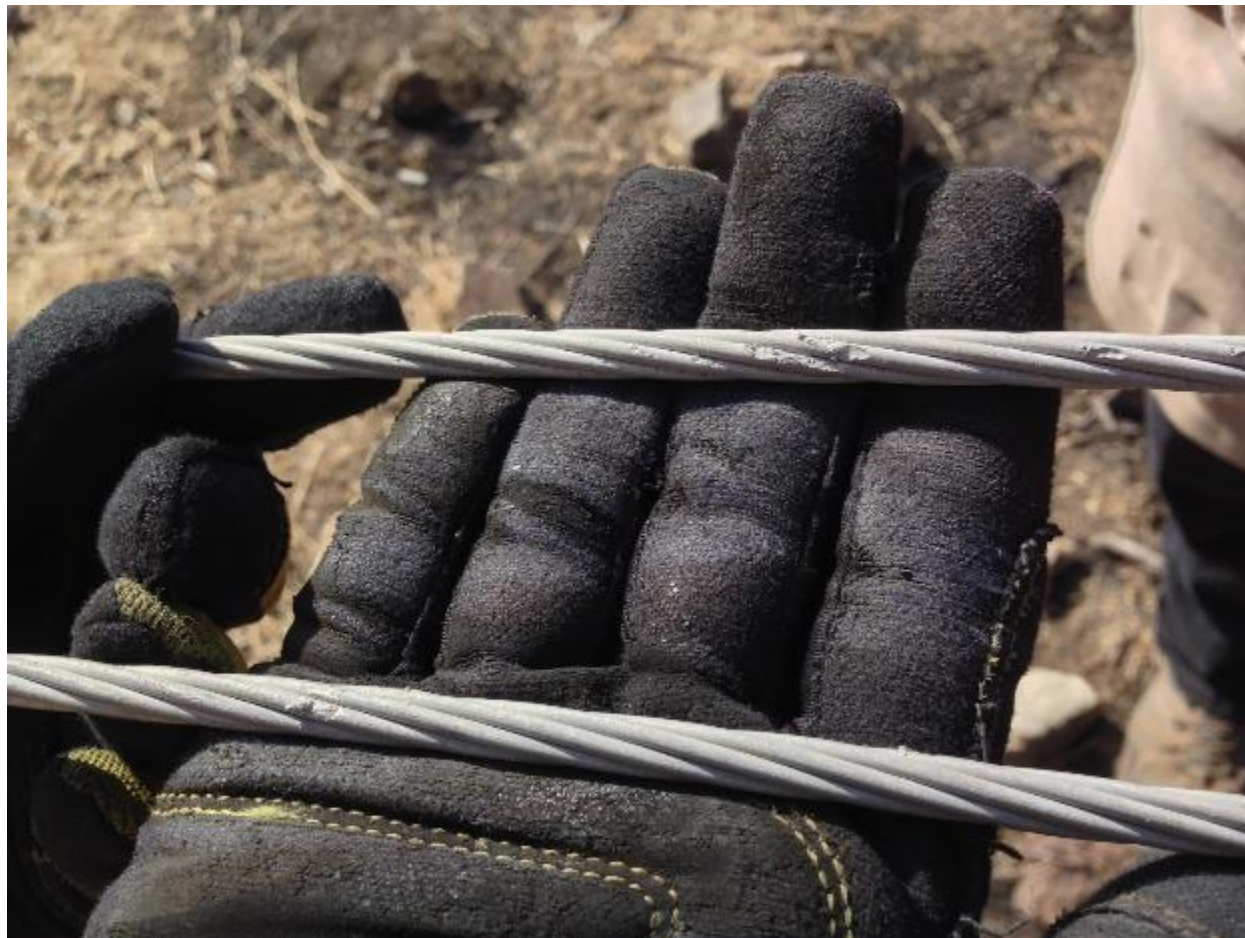
Figure 11: Edison photograph depicting damage on two unidentified adjacent conductors between poles numbered 1025341E and 3002114E.⁶²

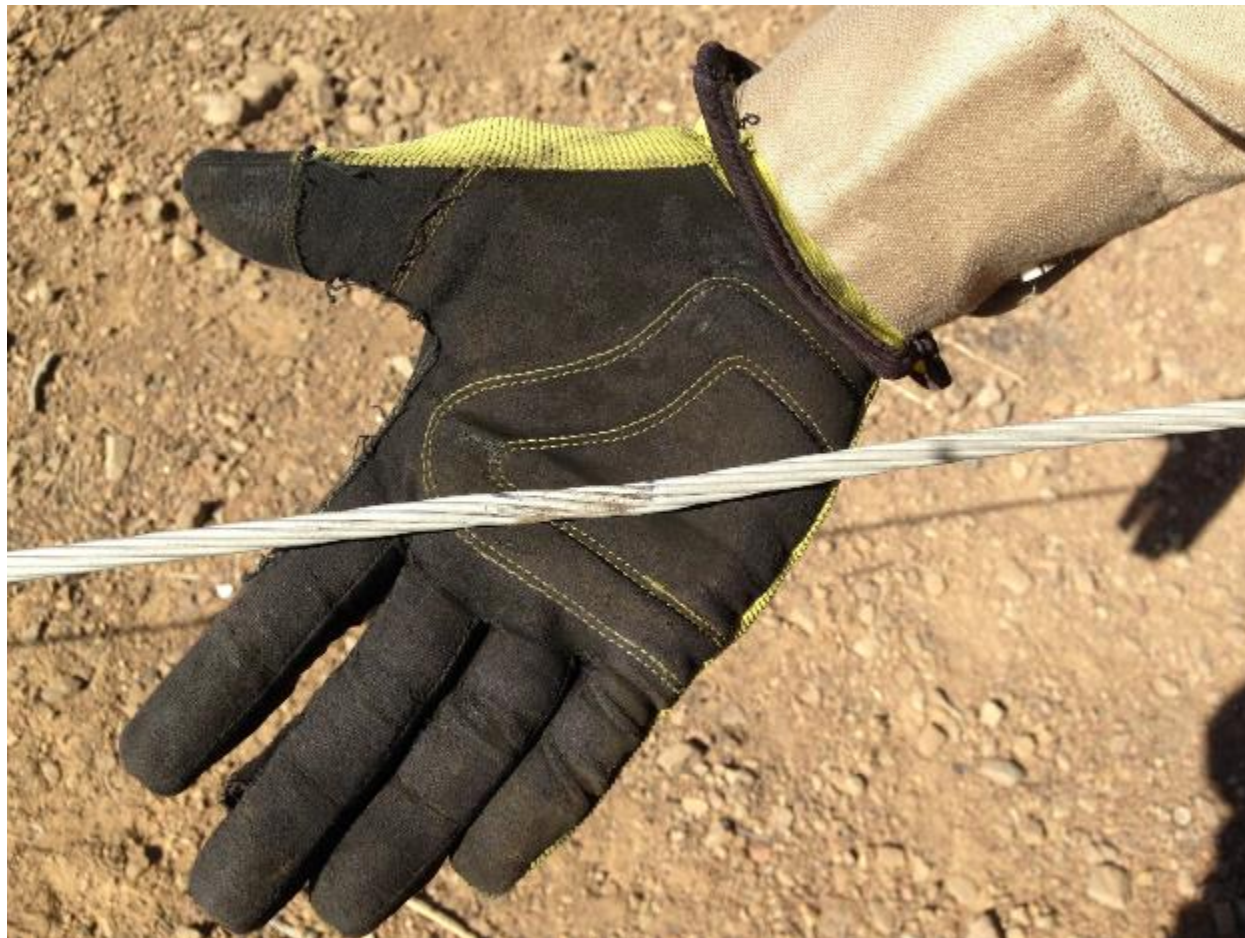
Figure 12: Edison photograph depicting damage on the center conductor between poles numbered 1025341E and 1202085E.⁶³

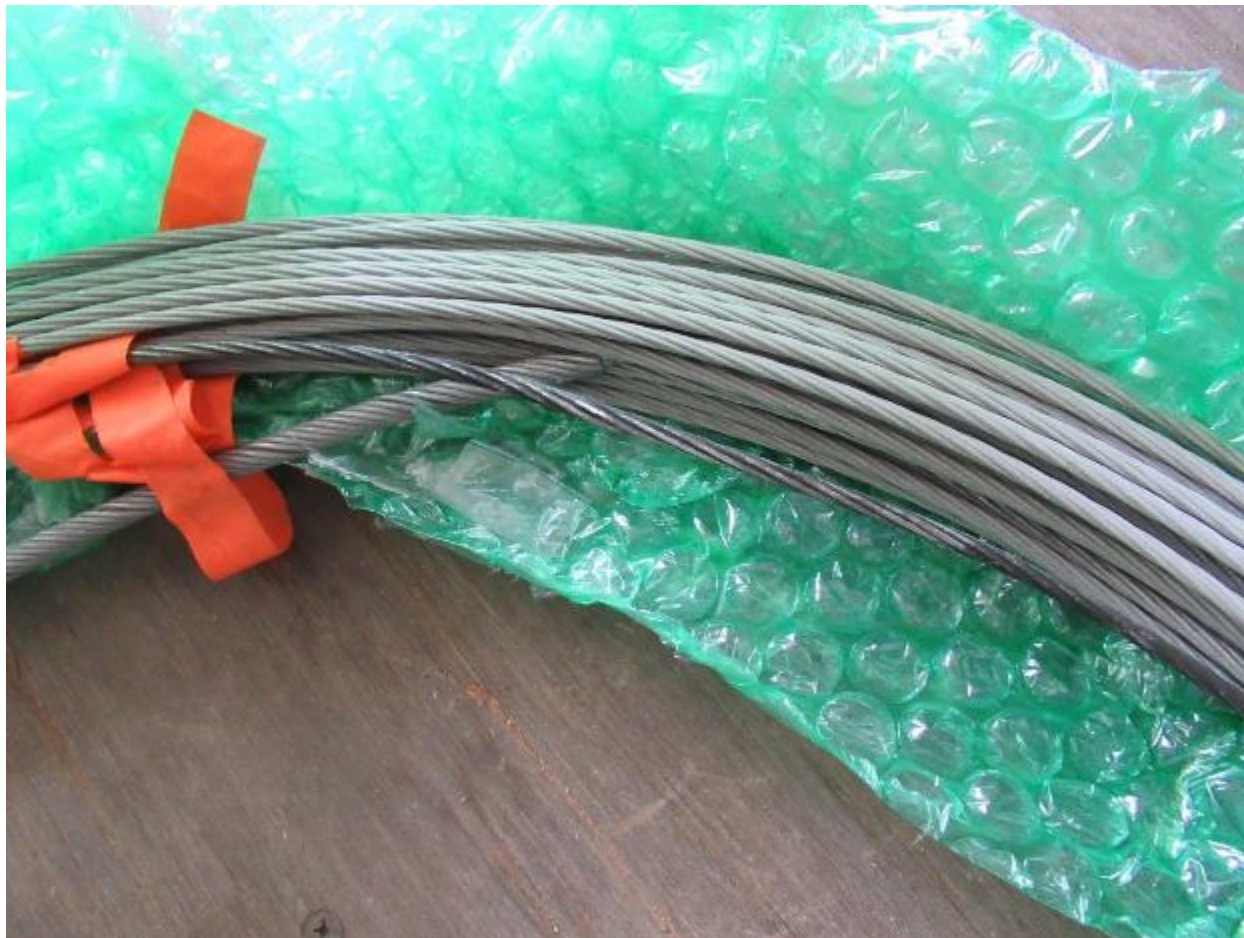
Figure 13: SED photo of February 2017 Anlauf Canyon evidence examination, damage on the east conductor between poles numbered 1025341E and 3002114E.

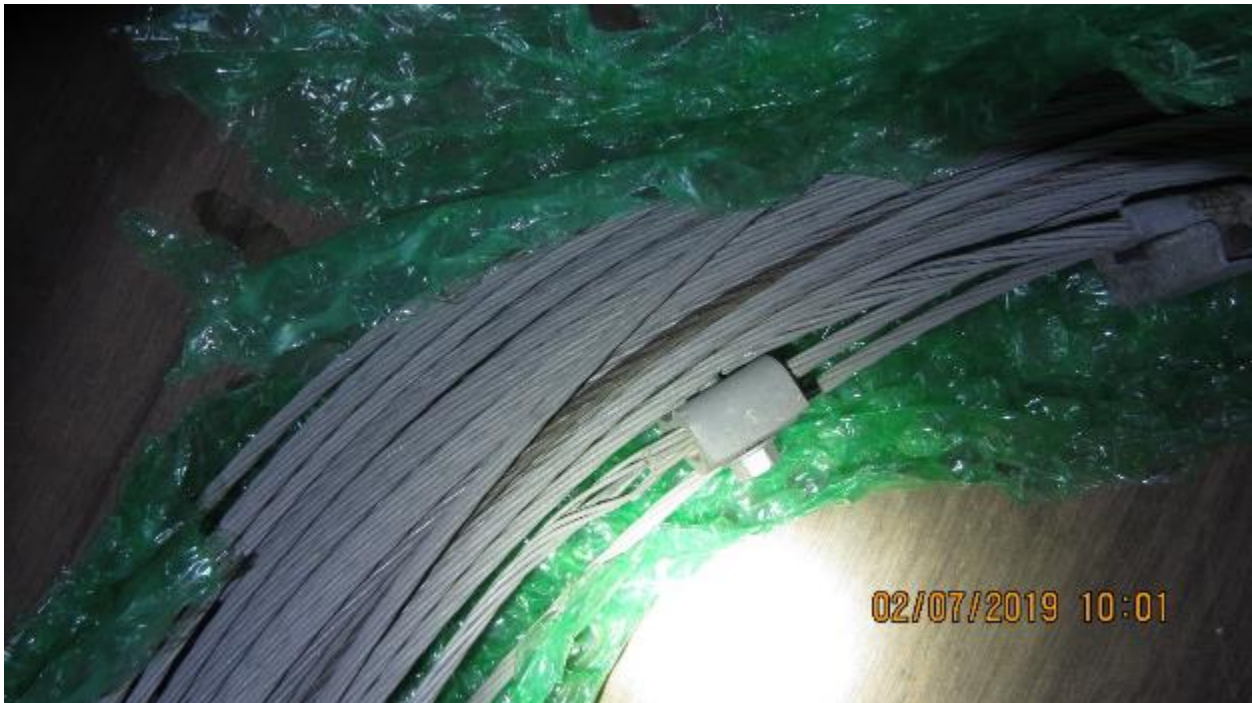
Figure 15: SED photo of February 2017 Anlauf Canyon evidence examination, burn marks and broken strands on center conductor between poles numbered 1025341E and 3002114E.
