**Appendix A
SED Incident Investigation Report for 2018 Camp Fire with Attachments**

Incident Investigation Report

Incident Number: E20181108-01

Utility: Pacific Gas and Electric Company (PG&E)

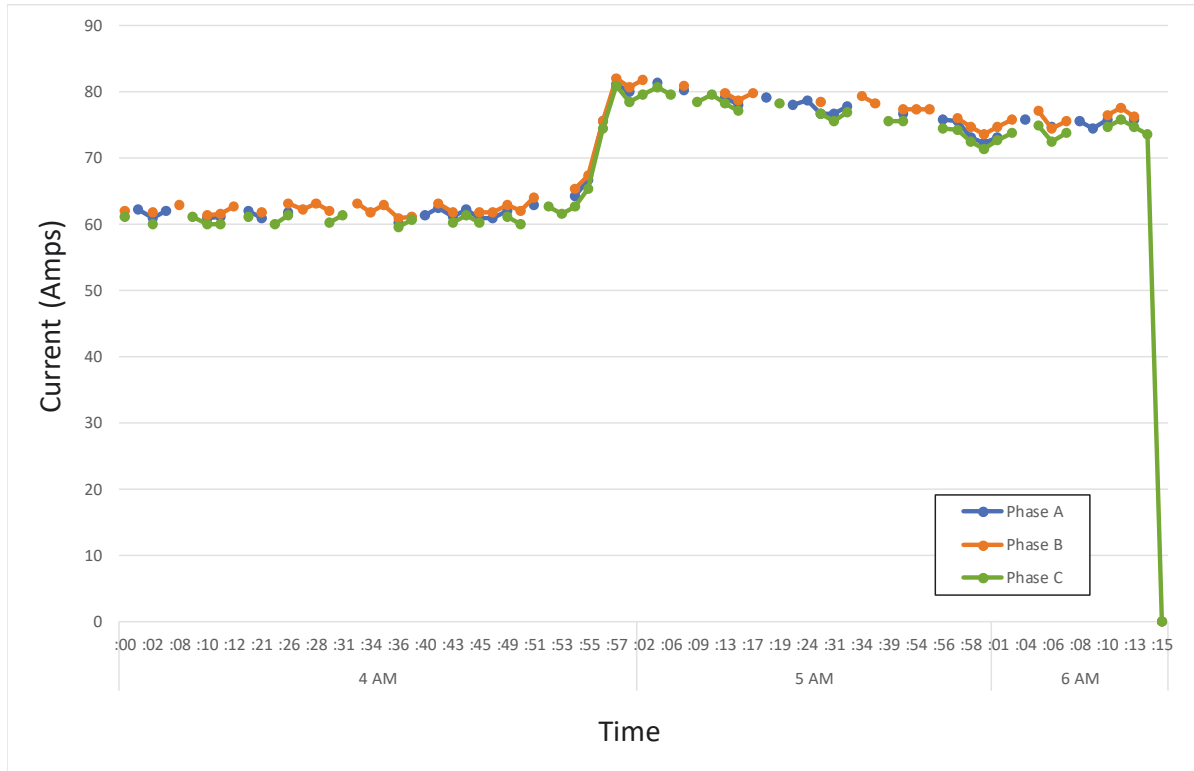
Figure 1: Chart of SCADA data recorded at Circuit Breaker 152 on the Caribou-Palermo 115 kV Transmission Line just before the incident.⁷⁷

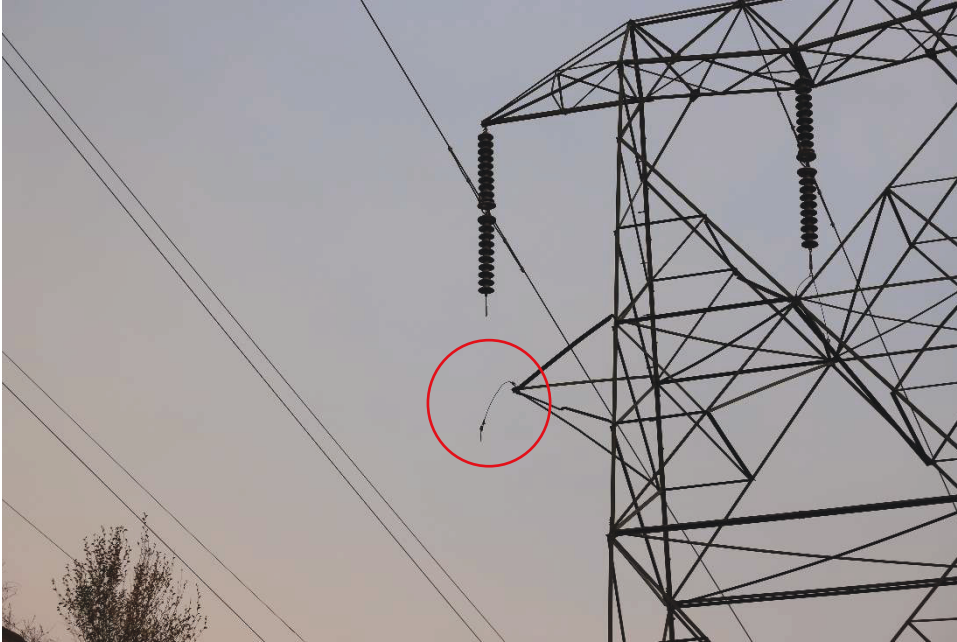
At first, SED made observations at Tower :27/221, adjacent to the Incident Tower. The distance between the two towers is approximately 845 feet.²⁷ SED observed that the hold-down anchor on Tower :27/221 had disconnected from the suspension insulator. This is shown in Figure 2.

Tower :27/221 had disconnected from a suspension insulator. PG&E assigned the condition a Priority Code E.⁴⁸ As defined in the ETPM Manual, the Priority E designation is for conditions which must receive corrective action within 12 months. SED notes that during additional enhanced inspections that PG&E performed after the Camp Fire, PG&E assigned a Priority A code for a separate broken hold-down insulator hardware on a different tower on the Caribou-Palermo Transmission line.⁴⁹ According to a PG&E lineman who was at the site on November 14, 2018 the hold-down anchor on Tower :27/221 was not broken, but rather had become unscrewed. Nevertheless, the hazardous condition created by an unscrewed hold-down anchor is similar to that created by a broken hold-down anchor. SED concludes that the unscrewed insulator hold-down anchor on Tower :27/221 should have been designated Priority A. This is a violation of GO 95, Rule 18.

Figure 2. At Tower :27/221, an insulator hold-down anchor was disconnected. Photo provided by PG&E.⁷⁸

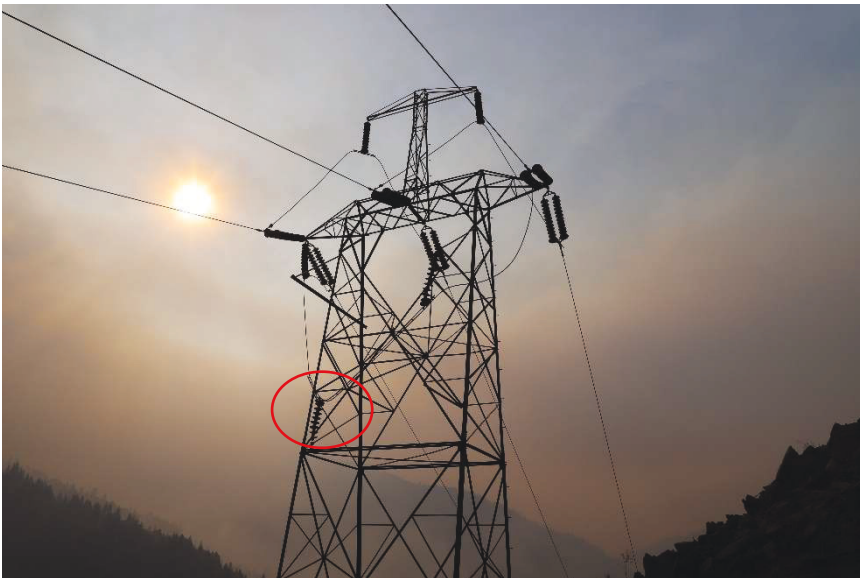
The Incident Tower is a dead-end transposition tower. On the Incident Tower, SED observed that a suspension insulator supporting a transposition jumper had separated from an arm of the tower and remained suspended above the ground (Figure 3). Prior to the failure, two C-hooks provided mechanical support to the incident transposition jumper; and each C-hook carried a load of approximately 143 lbs.²⁸ One of the C-hooks failed at the point where it had been in contact with the hanger plate. SED made a close observation of the portion of the failed C-hook that remained attached to the separated suspension insulator. SED observed that most of the cross-section was flat and smooth. At the upper portion of the cross-section – approximately the top 20 to 25 % of the cross-section of the C-hook where the failure occurred – the surface of the metal was rough, and a small, sharp piece of the material jutted out. In SED's assessment: the smooth portion is an indication of wear that occurred over a long period of time prior to failure; the rough upper portion of the cross-section fractured at the time of the incident. The observations are confirmed by the photo in Figure 4. SED also observed flash marks on the transposition jumper which SED concluded were a result of arcing between the jumper and the tower (Figure 5).

Figure 3. At the Incident Tower, an insulator detached from the hanger plate and hung upside down. Photo provided by PG&E.⁷⁹

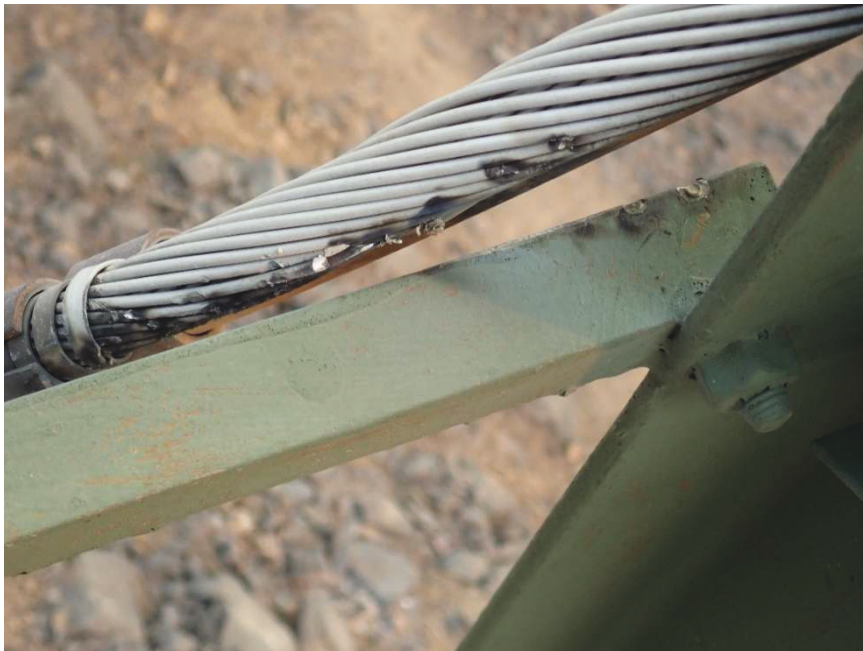
Figure 5. Flash marks on the transposition jumper and steel member on the Incident Tower. Photo provided by PG&E.⁸¹

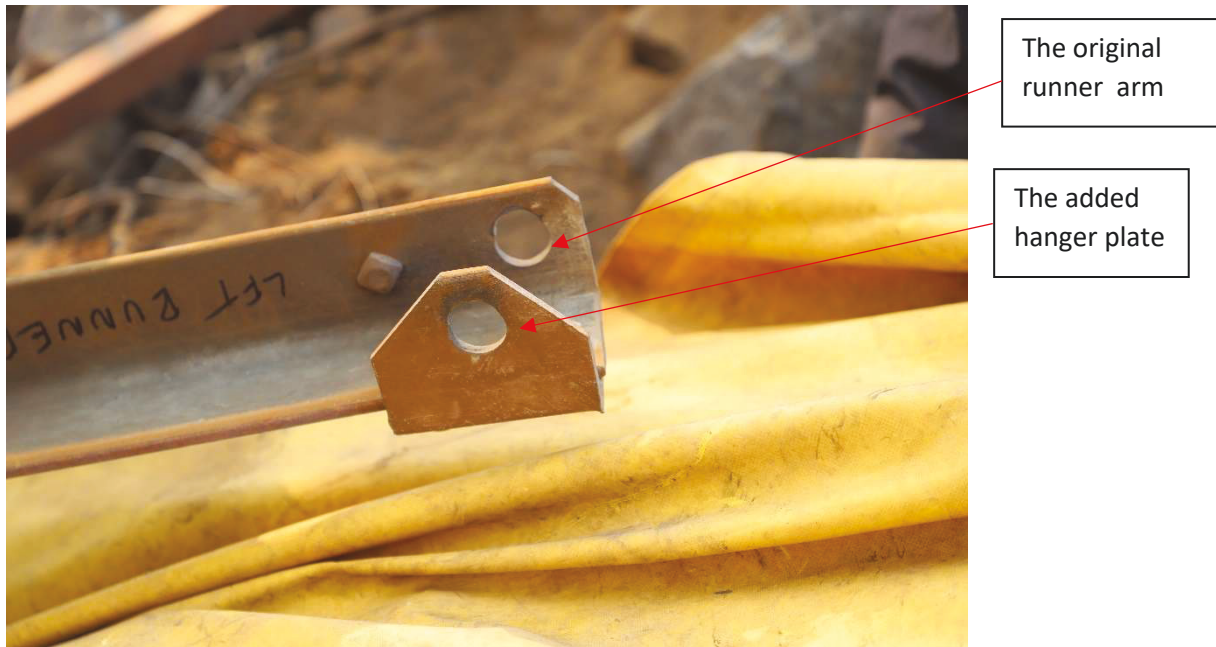
SED observed that hanger plates had been added to the left and right runner arms on the Incident Tower. PG&E could not locate records that identify when the hanger plates were added.²⁹ However, both the original runner arms, which remained in place, and the added hanger plates showed signs of wear on the working eyes as shown by

Also, the visible wear on the original runner arms on the Incident Tower (Figures 6 and 7) should have been an indication of the potential for similar problems with wear on the added hanger plates, triggering planned follow-up detailed climbing inspections. SED notes that during additional enhanced inspections that PG&E performed after the Camp Fire, PG&E assigned a Priority A code for 13 towers on the Caribou-Palermo Transmission Line where similar visible wear on the working eyes of the hanger plate was detected.⁵⁹

The original runner arm

The added hanger plate

Figure 6. The left runner arm and the added hanger plate from the Incident Tower.⁸²

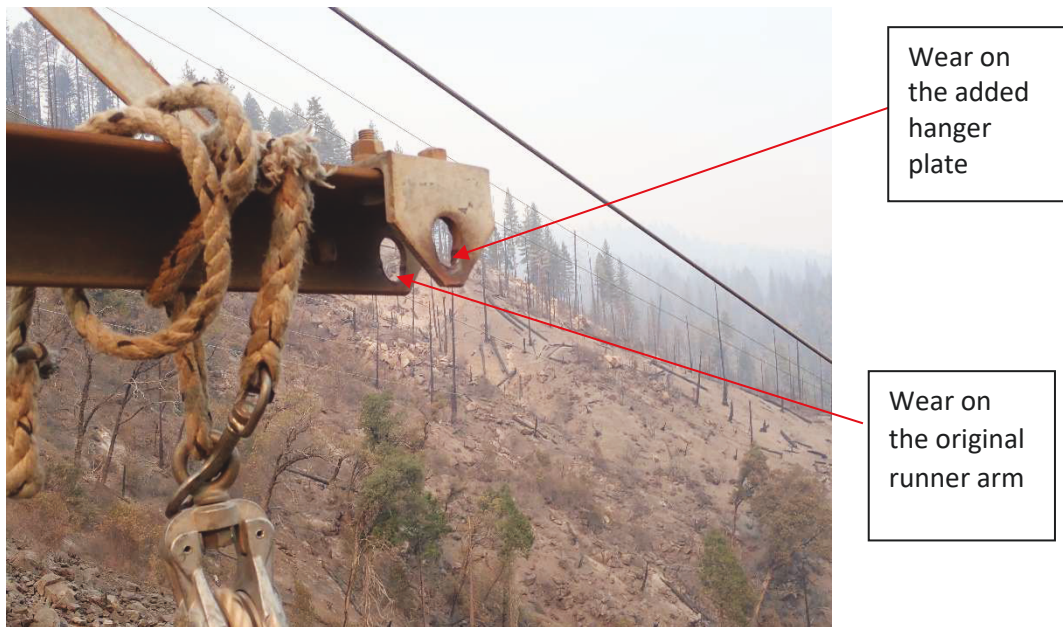
Wear on the added hanger plate

Wear on the original runner arm

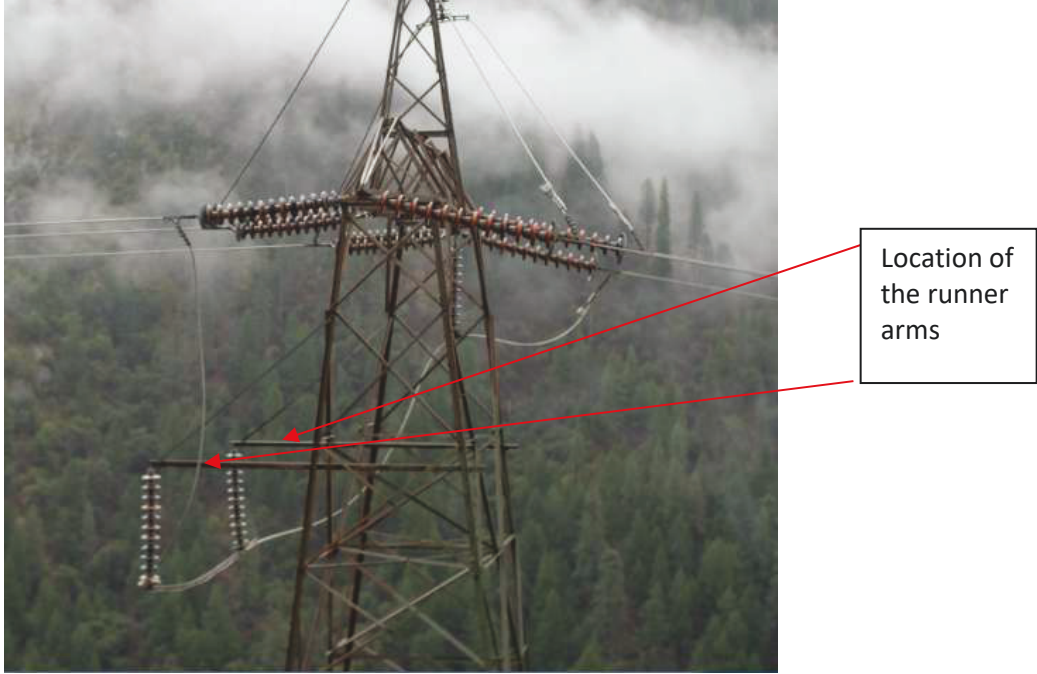
Figure 8. Typical location of runner arms on transmission towers similar to the Incident Tower. This is PG&E Tower :20/160 of the Caribou-Palermo 115 kV Transmission Line.⁸⁴
