Docket : A.23-08-013
Exhibit Number : CA-08
Commissioner : Alice Reynolds
Admin Law Judge : Larsen
Witness : H. Wehrman

PUBLIC ADVOCATES OFFICE
CALIFORNIA PUBLIC UTILITIES COMMISSION

**Testimony on the Koenigstein Ignition
for
Thomas Fire and Debris Flow
Cost-Recovery Application**

The Koenigstein Ignition

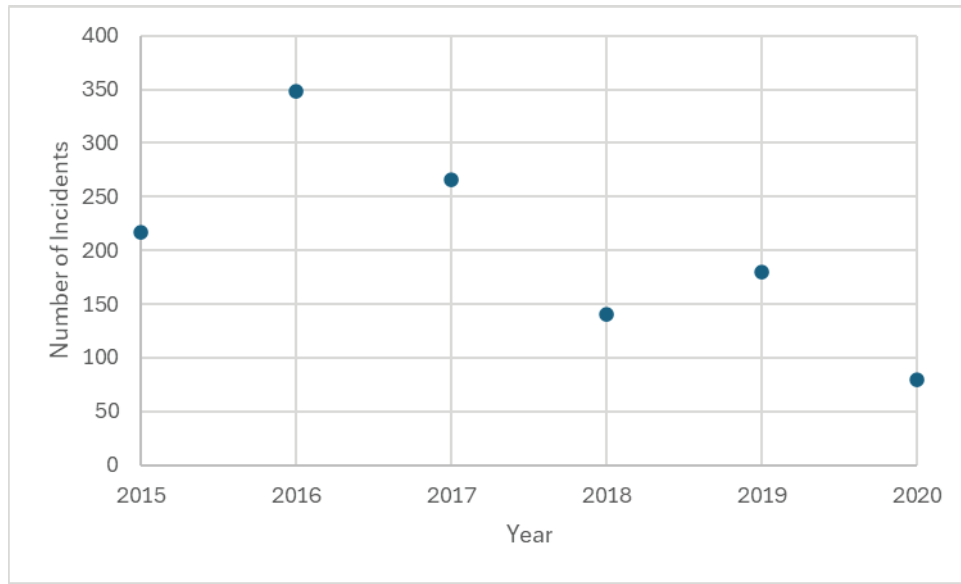
Figure 1: Wires down incidents with “unknown” cause⁶⁰

7 During the years 2015 through 2017, SCE’s data does not show a downward trend
8 in the number of wire-down incidents with "unknown" causes.⁵⁹ Figure 1 below shows
9 the number of wire-down incidents for each year from 2015 through 2020.

3 Figure 1 shows that there appears to be a general downward trend in wires down
4 incidents with “unknown” cause from 2016 through 2020. However, there is no such
5 trend in the years from 2015 through 2017.
