**PUBLIC ADVOCATES OFFICE**  
**CALIFORNIA PUBLIC UTILITIES COMMISSION**

# **Testimony on the Koenigstein Ignition for Thomas Fire and Debris Flow Cost-Recovery Application**

**The Koenigstein Ignition:  
Supporting Attachments**

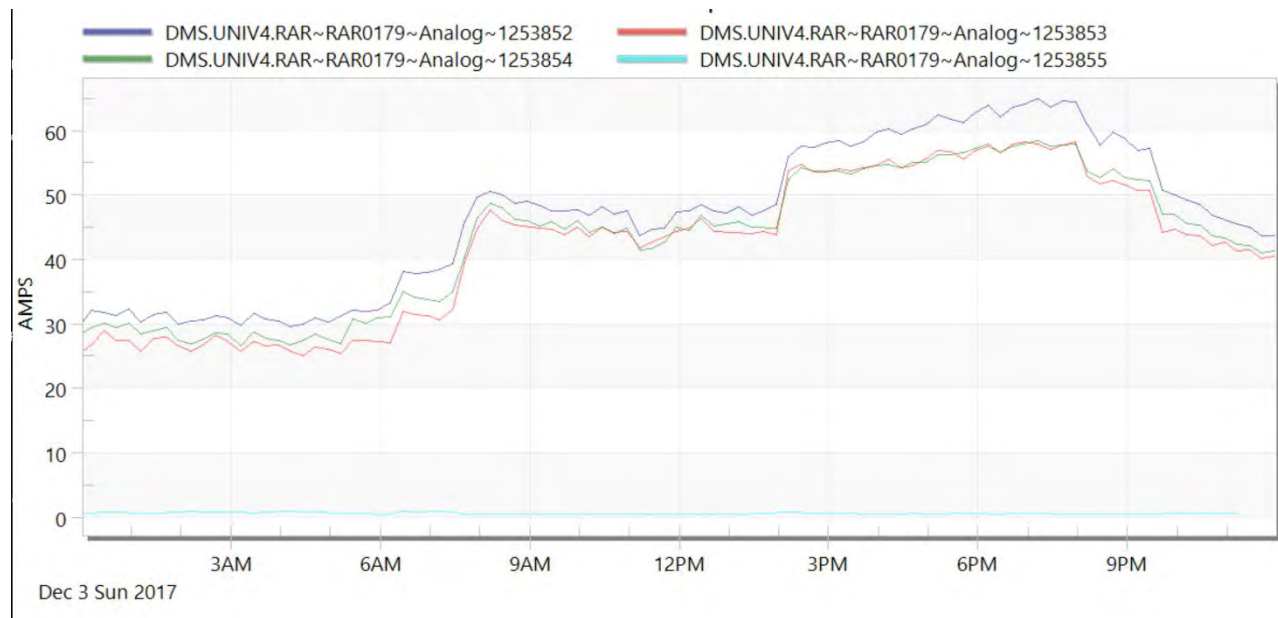
The center conductor between poles 565E and 566E was #4 ACSR, which has an ampacity of 160 amps. There was no primary voltage device that directly measured the current for the #4 ACSR at the specific location between poles 729565E and 729566E. However, the load profile for the nearest upstream recloser, automatic recloser 0179, for 24 hours before December 4, 2017, is provided below. Automatic recloser 0179 serves load for considerably more circuitry than just the #4 ACSR conductor between 565E and 566E and shows a peak current of around 65-amps on December 3, 2017.

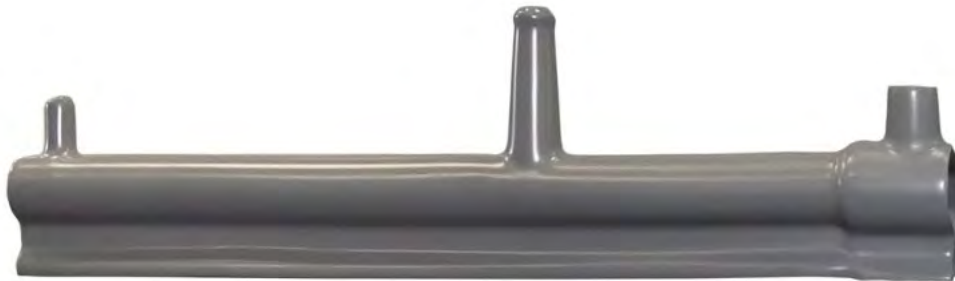
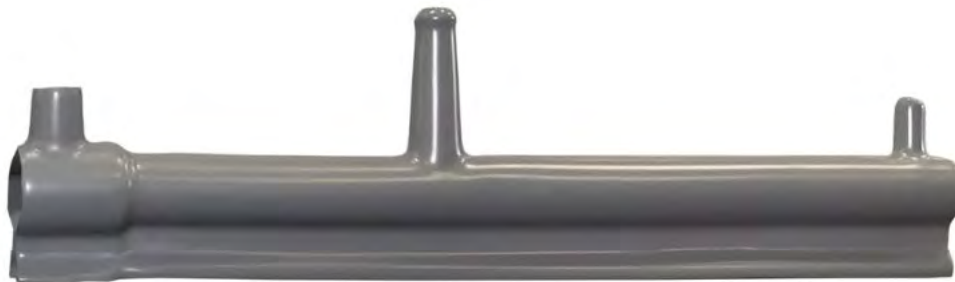
Please see below for pictures of the two types of avian protection devices that were employed at Pole 566:
