Application No.: A.24-10-002  
Exhibit No.: SCE-12 Vol. 01  
Witnesses: B. Chen  
R. Daffern  
G. Fowler

***Woolsey Fire Cost Recovery Application –  
Rebuttal Prudence of Operations – Design and  
Construction Testimony***

**Public Utilities Commission of the State of California**

Rosemead, California  
July 15, 2025

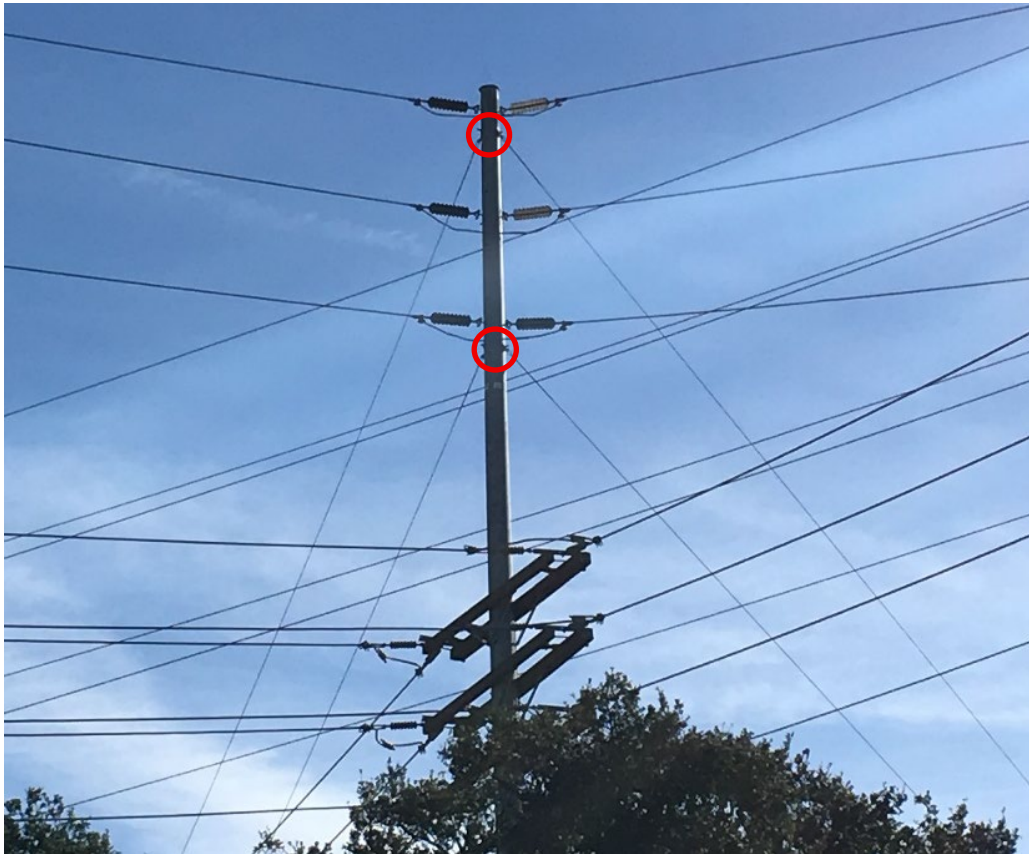
***Figure II-1***  
***Post-Fire Photograph of Subject Pole and Subtransmission Guy Attachments***

Cal Advocates critiques SCE's placement of the subtransmission down guy at the Subject Pole, suggesting that it should have been relocated to create more clearance from the distribution jumper. This criticism is misplaced. Cal Advocates does not dispute that a *taut* subtransmission guy wire—as designed and constructed by SCE—achieved at least 12 inches of clearance, or at least 133% of the applicable GO 95 requirement of 9 inches. The clearance of a taut guy wire was therefore entirely prudent. Put differently, Cal Advocates mistakenly conflates concerns about the slack condition (which are addressed below) with unwarranted concerns about clearance as designed and constructed with a taut guy.

Cal Advocates nonetheless suggests that SCE should have known to construct the Subject Pole differently to provide an even greater clearance between the subtransmission guy and the distribution jumper. But Cal Advocates does not explain why, at any point before the Woolsey Fire ignition, prudence would require any changes or point to any industry standard suggesting changes would be appropriate—particularly when the clearance between the subtransmission guy and the distribution jumper already exceeded GO 95 requirements.<sup>5</sup>
