PACIFIC GAS AND ELECTRIC COMPANY

KINCADE AND DIXIE AB 1054 WILDFIRE COST REVIEW AND RECOVERY PROCEEDING

PREPARED TESTIMONY

VOLUME 1 OF 2

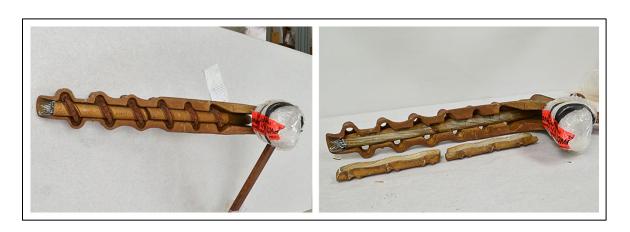
FIGURE 3A-4
PHOTOGRAPHS OF THE SHOE AND THE CONDUCTOR FRACTURE

Based on my examination of the evidence, associated reports and documents, and my training and experience, I reached the following conclusions. I determined that the jumper conductor separated due to fatigue, i.e., the gradual weakening of the conductor, induced by gusting winds over time. I also determined that there was no visible indication of fatigue prior to the separation, and that the separation point was located within the solid metal shoe, which obscured the failure location prior to separation.

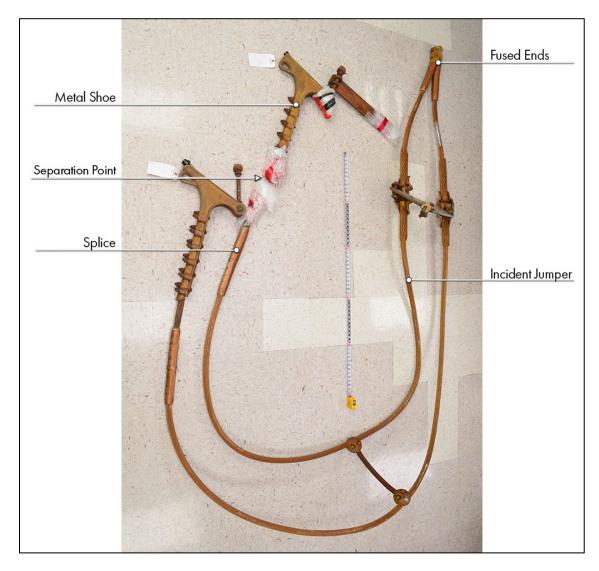
FIGURE 3A-5 INCIDENT JUMPER CONDUCTOR AFTER THE KINCADE FIRE

Fatigue affecting the jumper conductor. Fatigue occurs when a component is subjected to repeated stresses. In this case, movement of the jumper induced stresses that, although individually below the ultimate strength of the metal, collectively over time initiated and propagated cracks until fracture occurred. The incident jumper conductor separated due to the

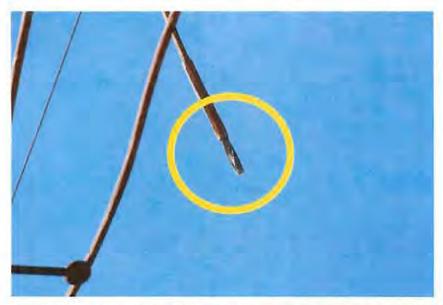
Figure 1 (IMG-1493JPG) Photo of the highlighted conductor wire on tower 1-6-41129111.

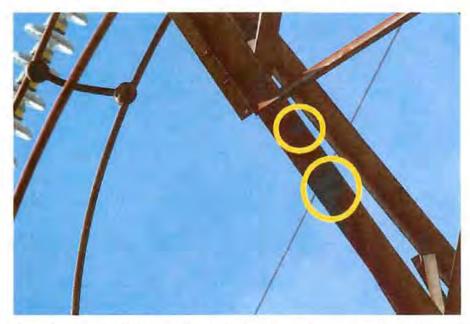
Figure 2 (IMG 1497)PGs Photo of the highlighted electrical are marks on the box frame of Fower 1-6-41129171.

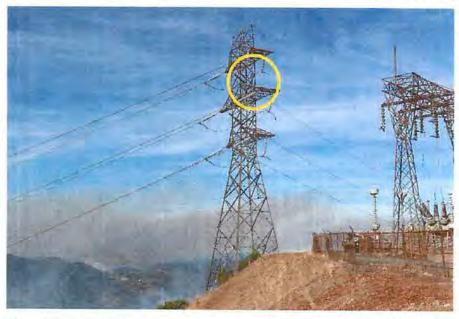
Figure 3(IMG-1460JPG) Looking west at east side of Fower 1-6 41129171. The highlighted area is the location on the tower where the failure occurred on October 23, 2019.

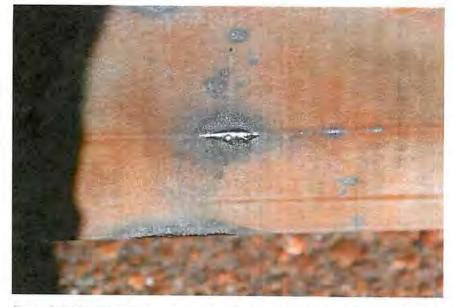
Figure 5.HMG 1829.IPG) One of several newly discovered electrical arc marks located on the box trame located after the removal of the box frame from tower 1-6-41129171

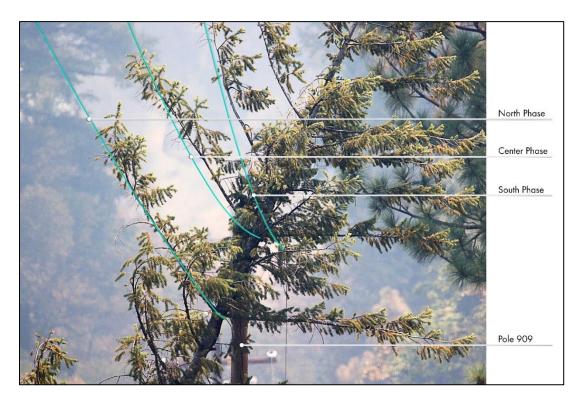
FIGURE 3B-4 SUBJECT TREE ON CONDUCTORS AT POLE 909⁴

After its initial impact, the Subject Tree slid downhill along the top of the conductors in the Subject Span. The Subject Tree stopped when it reached Pole 909, with the weight of the tree primarily supported by the north (A phase) conductor. The A phase remained energized and in contact with the Subject Tree, resulting in a high-impedance fault, i.e., a fault in which a small amount of electricity flowed through the tree to the ground. Over the course of several hours, this low and undetected flow of electricity caused localized heating that resulted in charring, smoldering, and burning on the surface of the Subject Tree where it was in contact with the north conductor. Examination of the tree trunk after the incident showed significant localized charring at this location. Burning material from this area likely fell to the ground and landed in a receptive fuel bed, resulting in the fire's ignition.

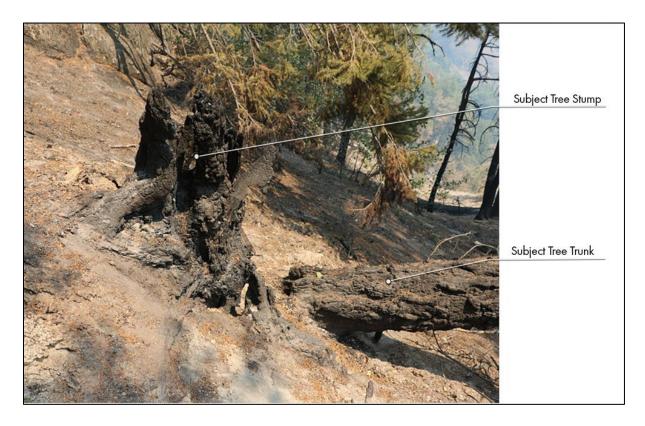
FIGURE 3B-7 PHOTOGRAPH SHOWING POST-FIRE CONDITION OF SUBJECT TREE STUMP AND LOWER TRUNK

When the Subject Tree failed on the day of the fire, the lower portion of the tree's stem (i.e., trunk) separated from the tree's base, as shown in Figure 3B-7 below; it did not uproot. Both the stump and lower portion of the trunk were heavily burned by the fire.

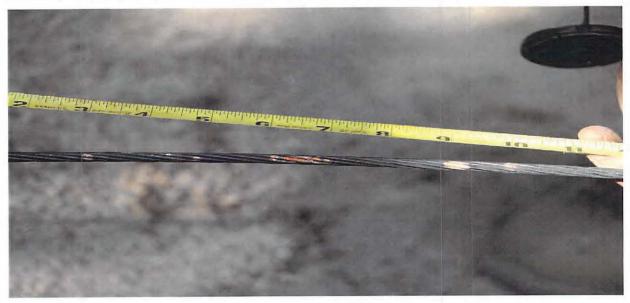
- 1 Conductor #1 (southern Conductor) Approximately 34 feet uphill (west) from the
- 2 insulator on the unmarked pole. Approximately 12 inches of conductor was removed
- 3 and packaged as E-7. This section of conductor showed signs of fresh arcing and
- 4 beading in multiple spots over the approximate 12-inch section.

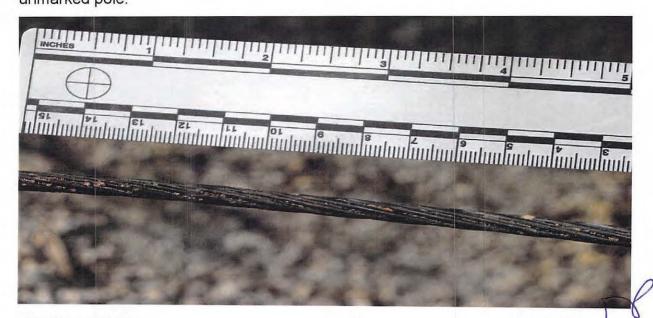
Conductor #2 (middle conductor) Approximately 5 feet of conductor was removed and packaged as E-8. This conductor showed remnants of tree bark and materials transfer from approximately 6 feet uphill (west) and up to 16 inches from the insulator on the unmarked pole.

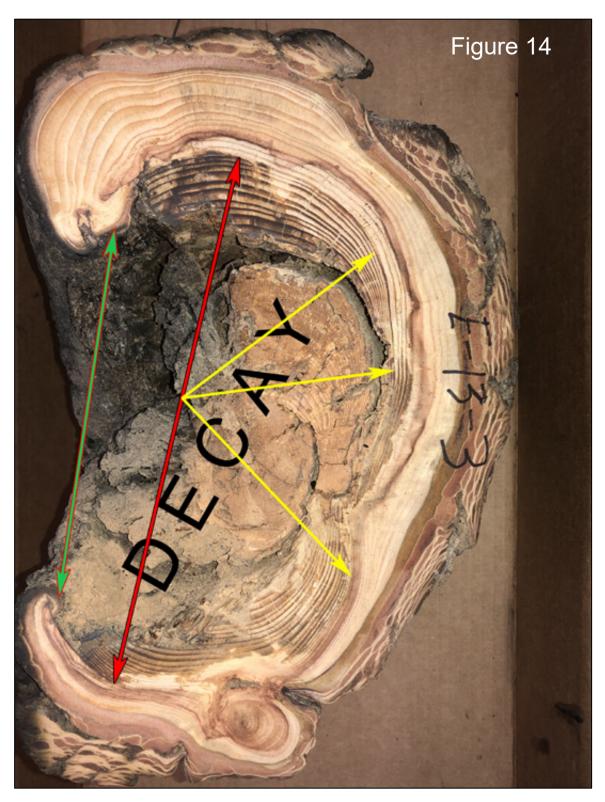
Figure 14 is of the single face of E-13-3 and was well above grade, likely 12 to 18 inches. As with previous figures, the yellow arrows illustrate the outline of the root prior to the 2008 fire. The red arrow describes the limit back to which the live cambium was killed in 2008. The area labeled as decayed represents advanced decay. Between the advanced decay and the tips of the arrow, where annual growth rings can be seen, the wood is sound.
