# **FINAL REPORT ON THE AUDIT OF THE ENCINA POWER PLANT**

**CONDUCTED UNDER GENERAL ORDER 167  
TO DETERMINE COMPLIANCE WITH  
OPERATION, MAINTENANCE, AND LOGBOOK STANDARDS**

ELECTRIC GENERATION PERFORMANCE BRANCH  
CONSUMER PROTECTION AND SAFETY DIVISION  
CALIFORNIA PUBLIC UTILITIES COMMISSION  
505 VAN NESS AVENUE  
SAN FRANCISCO, CA 94102

December 10, 2010

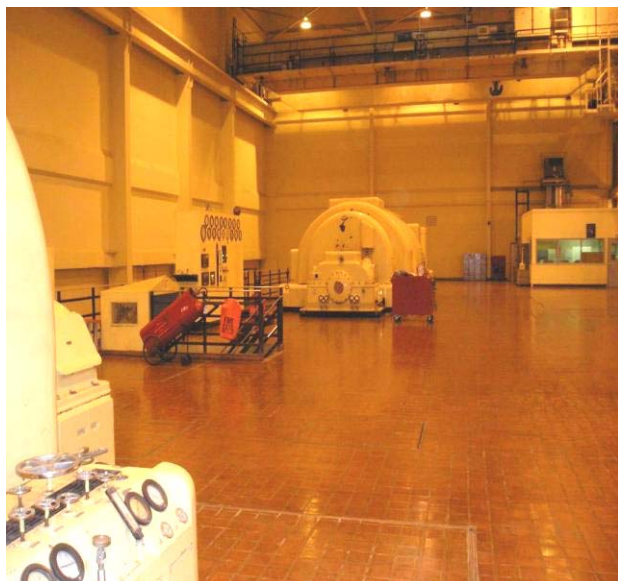
away. At the meet-and-confer meeting, CPSD verified multiple fire extinguisher systems near the steam turbines (See Photos 2 and 3).

Photo 2. Fire extinguishers are readily available on the turbine deck.

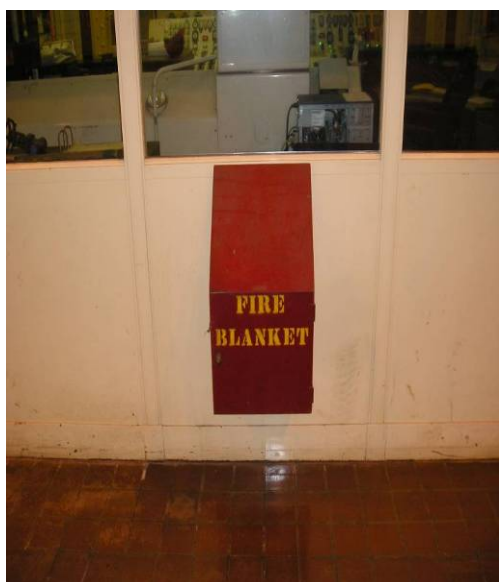
Photo 3. Fire blankets are available near the control room.

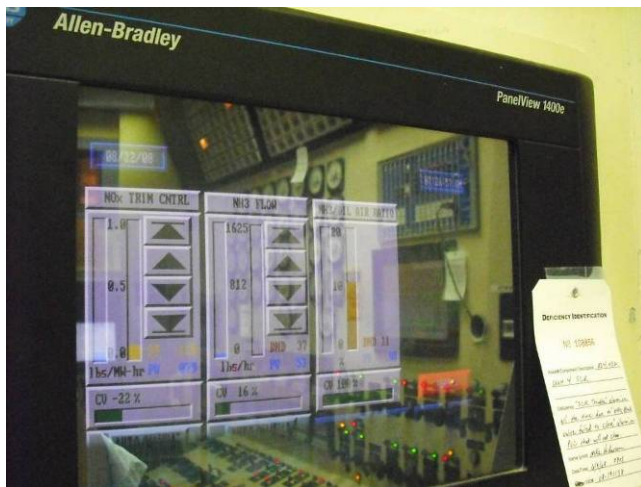
Photo 4. Deficiency tag on a digital display in the control room.

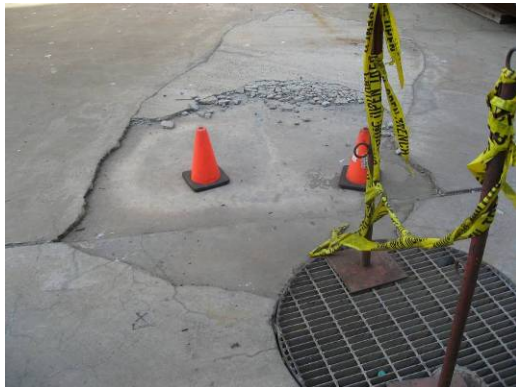
In addition, because the deteriorating tunnel might collapse, the repair delays threaten the plant's reliability. Even a partial collapse would restrict water flow to the condensers. This would reduce a condenser's cooling capacity and limit a unit's power output.

Photo 5. Sinking concrete atop the circulating water tunnel.

"The concrete in the picture is not in danger of breaking or falling into the circulating water tunnel, but it can present a tripping hazard to employees; the bright orange cones and barrier tape are mitigating actions. Any areas on the CW deck providing critical access have been promptly repaired; areas that are not providing critical access are isolated and marked, and will be repaired in normal course."

As a precaution, the plant erected a warning sign at the tunnel's entry. The plant also said it will hire a contractor to use a special epoxy to repair the tunnel. At the time of the audit, the plant has not yet repaired the deteriorating tunnel.

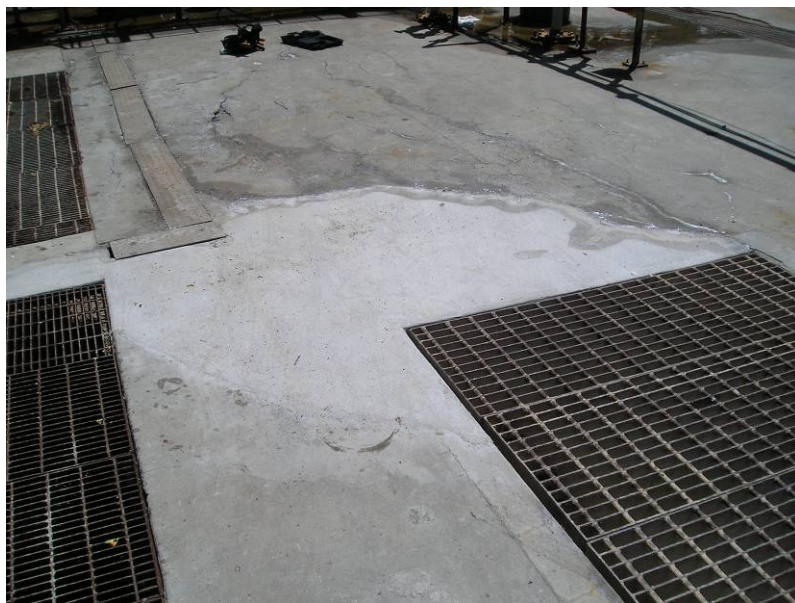
Photo 6. The plant repaired areas of surface delamination.

The plant made multiple repairs (See Photo 6), and allocated funds in the budget for future repairs. The plant also agreed to add inspection requirements to its tunnel cleaning procedures and checklists. No further corrective action is required.

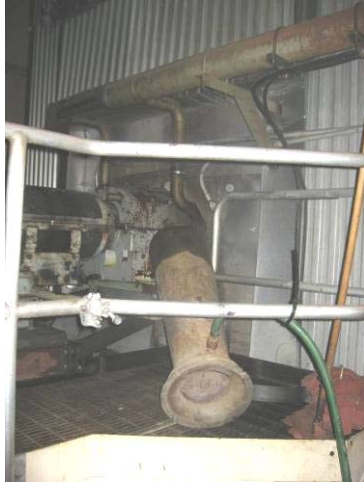
The plant delayed repairs on a recirculation fan bearing, violating maintenance standards.<sup>32</sup> The recirculation fan recycles flue gas into the furnace for re-burn. The defective bearing has registered higher than normal operating temperature. At the time of the audit, the plant used an air blower to blow ambient air to the bearing to keep it from overheating. The bearing can fail if operators continue to operate it above its normal temperature. If the bearing fails, it will take the recirculation fan out-of-service and limit the unit's power output.

Photo 7. The plant blows air to the bearing to keep it from overheating.

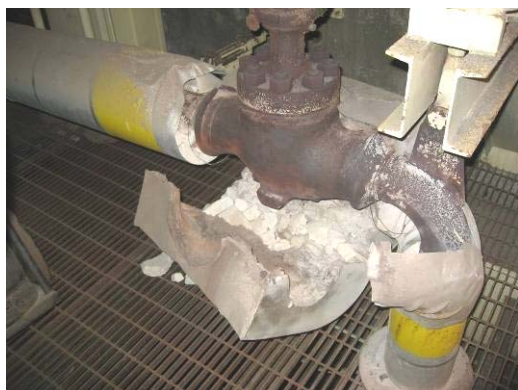
Photo 8. Asbestos insulation exposed at a valve on Unit 4.

In response, the plant hired an insulation contractor to analyze the insulation for asbestos. The result was negative and the plant provided a copy of the analysis. To mitigate burn risk hazards, the plant repaired the broken insulation. No further corrective action is required.

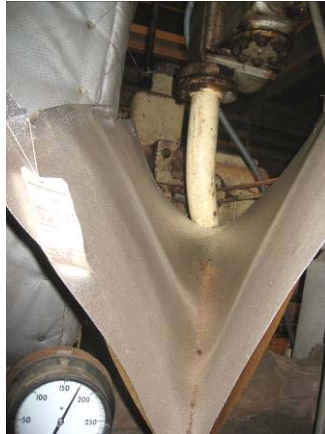
- (1) Work Order # CB1C119045 reported an oil leak from a boiler-feed-pump throttle valve. Although the work order stated that “*oil was dripping onto hot piping causing an extremely high risk of fire*”, the leakage posed no immediate fire hazard because the oil leak is slow (about one drop per second) and that the plant has temporarily installed metal sheeting which redirects the oil away from hot surfaces. Nevertheless, the plant has delayed this repair and the plant must repair the leak before it gets worse.

Photo 9. The plant temporarily installed metal sheeting which redirects oil drips away from hot surfaces.

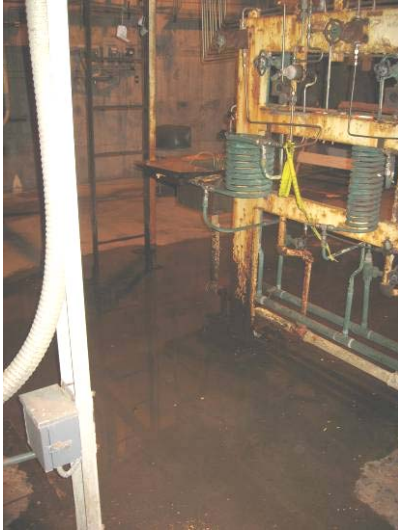
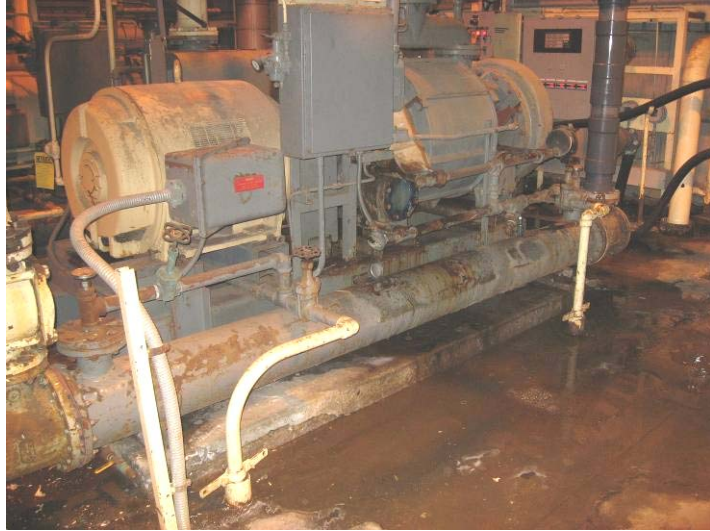
Photo 10 and 11. A defective chamber valve causes large water puddle to form on the ground near Site Column 20A.

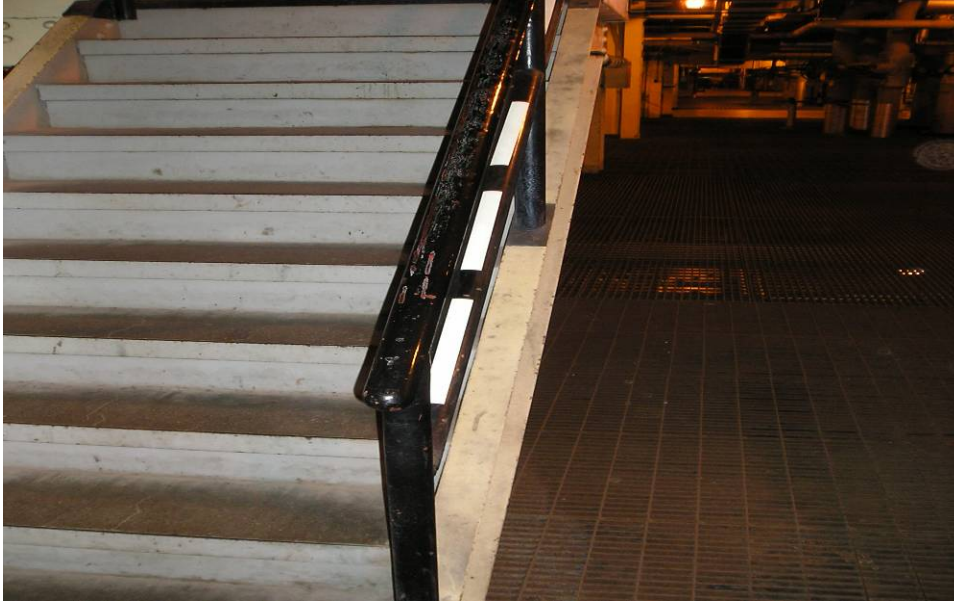
Photo 12. The plant marked this exit stairwell with luminescent tape.

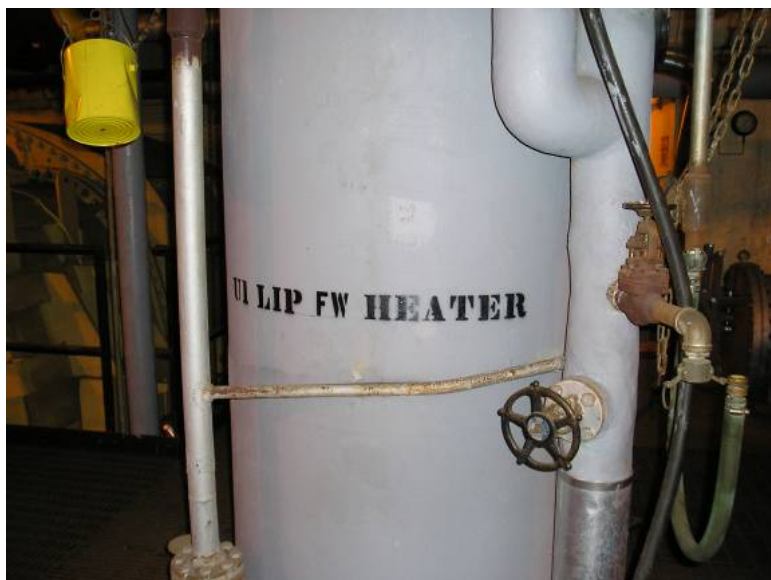
Photo 14. The plant labeled Unit 1's feedwater heater.

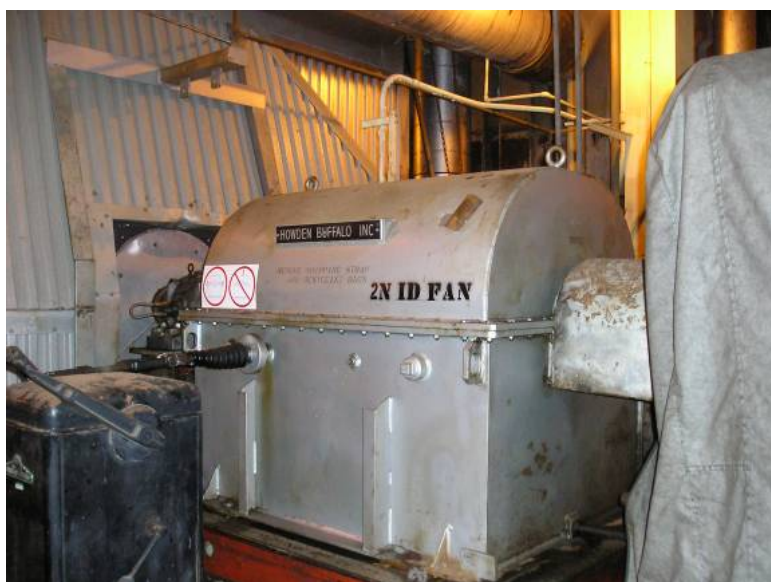
Photo 15. The plant labeled Unit 2's induced draft fan motor.

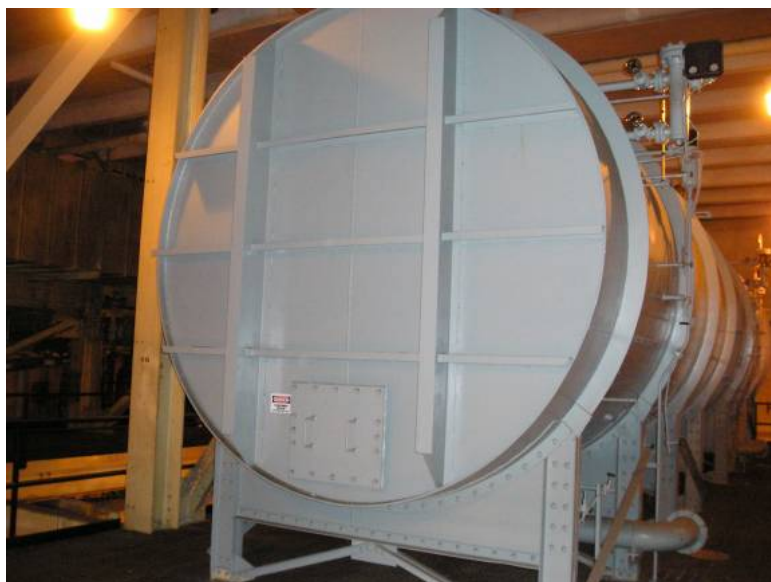
Photo 16. Unit 1's condensate storage tank to be labeled.

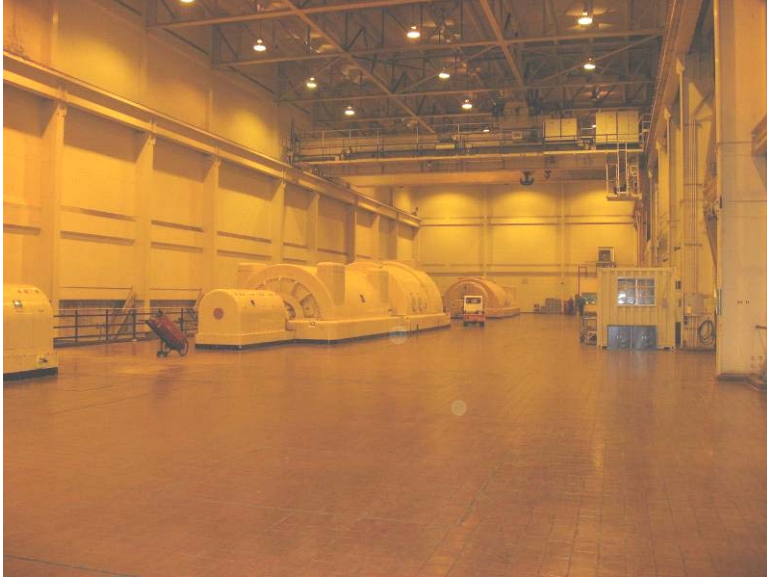
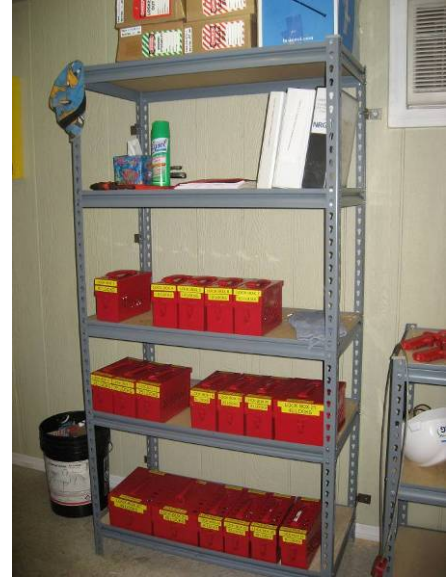
Photo 17 and 18. On the turbine deck, the plant has a shack where it keeps its locks and binders that track all active clearances.

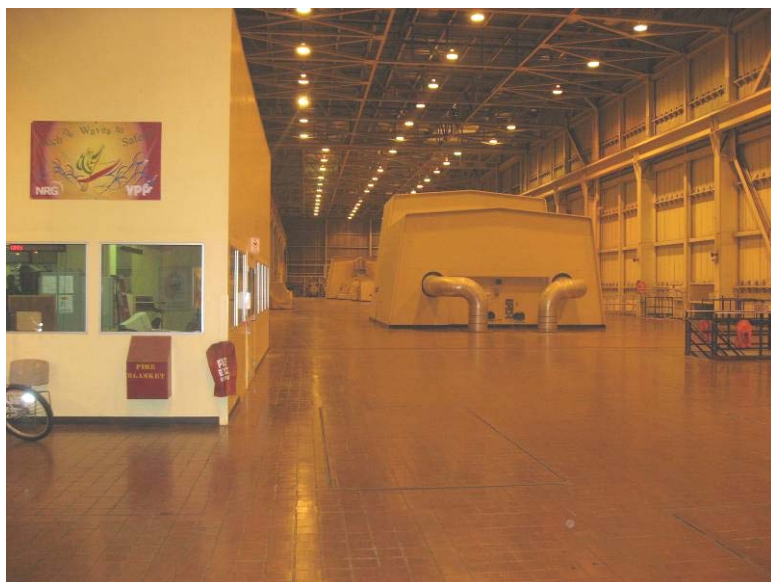
The plant keeps its facility orderly and clean. The plant is clean, particularly inside the power plant building. The plant stores unused equipment properly; secured and away from walk-aisles. During the plant tour, an auditor saw the shift supervisor repeatedly picking up and properly disposing trash and debris.

Photo 19. The plant keeps the turbine deck clean and orderly.
