# **FINAL REPORT ON THE AUDIT OF THE DELTA ENERGY CENTER POWER PLANT**

**CONDUCTED UNDER GENERAL ORDER 167  
TO DETERMINE COMPLIANCE WITH  
OPERATION, MAINTENANCE, AND LOGBOOK STANDARDS**

ELECTRIC GENERATION PERFORMANCE BRANCH  
CONSUMER PROTECTION AND SAFETY DIVISION  
CALIFORNIA PUBLIC UTILITIES COMMISSION  
505 VAN NESS AVENUE  
SAN FRANCISCO, CA 94102

May 29, 2009

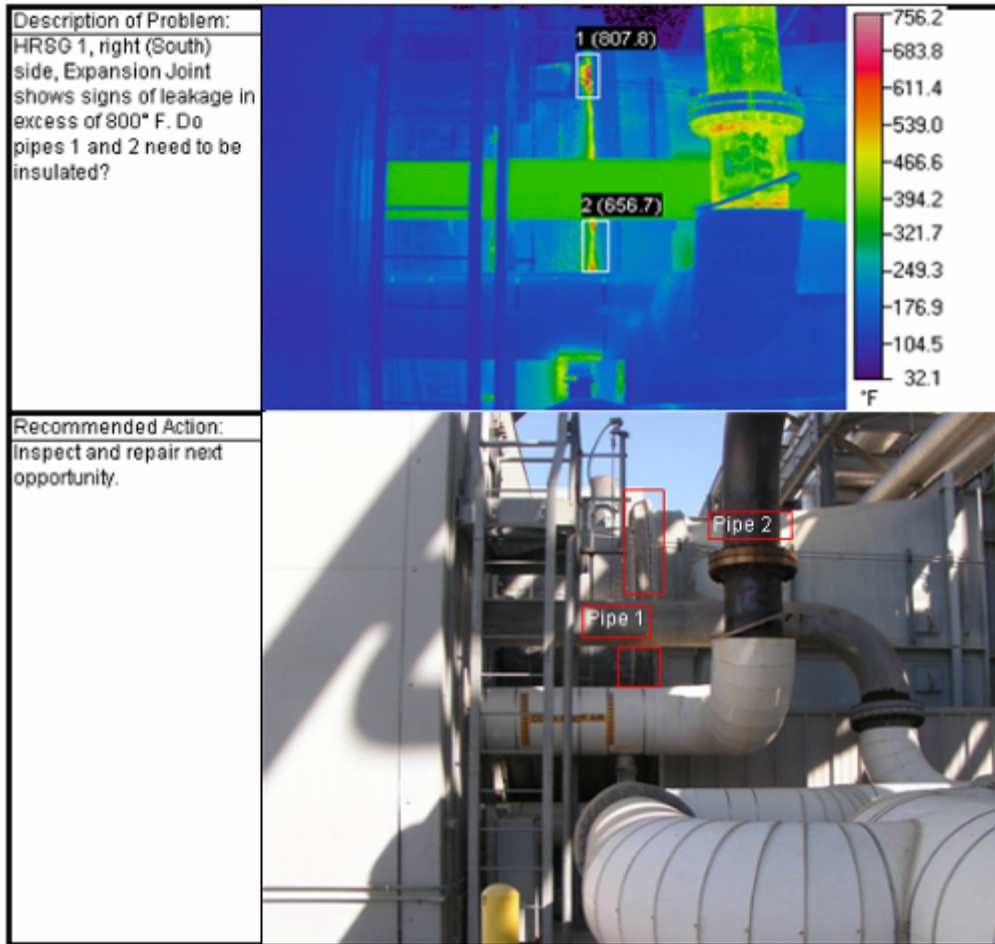
The plant deferred repairs of hot spots in the HRSG, a violation of Operation and Maintenance Standards.<sup>4</sup> Hotspots on the HRSG expose plant staff to burn hazards, reduce thermal efficiency and may lead to equipment damage that affects reliability.

Photo 1: Thermal image of Unit 1's expansion joint.

Further, plant staff identified several severe hotspots during an infrared scan in September 2006.<sup>6</sup> Staff recommended repair in the next immediate outage. However at the time of the audit, which was six months after the recommendation, the plant still had not repaired the hotspots.

The plant repaired most of the hotspots, but left two hotspots untouched because insulation could cause overheating and failure of fasteners. The manufacturer of the expansion joint (Photo 1), KE-Burgman, recommended against insulating that joint, saying that it functions

at high temperature by design. Insulating the joint would raise temperatures and cause the joint's fasteners to fail. To mitigate burn risks, the plant installed caution signs in the area (Photo 4). The HRSG's manufacturer, Deltek, similarly recommended that the plant maintain at least a 2-inch gap between the stainless steel bellow and the existing pipe insulation (Photo 5). The plant therefore left the gap in place, but did not post signs because the area is difficult to access. The plant did, however, install new piping insulation at other hotspots in the HRSG (Photo 6). Finally, the plant replaced gaskets and insulation to repair a hotspot at the manway door for Duct B (Photo 3).

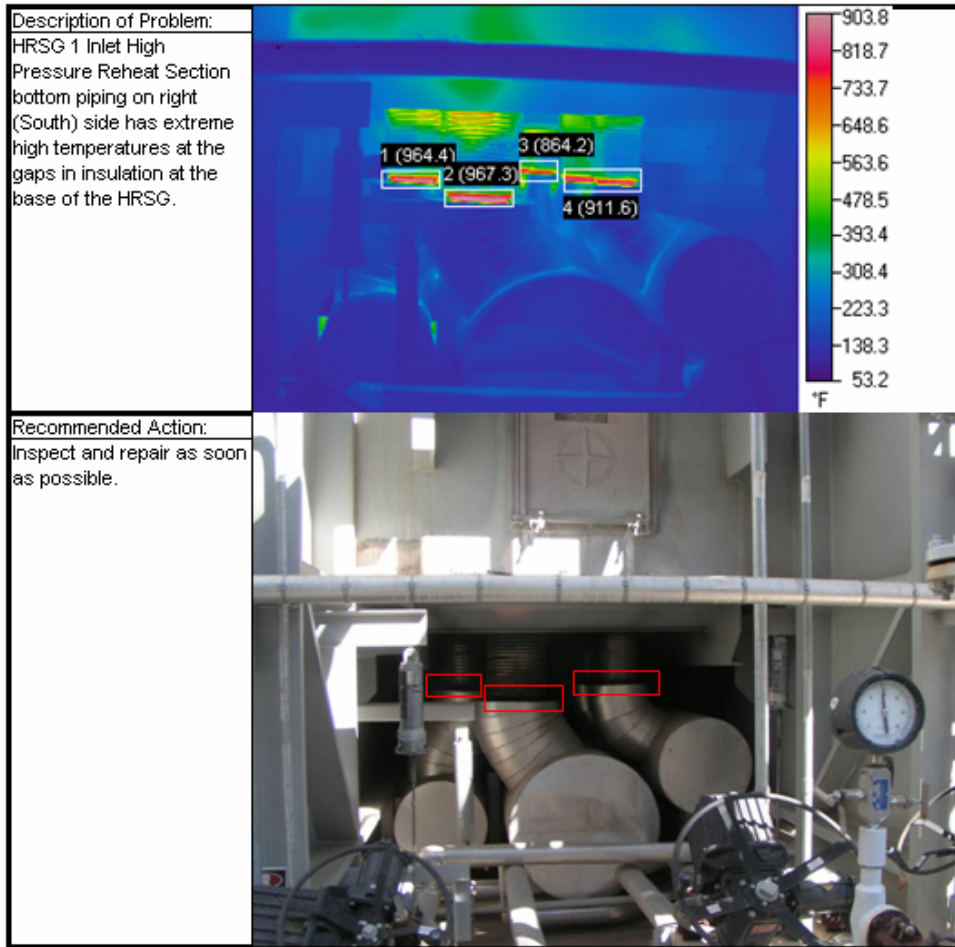
Photo 2: Thermal image of Unit 1's bottom reheater inlets.

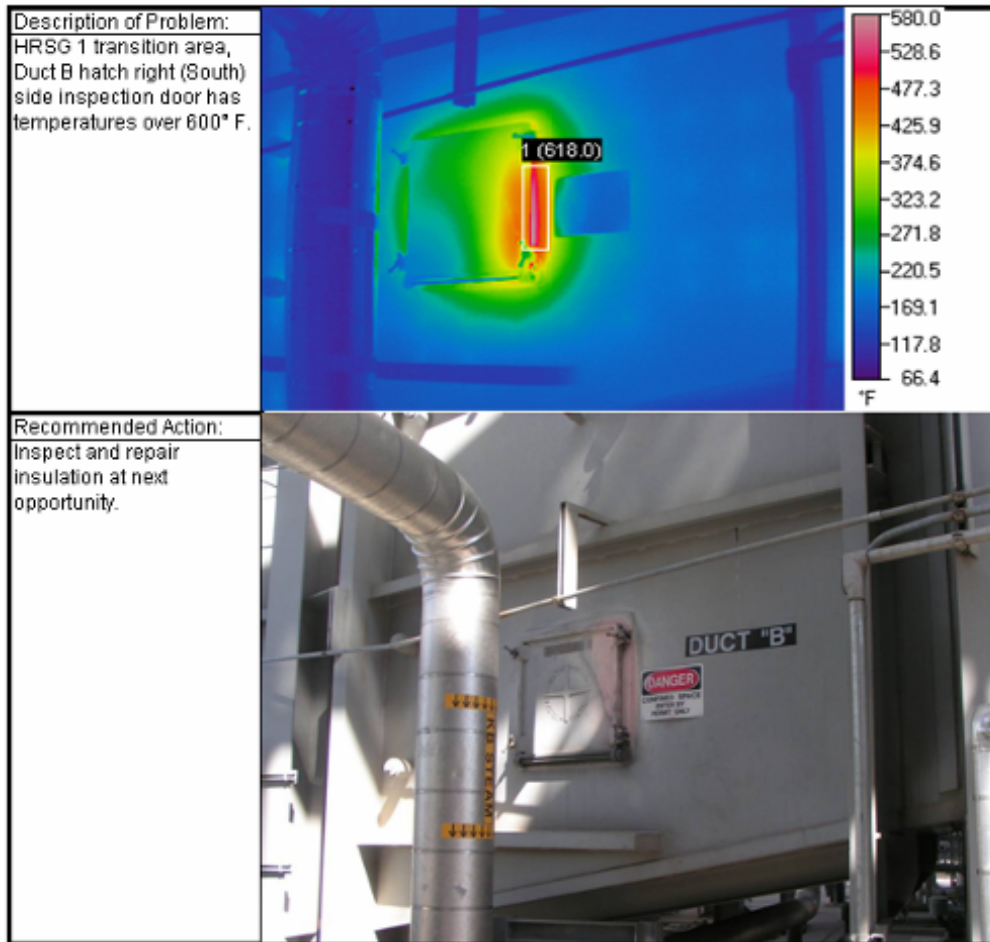
Photo 3: Thermal image of Unit 1's man-way in the transition duct "B".

In addition to posing safety hazards, hotspots reduce thermal efficiency and may lead to equipment damage that affects reliability. In this case, the insulation is beneath the HRSG's external casing. If allowed to continue, hotspots can cause thermal buckling of the HRSG's external casing and may lead to cracks. This risk is exacerbated because the HRSG's duct burners increase exhaust temperature and subject the HRSG to additional thermal stress.

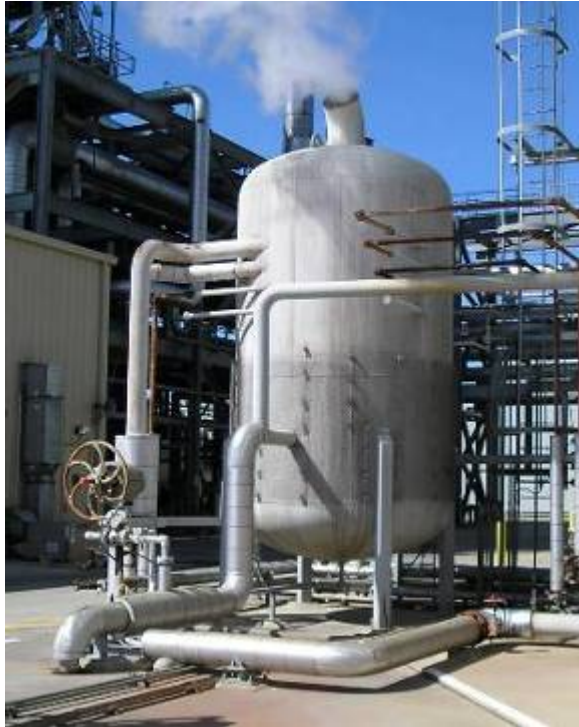
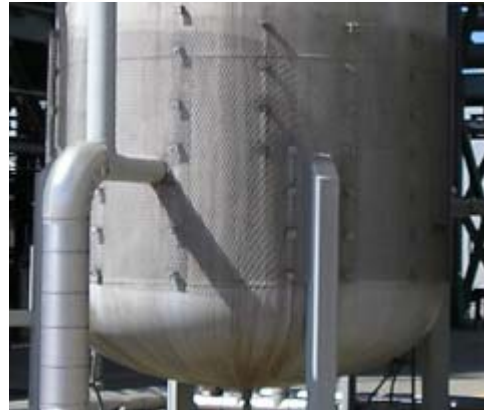
Inadequate barriers on the blow-down tanks expose plant staff to burn hazards, a violation of the Operation and Maintenance Standards.<sup>7</sup> While a mesh wire surrounds the midsection of the tank, the tank's lower portion lacks a protective barrier and exposes plant staff to burn risks.<sup>8</sup> Further, the tanks are near areas where plant staff walk frequently (See Photo 9).

<sup>8</sup> OSHA – Code of Federal Regulation Title 29 Part 1910 requires hot surfaces within 7 feet of the ground be covered with insulating materials or guarded in manners as to prevent contact.

Photo 9: Blowdown tank's lower portion lacks protective barrier.

The plant added an expanded metal shield to the lower portion of the blowdown tanks to guard against burns (Photo 10).

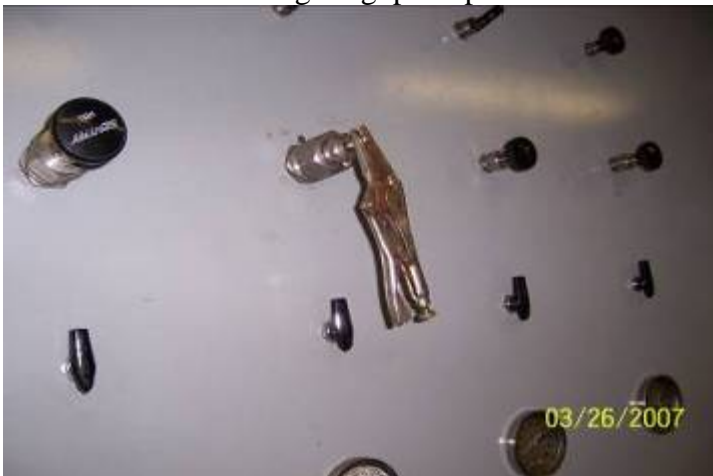
The plant replaced a valve handle (Photo 16) with a vise grip wrench, an awkward arrangement which violates Operation and Maintenance Standards.<sup>12</sup> Located on the chemical sampling panel, the valves isolate and control small streams taken for sampling from the plant's main water and/or steam streams. Use of the vise grip could damage (that is over-torque) the valve, making sampling difficult or impossible, and/or causing leakage of water or steam and thus endangering plant personnel.

Photo 16: A vise grip is used as handle to operate the sample valve.

The plant replaced the valve and wrench with a new valve and handle.

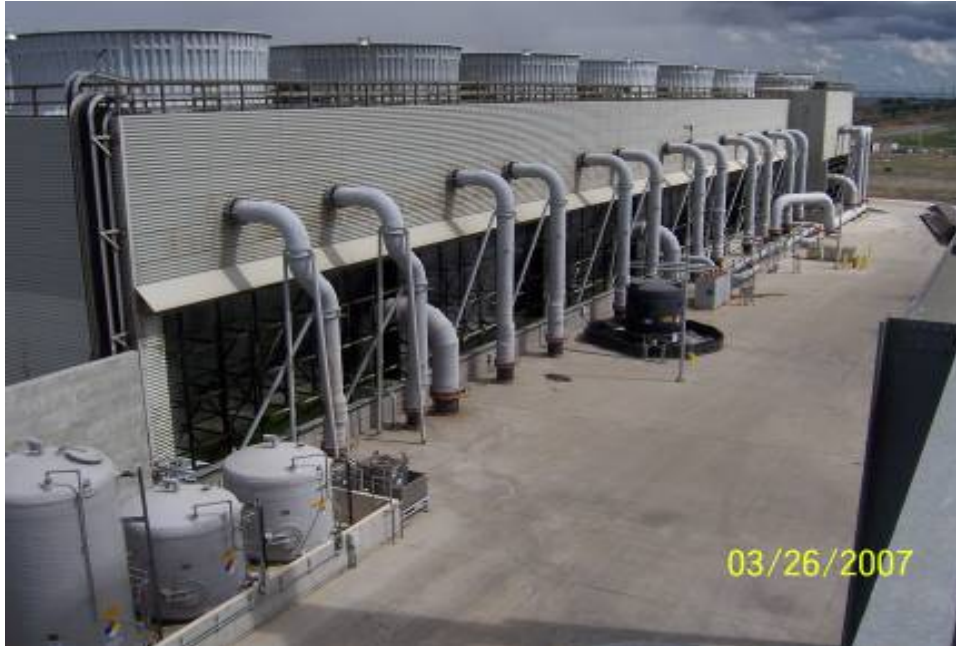
The plant's design drawings for cooling towers fail to show two recently-added cells (Figure 18), a violation of Operation and Maintenance Standards<sup>14</sup>. The plant added two new cells because the original 12 provided insufficient cooling, but never added the new cells to plant drawings. In particular, one design drawing and two of the plant's Piping and Instrumentation Drawings (P&IDs) lack tower numbers 13 and 14, specifically

There are many consequences of inadequate plant drawings. First, staff may order the wrong parts or make inappropriate repairs, causing outages or temporarily reducing the plant's capacity. Second, staff may be unable to determine how to isolate equipment for repair (through the lock-out, tag-out process), posing safety hazards for repair personnel. Finally, inaccurate drawings may mislead firemen or other emergency responders.

Photo 18: Cooling Tower drawings do not reflect the addition of two new cells to the cooling tower.

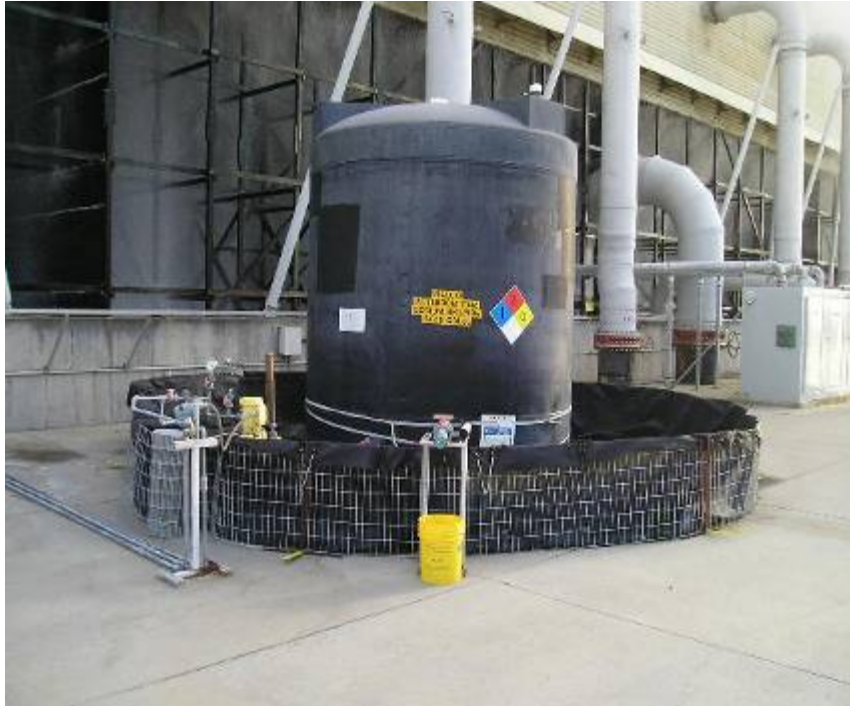
The plant relies on a flimsy plastic tarp, supported by steel mesh, to control spills of sodium bromide, a violation of Operating and Maintenance Standards.<sup>16</sup> The plant adds sodium bromide to cooling water in order to control the growth of bacteria. If touched, ingested, or inhaled, sodium bromide irritates the skin, eyes, and respiratory system; in large quantities it damages the eyes and nervous system. While experimenting with different chemicals and chemical injection systems, the plant installed the tarp (Photo 19) to provide temporary secondary containment,<sup>17</sup> that is, to control spills from the bromide storage tank. The plant permanently adopted the bromide injection system, but never replaced the tarp. The tarp is not acceptable for permanent use because it is located in an open area where passing vehicles, hand carts, or heavy winds can damage it.

Photo 19: Temporary sodium bromide chemical injection system.

The plant decided to discontinue use of sodium bromide and to remove the associated chemical injection tank and system. An auditor verified the removal of the tank piping and pumps on Sept. 11, 2008 (Figure 20).

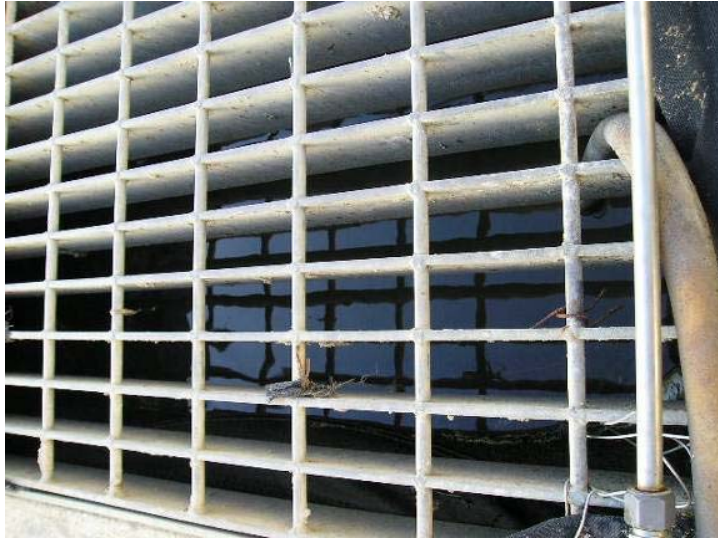
Photo 21: Clogged debris screen in storm drain.

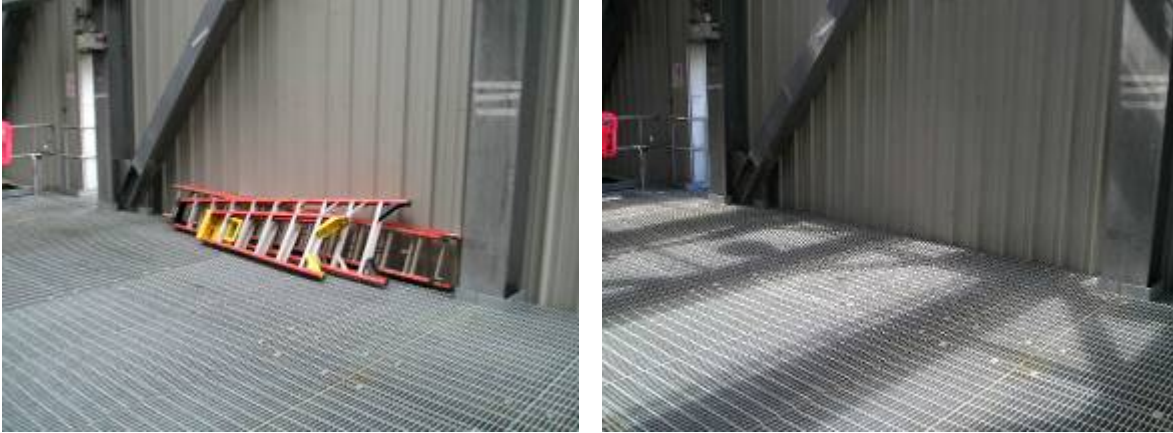
- Plant Staff contribute to overall safety by properly storing equipment (Photos 30 thru 34), regularly sweeping areas and removing debris.
- Plant Staff are responsive and keen to improve general plant safety. The Auditor pointed out ladders that were improperly stored. Plant staff picked up and properly stored the ladders within hours (Photos 28 and 31).

Photo 30: Improperly stored ladders were removed within hours of notification during the Audit.

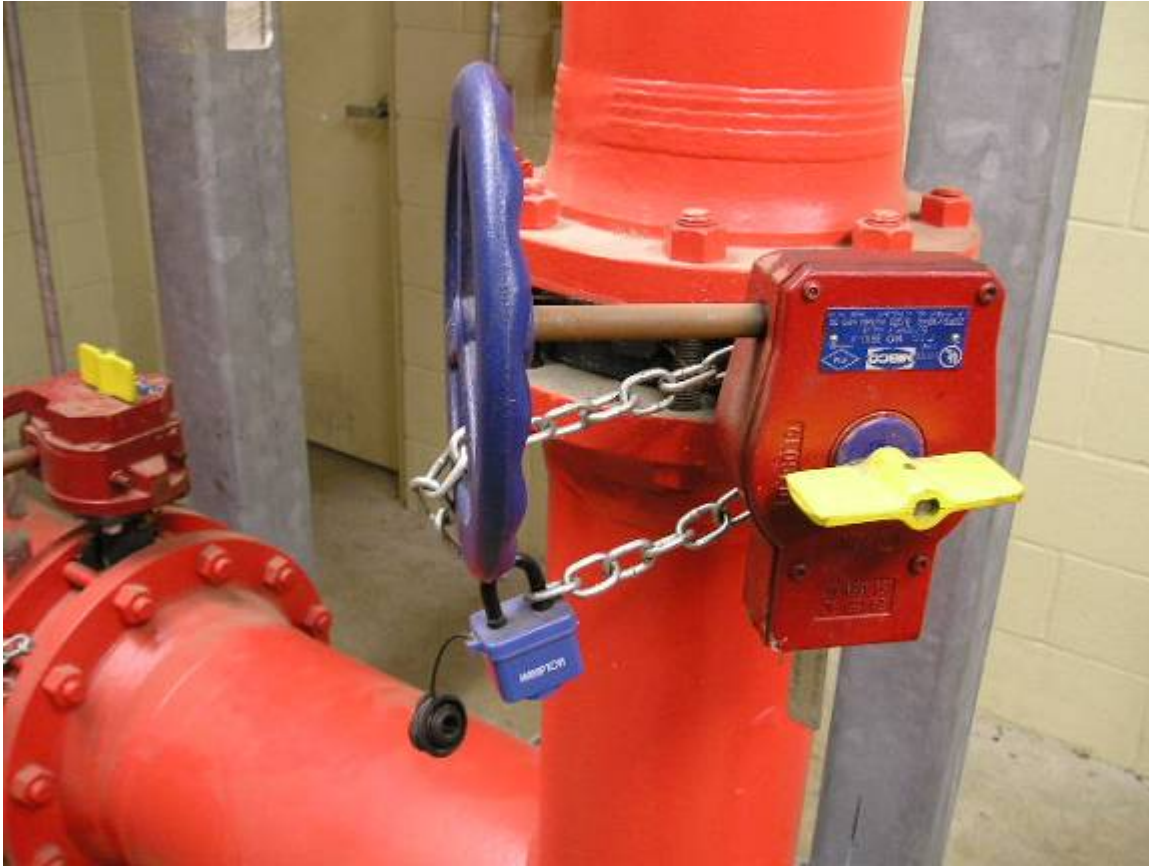
- All extinguishers and remote equipment have current inspection tags (Photos 33 & 34)
- Plant operators test run the main diesel powered fire pump weekly (Photo 35).
- The contractor inspected the fire protection system on May 11, 2006. The contractor wrote a report and plant staff implemented all of the suggested changes and upgrades from the report (i.e. valve locks; see Photo 36).

Photo 36: Locks are installed to prevent accidental closure of valves as recommended in the May 2006 inspection.
