| | Case 3:14-cr-00175-WHA D | ocument 1128 | Filed 12/19/19 | Page 1 of 14 |
|---|--|---|---|---|
| | RESPONSE TO FOLLOW-UP QUESTIONS F<br>BE ANSWERED BY PG&E BY D<br>Case | RE CPUC REPORT (<br>ECEMBER 19 AND<br>No. 14-CR-00175-V | ON CAMP FIRE, FU<br>SUPPLEMENTAL (<br>WHA | RTHER QUESTIONS TO<br>QUESTION 6a |

Defendant Pacific Gas and Electric Company ("PG&E") respectfully submits this response to the Court's December 5, December 6 and December 16, 2019 requests for information relating to the November 8, 2019 Incident Investigation Report regarding the Camp Fire issued by the Safety and Enforcement Division ("SED") of the California Public Utilities Commission ("CPUC").

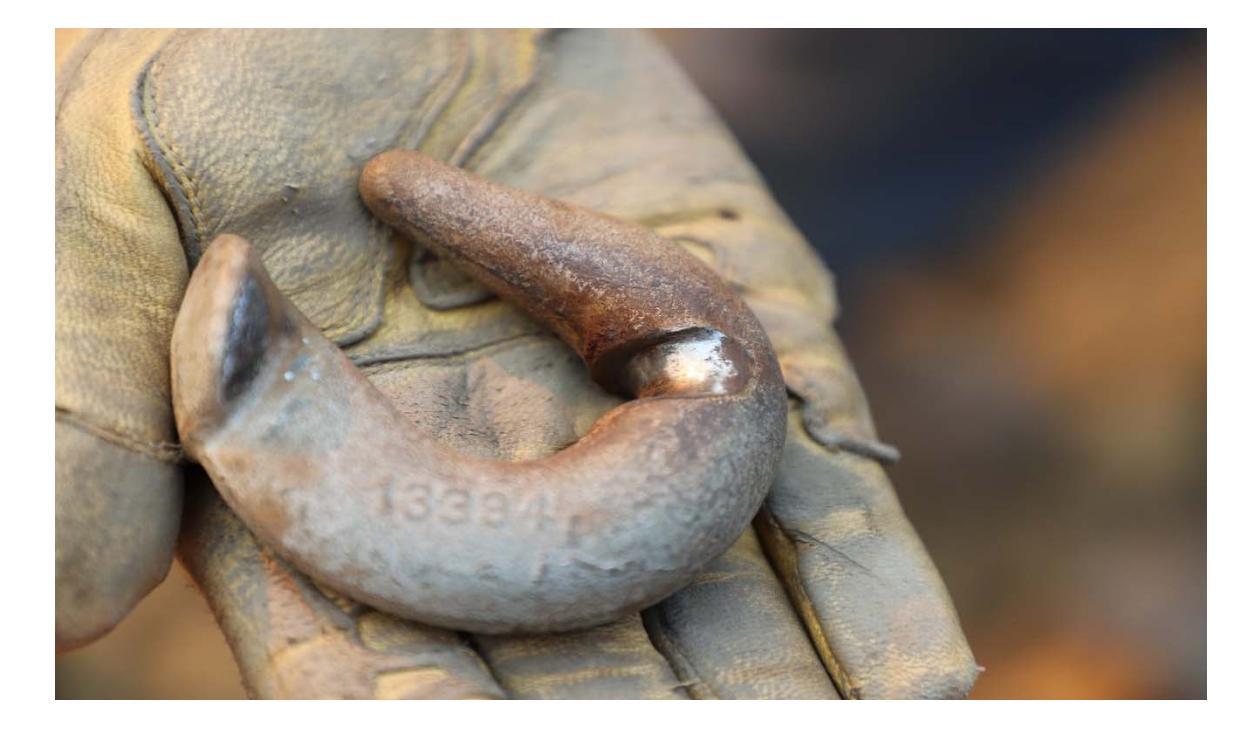
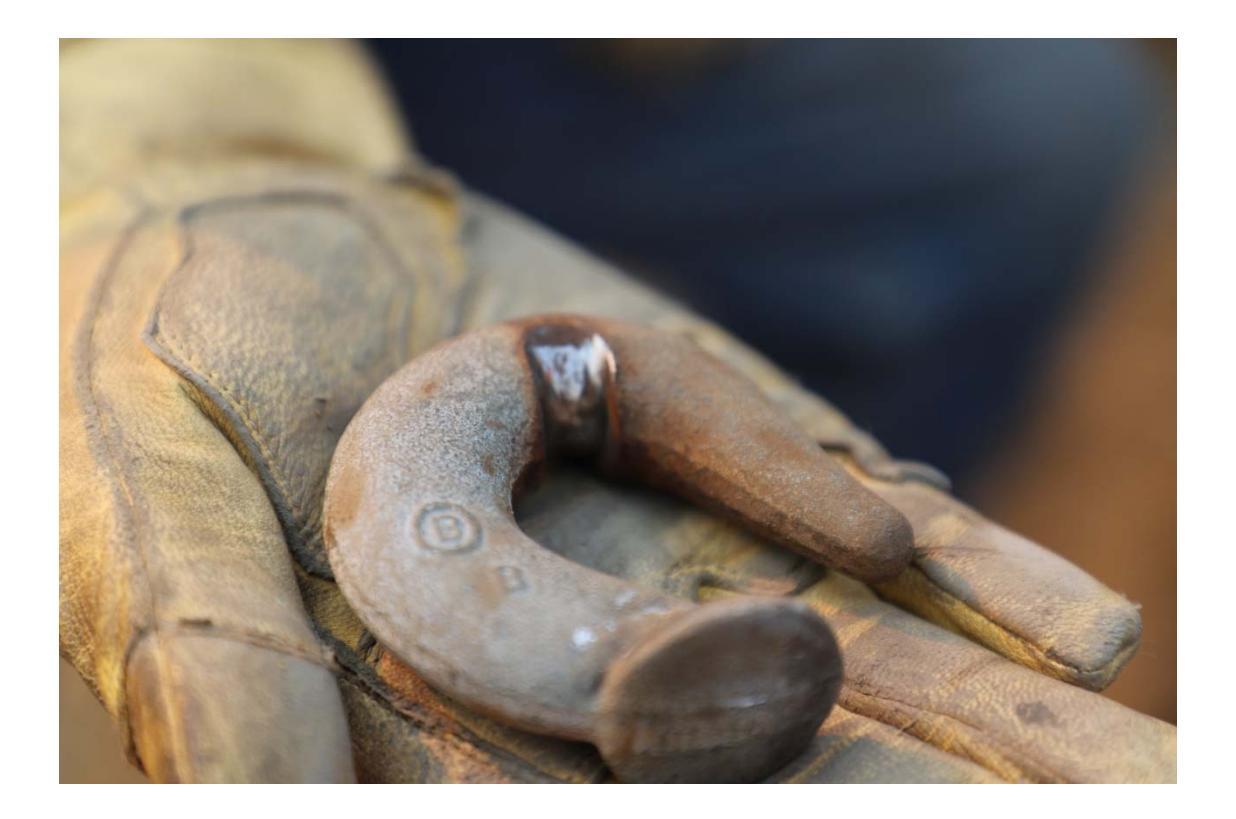
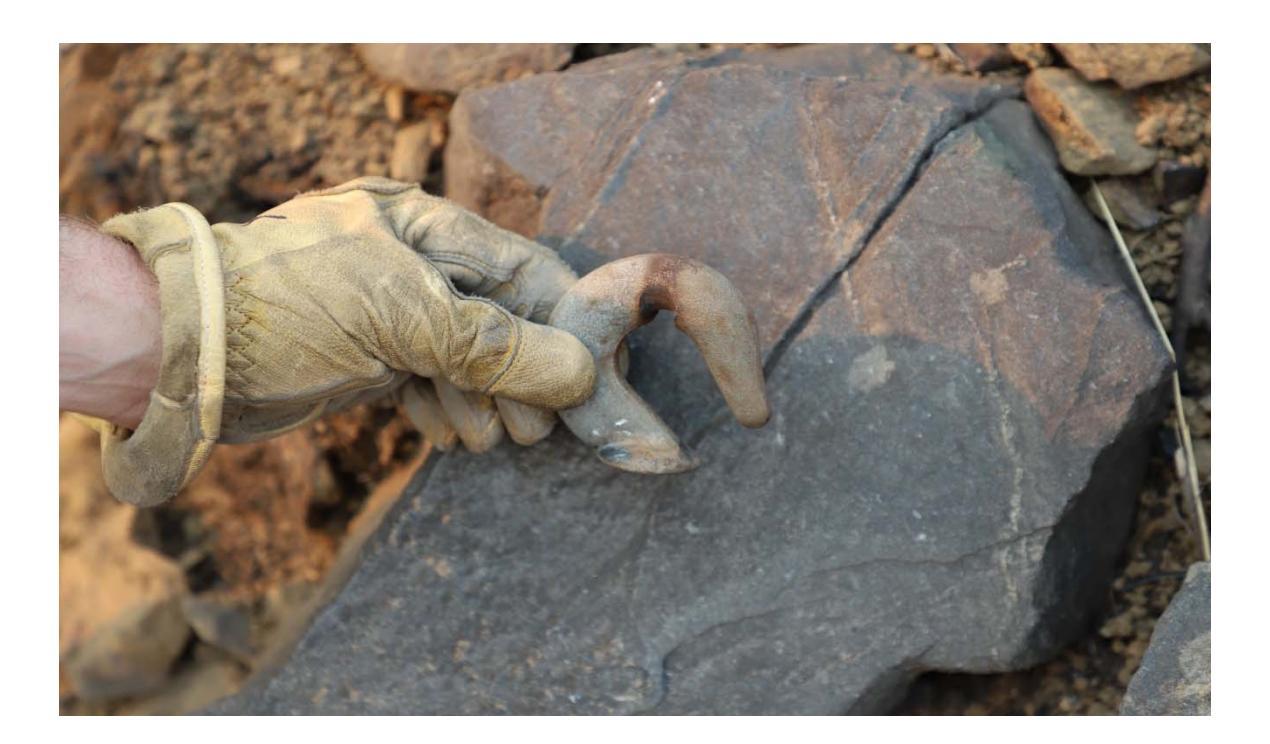
# **EXHIBIT** A

PG&E is providing as Exhibit A photographs showing the condition of the C-hook on the right-phase transposition runner arm on Tower :27/222 at the time the California Department of Forestry and Fire Protection ("CAL FIRE") collected it on November 14, 2018. At that time, PG&E assisted CAL FIRE's collection of, among other items of evidence, the C-hook that broke on Tower :27/222, the C-hook on the right-phase transposition runner arm that did not break, the transposition runner arms and the insulator strings to which the foregoing C-hooks were attached. CAL FIRE permitted PG&E to take photographs of the November 14, 2018 evidence collection. PG&E previously provided the photographs attached as Exhibit A to the CPUC, CAL FIRE, the Butte County District Attorney's office and the California Attorney General's office in connection with their investigations related to the Camp Fire.

Based on the photographs, PG&E believes that, as depicted in the photographs, the C-hook on the right-phase transposition runner arm had material loss of roughly 30%. Under the guidelines in PG&E's Electric Transmission Preventive Maintenance ("ETPM") Manual in effect at the time of the Camp Fire, material loss of between 30% and 50% on insulators and steel structures, including C-hooks, is a condition that should be assigned Priority Code E. Such conditions must be addressed within 12 months.

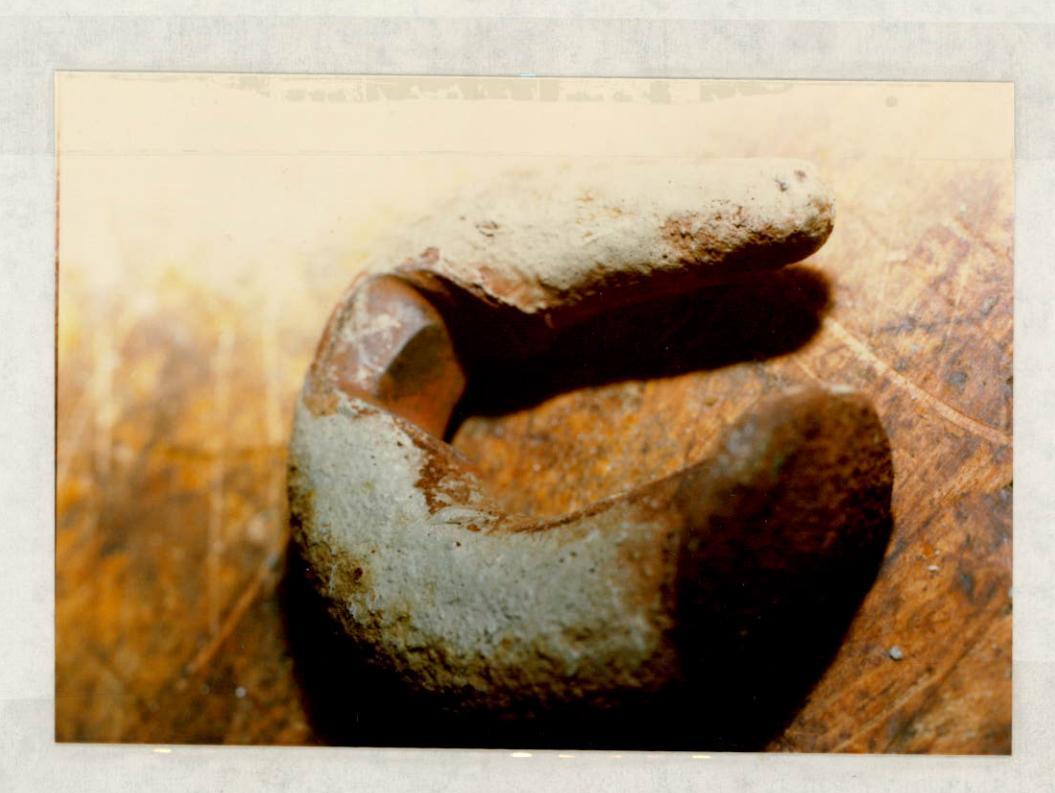
Both of the J-Hooks and their attaching plates had grooves worn in them and there was a concern that they may not be able to hold the weight of insulator strings that are suspended from them, (See Figures 1 and 2).

Figure 1. As shown in the Figure above a wear pattern was formed in the bowl-saddle of the J-Hook. This was possibly caused by the insulator string swinging in the wind over a period of time.

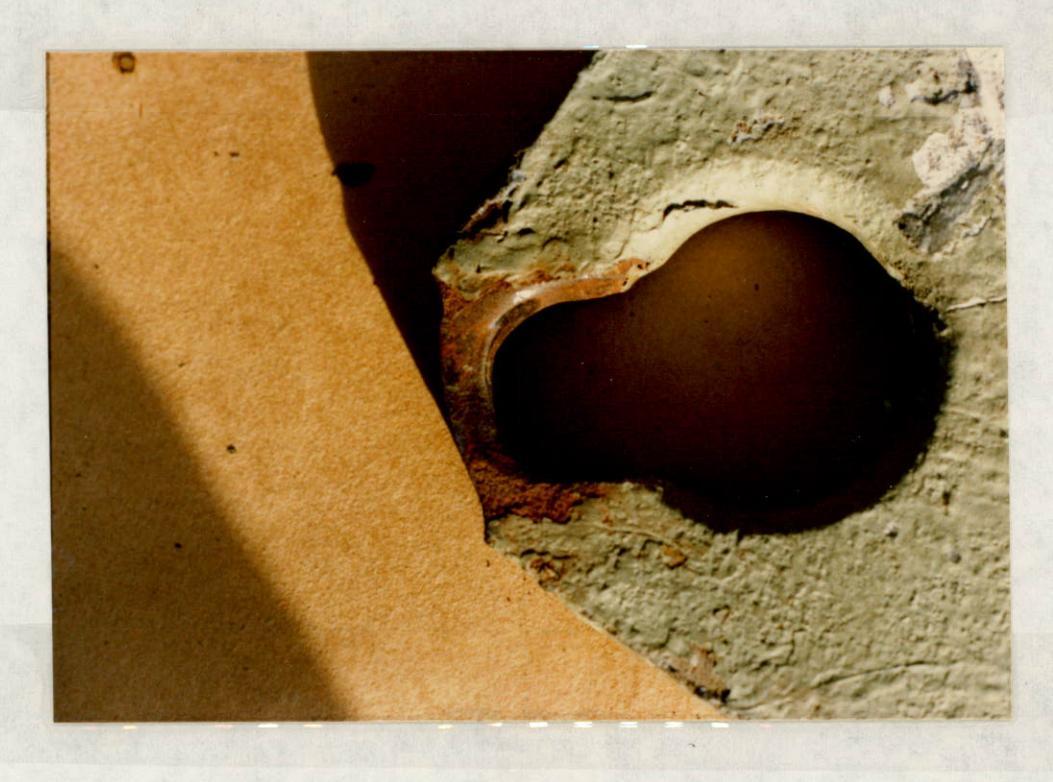
Figure 2. This Figure shows the key-hole wear in the plate eye caused by the J-Hook while in service.

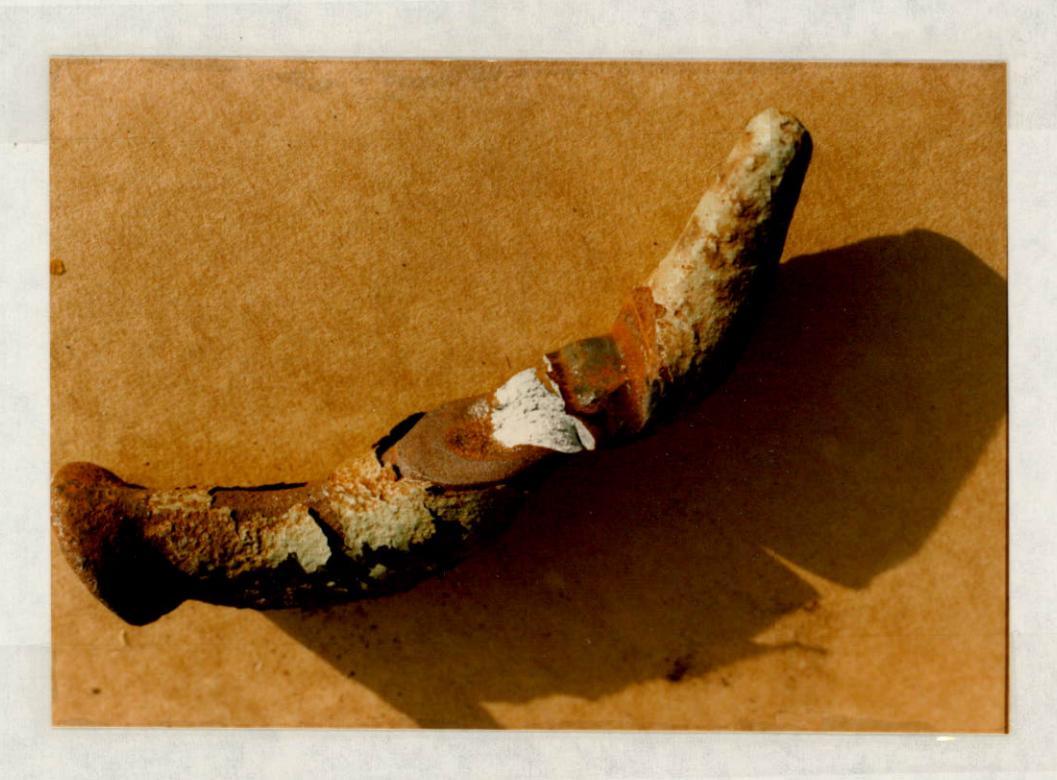
Both hooks failed at 11,500 lbs., (See Figures 4 and 5). Since the plates did not fail during this test an additional test was done on one of the plates. A shackle was attached to the eye of the plate and tension was applied. The eye failed at 19,600 lbs., (See Figure 6).

Figure 4. This hook shows the point of failure to be in the worn section of the bowl-saddle.

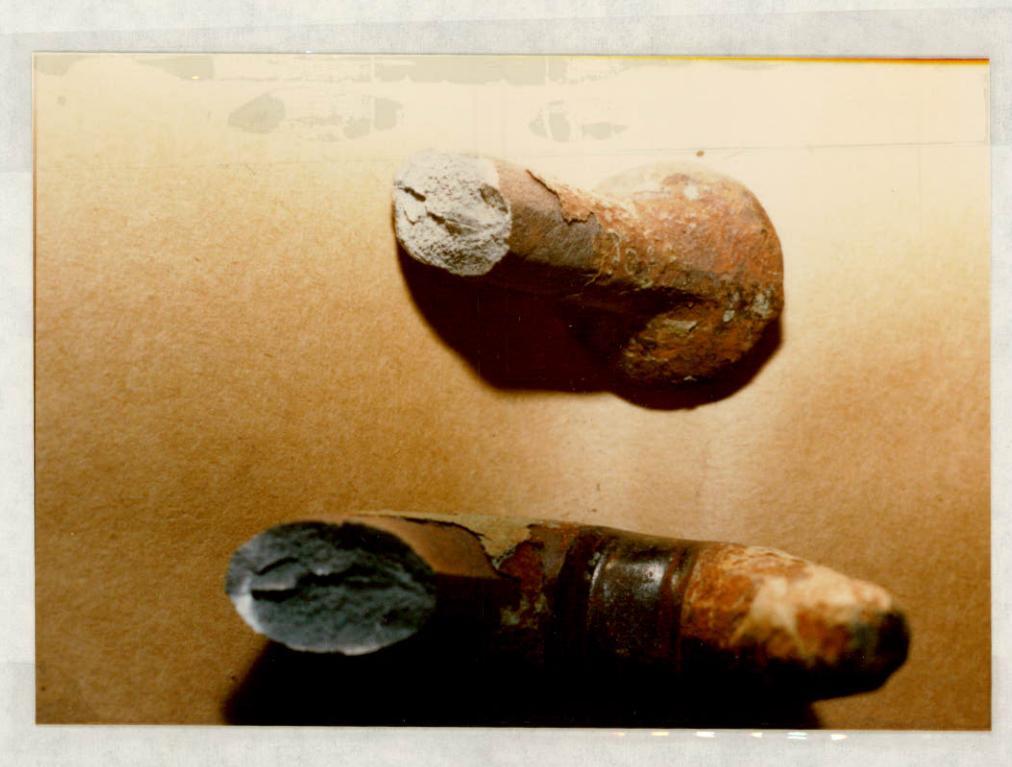
Figure 5. This hook failed at the heel even though it had approximately the same wear pattern in the bowl-saddle as the hook in Figure 4.

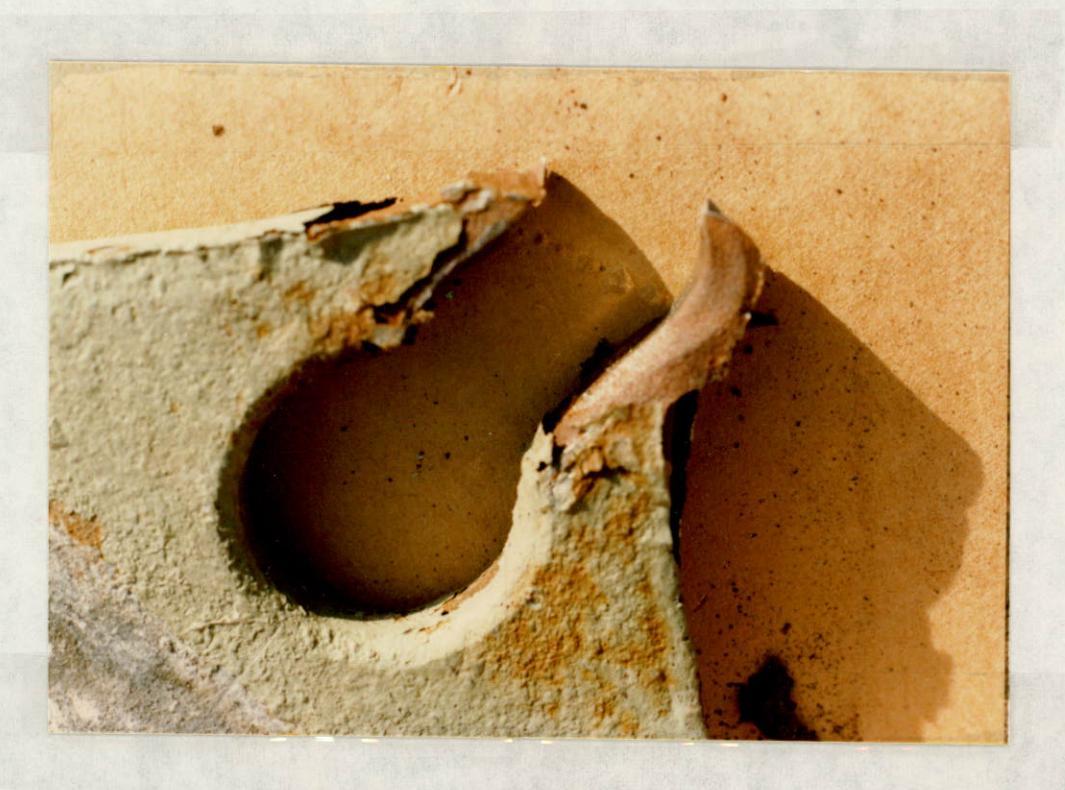
Figure 6. This Figure shows the failure of the eye in the plate when a shackle was pulled through it.
