Company: San Diego Gas & Electric Company (U 902 M)  
Proceeding: 2024 General Rate Case – Track 3  
Application No.: A.22-05-016  
Exhibit: SDG&E-T3-WMPMA-17

**HEARING EXHIBIT  
OF SAN DIEGO GAS & ELECTRIC COMPANY**

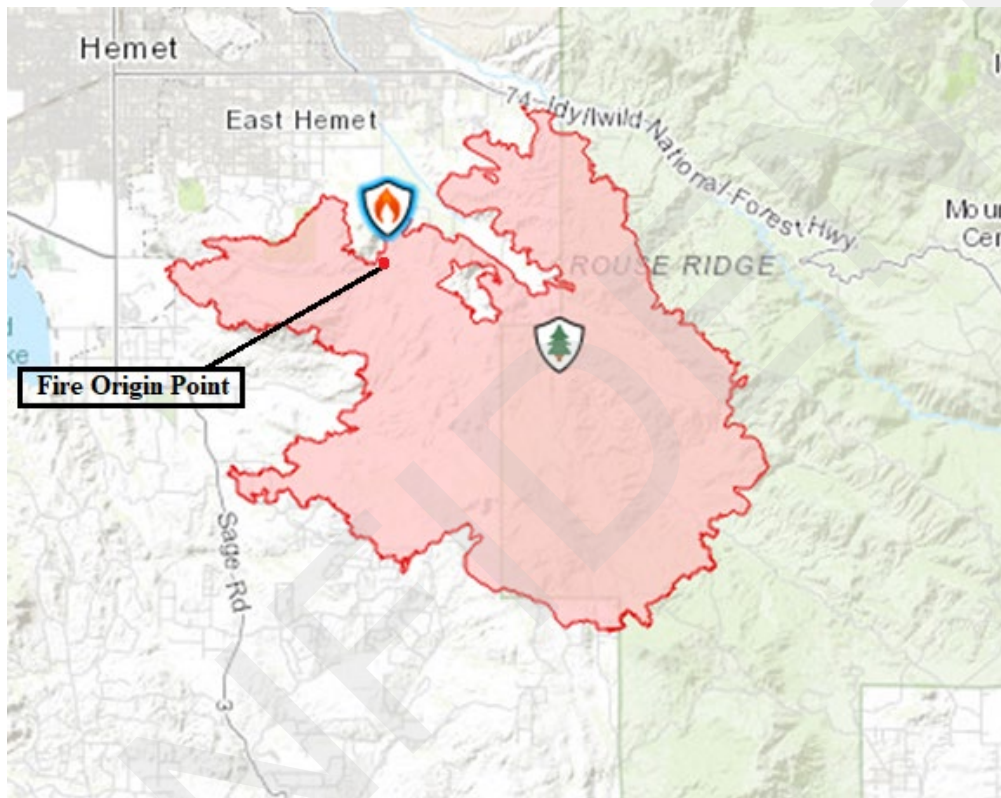
Figure 1: Fairview Fire incident map from CAL FIRE showing the fire footprint.

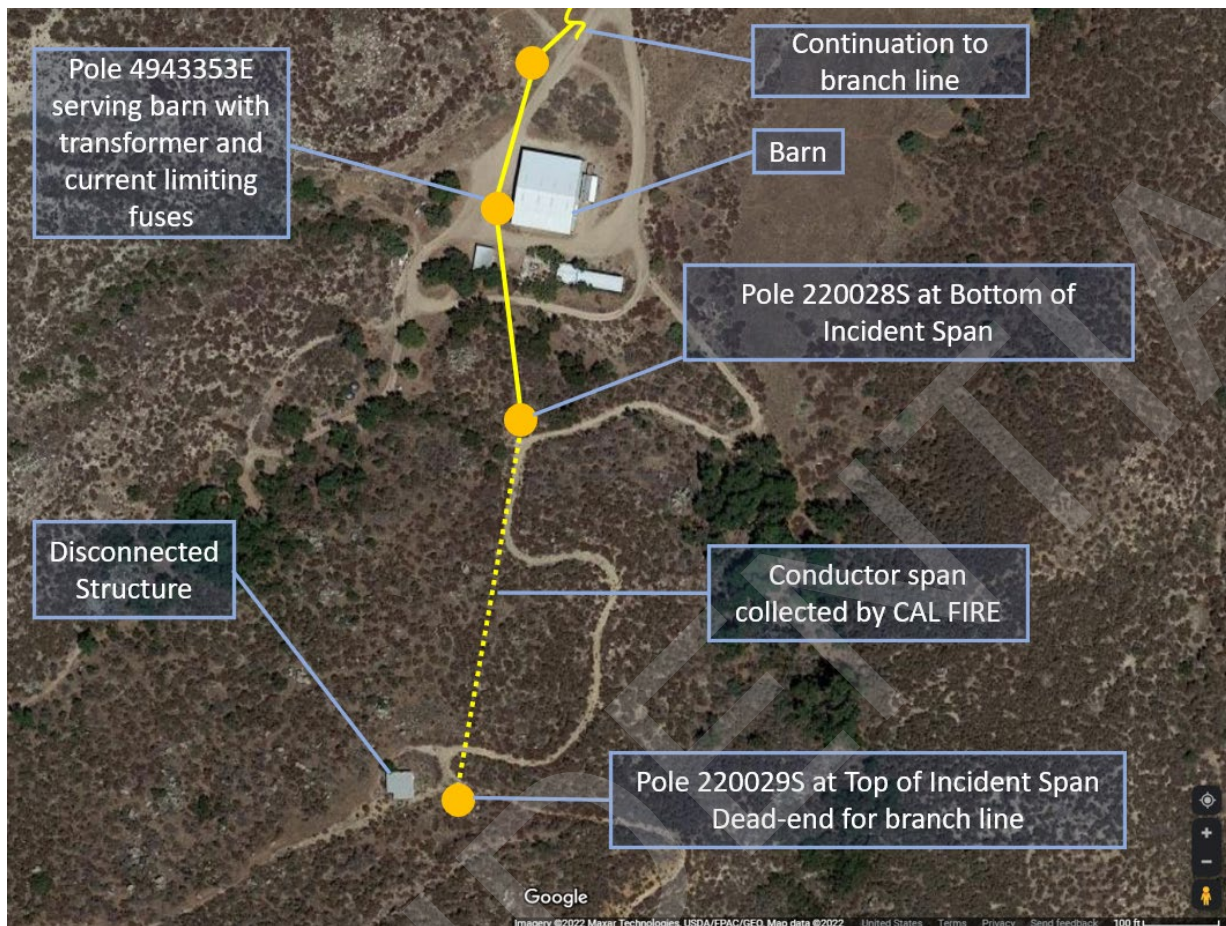
Figure 6: Detailed view of Incident Location.

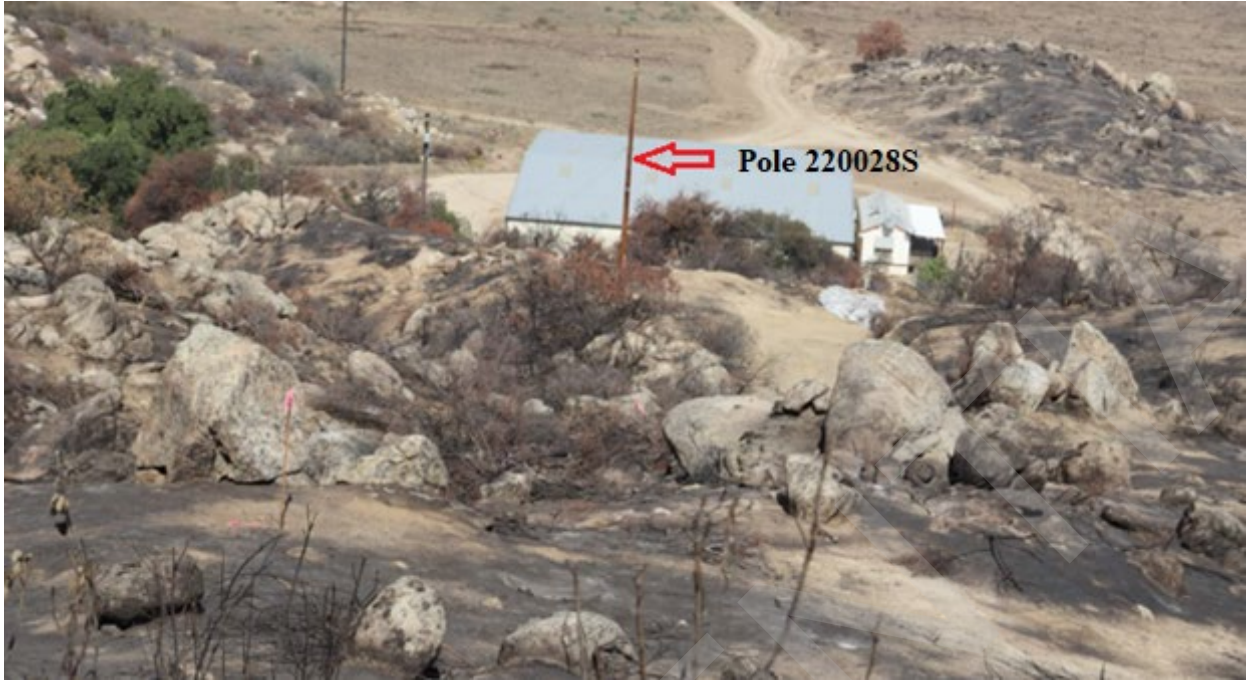
Figure 7: View of Incident Span between Incident Pole 220029S at the top of hill (behind the camera) and Pole 220028S (brown pole in front of barn).

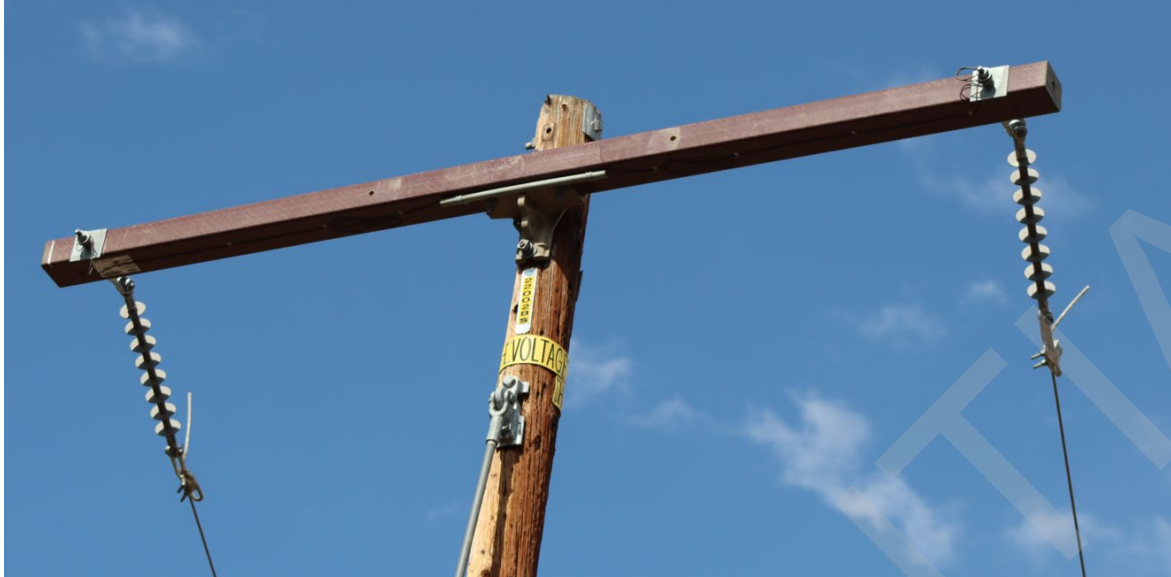
Figure 9: Close up view of Pole 220028S at the bottom of the Incident Span with conductor lines and communication lines collected by CAL FIRE.

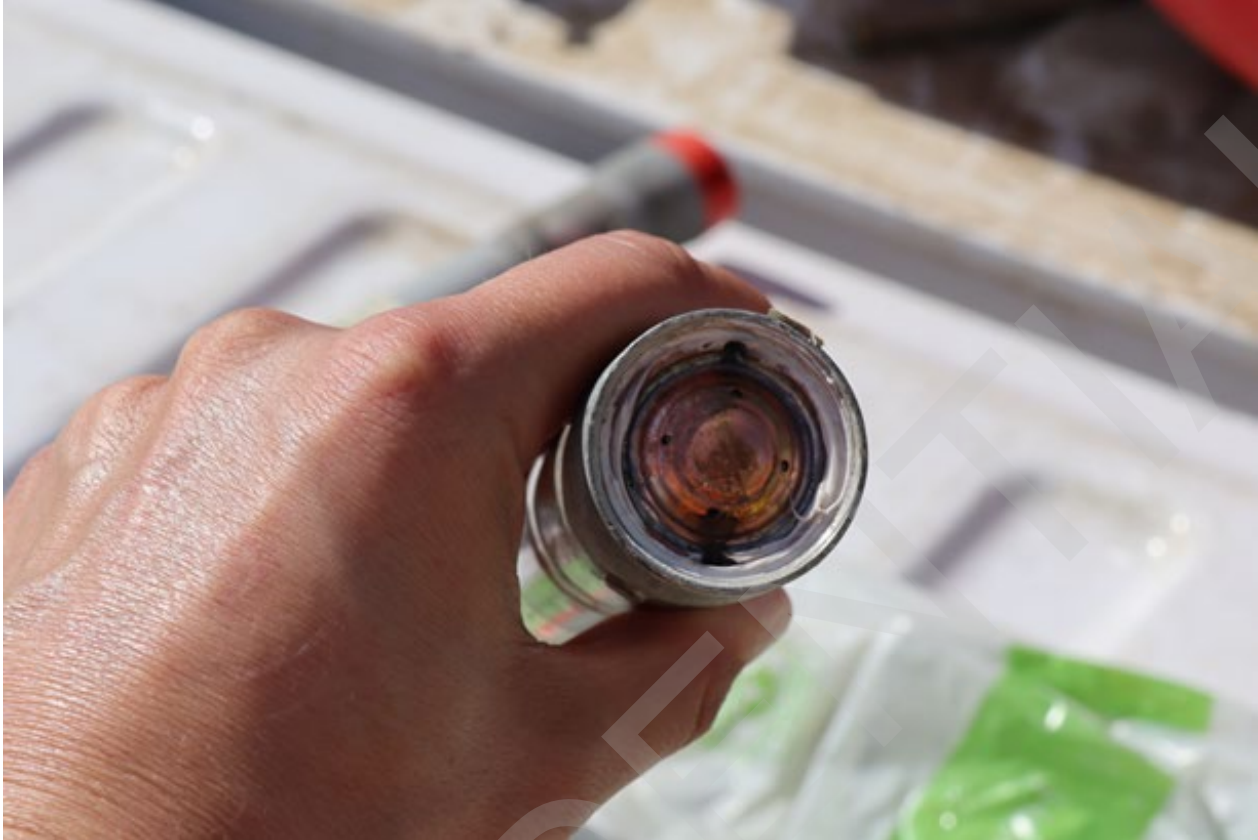
Figure 11: The East phase fuse is missing the red cap, indicating that the fuse activated and opened the circuit.

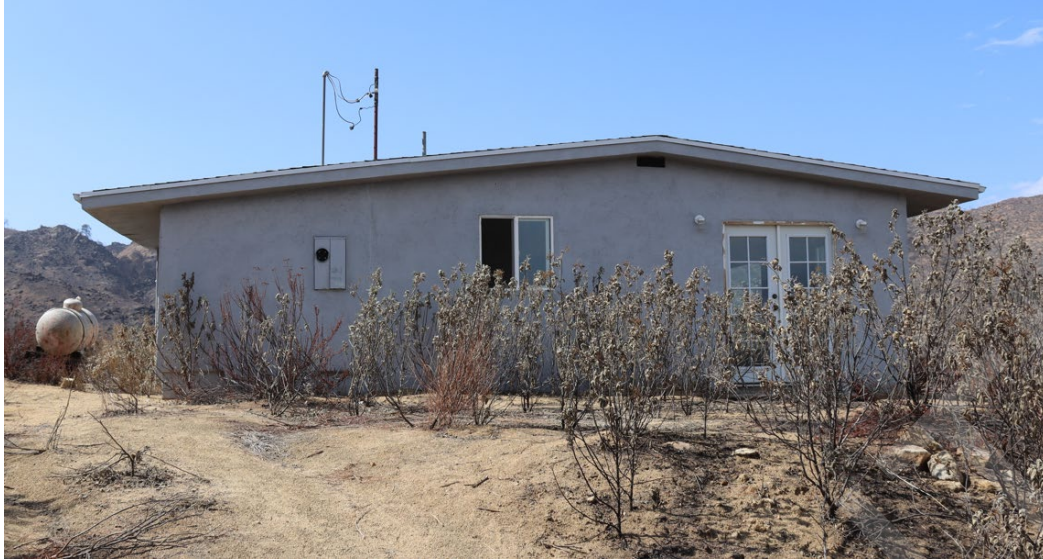
Figure 12: Unoccupied structure on the top of the hill, which was unconnected to the dead-end Incident Pole 220029S.

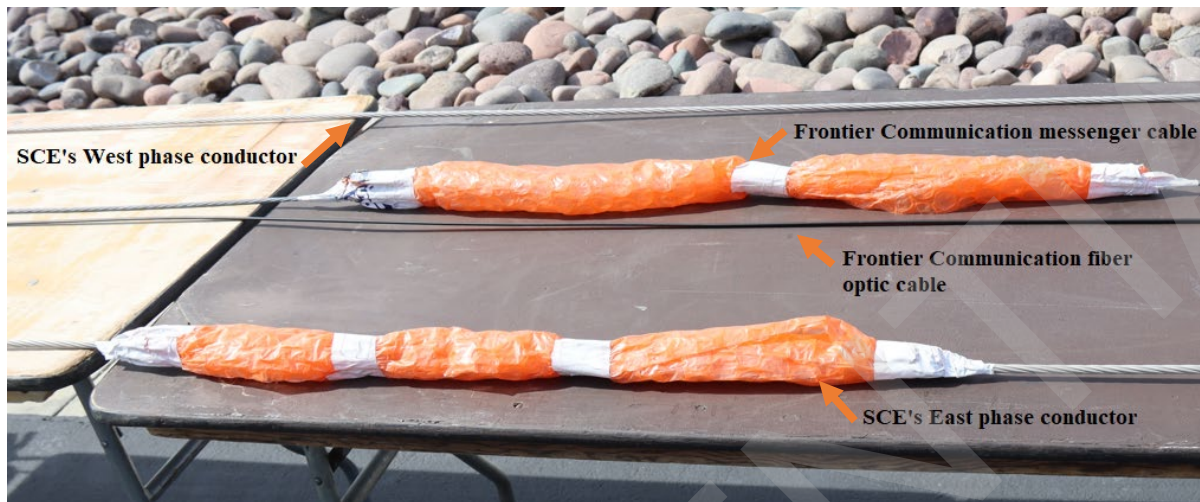
Figure 16: SCE's East and West phase conductors and Frontier Communications' fiber optic cable and messenger cable.

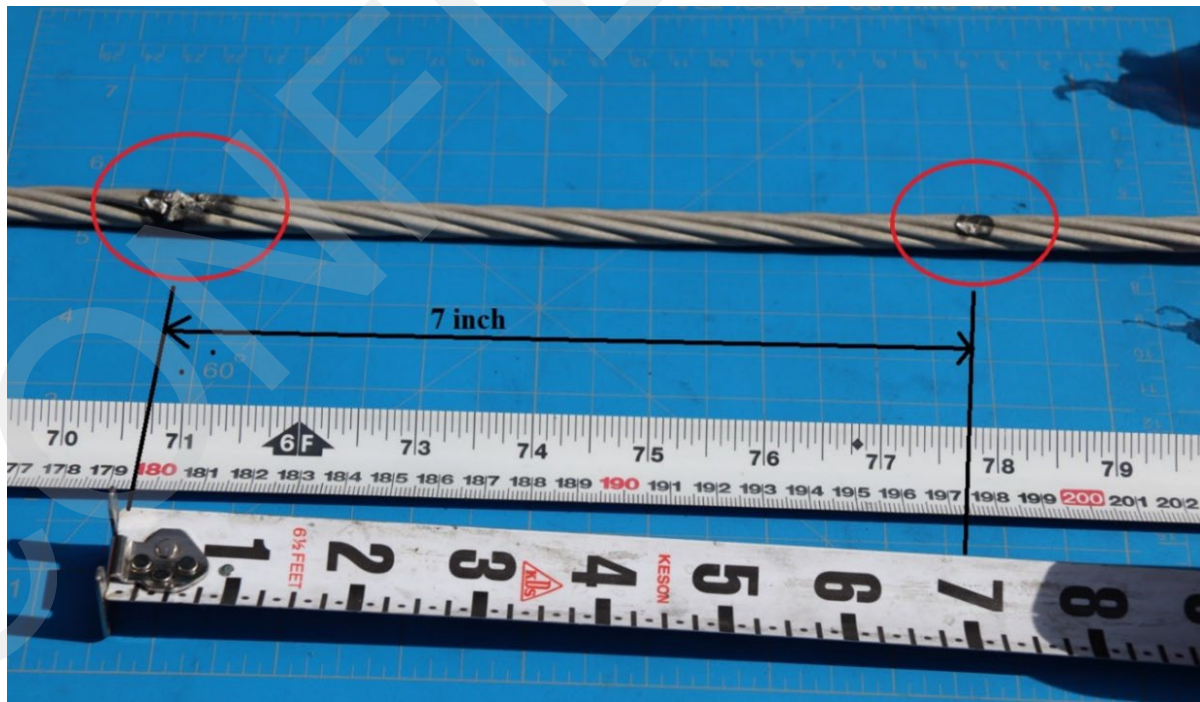
Figure 17: SCE's East phase conductor with two scorch marks.

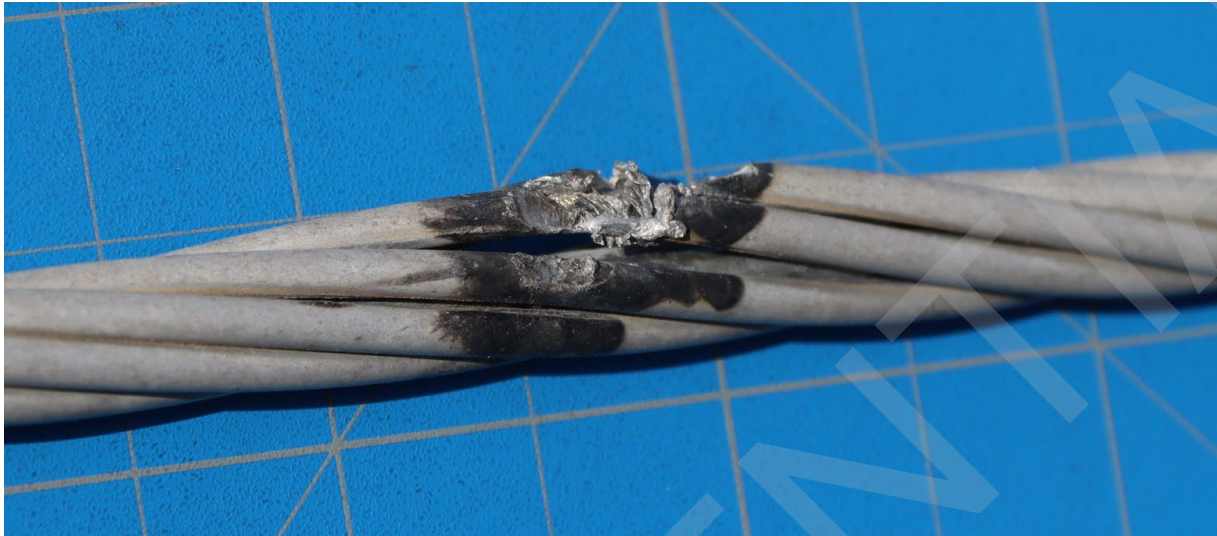
Figure 18: Detailed view of one of the scorch marks on SCE's East phase conductor showing missing metal.

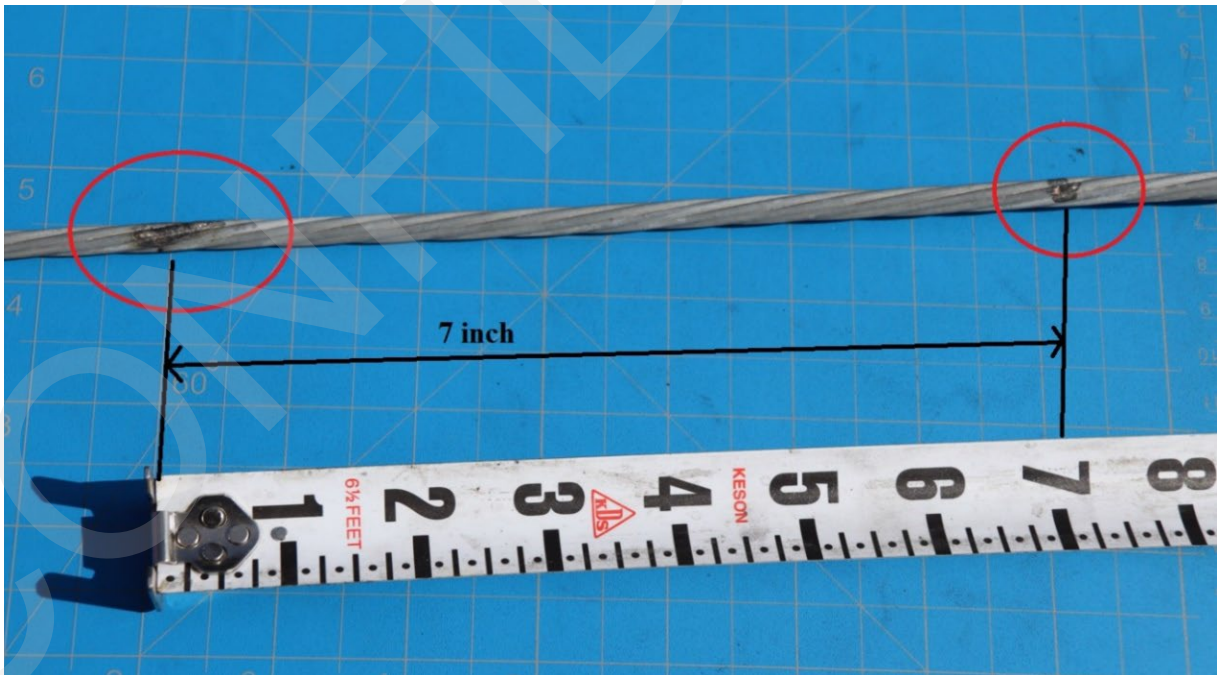
Figure 19: Frontier Communications' messenger cable exhibiting two distinct scorch marks.

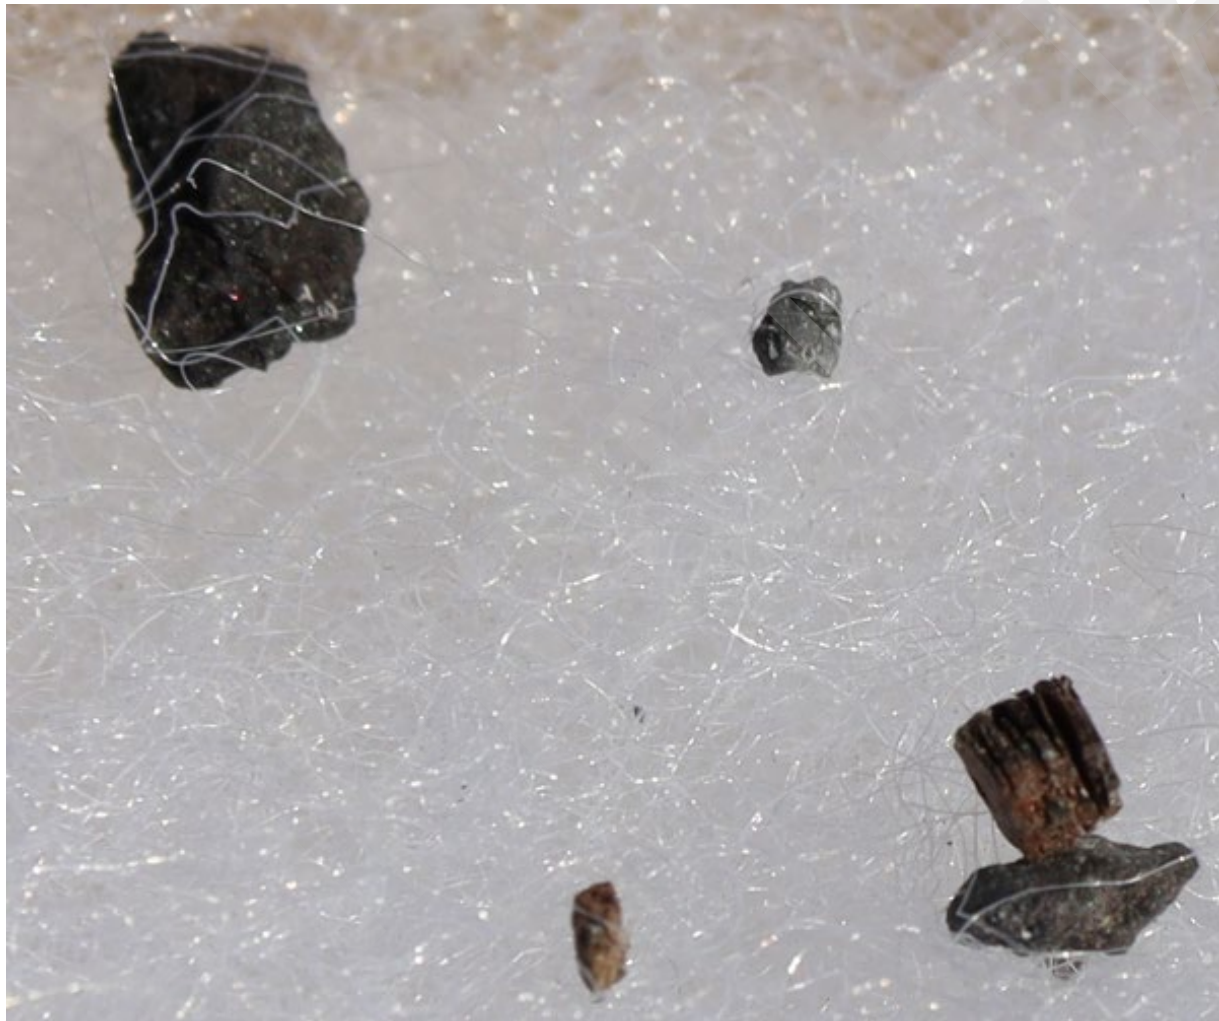
Figure 20: Miscellaneous metal pieces/fragments recovered by CAL FIRE at the Incident Location.

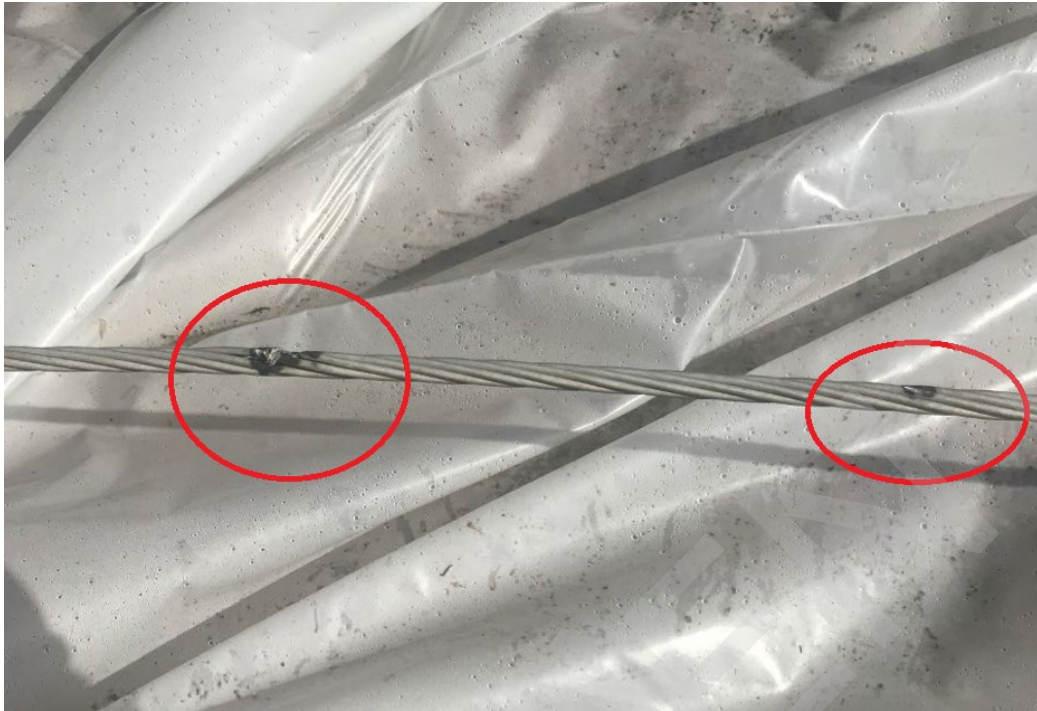
Figure 21: SCE provided a photo of the phase 1B conductor showing damaged areas.

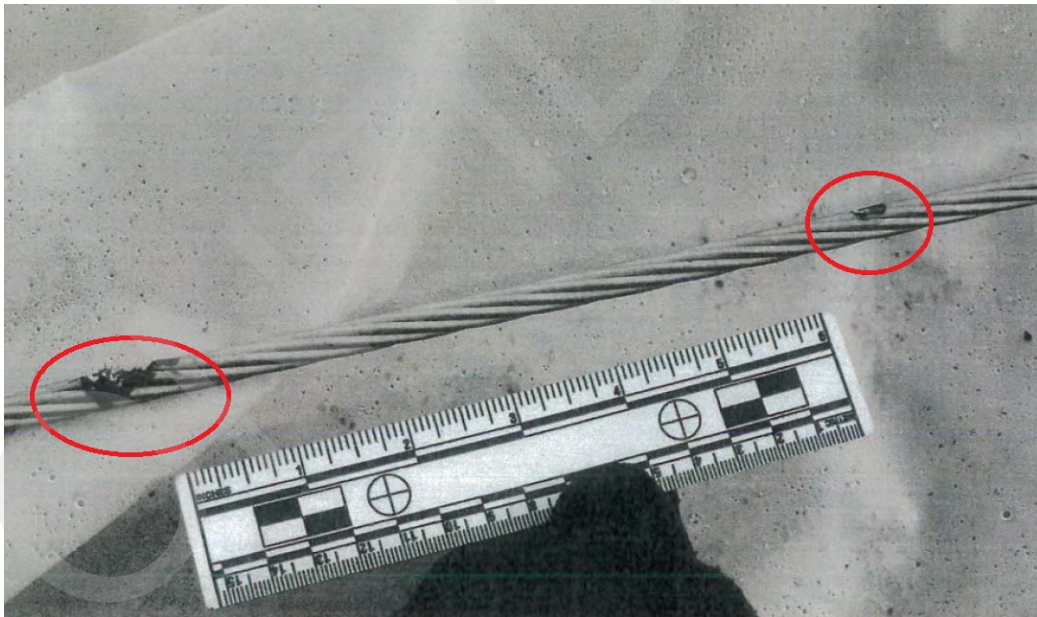
Figure 22: CAL FIRE's photo of SCE's phase 1B conductor showing damaged areas.<sup>40</sup>

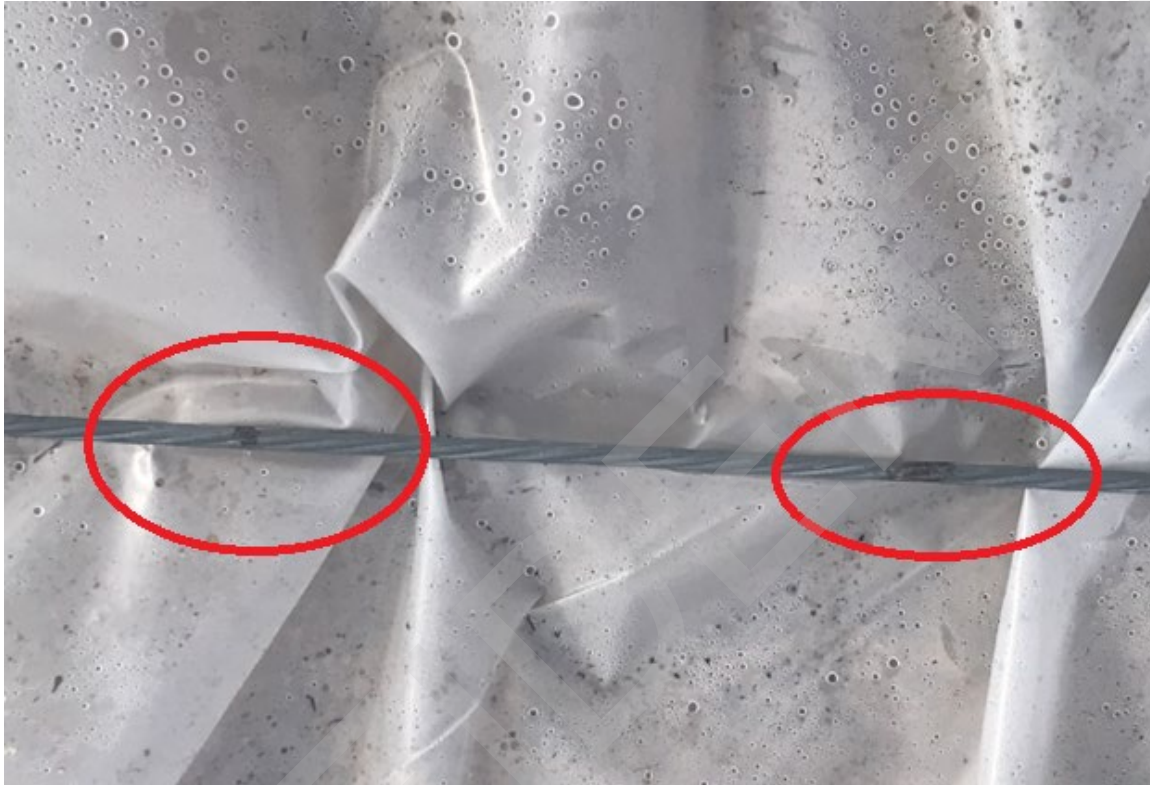
Figure 23: SCE provided a photo of the Frontier Communications messenger cable showing damage.<sup>41</sup>

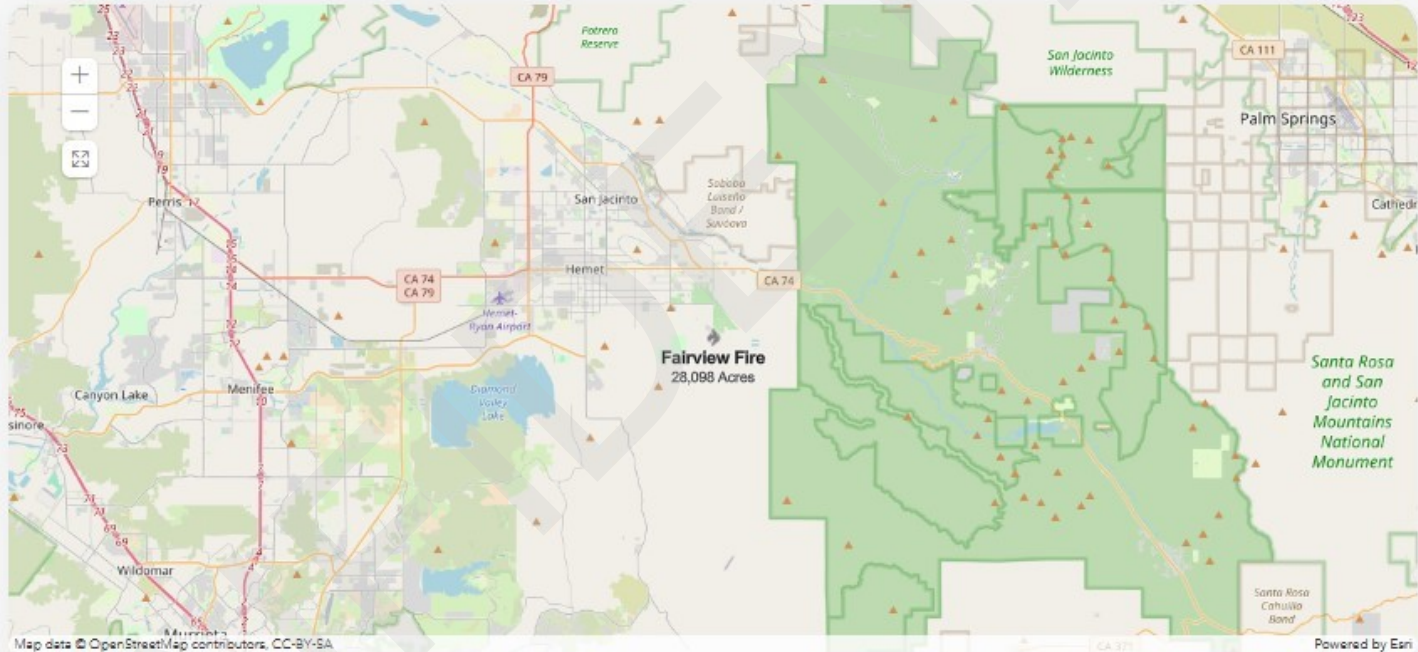
<p><b>Last Updated</b> 06/14/2023 8:58 AM</p>	<p><b>Date Started</b> 09/05/2022 4:00 PM</p>	<p><b>Location Information</b> Fairview Avenue and Bautista Canyon Road, near Hemet</p>
<p><b>Latitude / Longitude</b> [33.717062,-116.893227]</p>	<p><b>Admin Unit</b> Lead Agency: USFS - San Bernardino National Forest</p>	<p><b>Cause</b> Under Investigation</p>
<p><b>External Incident Link</b> <a href="https://inciweb.nwccg.gov/incident-information/cabdf-fairview">https://inciweb.nwccg.gov/incident-information/cabdf-fairview</a></p>	<p><b>Reports</b> <a href="#">Prior status reports</a></p>

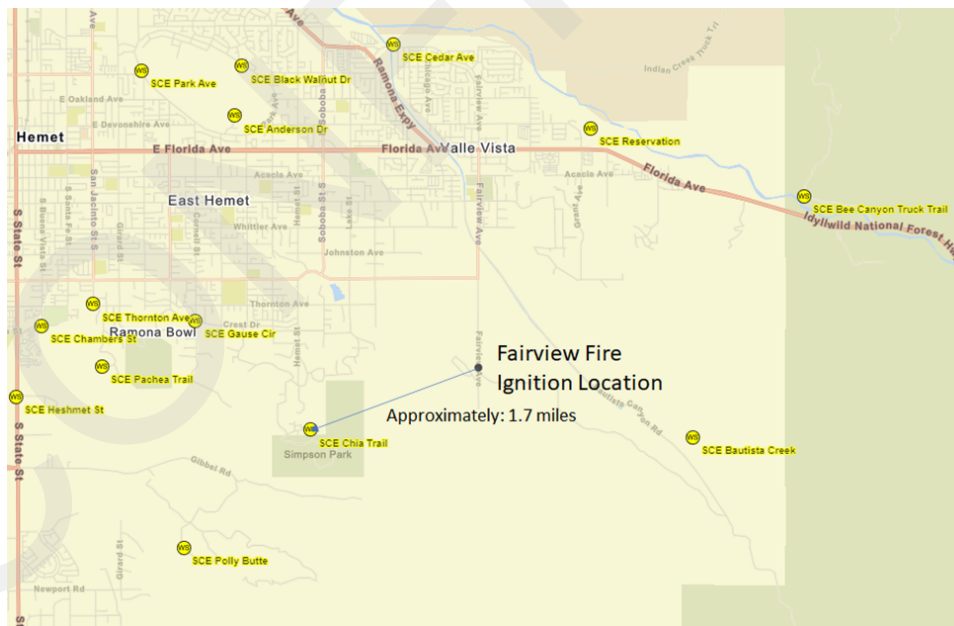
The weather conditions reported by SCE Chia Trail for the time indicated on September 5, 2022 are provided below.

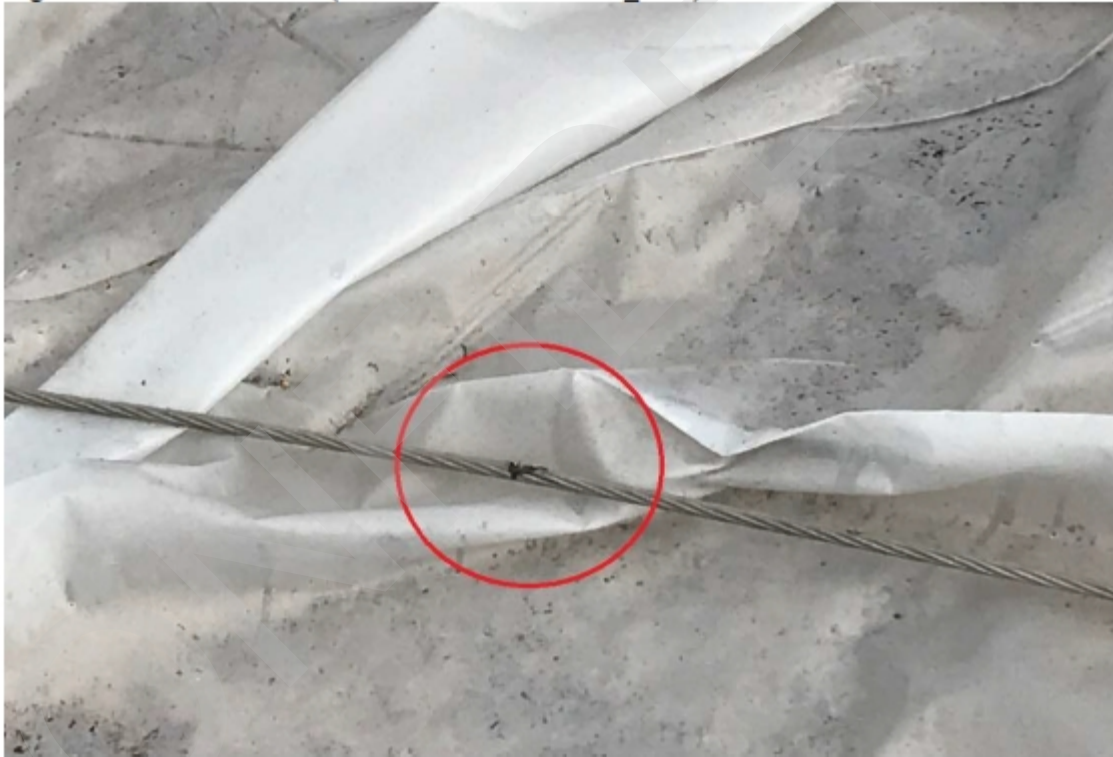
**Response to Question 16:**
