**State of California
Public Utilities Commission**

**Investigation Report
on
PG&E Mission Substation Fire and Outage**

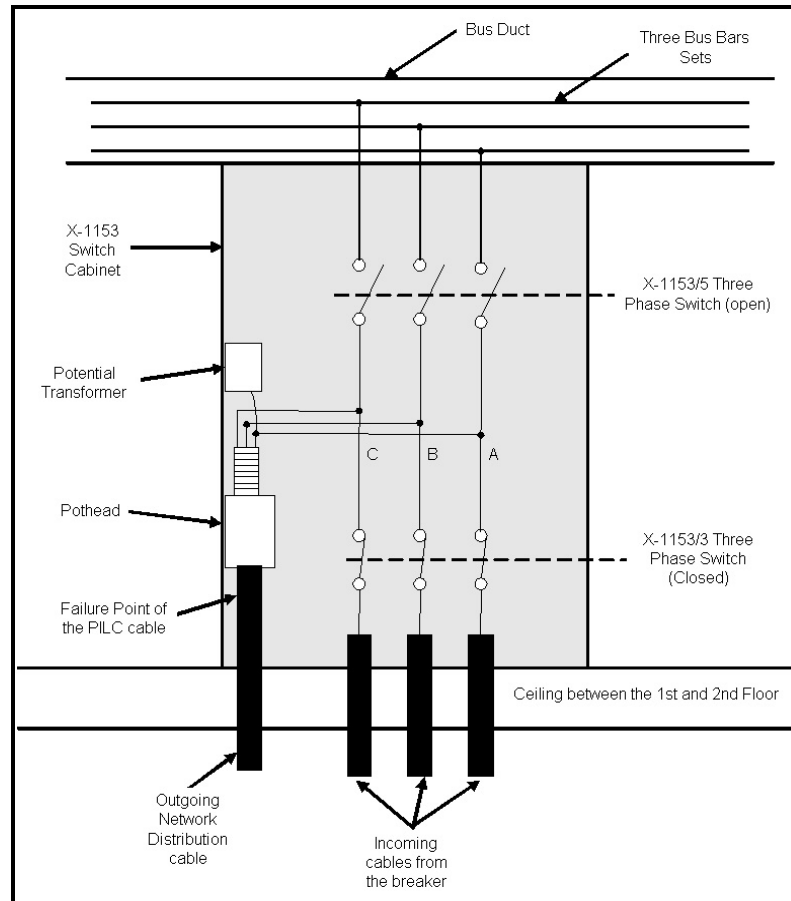
Figure III-3. The X-1153 switch cabinet with the N bus located on top

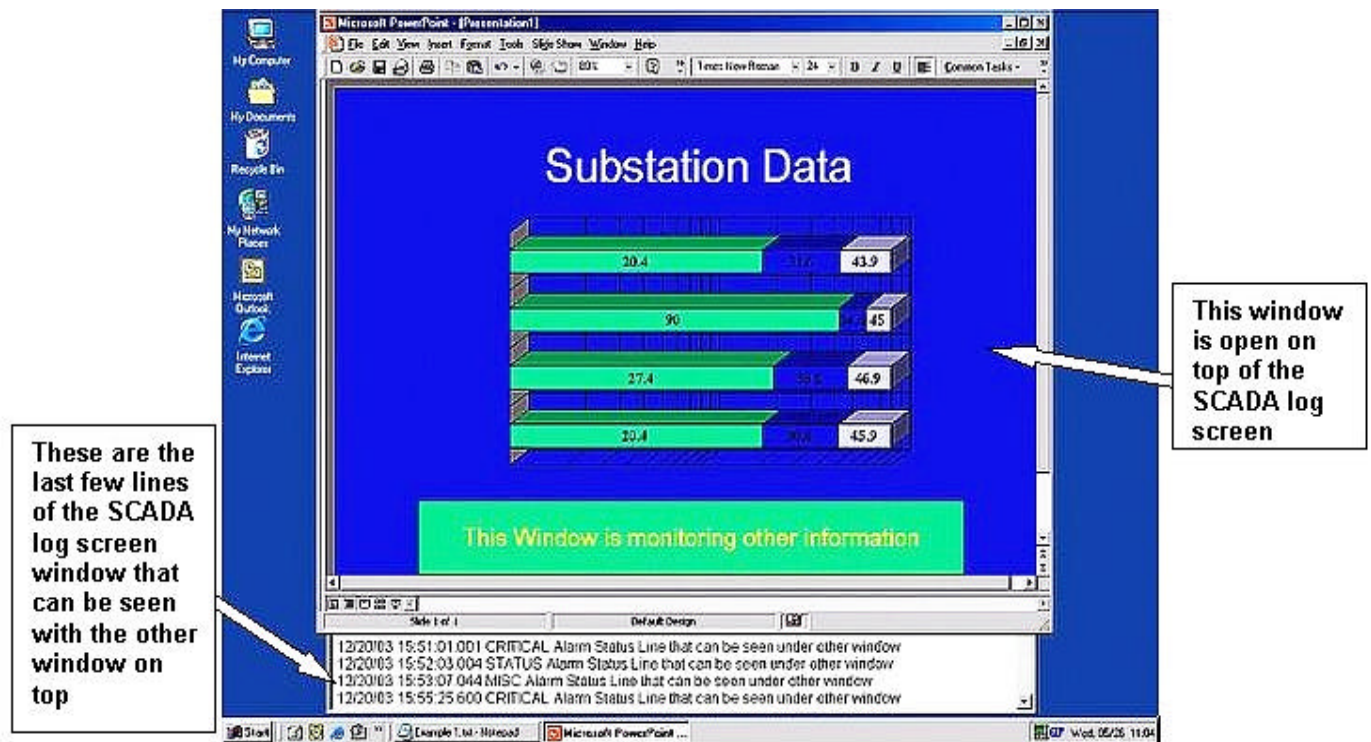
Figure III-5.⁶ SCADA Screen Display

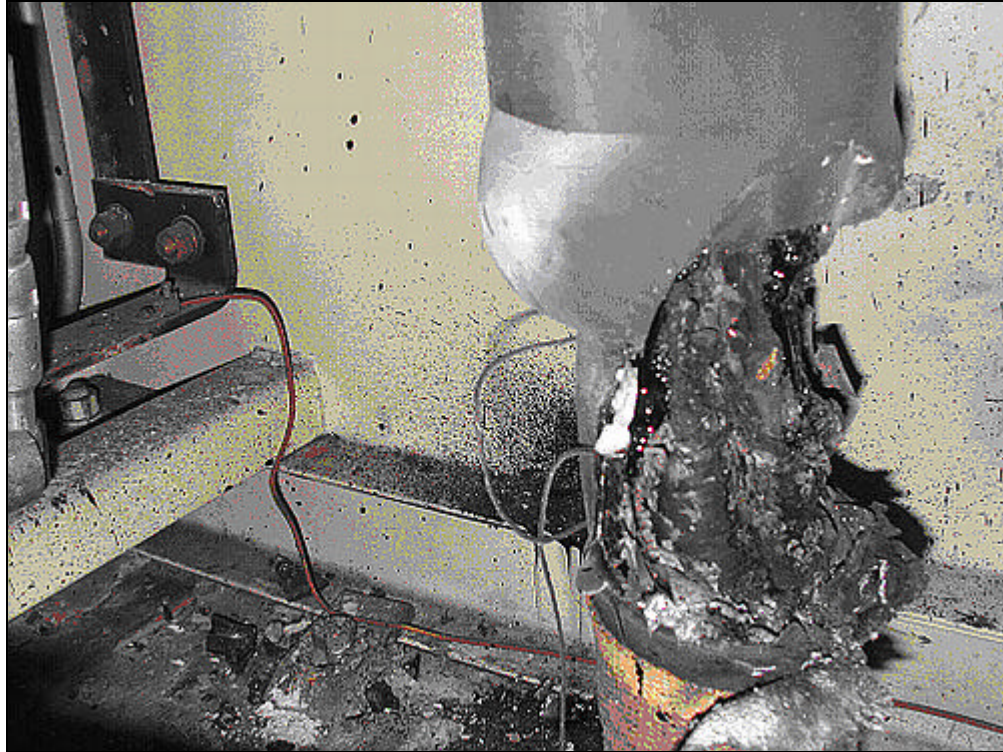
Figure XII-1. Damaged X-1153 cable

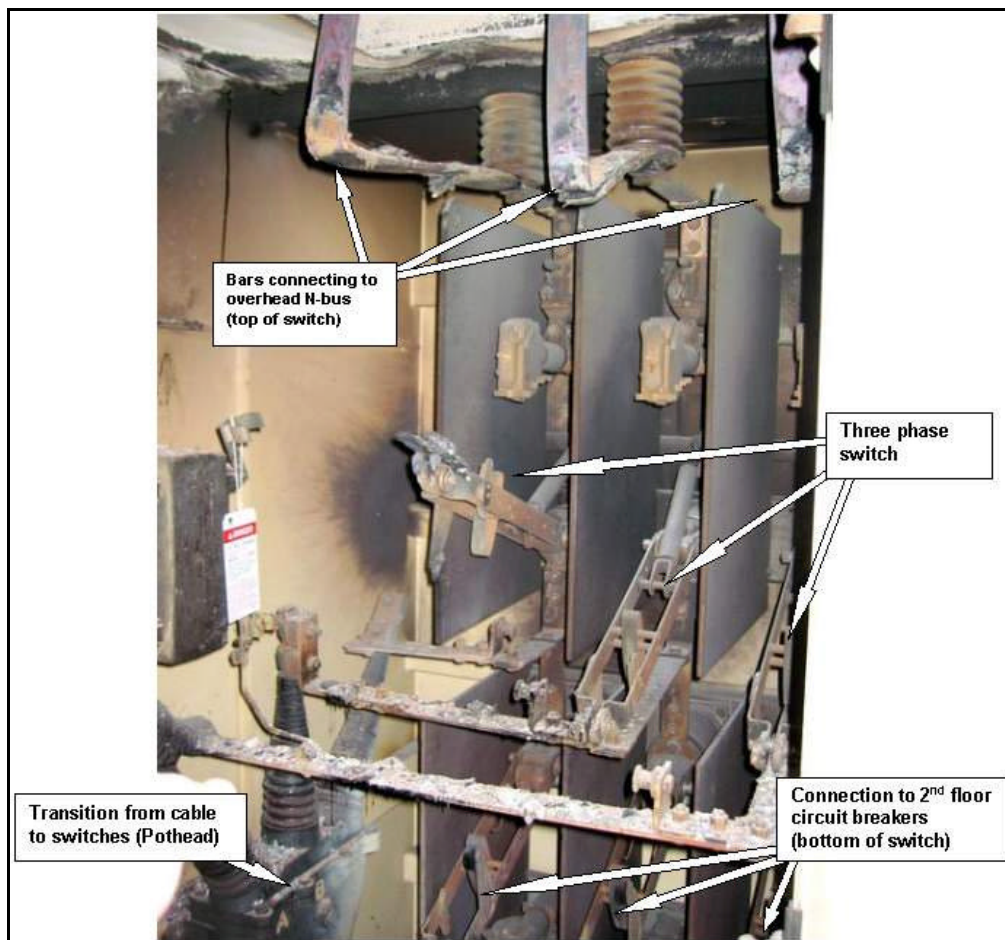
14
15
16 **Figure XII-2. Damaged X-1153 cubicle**

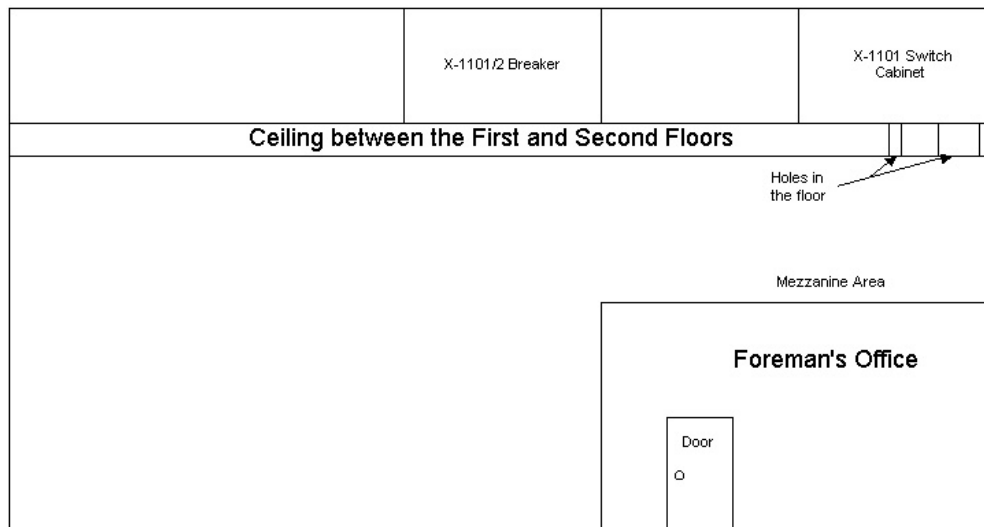
Figure XII-3. Cross section of substation underneath switch cubicle X-1101

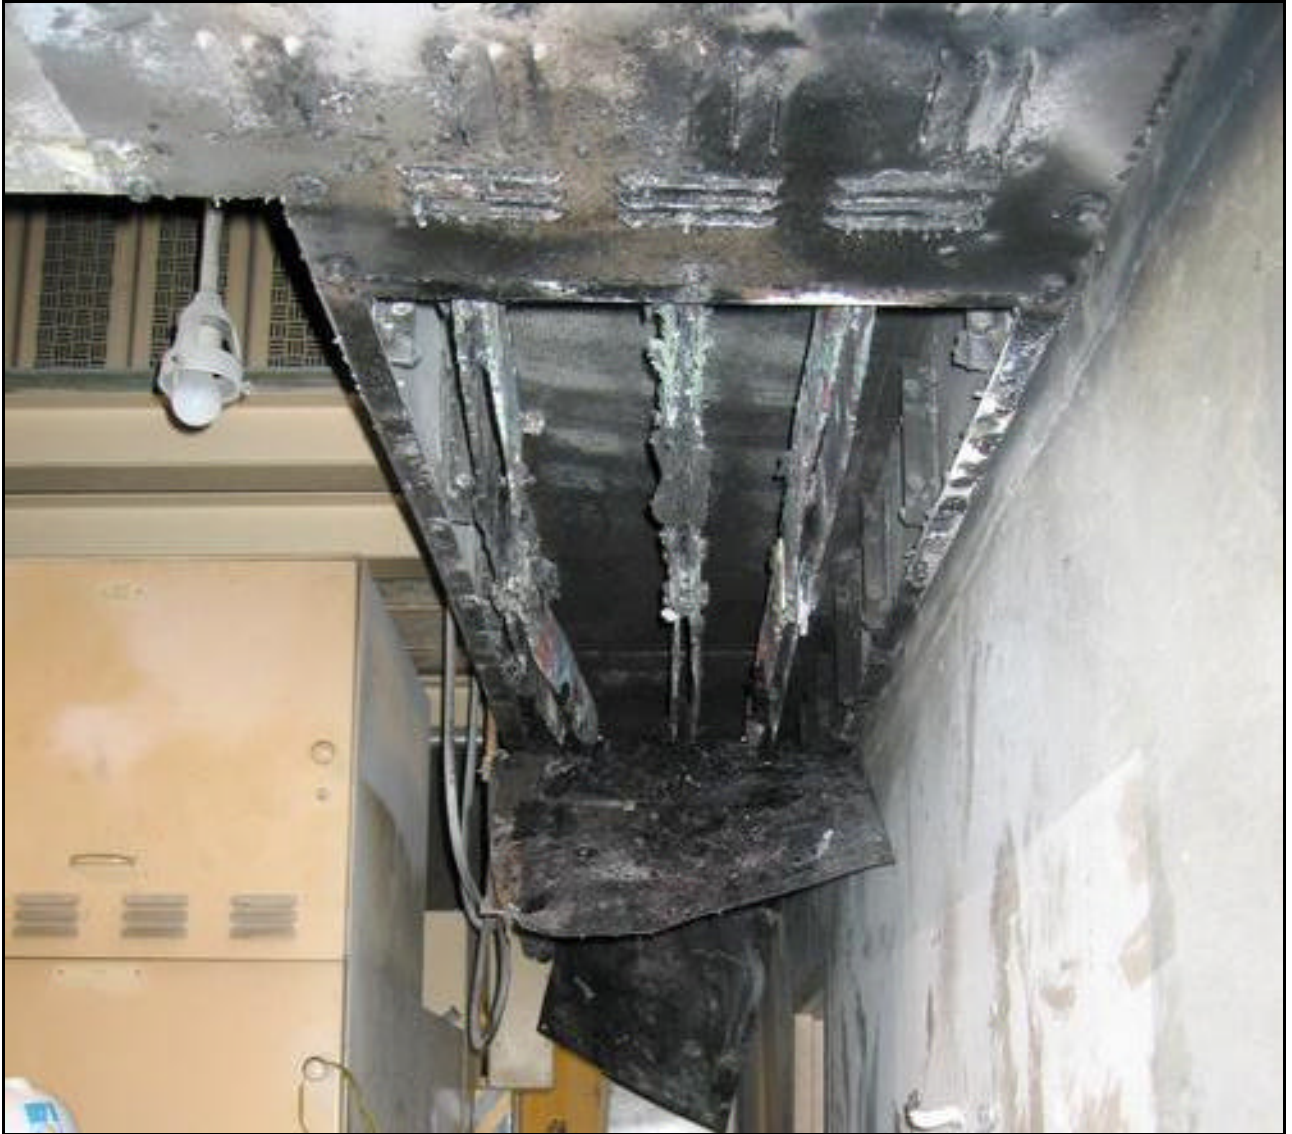
Figure XII-4. N-Bus fire damage

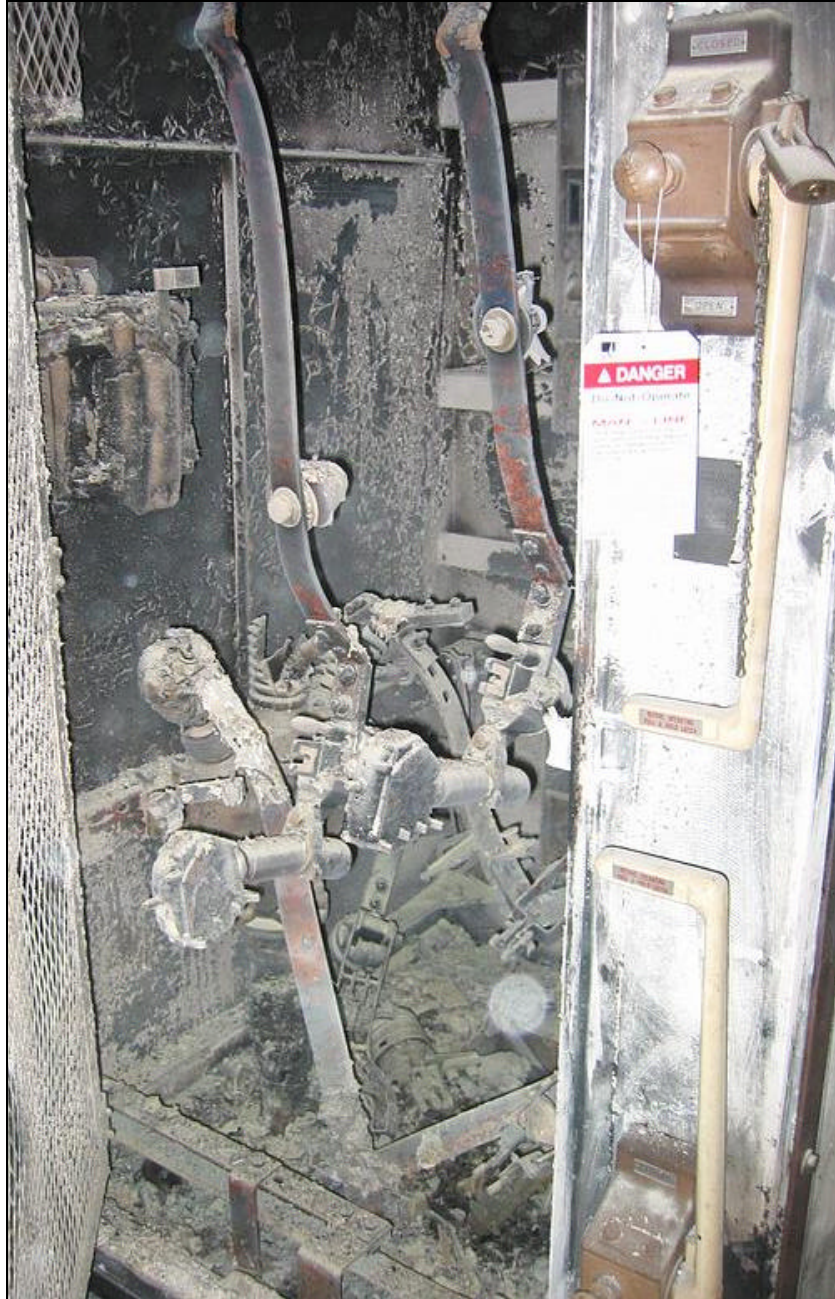
Figure XII-5. Fire damage X-1101 switch cubicle

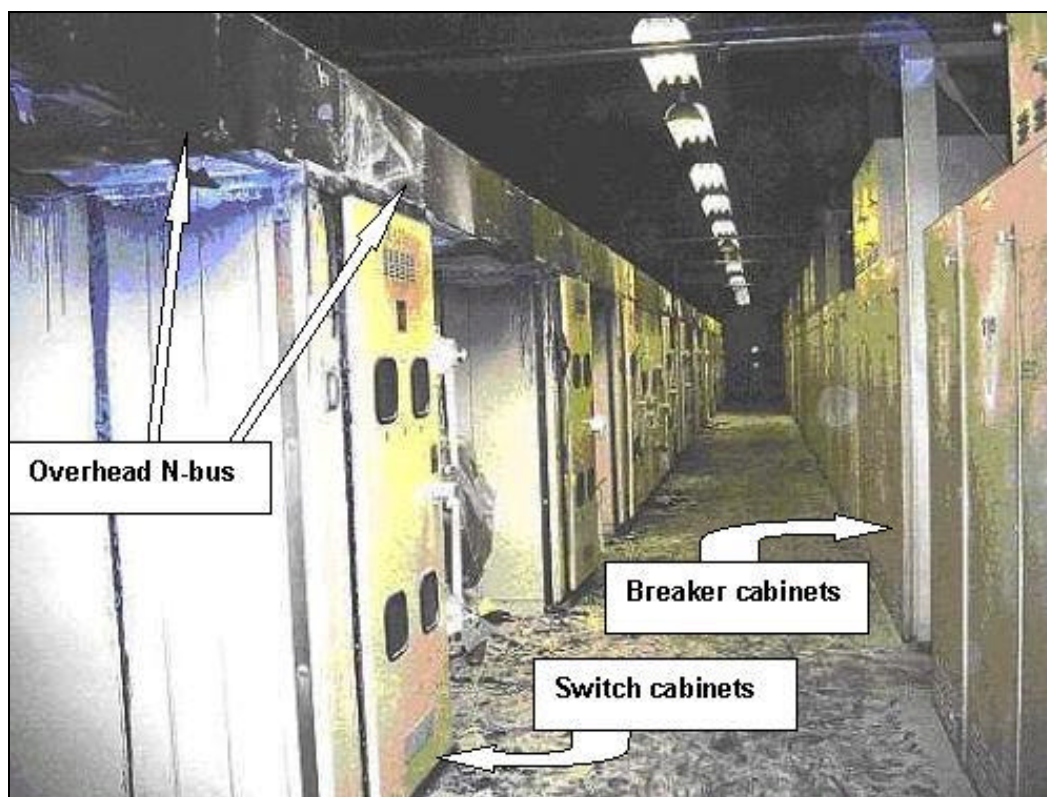
Figure XII-6. Soot and debris on second floor switch room
