BEFORE THE PUBLIC UTILITIES COMMISSION  
OF THE STATE OF CALIFORNIA

Application of Californians for Renewable  
Energy, Inc. (CARE) to modify Decision 06-  
07-027

Application 10-09-012  
(Filed September 20, 2010)

**Motion to provide supplemental information to CARE's Application 10-09-012**

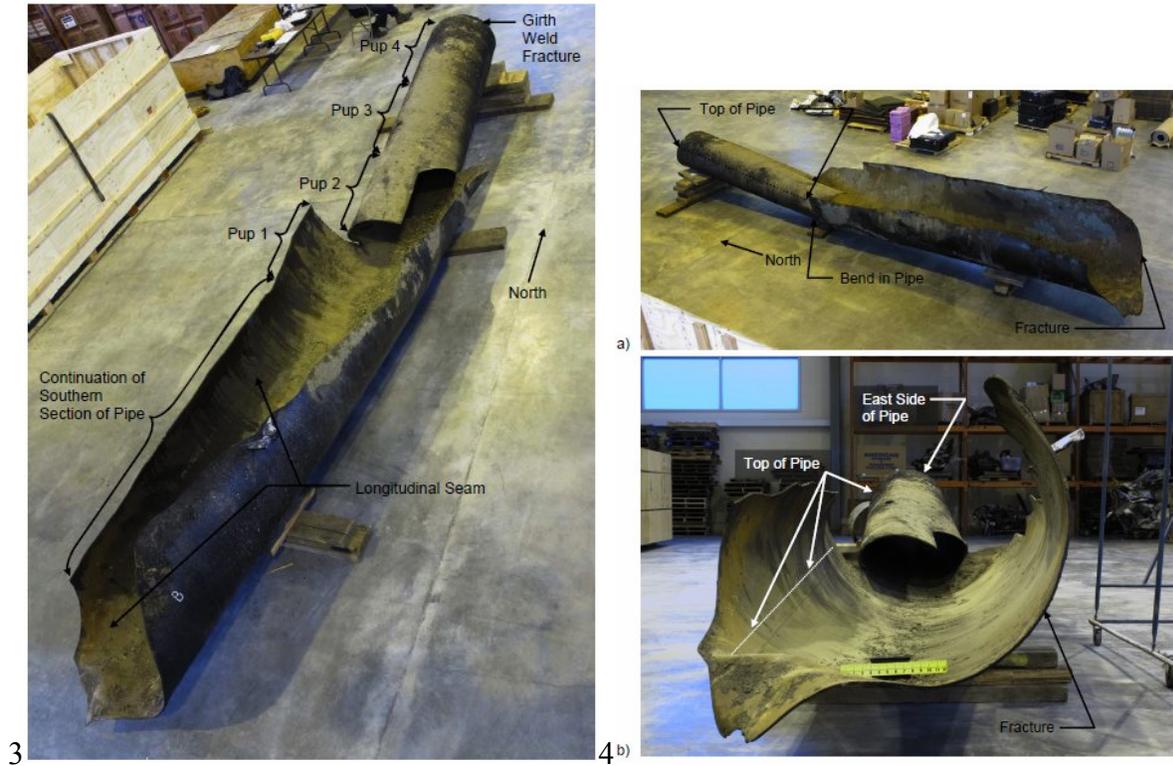
The NTSB report states “[t]he center section was 27 foot – 8 inch at its longest point and was comprised of the same long joint continuing from the southern section as well as four shorter lengths of pipe (pups) as shown in figures 3 and 4. For convenience the pups were numbered 1 through 6 in the south to north direction. The *circumferential*

welds (i.e. girth welds) that joined the pups were numbered sequentially from south to north as C1, C2, and so on through C7. The center section had *circumferential fractures* at both ends. One fracture was through the long joint to the south of pup 1 as shown in figure 4.”

Figure 3 and 4 shows that a huge force was necessary to blow this 28 foot section of the gas main out of its buried location in order to throw the pipe over a thousand feet

away from the ground where it was buried under asphalt and soil. Notice that this force was also sufficiently strong to bend the section of pipe by 10 degrees on both ends and to collapse the pipe's diameter in the center where the explosion appears to have occurred.

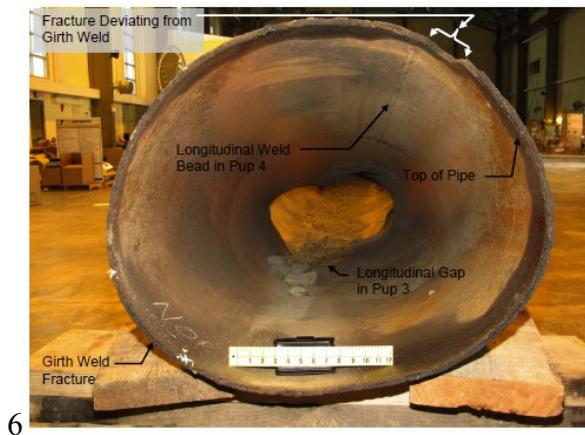
“The other fracture was at the girth weld between pup 4 and pup 5 (girth weld C5 in figure 1) as shown in figures 3 and 6. “

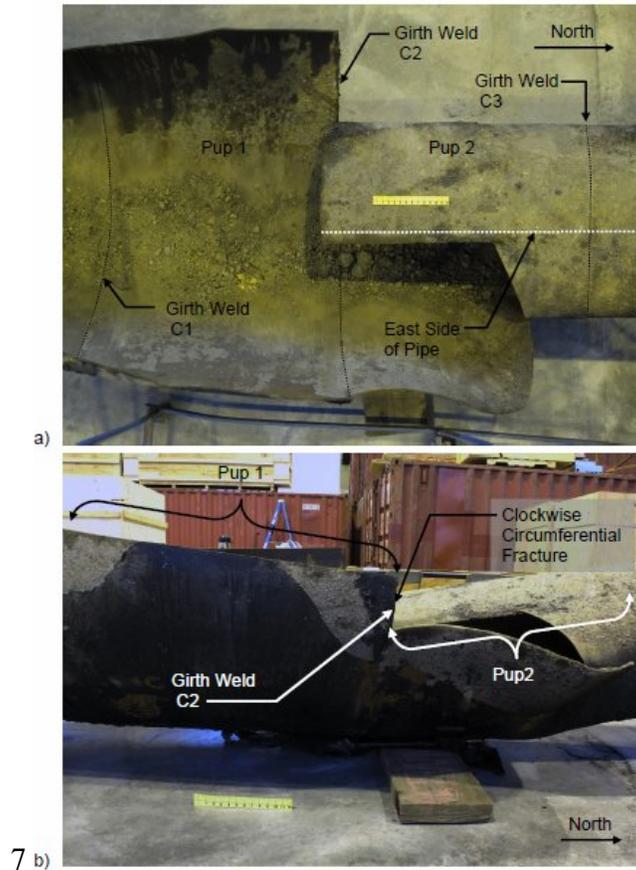
The NTSB report goes on to state “[t]here was a longitudinal fracture in pup 1 that continued in the long joint south of pup 1 to the *circumferential fracture* at the south end of the center section, visible in figure 3. There were *circumferential fractures* in girth weld C2 between pup 1 and pup 2 on both sides of the pup 1 longitudinal fracture as shown in figures 7a and b. In the counterclockwise direction, the *circumferential fracture measured 27 inch* (Note: Clockwise and counterclockwise directions are assigned as a rotation about the longitudinal axis of the pipeline looking north). At the end of the fracture there was a 10 inch diameter circular depression in the pipe. In the clockwise direction, the *circumferential fracture measured 6.25 inch, at which point it intersected with a longitudinal fracture in pup 2* as shown in figure 7b.”

“The longitudinal fracture in pup 2 extended 29.25 inch from girth weld C2 at which point it branched in two, visible in figure 7a and 7c. One branch continued in the

longitudinal direction to within 3 inch of girth weld C3 (Note: This was only visible after removal of the coating as shown in figure 7c). The other branch was angled 66° to the longitudinal direction and measured 18 inch. The *circumferential fracture* at the north end of the center section deviated from girth weld C5 along a 3.5 inch *circumferential* length up to 1 inch longitudinally in pup 4 at the location shown in figure 6.” The *circumferential fractures* appear near the top of the pipe section and show that fracture likely occurred after the initial fire below the line since there is little heat damage visible near the fractures themselves.

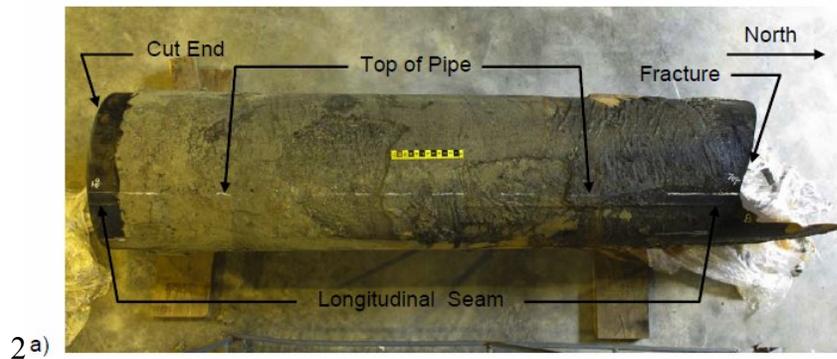
The presence of the fire below the gas main before the explosion blew the pipe out of the ground is demonstrated by the NTSB report where its states “[t]he appearance of the pipe coating was consistent with hot applied asphalt, parts of which had been exposed to elevated temperatures. Examples of the coating condition on the southern sections are shown in figures 2 and 11.”

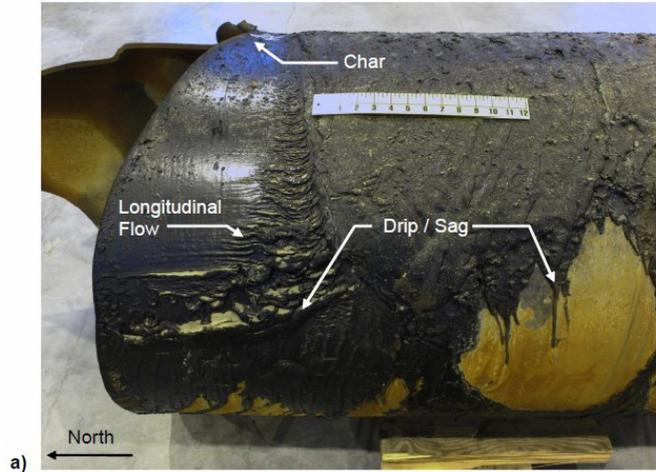
“No coating was observed on the bottom half of the pipe starting 3 foot – 4 inch from the cut end and continuing to the fractured end. The visible pipe surface was an orange color. The coating on the top half of the pipe close to the fracture exhibited features consistent with drips, sags, and charring as shown in figure 11a.”

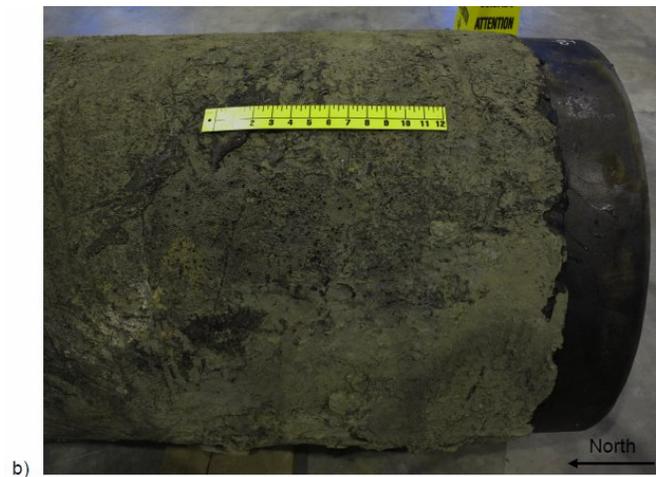
“The coating flow patterns were complex with longitudinal and circumferential flow occurring in different regions. Close to the cut end, the coating features were more consistent with as-applied asphalt as shown in figure 11b.”

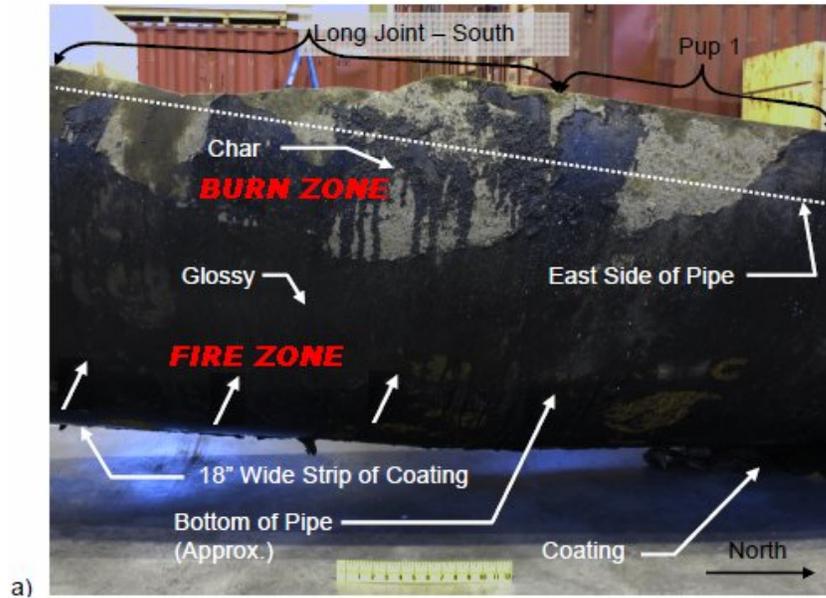
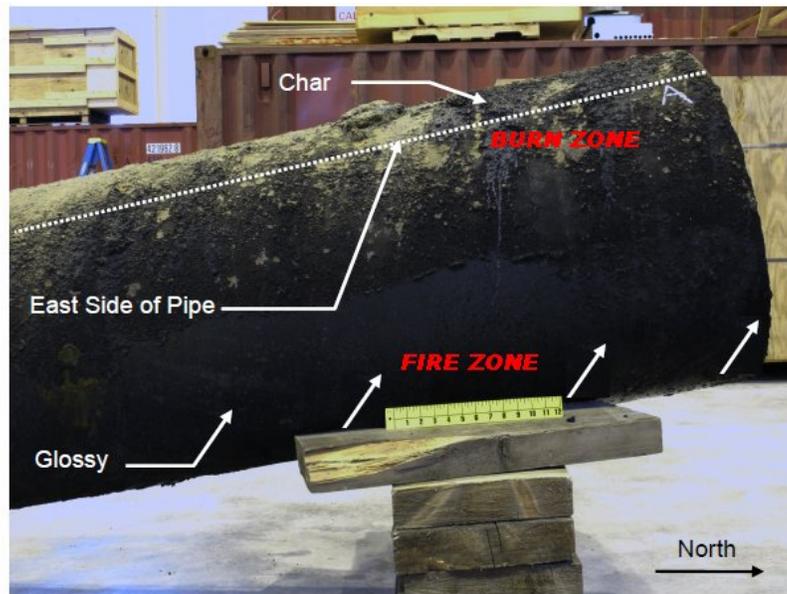
a)

*“The coating on the top and sides of the center section (in its resting position and not as installed) had either a charred or glossy appearance in various locations as shown in figure 13. In some locations, the coating appeared to be comingled with soil. On the underside of the pipe (in its resting position) between pup 1 and pup 2 there was a partially attached piece of coating approximately 32 inch in length, the start of which is indicated by an arrow in figure 13a. There was also an approximately 18 inch wide strip of coating attached to the underside running from pup 1 and continuing south to within 6 foot of the southern fracture, the start of which is also indicated in figure 13a. “*

The Figure 13 “Glossy” or “Char” regions of the exploded center section demonstrate the fire zone started at the bottom of the pipe since the heat was applied for a long enough period in the “fire zone” to make the tar coating on the bottom portion of the pipe melt and the upper portion to burn since the heat is greatest at the top of the flaming area where there is sufficient temperature and oxygen for the tar to combust leaving a carbon ash residue [noted as the “burn zone” in red text]. The Char area also demonstrates that the fire lasted a significant amount of time [several minutes] before the explosion occurred.

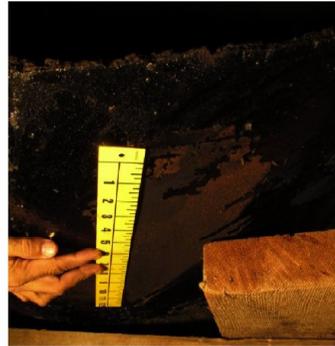
14 a)

Finally according to the NTSB report “[t]here were also regions on the underside where no coating was observed and the pipe surface was visible. One region on pup 4 near the girth weld fracture is shown in figure 14a. The region was approximately 12.5 inch at its longest and 6 inch at its widest. The visible pipe surface had an orange/brown appearance.”

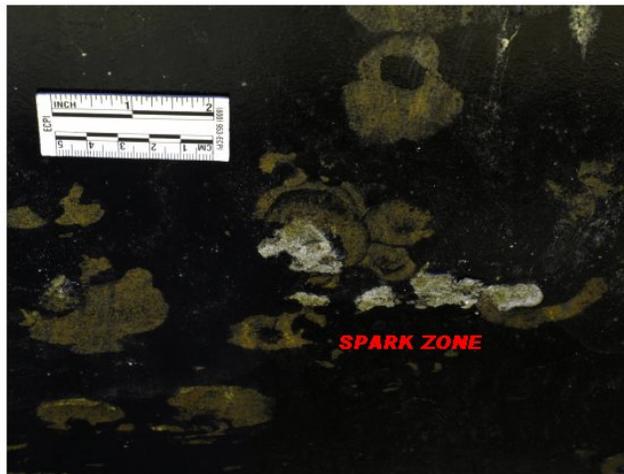
“A second region from the underside of the long joint south of pup 1 is shown in figure 14b.”

“No coating was observed over a cluster of small patches each approximately 2 inch in diameter. The visible pipe surface had an orange/brown appearance. Similar areas of no coating were observed on the undersides of pups 1, 2, and 3.”

In Figure 14 b) you can observe newly exposed uncoated metal, that due to the lack of oxidation of the metal exposed [marked in red text as “spark zone”], would have had a lower electrical resistance to electrical arcing than the surrounding oxidized uncoated regions of the underside of the pipe where the explosion pressure was sufficient to throw the pipe 1000 feet.
