Accident Investigation Final Report

San Francisco Bay Area Rapid Transit District
Train Collision with Two Roadway Workers

Between Walnut Creek and Pleasant Hill Stations

October 19, 2013

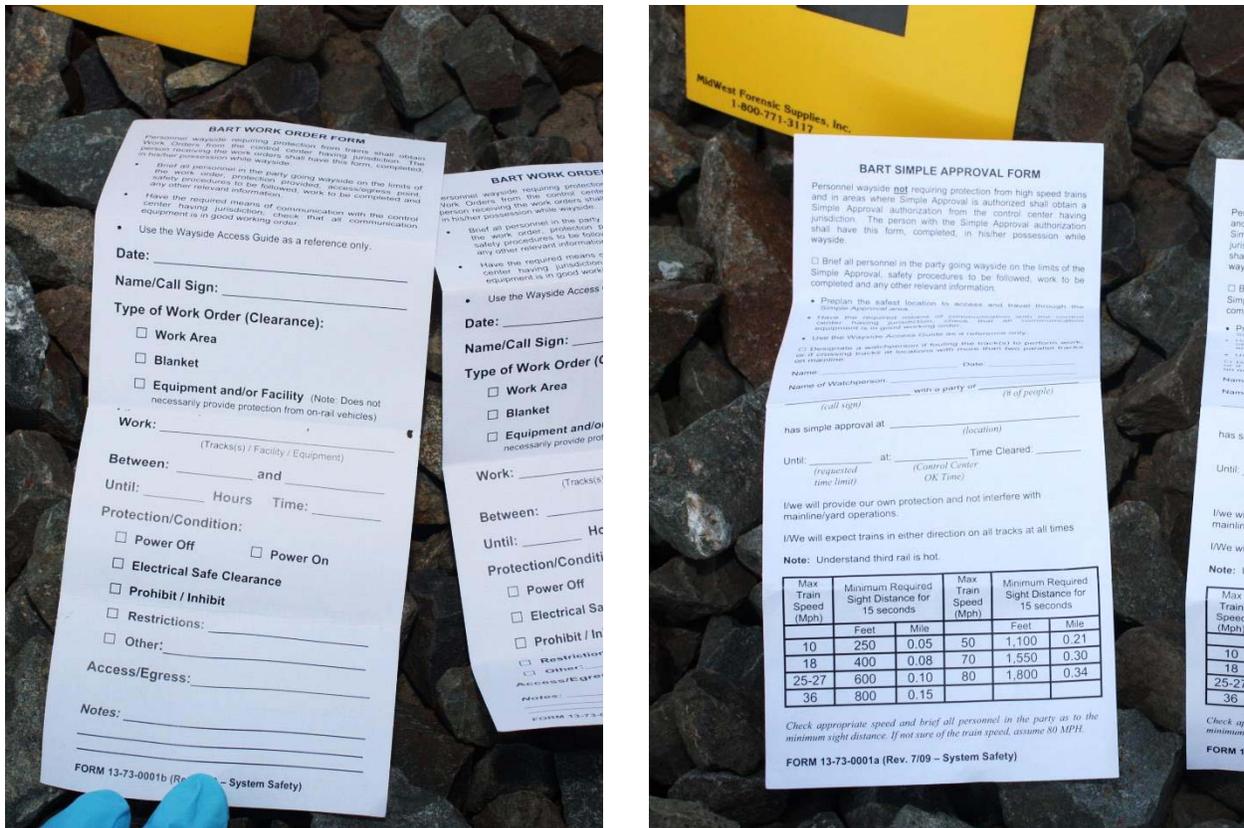
Figure 2 – Example Work Order/Simple Approval Forms Found at the Scene of the Accident

“Provide [their] own protection” as required by OR&P Manual, Rule 6215.F, but Track #80 included acknowledgement of the condition in their readback, per Rule 6215.G. In addition to the radio communication, the workers were required to complete a Simple Approval Form similar to the blank forms shown in Figure 2.

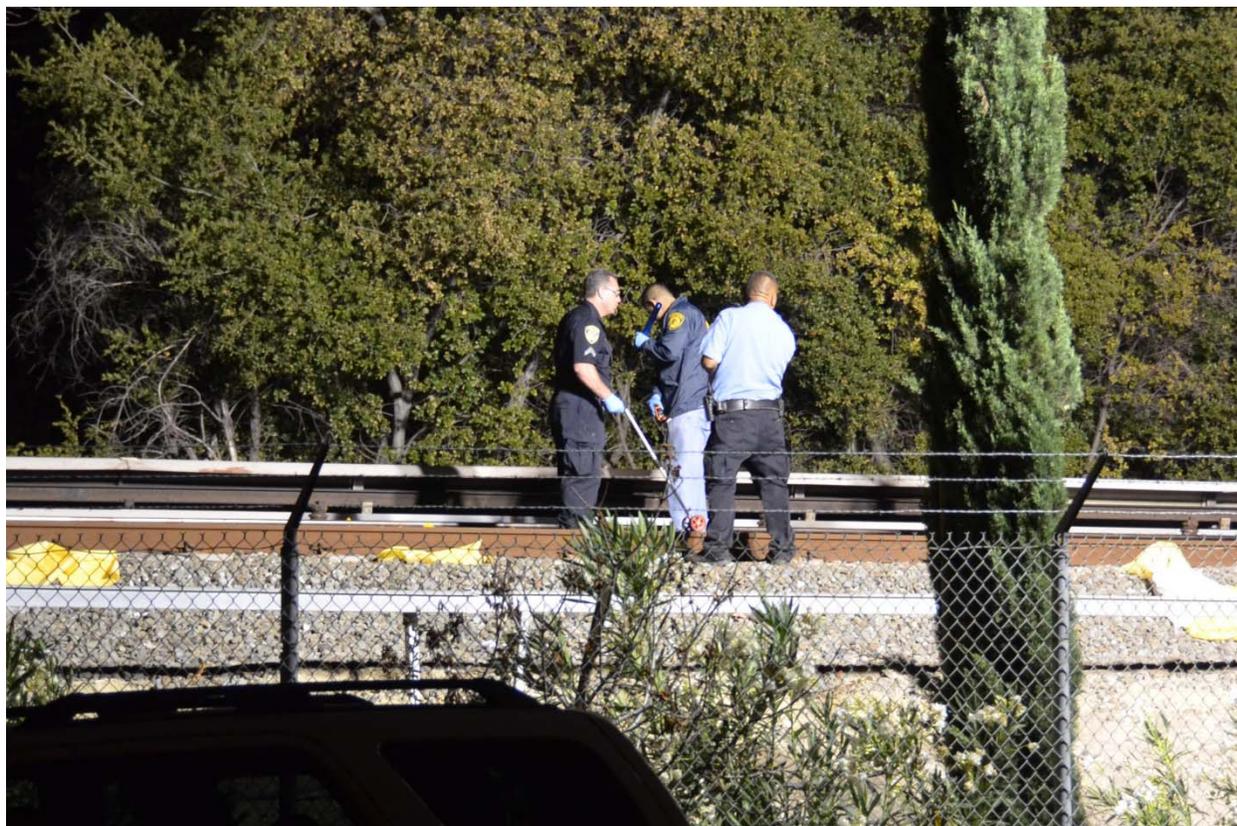
Figure 4 – BART Police Collecting Accident Site Measurements

BPD arrived at the site of the accident approximately 3 minutes after the collision and immediately setup as Incident Command. The two bodies were located and found to be unresponsive. CCCFD soon after and declared the bodies deceased, and, at approximately 13:59, took over Incident Command with BPD taking the role of Liaison. The Contra Costa County Coroner took custody and transported the two bodies off-site. At the time of this report's writing, the Coroner's report had not been released.

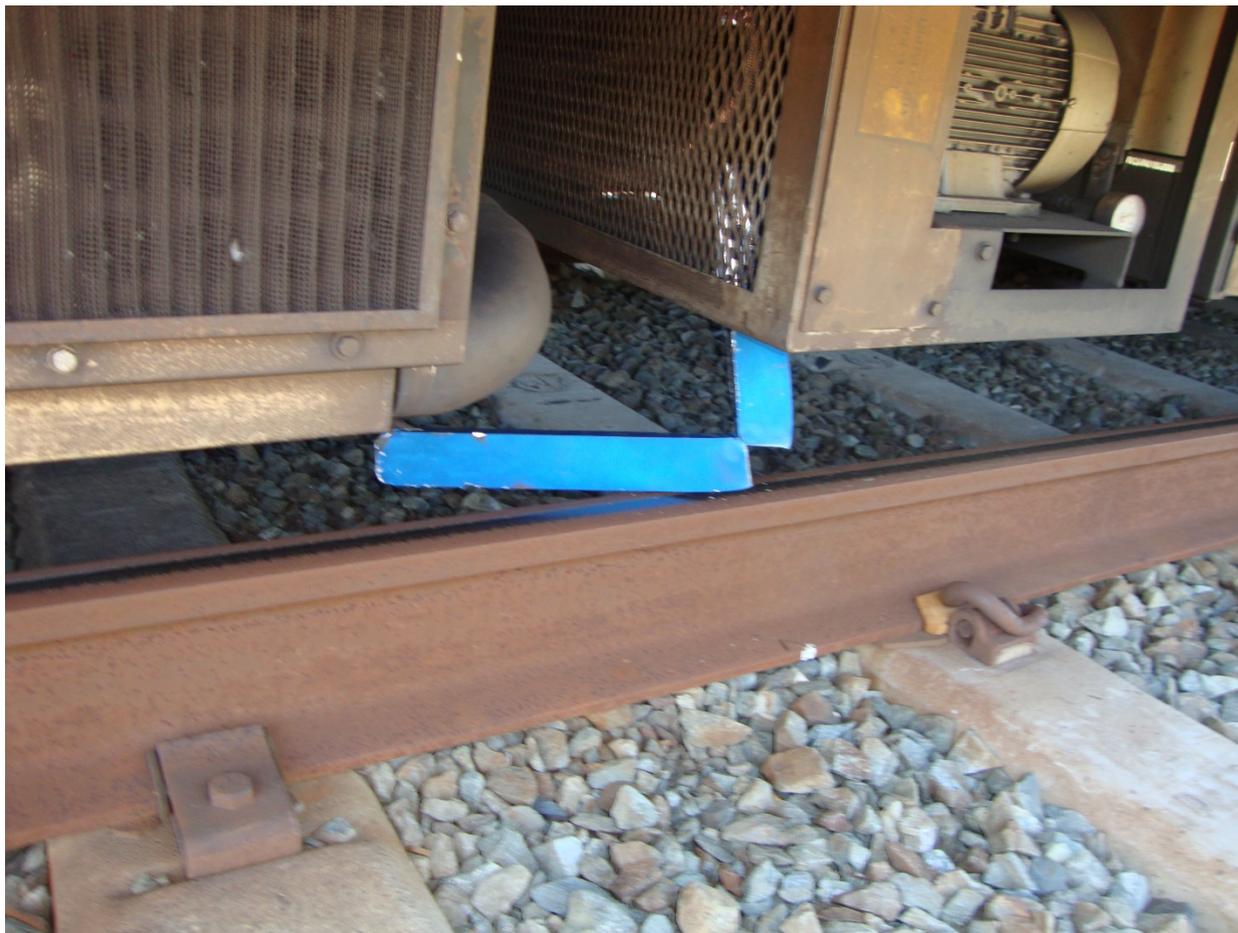
Figure 5 – Aluminum Track Gauge Lodged under Car #2528

Following the accident, mechanical inspectors performed an on-site visual inspections of each car in the consist, starting with the lead car #2528 and moving toward the tailing car #397. The aluminum track gauge Track 80 had been using to measure the tracks was discovered lodged under car #2528 on the right side. Car #2528 sustained damage to the left leaf of the front access door and to the lower right corner. No other defects were discovered at that time.

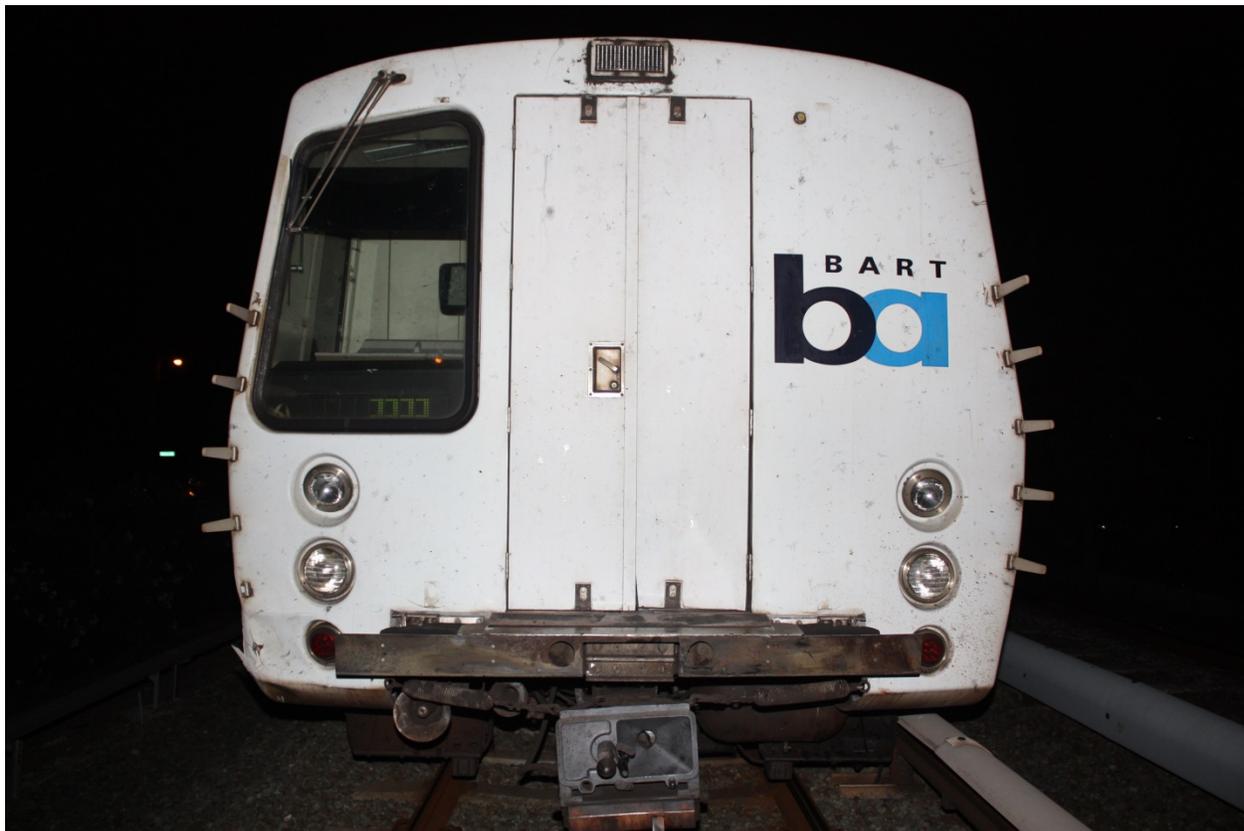
Figure 6 – Visible Damage to Car #2528

The consist was transported to Hayward Yard for further detailed inspections, including the undercarriages. Inspectors found that a traction motor cover was missing from car #2528, a brake caliper on car #1868 was found leaking, and a wheel on car #397 were found to have flat spots.

Car #:	Description of Repair:	Cost:
2528	Extensive damage to front end, bio hazard clean-up (parts and labor)	\$37 207.27
1869	HVAC overhaul, electric horn (labor only)	\$2 656.50
1508	Electric coupler and inverter cover (labor only)	\$2 783.00
397	Wheel assembly (parts and labor)	\$13 550.77
Total:		\$56 197.54

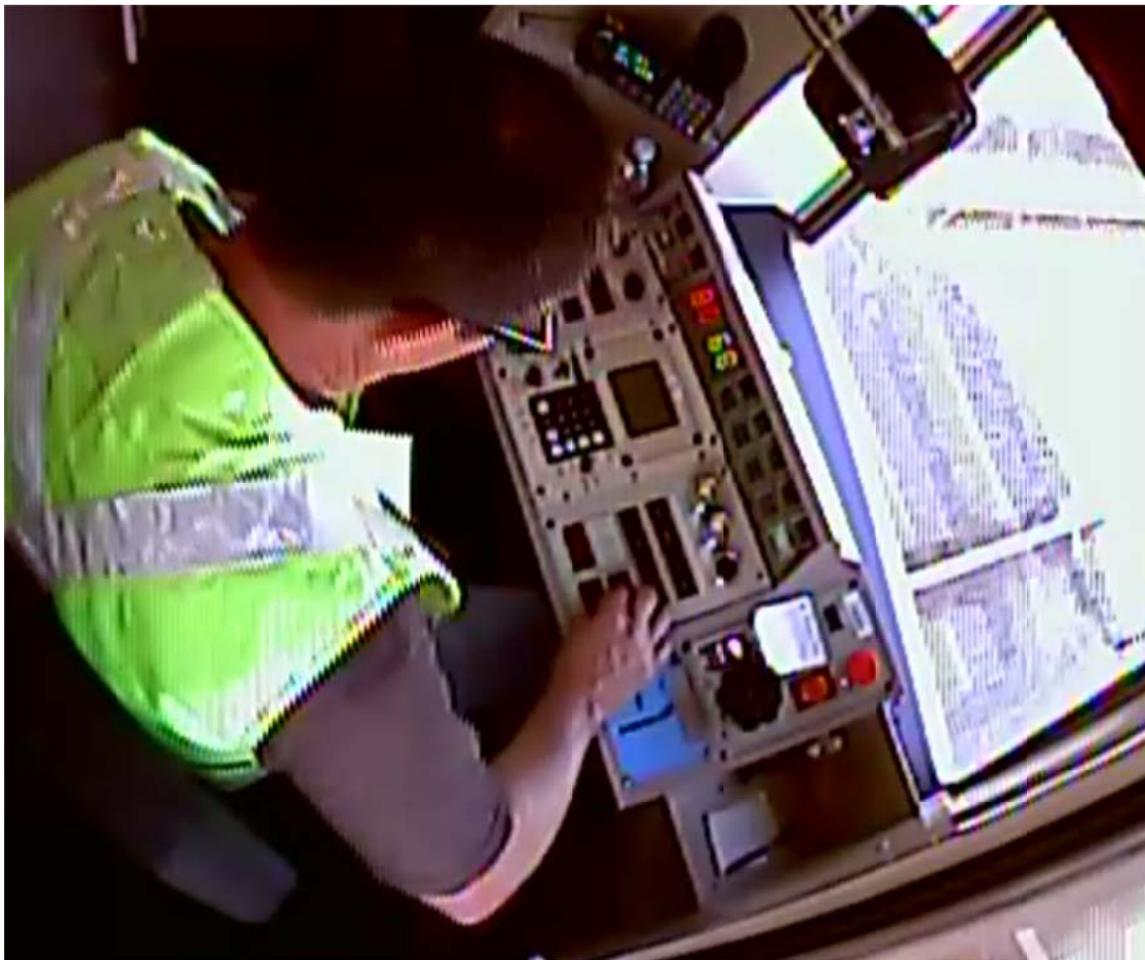
Figure 7 – TOT Presses a Button Before Applying Emergency Braking

As the train approaches the roadway workers, the TOT appears to depress a button shortly before activating emergency braking 4.8 seconds before the train made contact with the roadway workers. Comparing Figure 7 with Figure 8, the TOT pressed the "Hold/Door Close," which is located directly above the electric horn button. No horn sound was audible in the video. After pressing the button, the TOT repeatedly pressed the emergency stop "mushroom" button while making no further attempts to sound the horn.

The TOT, however, did not use the two-handed technique while performing station bypasses earlier in the day. It is probable that he intended to sound the horn as the train approached the roadway workers, but instead pressed the "Hold/Door Close" button which had no effect. By failing to sound the horn, he violated the Train Operator Manual¹⁹, rule 304.

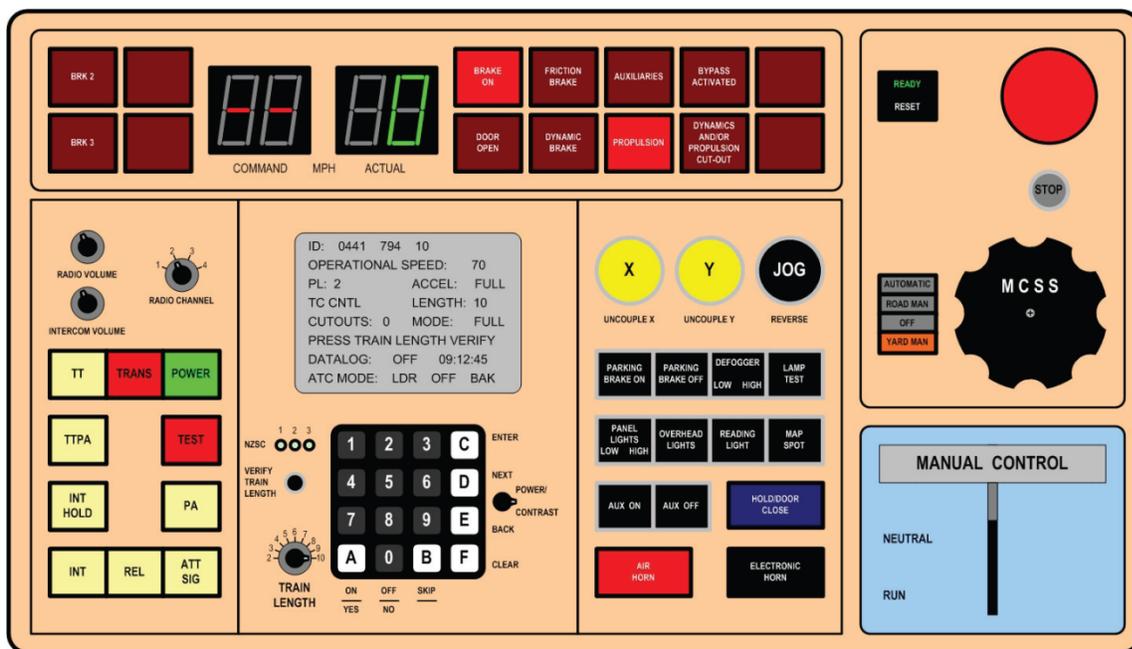
Figure 8 – Train Operator's Console Diagram¹⁸

The in-cab video also shows the speed of the train displayed on the operator's console at most times. The speed shown at moment the TOT activated emergency brakes is 68 mph, and the

The BART Train Operator Certification Textbook advises train operators to hold the right hand over the stop button while pressing the horn button with the left hand when approaching stations. This allows the operator to sound the horn while being prepared to begin stopping if necessary. While the textbook offers only guidelines, it is conceivable that a more experienced operator would have assumed this recommended position upon approaching roadway workers. Furthermore, a more experienced operator may have been better able to assess the roadway workers' position and inattention, and reacted by either sounding the louder air horn, activating emergency braking earlier, or both.

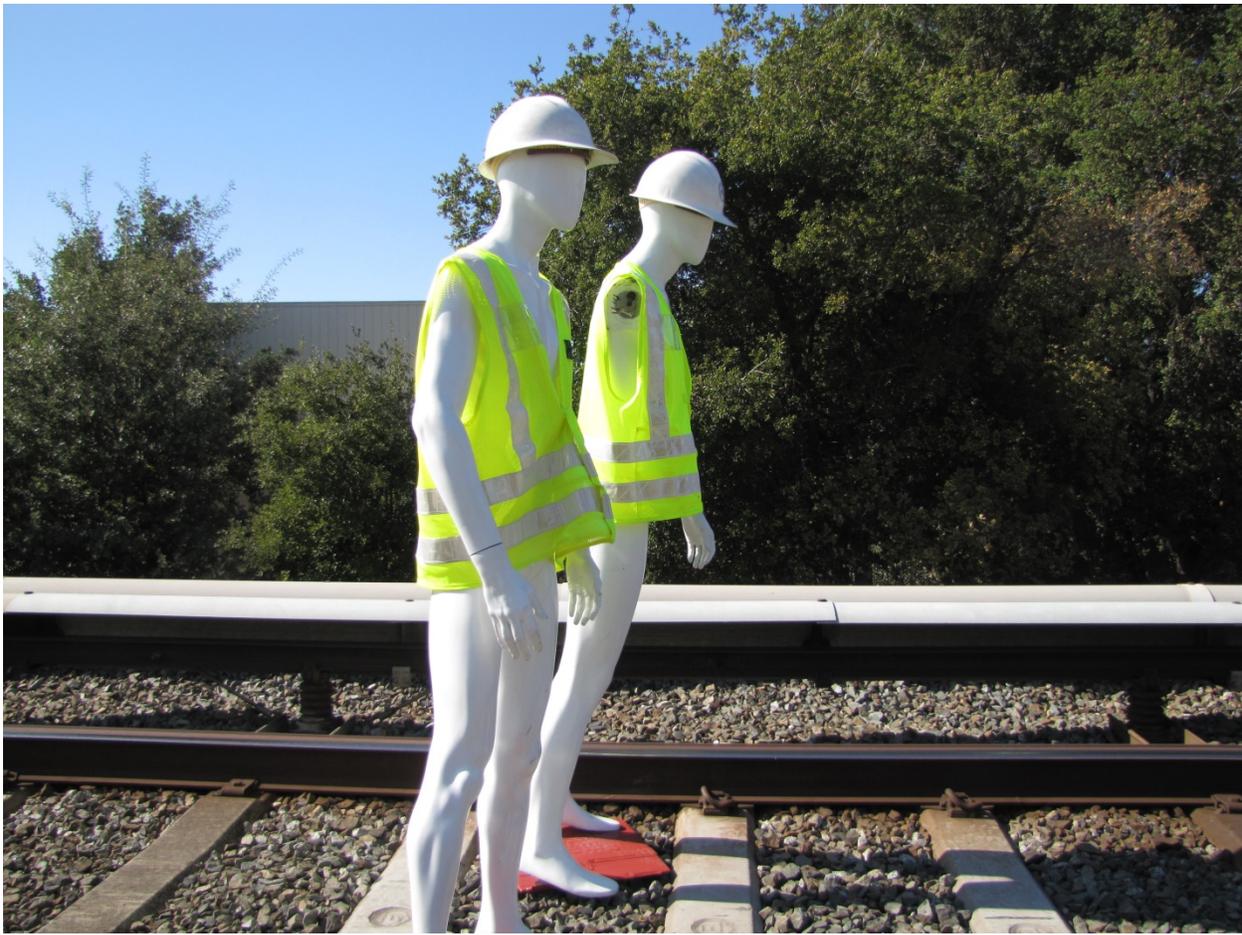
Figure 9 – Mannequins used for Site Distance Test

The first test brought the test train to the location of the accident, and two mannequins wearing safety vests were placed at the estimated point of impact (POI), as shown in Figure 9. The train was then reverse-run (southbound) in Road Manual mode by the second train operator at the back of the train. The train operator at the front of the train was asked to announce when the mannequins were no longer visible, and the train was stopped. Then, the train operator slowly maneuvered the train in the normal direction (northbound) to where the mannequins were first visible, then apparently within the track gauge. Both locations were verified by a CPUC investigator, and the positions were marked by wayside personnel. The distances to the estimated POI were, respectively, 1230 feet and 1135 feet.

After establishing the two locations, the train was moved south of Walnut Creek Station (C40), toward Lafayette Station (C30) and operated in ATO mode, at typical speed, northbound toward the scene of the accident for a braking test. The train operator was asked to apply emergency braking from ATO mode at the point where the mannequins were first visible, marked by traffic cones on the wayside. The stopping distance, between first application of brakes and final resting point, was approximately 1299 feet, and the train came to rest 69 feet beyond the POI.

A second braking test was run under similar conditions. In this trial, the train operator applied emergency braking at the location where the mannequins were apparently within the track gauge. The stopping distance was approximately 1317 feet, and the train came to rest 182 feet past the POI.
