**CRUISE LLC'S INFORMATIONAL FILING CONCERNING PUBLIC
RELEASE OF QUINN EMANUAL INVESTIGATION REPORT**

Attachment A
Quinn Report

¹⁰ This information is derived from three sources: (i) a detailed description of the October 2 Accident is set forth in a report by Exponent, titled “Cruise AV SF Incident – Pedestrian Collision (Exponent Project 2310645.000) Technical Root Cause Analysis,” (Dec. 12, 2023) (“Exponent Report”), a redacted copy, to protect confidential business information, is included as the Appendix in this Report; (ii) the San Francisco Police Department’s Traffic Collision Report (“Police Report”) about the Accident, (Oct. 6, 2023); and (iii) various Cruise documents discussing the Accident.

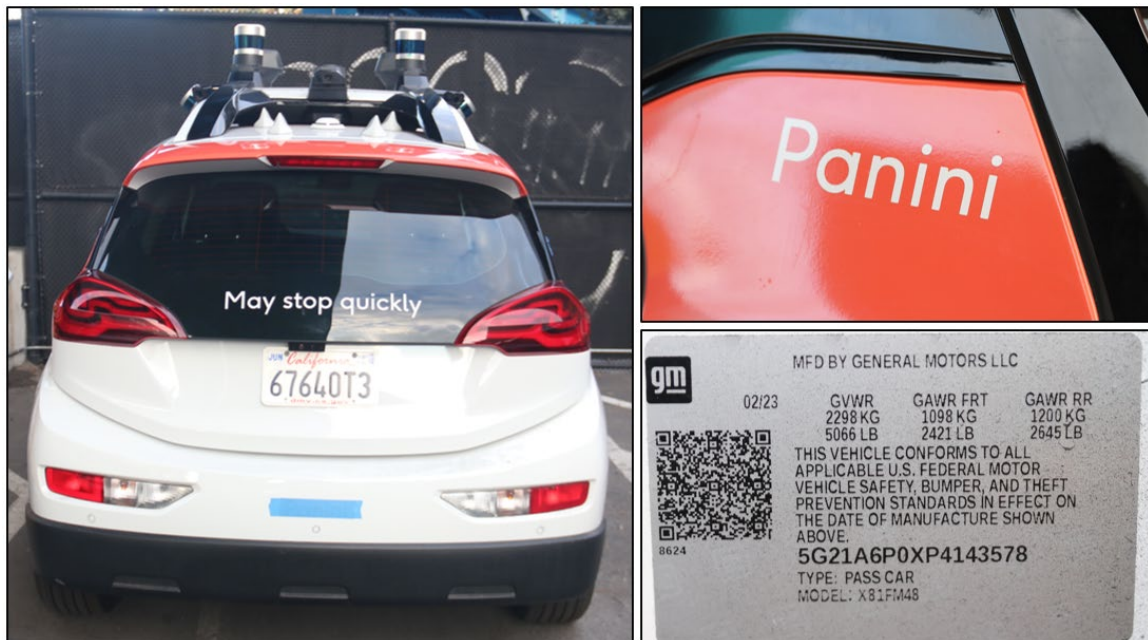
Figure 3. Photographs showing the rear of AV (left), vehicle moniker label on left side C-pillar (top-right), and vehicle VIN sticker (bottom-right).⁵

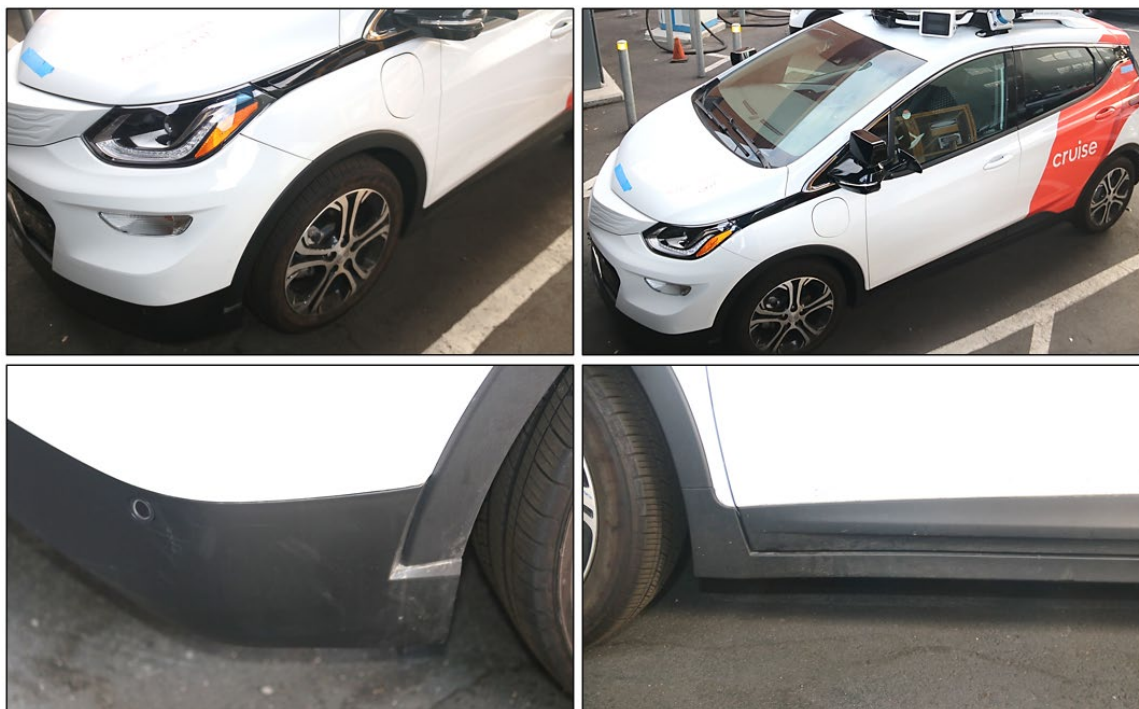
Figure 4. Photographs of the outside of the AV.

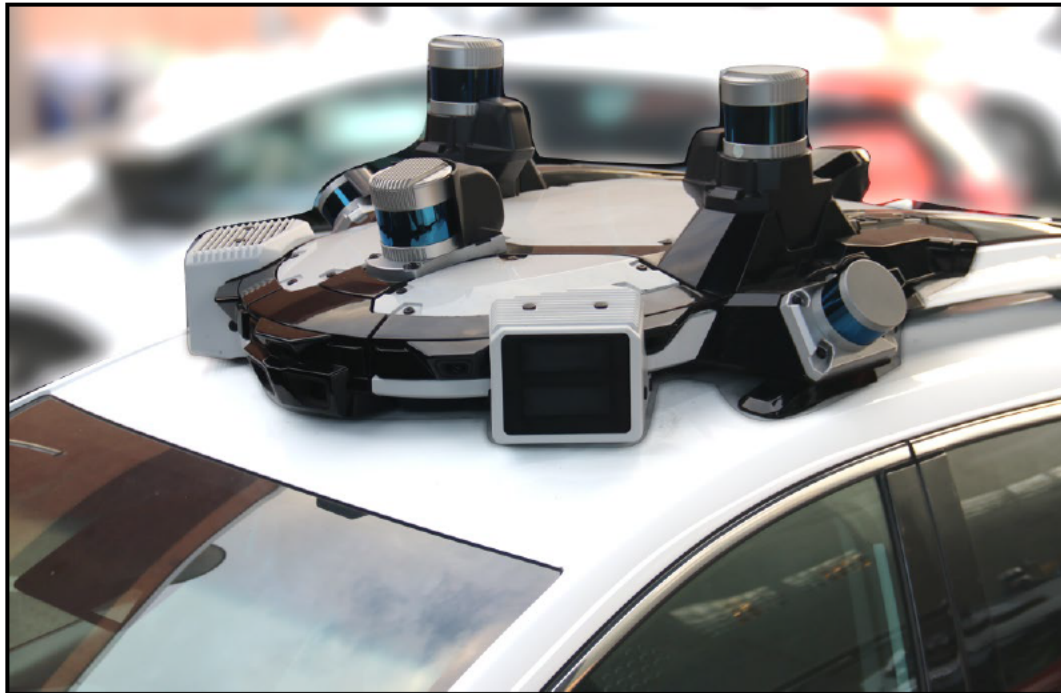
Figure 7. Roof mounted sensor array which includes lidars, cameras, and radars.
