BEFORE THE PUBLIC UTILITIES COMMISSION  
OF THE STATE OF CALIFORNIA

Complaint  
(Rule 4.2)

**Inspection - Complete (B2C) -**

**Scope of Work**

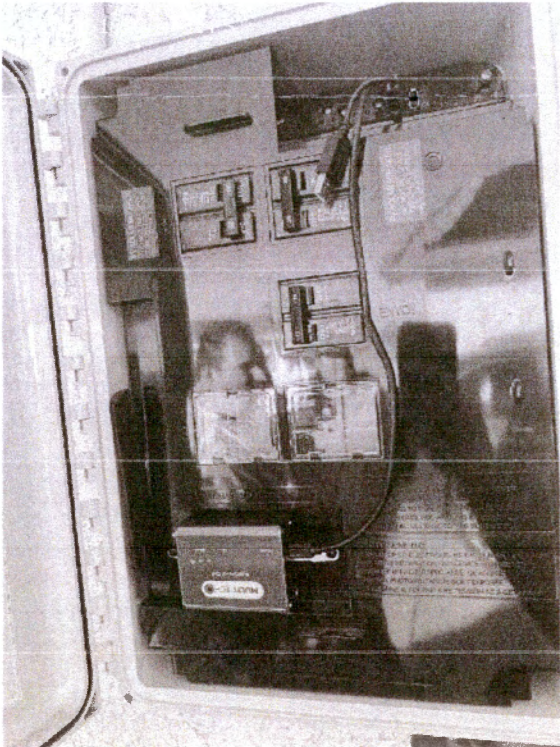
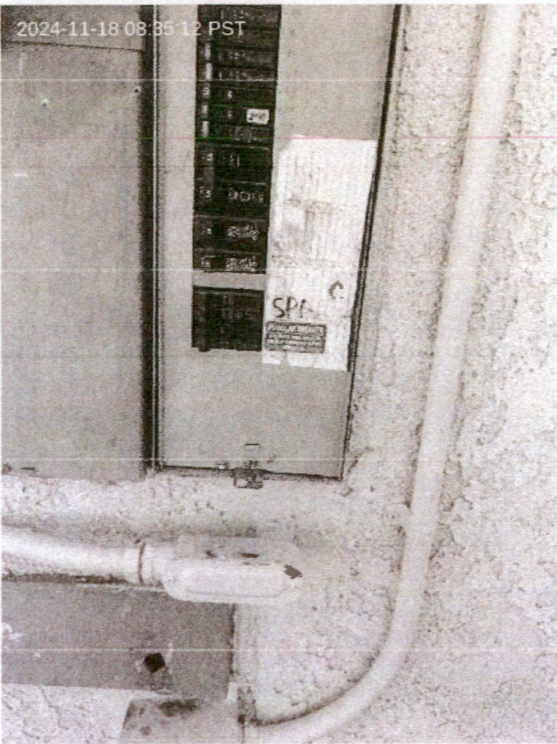
Electrical Information / Photo: Main Service Panel Location

Despite repeated inquiries, SCE insisted for years that there was “nothing wrong.” My meter was visibly defective — it was blackened to the point where no numbers or movement could be seen. Nevertheless, SCE refused to investigate unless I first hired an independent contractor at my own expense.

On November 19, 2024, I engaged Energy Aid to conduct an independent inspection and testing of the meter system. Their report and photos confirmed irregularities. Within two days of that report, SCE finally sent a technician and replaced the meter. Immediately following this replacement, my usage dropped from the thousands of kilowatt-hours per month back to normal levels in the hundreds — consistent with actual household needs and solar generation.

- 1. arrived on site greeted customer equipment located on the right side of the house.
- 2. Customer explain to me that they're receiving really high trueup bills
- 3. Initially, I noticed that the Enphase combiner box is online and no red light
- 4 Was able to connect to the tool kit
- 5. All panels are reporting and working.
- 6. Is connected to the Internet.
- 7. Checked amperage on each string.  
String one 1 amp  
String two 2 amps
- 8. was later in the day, so amperage was kind of low.
- 9. Cannot find any problems with the system.
- 10. I noticed that the Edison meter. Screen was damaged.
- 11. I informed customer to contact Edison and make sure that the meter is producing.
- 12. And have Edison meter replaced.
