Thomas Fire and Debris Flow Cost Recovery Application – Rebuttal Ignitions Testimony

Before the
Public Utilities Commission of the State of California

SCE-13: Thomas Fire and Debris Flow Cost Recovery Application – Rebuttal Ignitions Testimony

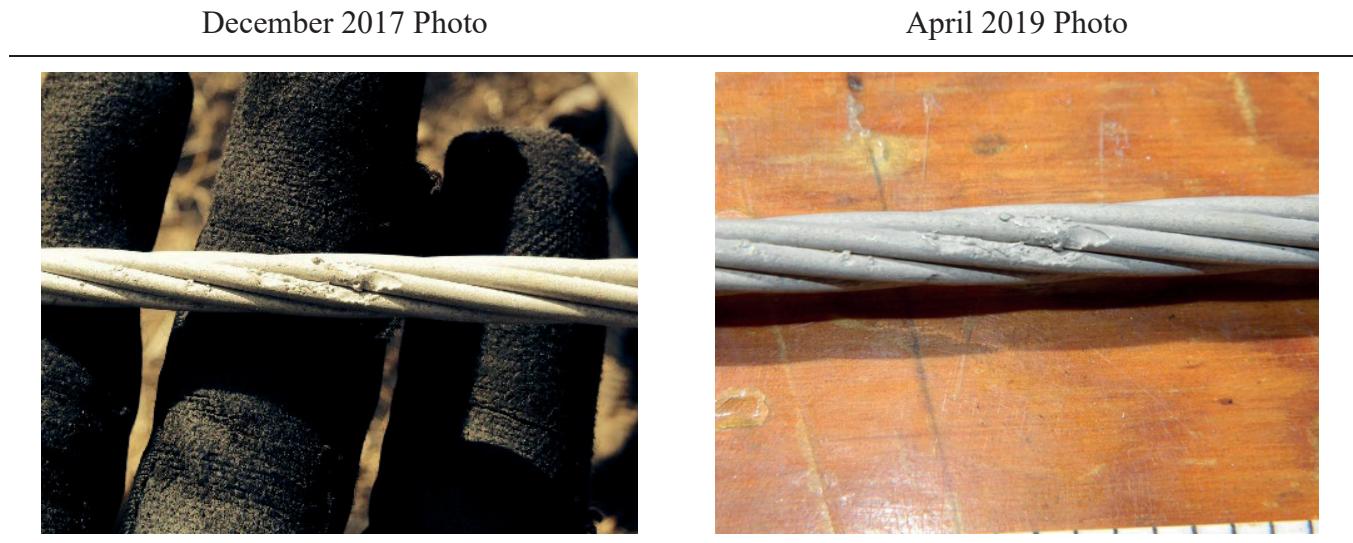
Figure II-1
Oxidized Arc Marks in CP Rectifier Area: December 2017 and April 2019

1 Second, if the conductors from the CP Rectifier area had experienced exposure to fire or
2 smoke sufficient to alter the appearance of the arc marks on the conductors as Cal Advocates suggests, I
3 would expect to see physical evidence of that exposure on the conductors. Yet I saw no indication of
4 smoke and/or flame exposure or heat-related damage during my detailed metallurgical examination of
5 the conductors. Smoke and/or flame exposure leaves a dark soot deposit on the surface of a conductor
6 and heat exposure also can cause melting or other heat-related damage to the conductor. Evidence of
7 soot deposits and discoloration on the separated conductor that contacted the ground in connection with
8 the Koenigstein ignition is shown in Figure II-2. In contrast, my evidence examination confirmed that no
9 such evidence is visible on the conductors in the CP Rectifier area.⁸ This accords with the fact that the

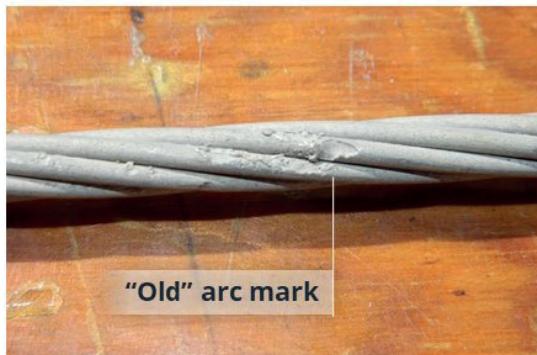
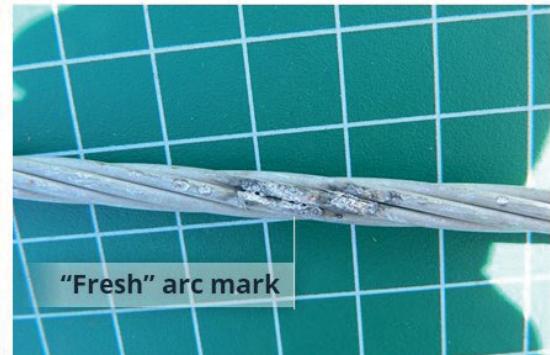
1 Finally, a comparison between the conductors collected from the CP Rectifier area and
2 from the Oil Field Area further disproves both of Cal Advocates' attempts to explain away the clear
3 metallurgical evidence that the arc marks on the conductors in the CP Rectifier area did *not* occur on
4 December 4, 2017. The conductors in the Oil Field Area were collected from the field shortly after the
5 conductors from the CP Rectifier area were collected.¹⁰ I examined both sets of conductors at Cal Fire's
6 facility in Fresno, California during the same evidence inspection, which occurred on April 9-10, 2019.
7 The difference in appearance between the two is self-evident in photos taken during my evidence
8 inspection as shown in Figure II-3.¹¹

Dull, fully-oxidized appearance;
similar to rest of conductor

Shiny and reflective appearance indicating
recent contact; contrasts with oxidized conductor

Example from CP Rectifier Area

Example from Oil Field Area

1 The conductors from both areas are #4 ACSR conductor, were taken into evidence only
2 days apart, and were stored in the same Cal Fire evidence locker in the same conditions. Thus, their
3 oxidation process would have been slowed to the same degree. Moreover, in contrast to the conductors
4 in the CP Rectifier area that were still in the air, the Anlauf fire agency report states that some of the
5 conductors in the Oil Field Area—specifically the one shown in Figure II-3 with a fresh arc mark—were
6 in contact with the ground at the time they were taken into evidence. Thus, these conductors were more
7 likely to experience smoke and/or flame exposure than the conductors in the CP Rectifier area. If Cal
8 Advocates' hypotheses were correct, the arc marks on the conductors from the Oil Field area would
9 appear "old"—either because of smoke and/or flame exposure or passage of time in an evidence locker.

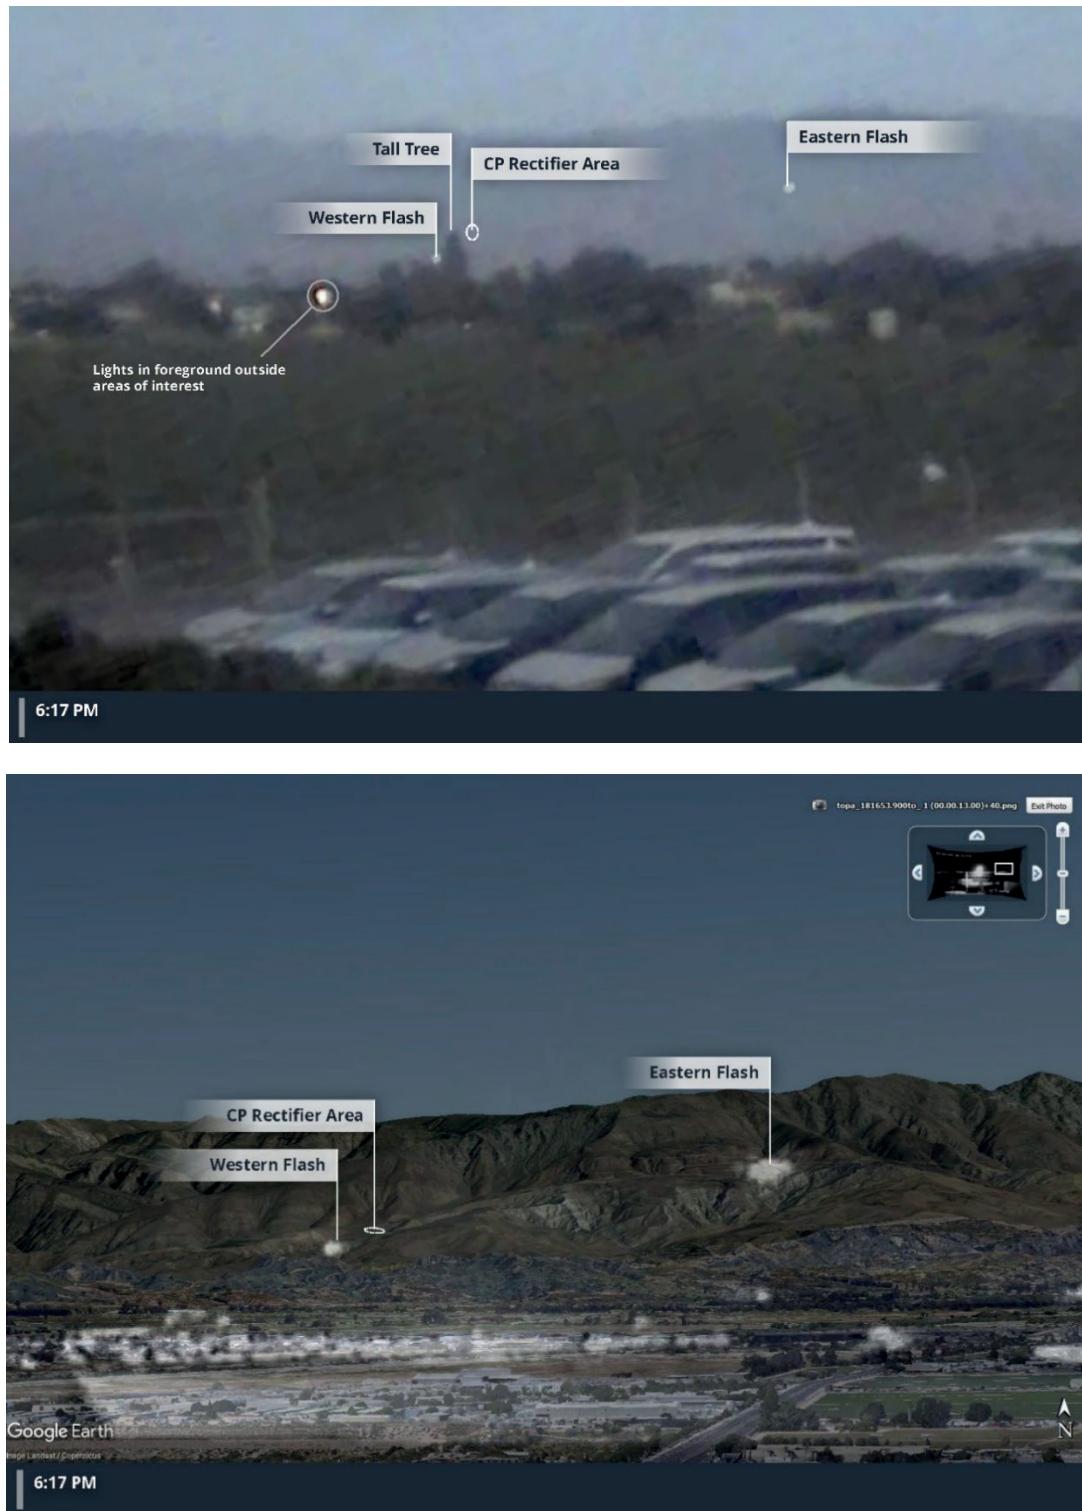
Figure III-5
(SCE-02, Figures III-20 & III-21)
Analysis StorHouse and Topa Showing Location of Flashes

1 Cal Advocates also ignores entirely my analysis of the flashes—which is what the fire
2 agency investigation report, and apparently Cal Advocates, identifies as the ignition event in the CP
3 Rectifier area.¹⁵ Again, this analysis shows that the western flashes—the supposed ignition event—are
4 visible on the left side of the Tall Tree when viewed from the StorHouse camera. Indeed, both the
5 StorHouse and Topa cameras show that the western flashes were not located in the CP Rectifier area and
6 thus could not have been the cause of an ignition in that area as the Anlauf fire agency report concludes.
7 In fact, the fire agency investigators' own lines of sight to the western flashes do not go through the CP
8 Rectifier area.

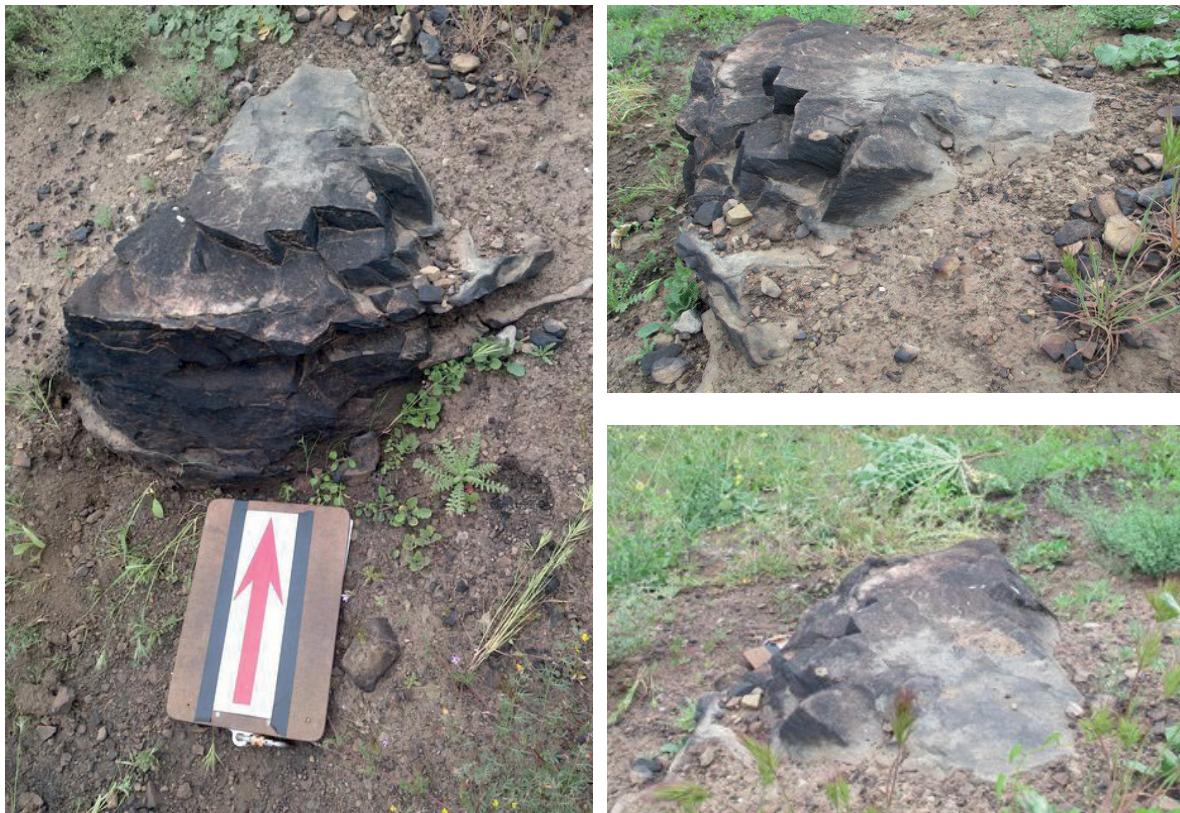
Figure II-6
(SCE-02, Figure III-5)
Example of Fire Movement Indicator in Anlauf Canyon

1 Many indicators—such as the staining on a large rock embedded in the earth as shown in Figure II-6—
2 are unlikely to be disturbed for months or years following a fire. Whenever there is evidence of potential
3 disturbance, we do not use that fire movement indicator.

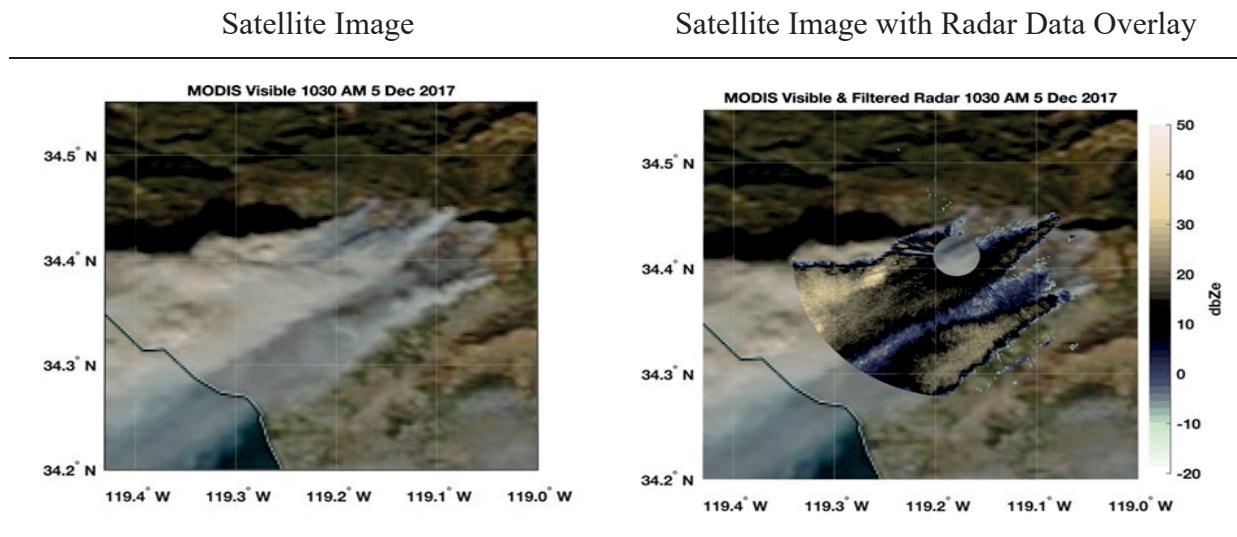
Figure II-7
Comparison between Sulphur Mountain (KVTX) Radar and MODIS Satellite Imagery at 10:30 AM PST on December 5, 2017

19 disputed that KVTX detected the ash plume from the Thomas Fire. For instance, at a time that is not in
20 dispute (10:30 a.m. on December 5, 2017), there is clear alignment between satellite imagery²¹ showing
21 the observed plume of the Thomas Fire and the plume detected by KVTX. This is illustrated in Figure
22 II-7.

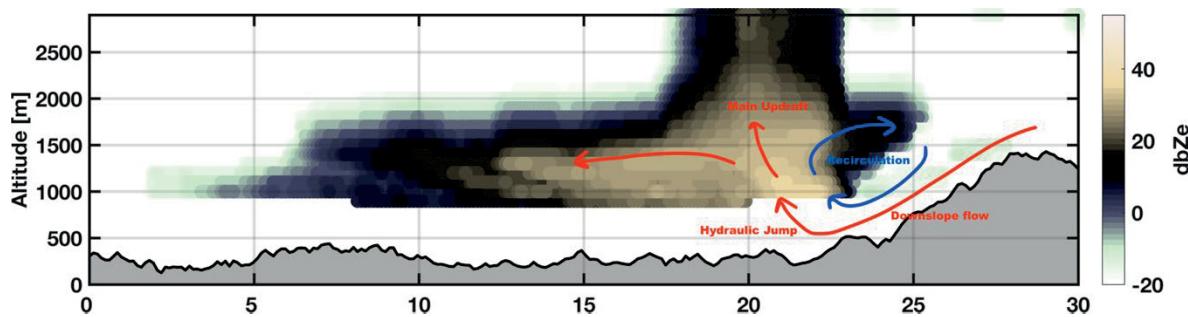
Figure II-8
Radar Cross Section at 6:46-6:58 PM PST on December 4, 2017 Showing the Recirculation Zone

12 4, 2017, as shown in Figure II-8 with the blue marks depicting the recirculation zone and the red marks
13 identifying the direction of the plume’s drift.

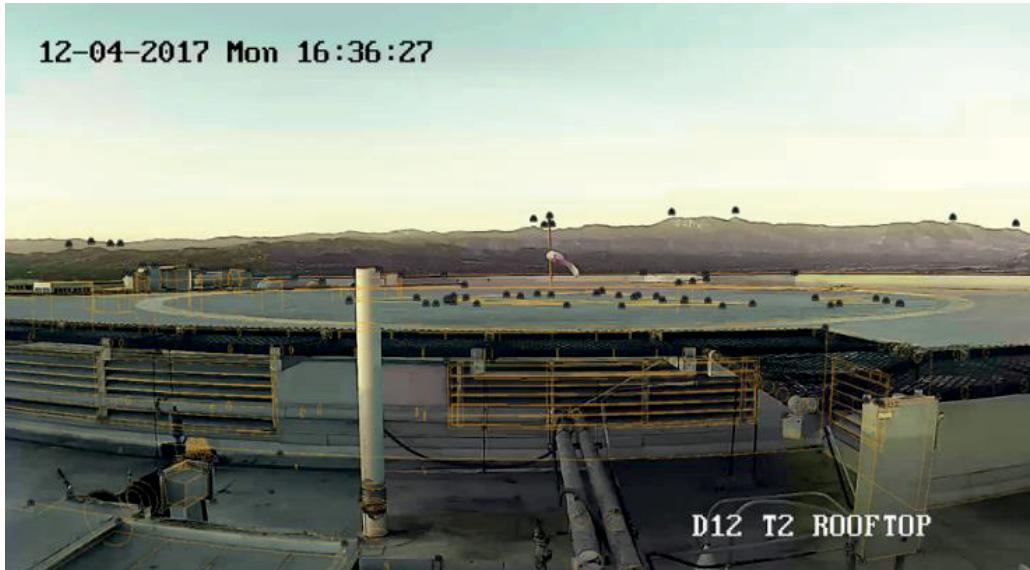
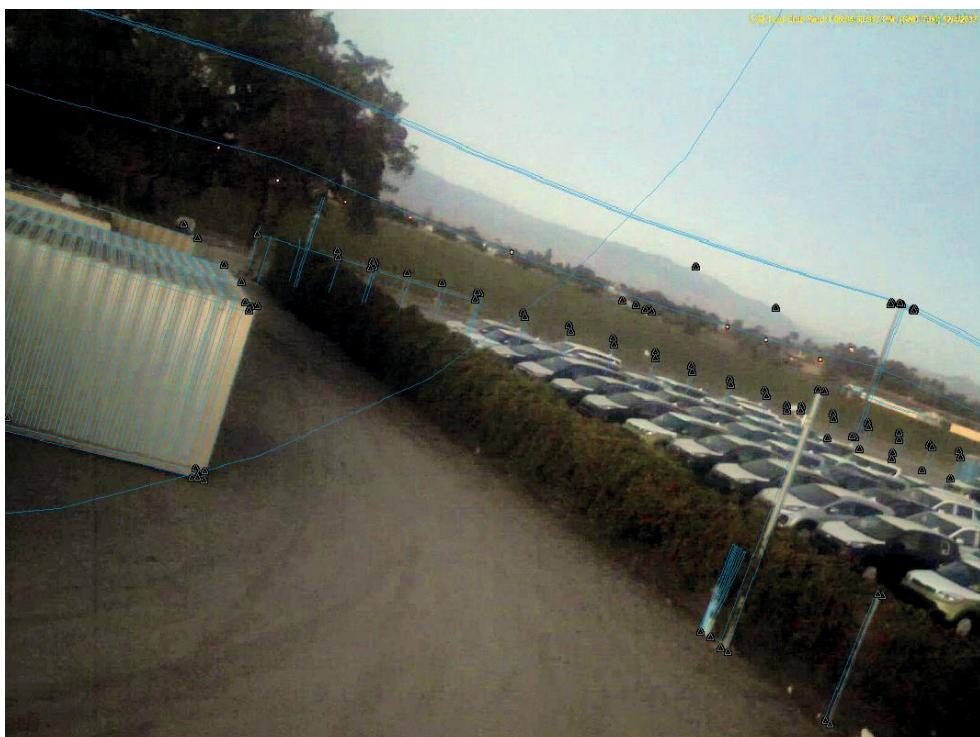
aligned to the 3D model by extracting control points and spline outlines that corresponded to distinct features on the surveillance video (below).

Topa:

StorHouse:

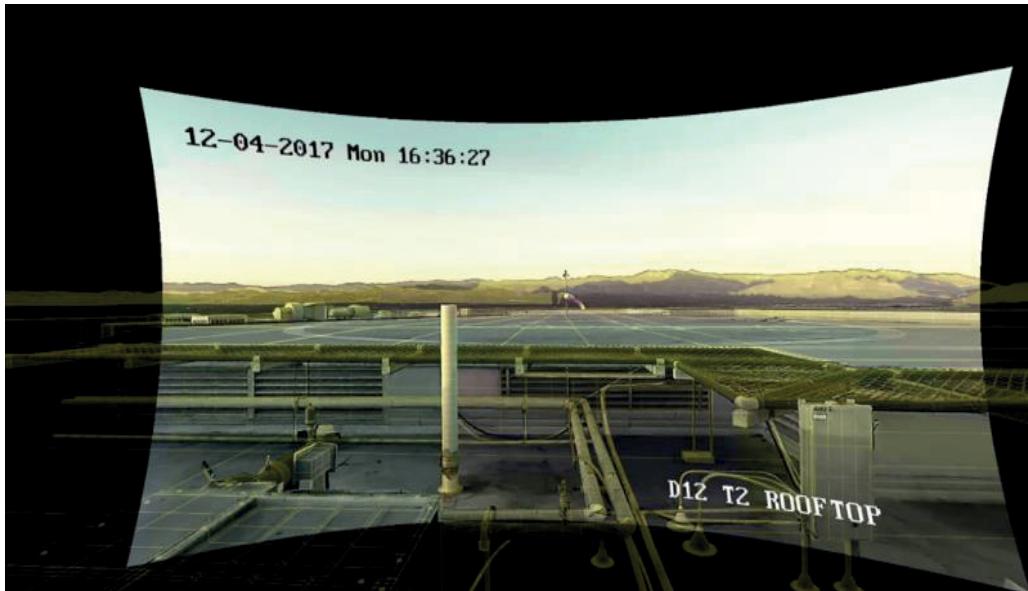
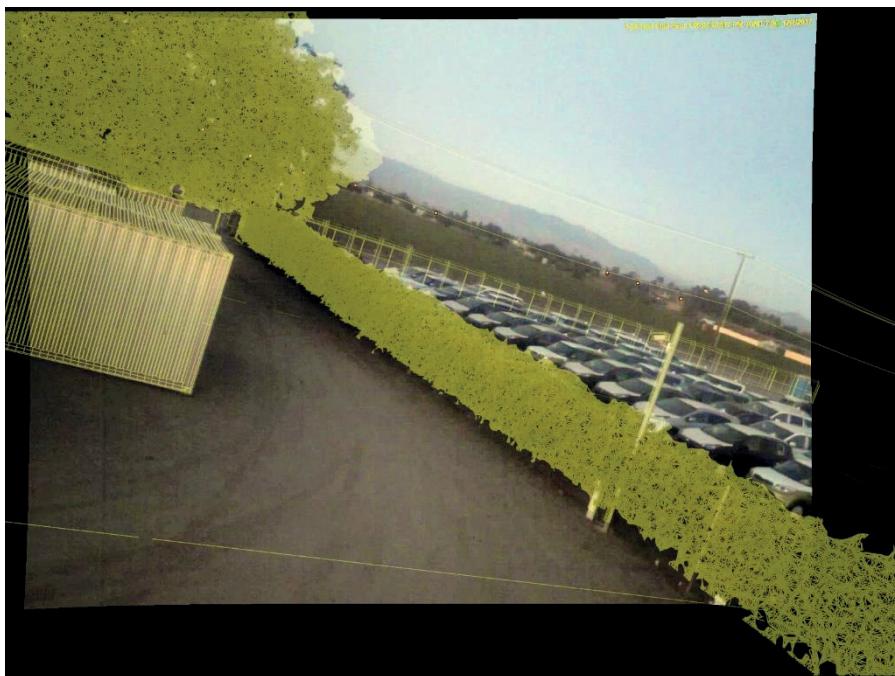
The calibrated camera parameters and surveyed points were then used to produce an idealized camera and accompanying image. Consistent with photogrammetric industry standards and practices, the image is remapped (pixel by pixel) to reverse any lens distortion, non-centered

principal, point, and any non-square pixels. The control points are then adjusted to match the undistorted image. The virtual camera and undistorted image used as a backplate are imported into the virtual 3D model (below).

Topa:

StorHouse:
