Water Main Break Rates in the USA and Canada: A Comprehensive Study

December 2023

A Resource to Support Asset Management,
Pipeline Renewal, and Replacement

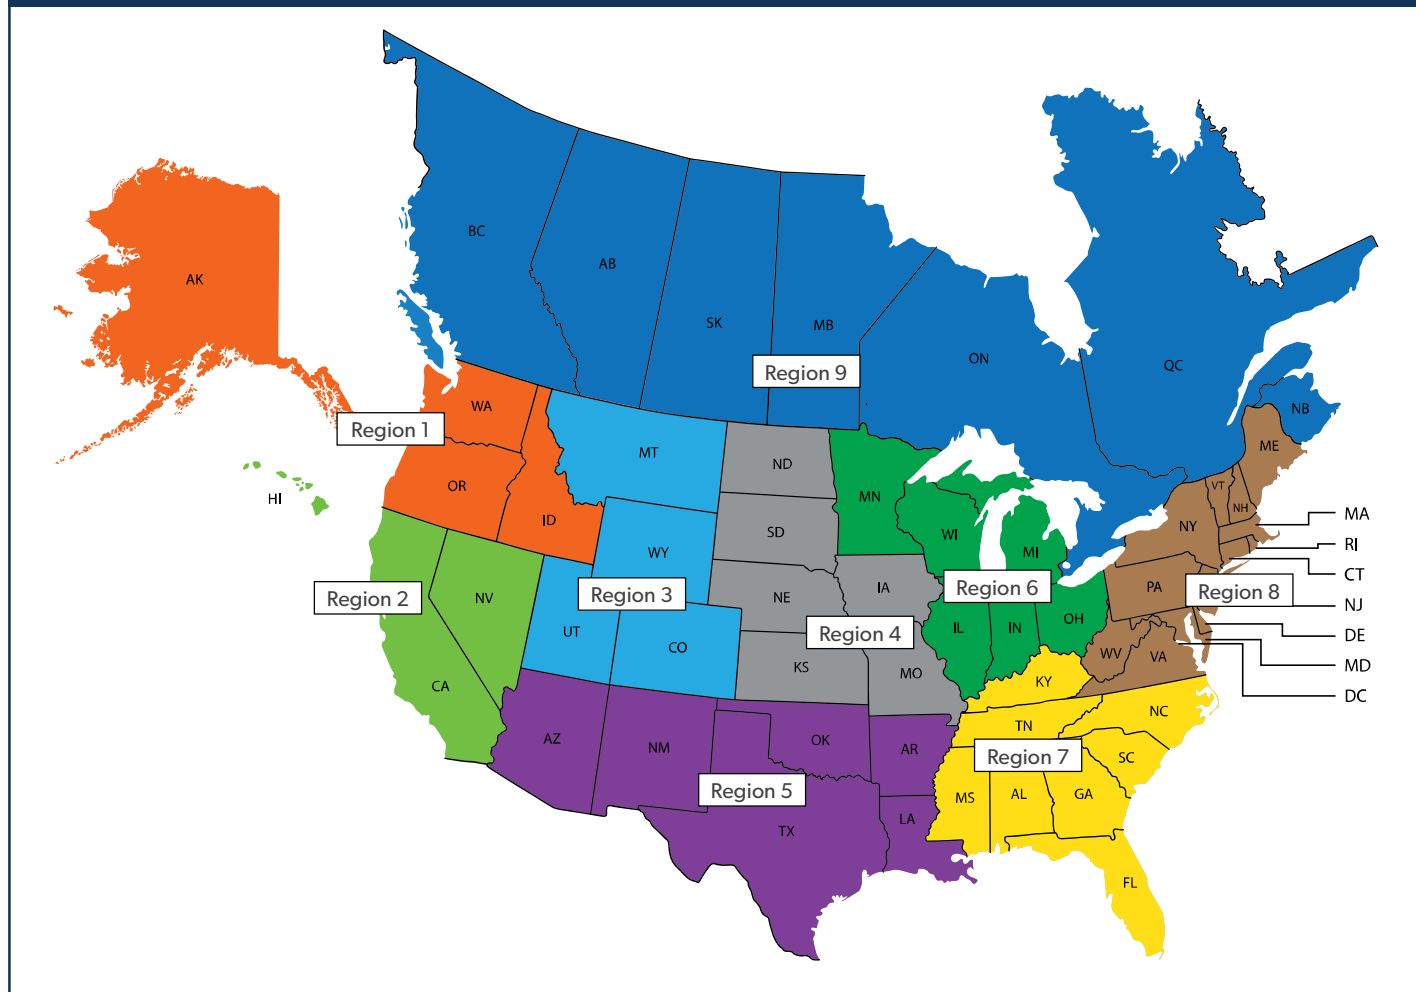
FIGURE 3: REGIONS USED TO REPORT SURVEY RESULTS

To facilitate direct comparisons with previous USU surveys, nine survey regions in the US and Canada were utilized (Figure 3). The regions are used to indicate geographical variations. In total, 791 utilities provided pipe distribution data. Table 1 lists the number of respondents with pipe material distribution data, the miles of pipe, and the population served in the basic and detailed surveys from each region.

For this study, the US and Canada were divided into nine regions (Figure 3). Basic survey respondents were categorized according to region and utility size based on total pipe miles. The study represents 399,812 miles of pipe as shown in Table 1. This report provides results from both basic and detailed surveys and draws from other relevant industry sources.

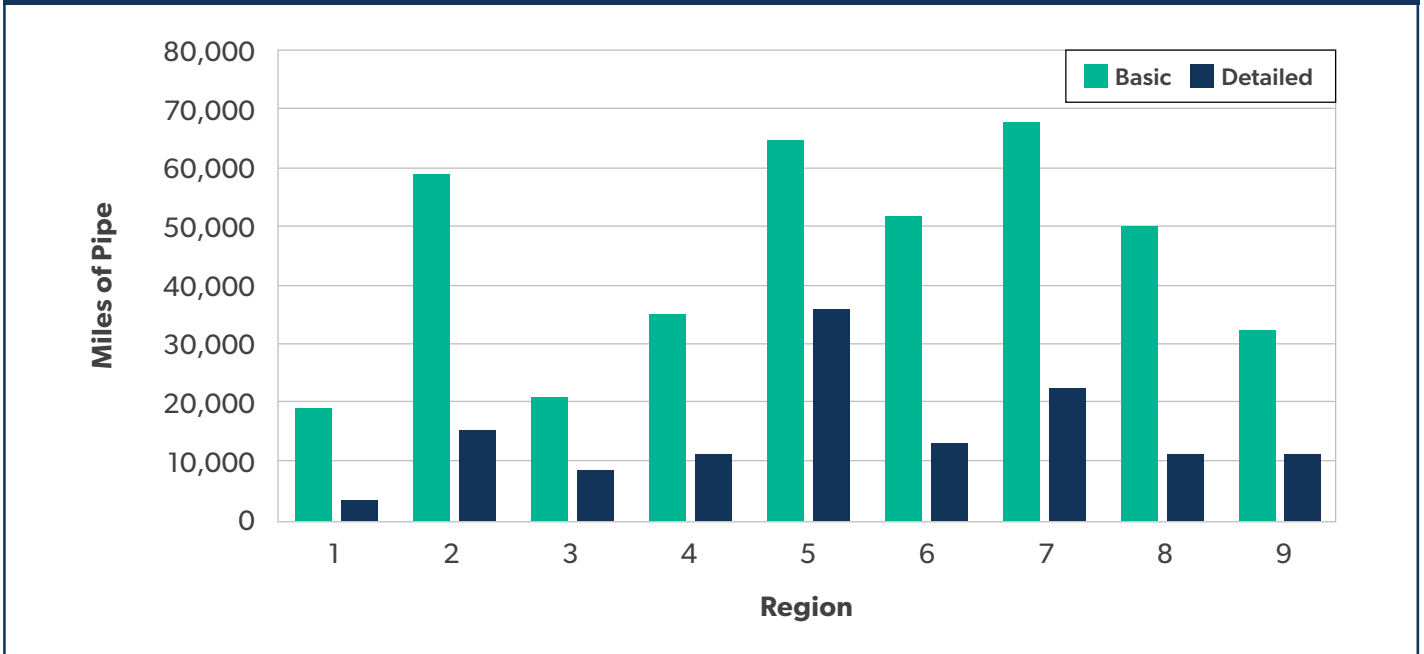
FIGURE 4: MILES OF PIPE FROM EACH REGION FOR THE BASIC AND DETAILED SURVEYS

As illustrated in Figure 4, Regions 5 and 7 reported the most miles of pipe from the basic survey. Figure 5 shows that the greatest number of respondents came from Region 6. Figure 6 shows the average miles of pipe per utility from the basic survey by region. Region 5 had the highest average pipe length at 783 miles and Region 3 had the lowest with 256 miles. The average miles of pipe represented per utility respondent is 505 miles (Figure 6) serving an average population of 146,432 (Figure 7). For comparison, the 2012 and 2018 surveys reported an average utility had 626 and 607 miles of pipe serving 164,325 and 186,752 people, respectively. The decrease in both average miles of pipe per utility and average population serviced seems to indicate a greater participation from smaller utilities for this study. The 2023 basic survey had 2.8 times more respondents and 2.34 times more miles of pipe than in 2018, increasing the statistical validity of this study.

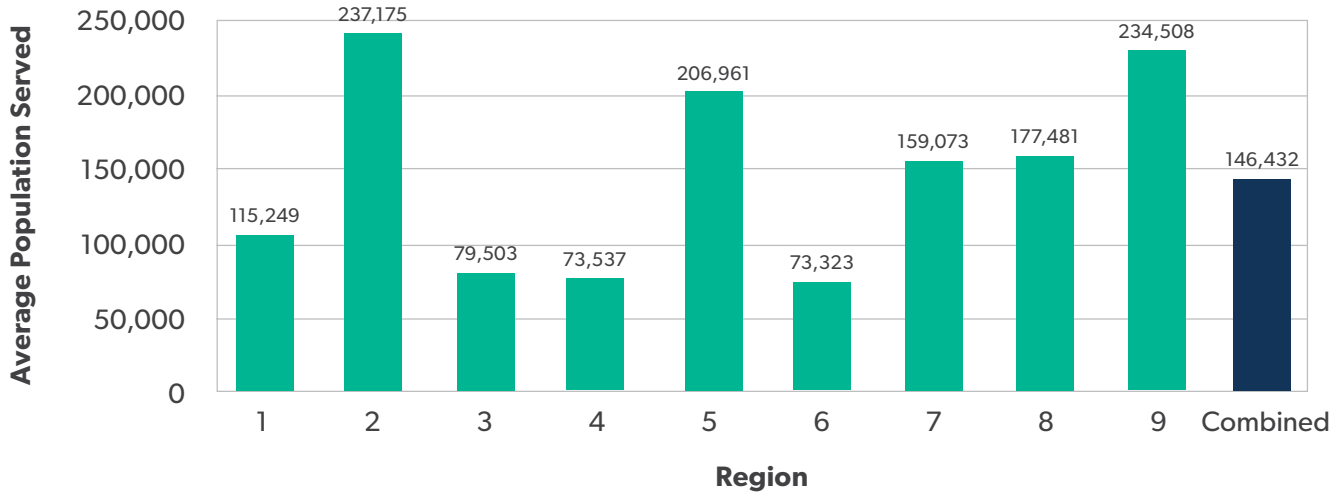
FIGURE 7: AVERAGE UTILITY POPULATION SERVED BY REGION (BASIC SURVEY)

Figure 7 shows the average population served per utility for each region. The average population served per utility for the basic survey was 146,432.

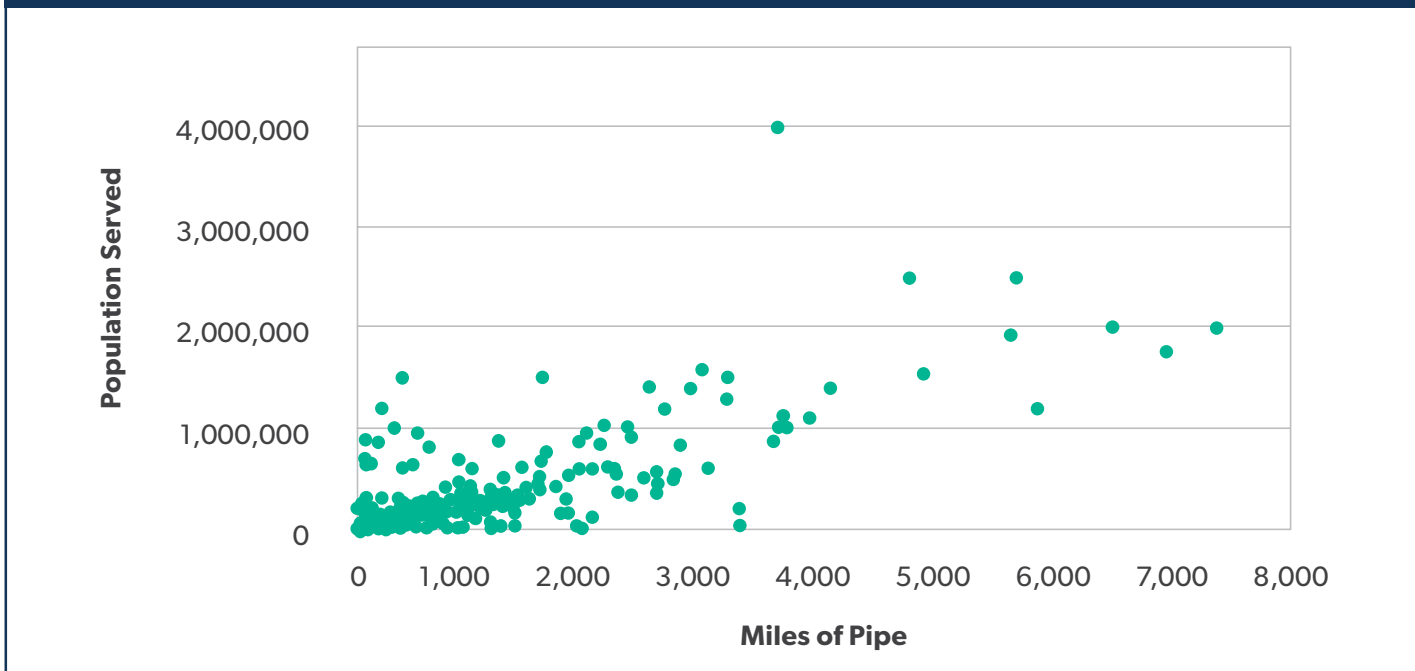
FIGURE 10: POPULATION SERVED RELATIVE TO TOTAL MILES OF PIPE (BASIC SURVEY)

Figure 10 illustrates the distribution of population served by the utilities participating in the basic survey against the number of miles of water mains. Figure 11 shows average population served per mile of pipe for each region, producing an overall average of 287 people served per mile. The 2018 survey reported this value as 308 while the 2012 survey reported 264 people served per mile. Utilities that provided transmission pipe data exclusively were not included (typically wholesale water providers). Water systems with a higher density of people served per mile have an increased consequence of failure and may require a higher level of asset oversight.

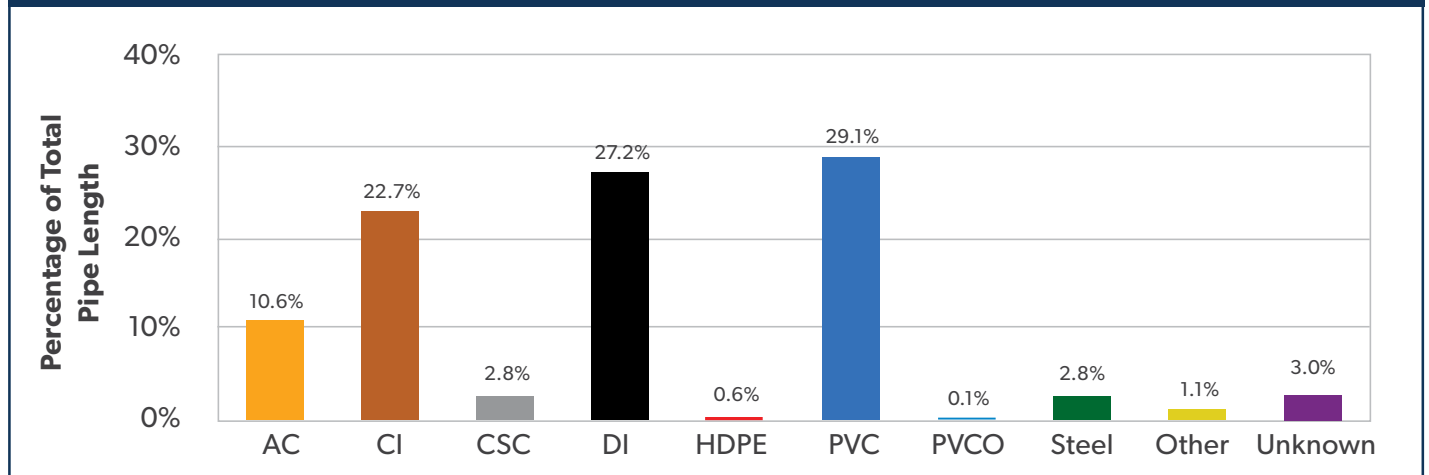
FIGURE 13: PERCENTAGE OF PIPE LENGTH BY MATERIAL TYPES (BASIC SURVEY)

Figure 13 illustrates the percentage of total length of water mains by pipe material. It is significant to consider that nearly 90% of the water mains reported are made from cast iron (CI), asbestos cement (AC), ductile iron (DI), and polyvinyl chloride (PVC) materials. This is consistent with earlier USU studies (Folkman, 2012; 2018). The EPA provides a summary of the timelines of when these materials have been in use: *The majority of distribution piping installed in the United States, beginning in the late 1800's up until the late 1960's, was manufactured from cast iron... referred to today as "pit" cast iron pipe. ...In 1920, the process of centrifugally casting pipe in a sand mold was introduced... referred to as "spun" or "centrifugally" cast iron pipe (which was commonly installed until the 1970's). Asbestos cement became commercially available in the 1930's and was commonly installed during the 1950's and 1960's. Following this was the introduction of ductile iron pipe in the late 1960's. Shortly after the introduction of ductile iron, the use of ... polyvinyl chloride (PVC) ... in this country began to emerge in the 1970's (EPA, 2002).*

As shown in Figure 13, the percentages for the installed CI and AC pipe in 2023 are 22.7% and 10.6%, respectively. Figure 13 also illustrates that PVC has the highest percentage of all pipe materials at 29.1%, with DI pipe at 27.2%. As shown in Figure 14, in 2018 CI and AC pipe accounted for 28.4% and 12.7% of all pipe miles, respectively. The combined inventory for these two materials in 2018 was 41.1%, and 33.3% in 2023. This represents a reduction of 7.8% in the reported pipe inventory. During the same 5-year period, reported PVC pipe length increased by 7.0% and DI remained approximately the same. It is noteworthy that the reduction in CI and AC is similar to the increase in the installed length of PVC pipe.

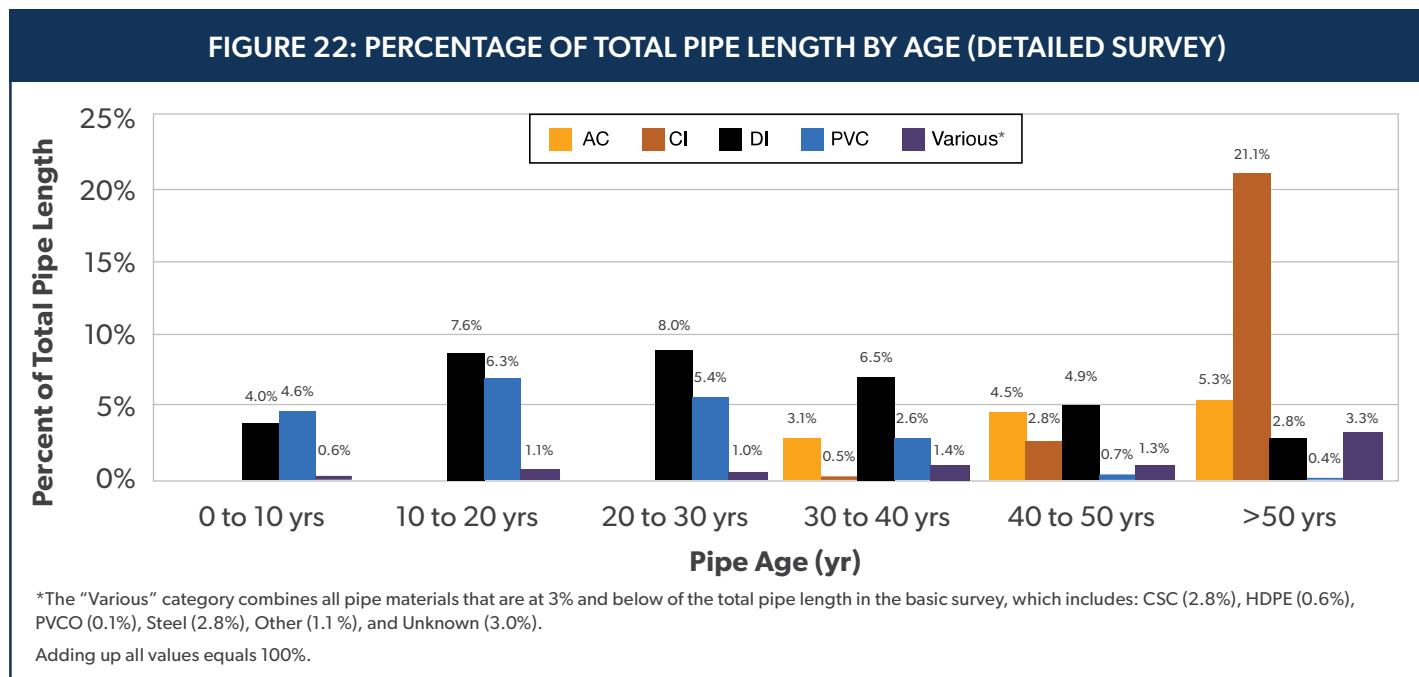
Figure 22 shows the age distribution as a percentage of the total length of all pipe materials from the detailed survey. For example, CI older than 50 years is 21% of all installed pipe. For ages between 0 to 10 years, DI and PVC both have about 4 to 5% of the total installed length. This means that the most common pipe materials installed over the last 10 years are DI and PVC.

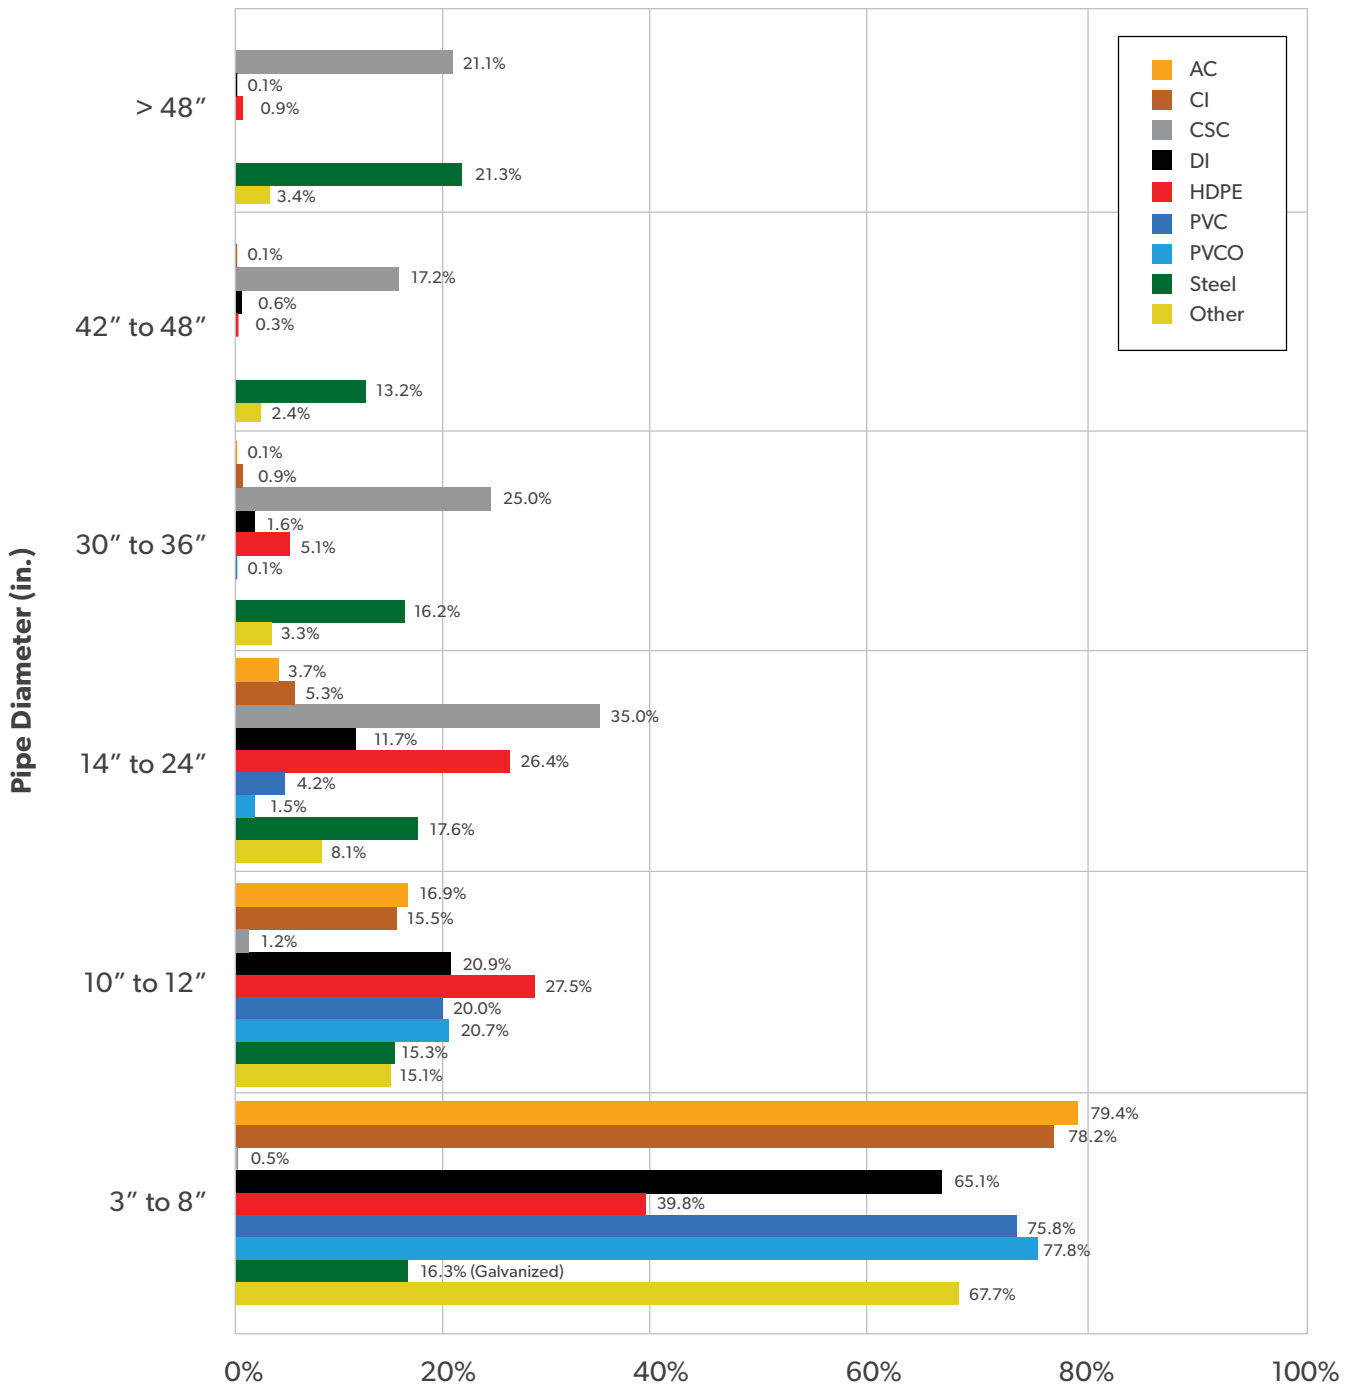
FIGURE 24: PIPE DIAMETER DISTRIBUTION BY MATERIAL TYPE (DETAILED SURVEY)

Figure 24 illustrates the diameter distribution for each material type as reported from the detailed survey. The figure shows that most large diameter pipes (14-inch and larger) are predominantly steel and CSC, with each material having more than 21% of their length in sizes larger than 48-inch. More than 98% of the CSC pipe was in sizes 14-inch and larger. The figure also shows that over 75% of all AC, CI, PVC and PVCO pipe, respectively, is 8-inch or smaller.

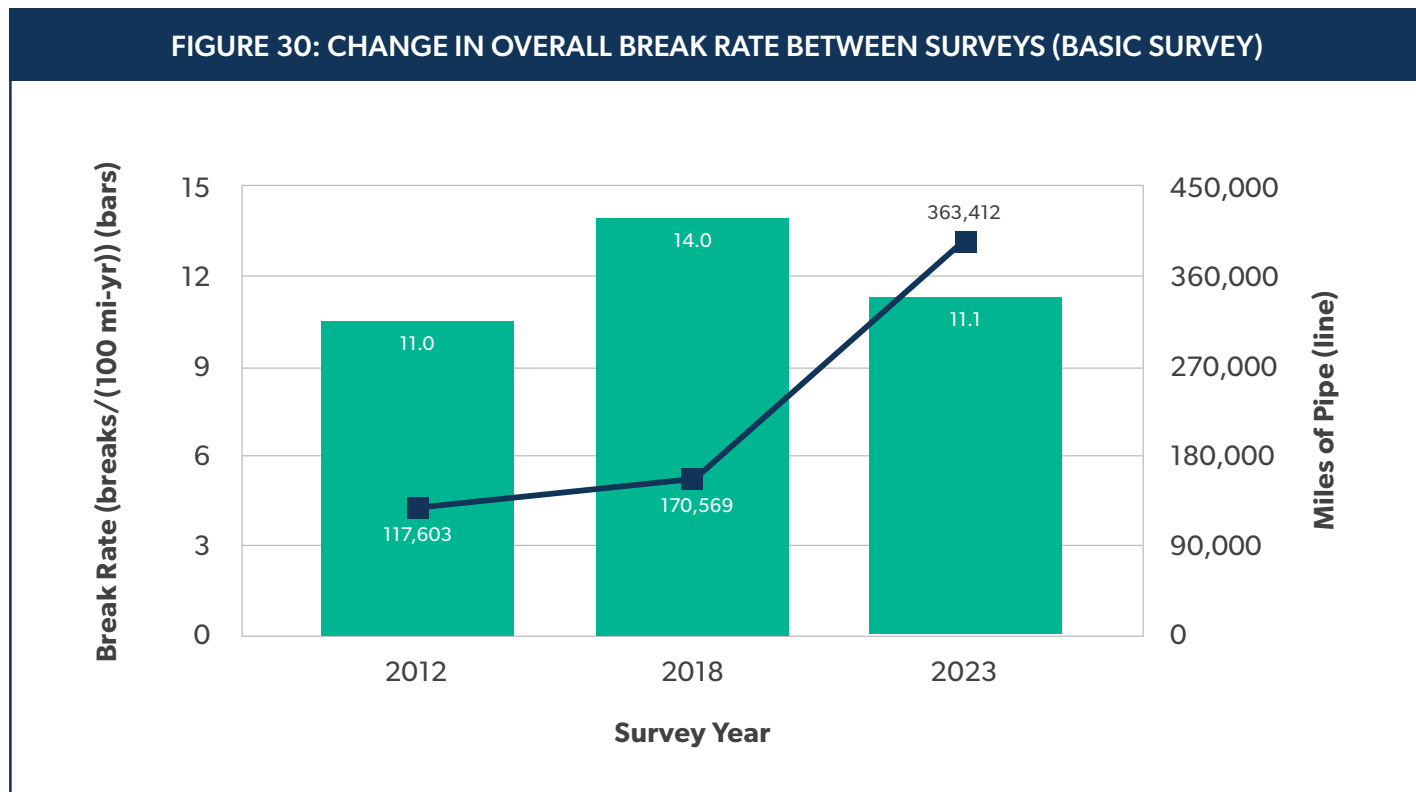
Figure 30 illustrates the overall reported break rates from this survey and the two previous reports (Folkman, 2012; 2018). It is apparent from the figure that the current survey represents a significant number of pipe miles. Even with this large sample size, the overall break rates are relatively consistent with only a slight reduction in failure rates in the last five years. This decrease may indicate that more utilities are applying asset management techniques and replacing pipe with the highest break frequency.

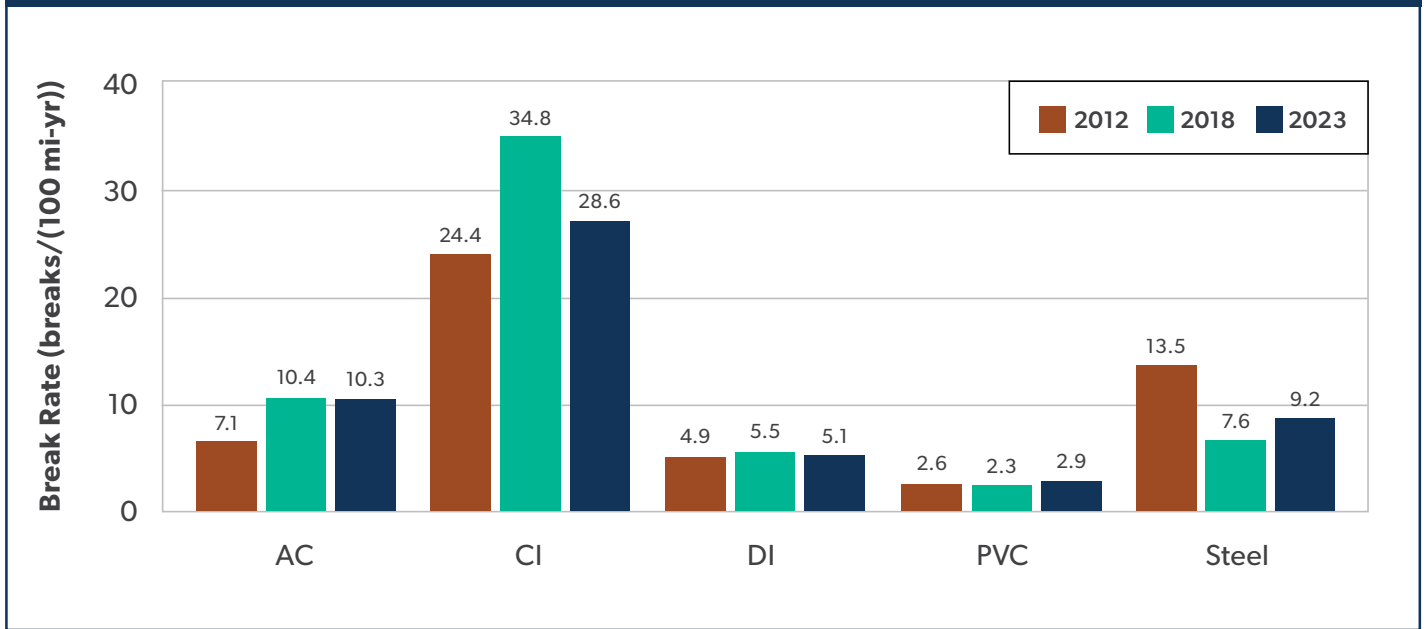
FIGURE 31: COMPARISON OF BREAK RATES FROM THE 2012, 2018, AND 2023 BASIC SURVEYS

Figure 31 compares the break rates of common water pipe materials from the 2012, 2018, and 2023 USU surveys. The consistent break rates across the three studies help to validate the accuracy of the data. Small variations can be assumed to be data scatter. Since about 90% of installed pipe consists of AC, CI, DI, and PVC, the break rates for these materials are the most accurate, which avoids inaccurate calculations for pipe materials with low reported mileage. Figure 31 shows an insignificant break rate change over time for PVC and DI pipe.

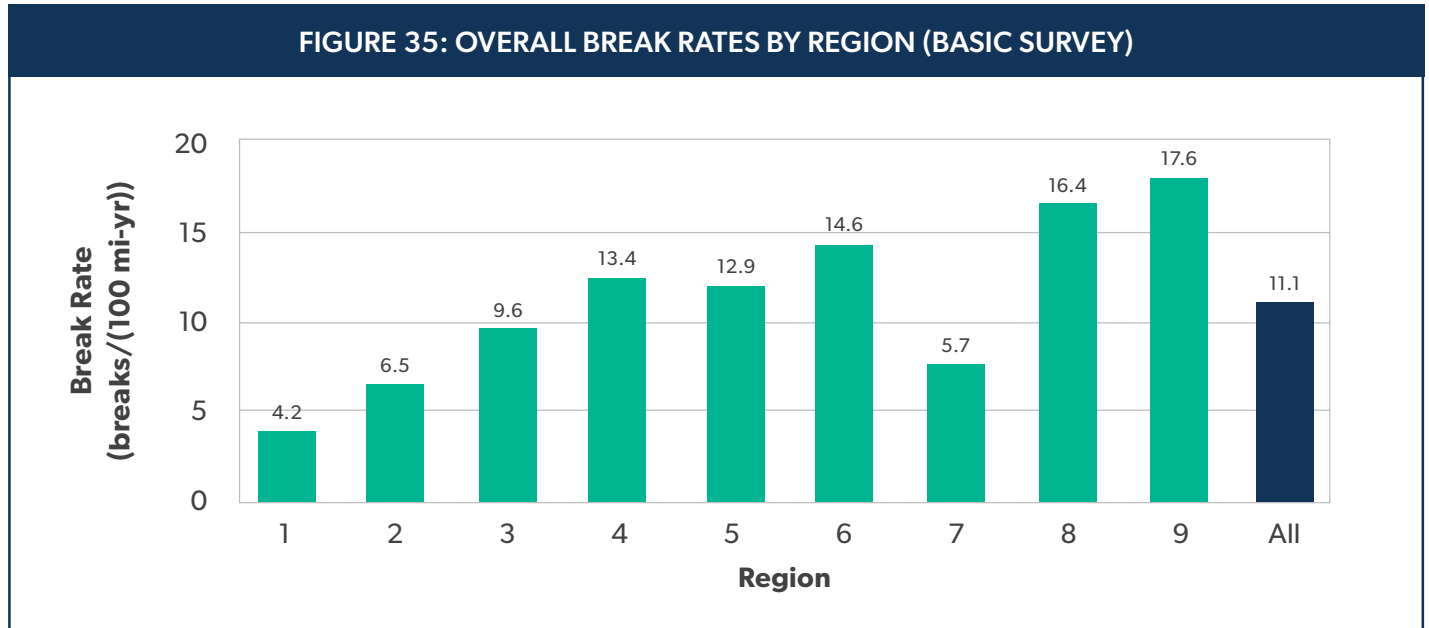
Figure 35 illustrates the reported overall break rates by region (Figure 15). In Table 1, the number of respondents for each region is summarized. Not all regions are experiencing the same failure rate. Five of the regions (4, 5, 6, 8, and 9) are above the overall average break rate.

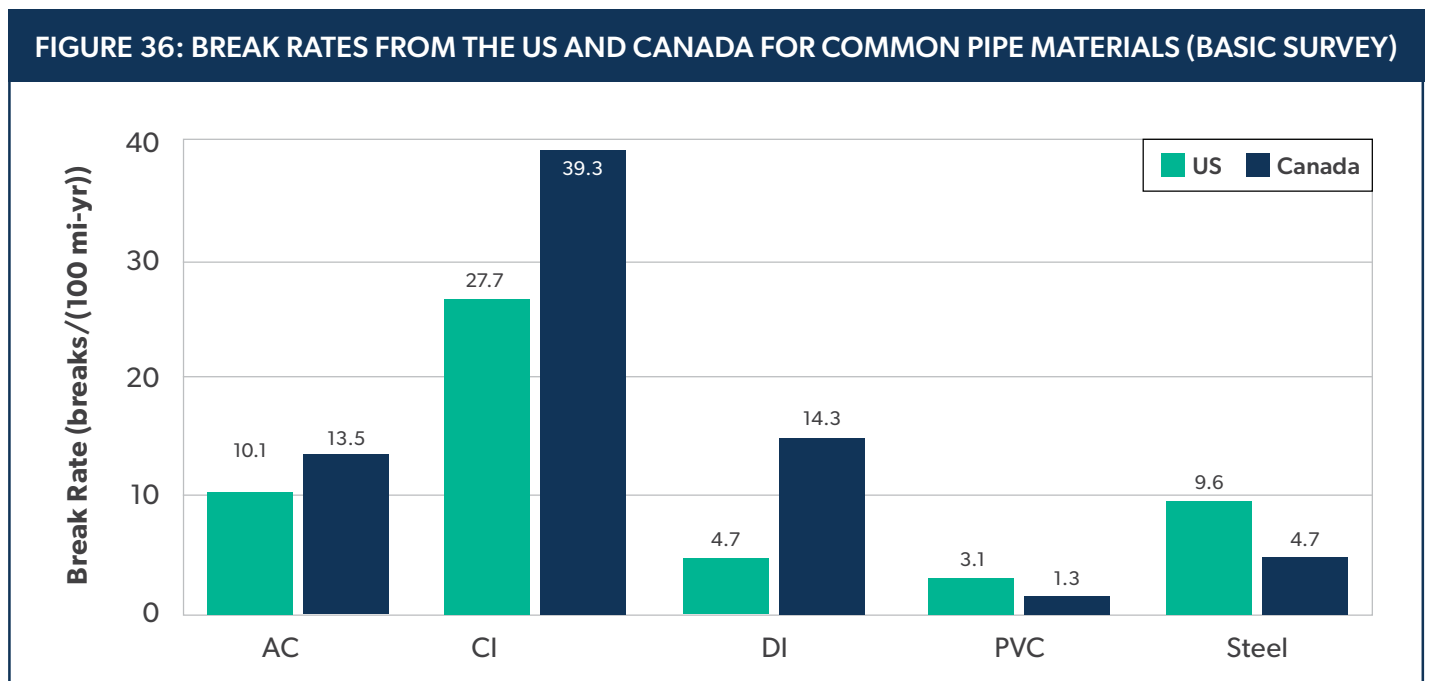
Figure 36 shows the break rates between US and Canada for the most common water pipe materials. It should be noted that portions of Canada have very corrosive soils and can have extremely cold weather. These factors could potentially explain the high Canadian break rates for CI and DI pipes (Seargeant, 2018).

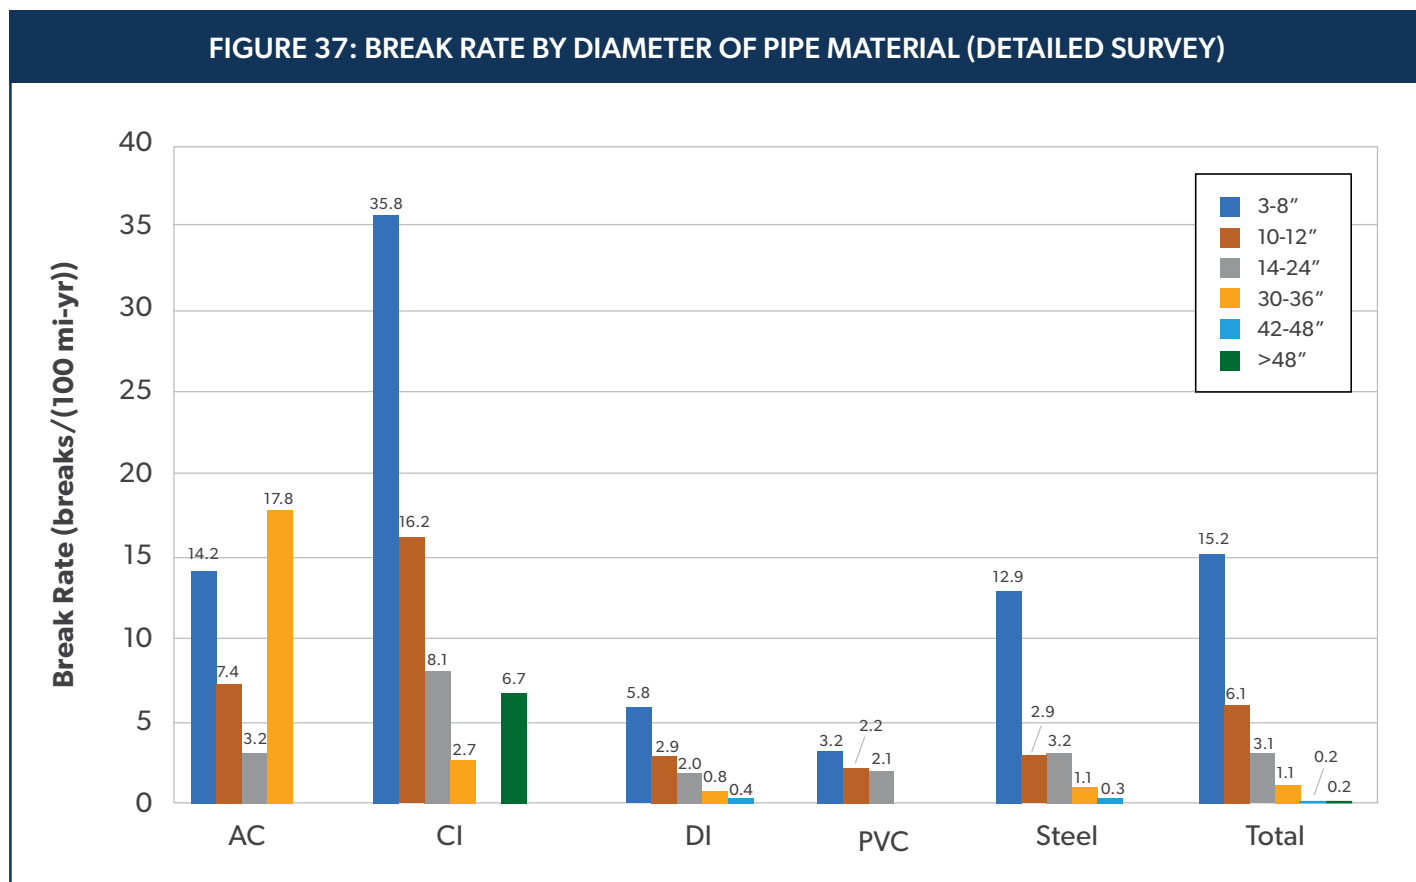
The detailed survey asked utilities for information on the size of different pipe materials in their water systems and their corresponding break rates. Figure 37 illustrates how the break rate changes as a function of pipe diameter. It is noteworthy that the break rate for all materials decreases as pipe diameter is increased. This is likely because of the greater effort put into installing, maintaining, and monitoring larger diameter pipes due to a higher consequence of failure. The higher break rates in larger diameters for AC and CI pipe are likely due to the low number of miles for these materials in this survey.

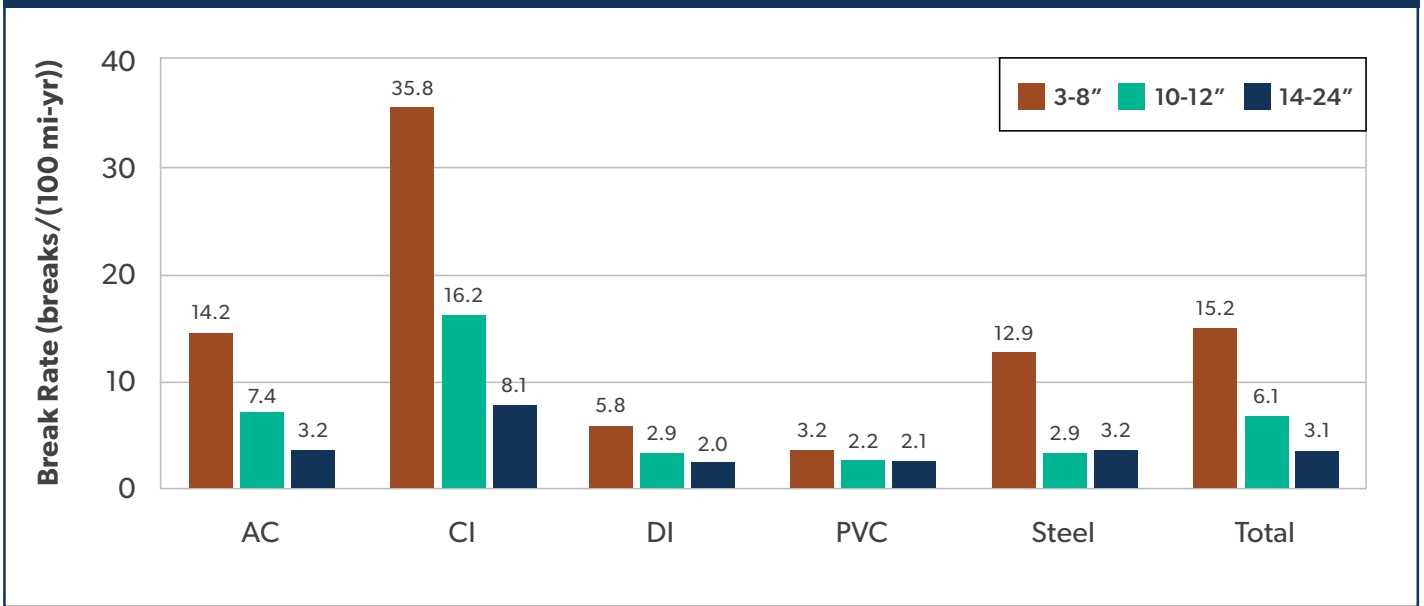
FIGURE 38: BREAK RATES FOR 3- TO 8-INCH, 10- TO 12-INCH, AND 14- TO 24-INCH PIPE BY MATERIAL (DETAILED SURVEY)

Figure 38 displays the break rates for the following size ranges: 3- to 8-inch, 10- to 12-inch, and 14- to 24-inch pipe. The objective is to focus more on the most used pipe diameters. The 14- to 24-inch sizes are commonly considered transmission mains, while 12-inch pipe and smaller is usually categorized as distribution pipe. Figure 23 indicates that 86% of all miles of water pipes are 3- to 12-inch in diameter, and a total of 68% are 3- to 8-inch in size.

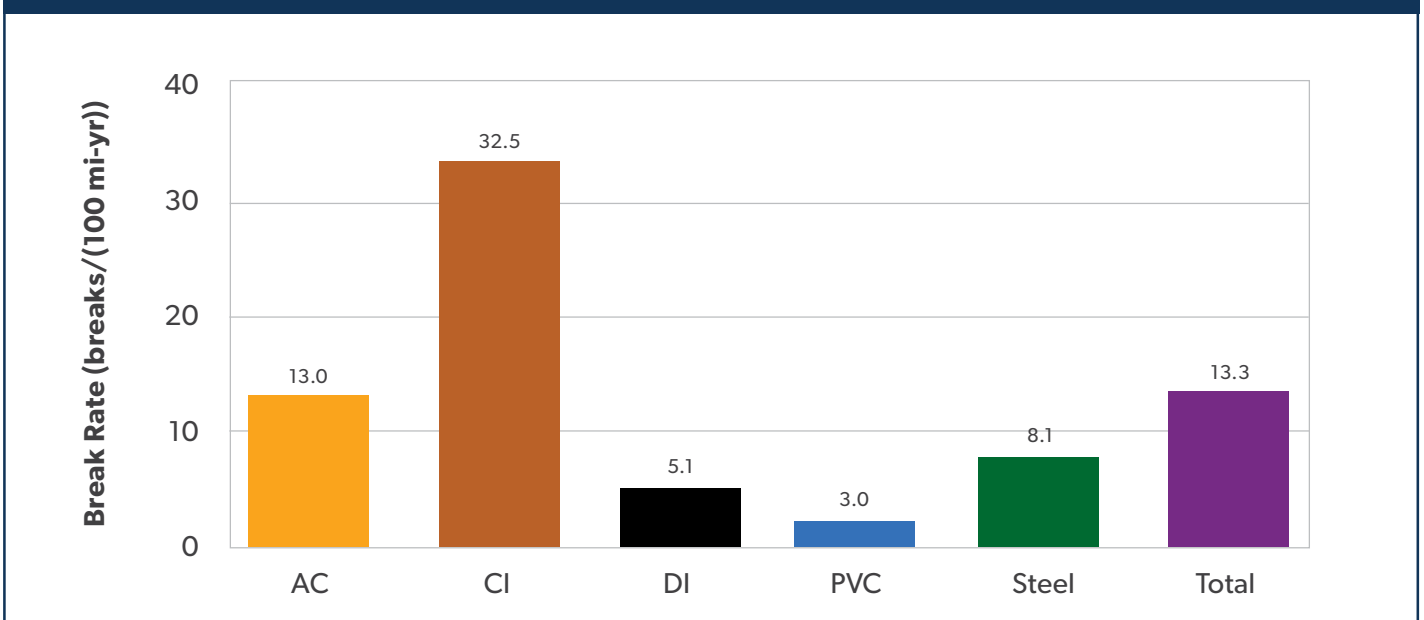
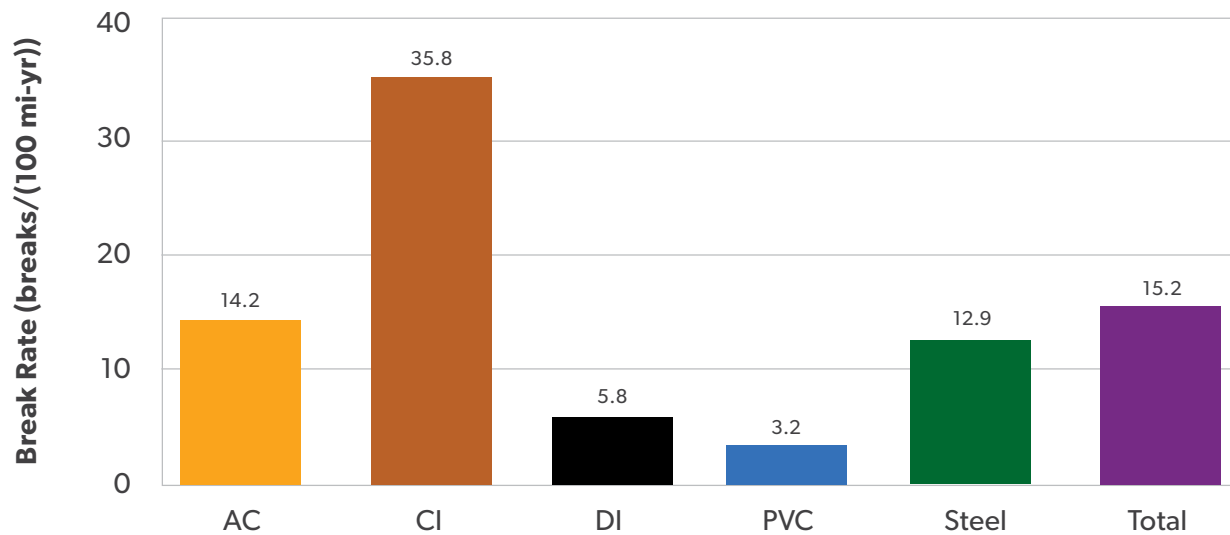
FIGURE 39: BREAK RATES OF 3- TO 12-INCH PIPE BY MATERIAL (DETAILED SURVEY)

Figure 39 illustrates the break rate of 3- to 12-inch pipe, while Figure 40 indicates the break rates of 3- to 8-inch pipe. Comparing these two figures shows a small difference in break rates. The 3- to 12-inch diameter range represents 86% of all pipe materials.

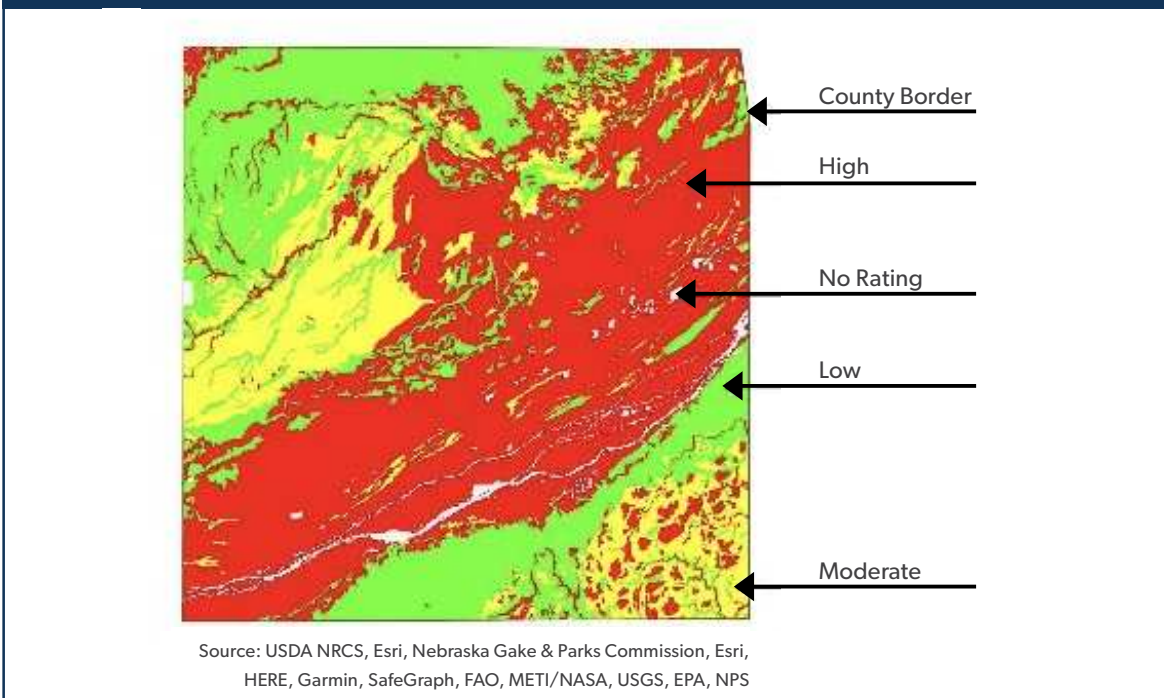
FIGURE 43: COUNTY MAP SHOWING CORROSIVE SOIL RISK

Corrosion index values were computed for 458 counties in the US. For example, the county shown in Figure 43 generated a corrosion index of 2.2, which is slightly above a moderate level. Some US counties had little or no data for the soils inside their boundaries, preventing determination of a corrosion index.

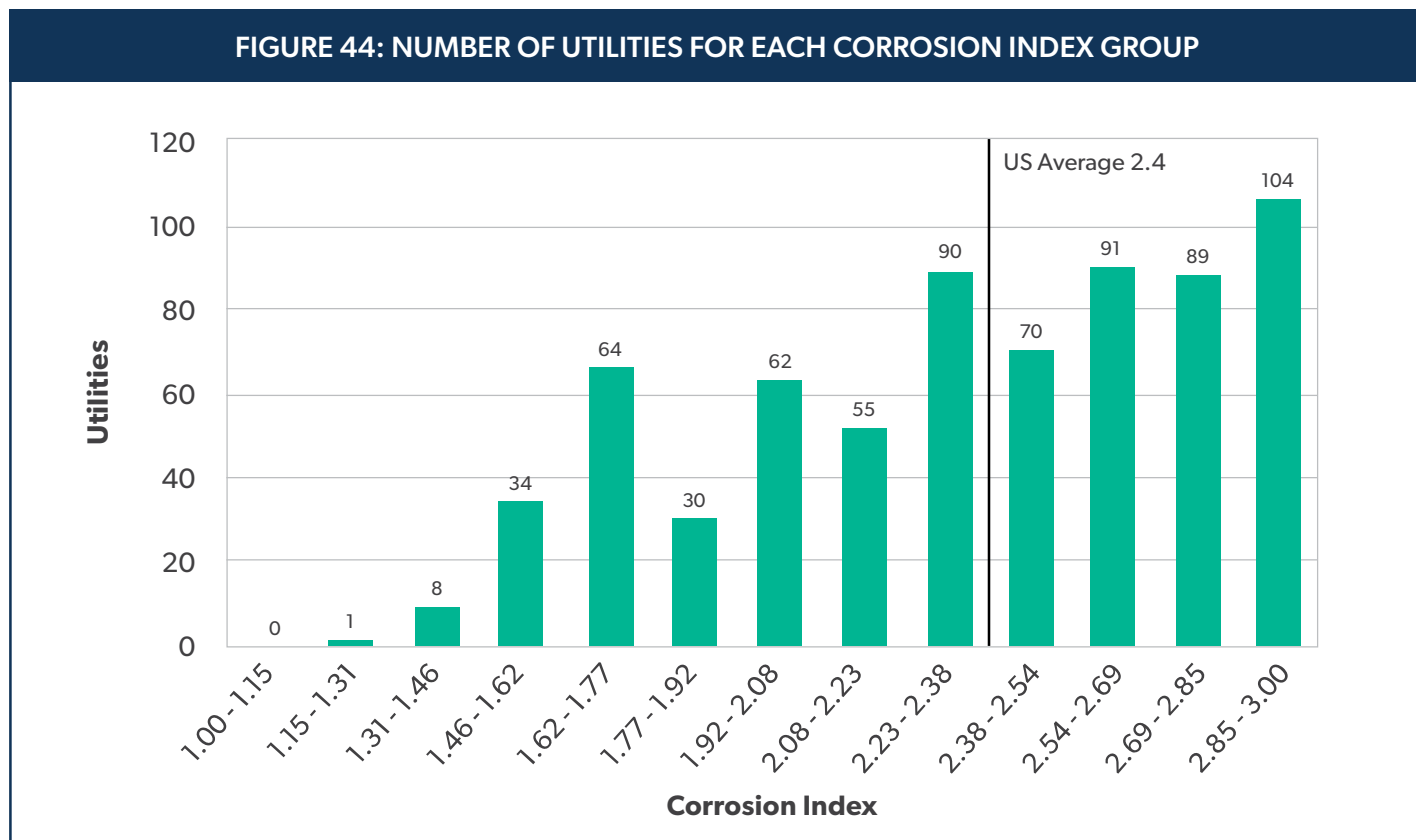
The corrosion index value calculated for each county was placed into one of thirteen range categories, shown in Figure 44.

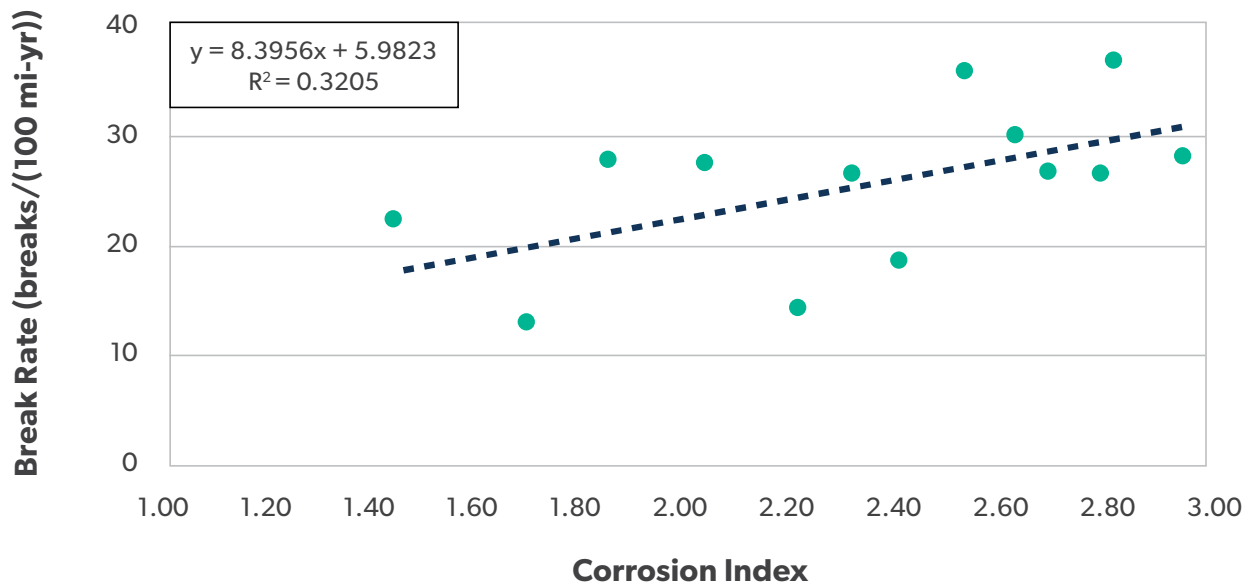
FIGURE 45: CAST IRON PIPE BREAK RATE BY CORROSION INDEX (BASIC SURVEY)

The slope of the line in Figure 45 demonstrates that CI pipe in highly corrosive soil (corrosion index of 3.0) is expected to have more than twice the break rate of one in low corrosive soil (corrosion index of 1.0). Similarly, Figure 46 shows that DI pipe in highly corrosive soil (corrosion index of 3.0) will have a break rate approximately six times greater than one in low corrosive soil (corrosion index of 1.0). Very poor correlations were found for all other pipe materials in this survey. It is understood that other factors not included in the survey may contribute to DI and CI pipe's failure rates.
