**SAFETY ENFORCEMENT DIVISION  
California Public Utilities Commission**

**USFS Slater Fire Investigation Report**

The case originated on September 8, 2020 when fire was reported in the early morning hours on Slater Butte within the KNF. The fire would eventually spread to the north and west and impact 157,229 acres to also include portions of the Six Rivers NF, the Rouge Siskiyou NF, and the counties of Siskiyou (CA), Del Norte (CA), and Josephine (OR).

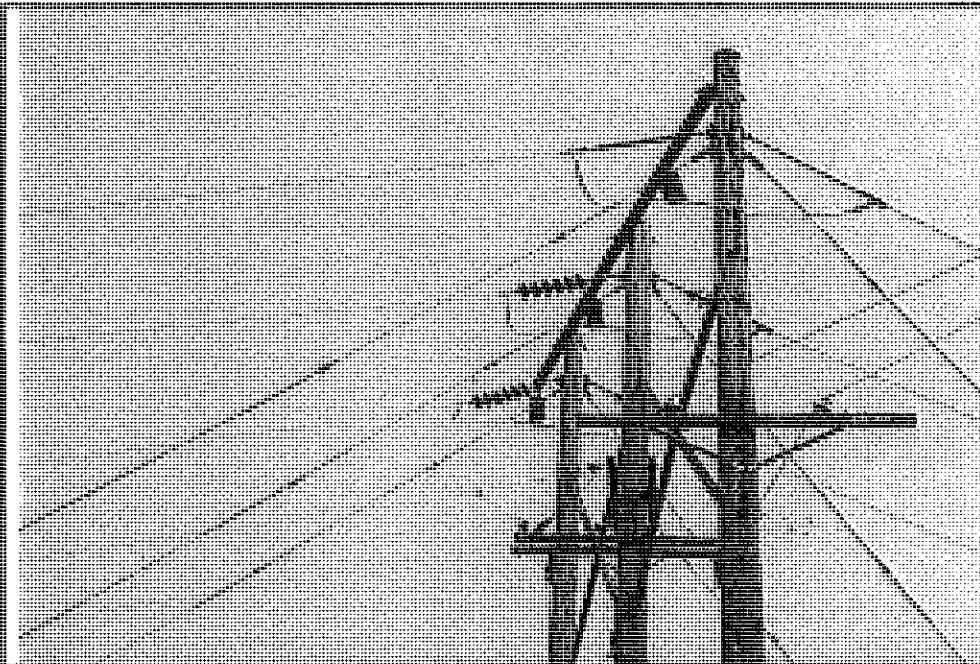
Photograph Number:  
5 Electrical  
Date:  
9/13/20  
Time:  
1:00  
Photographer:  
[REDACTED]  
Subject:  
Point at which where 69kV  
transmission line and 12kV  
distribution line diverge.

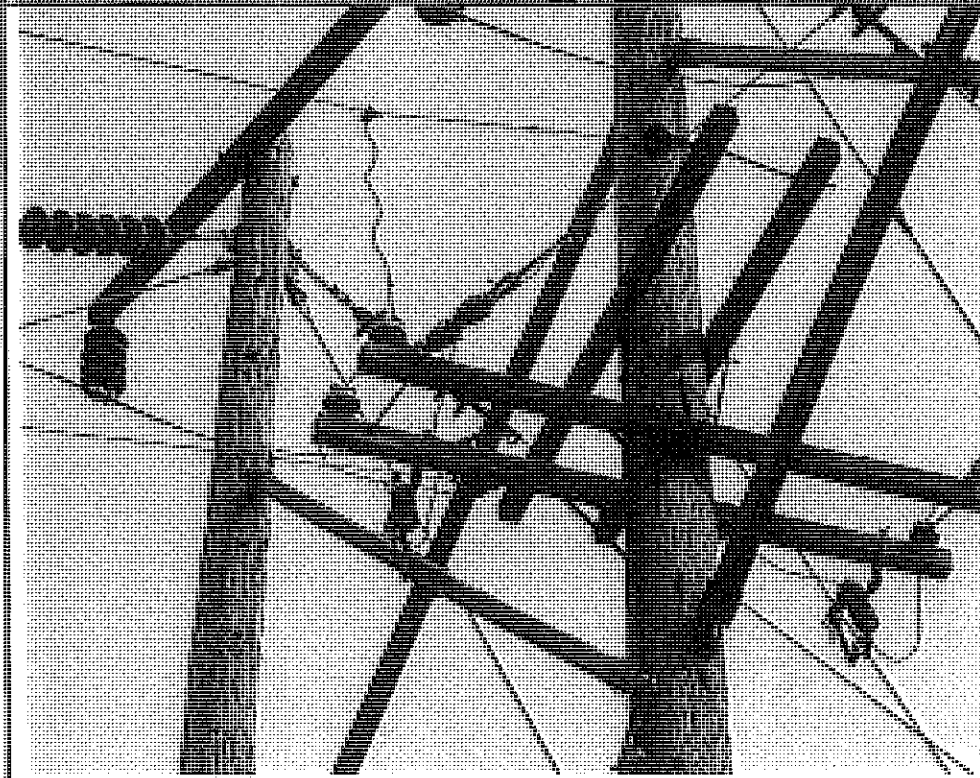
Photograph Number:  
6 Electrical  
Date:  
9/13/20  
Time:  
1:00  
Photographer:  
[REDACTED]  
Subject:  
Overall of lines on 12kV distribution  
line.

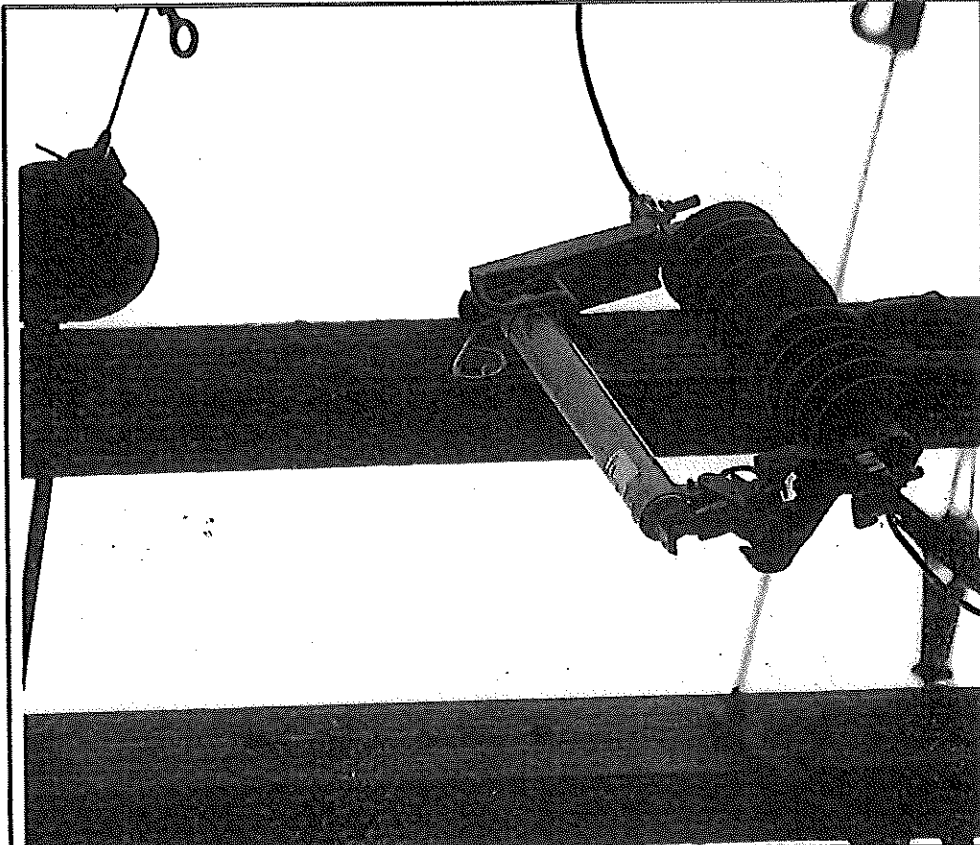
Photograph Number:  
12 Electrical  
Date:  
9/13/20  
Time:  
1115  
Photographer:  
b6 & b7C  
Subject:  
Close up of west fuse

Upon arrival on September 11, 2020 SA **b6 & b7C** and SA **b6 & b7C** located evidence of maintenance to the 12Kv power line. Two fuses were hanging from the center pole of the 69Kv transmission line. Several discarded pieces of power line and cooper wire were found within the power line right of way of the 12Kv distribution line. The power line pieces were determined to be discarded pieces from prior line maintenance due to the nature in the way it was located. The line was coiled and removed to the sides, or even outside the right of way. When digging out a fulgurite, solid copper wire was located buried below ground (**Exhibit 11- Discarded Conductor**).

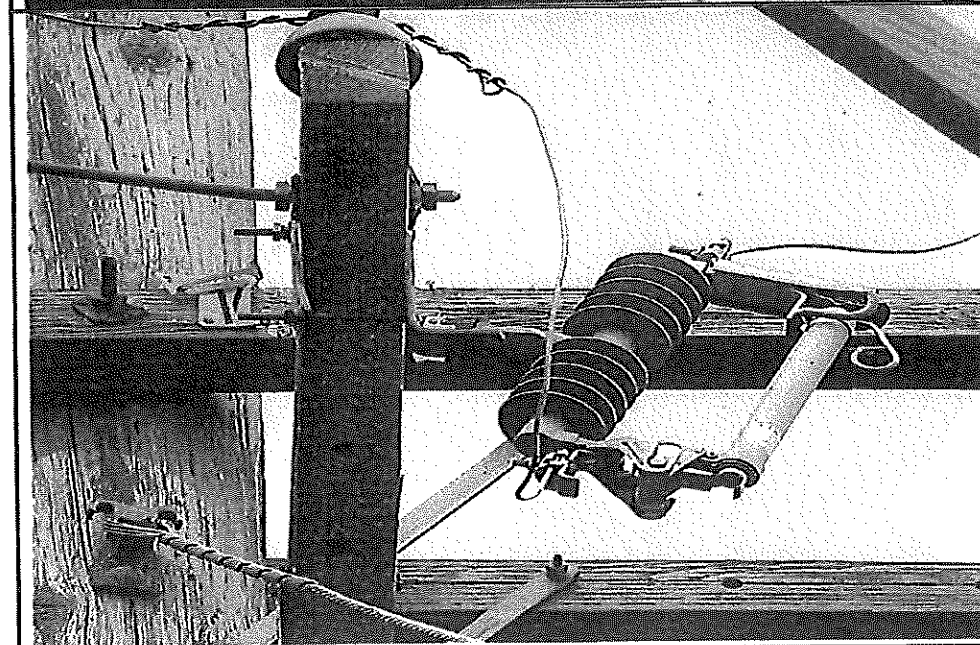
Photograph Number:  
15 Electrical  
Date:  
9/13/20  
Time:  
1118  
Photographer:  
b6 & b7C  
Subject:  
Close up of east fuse

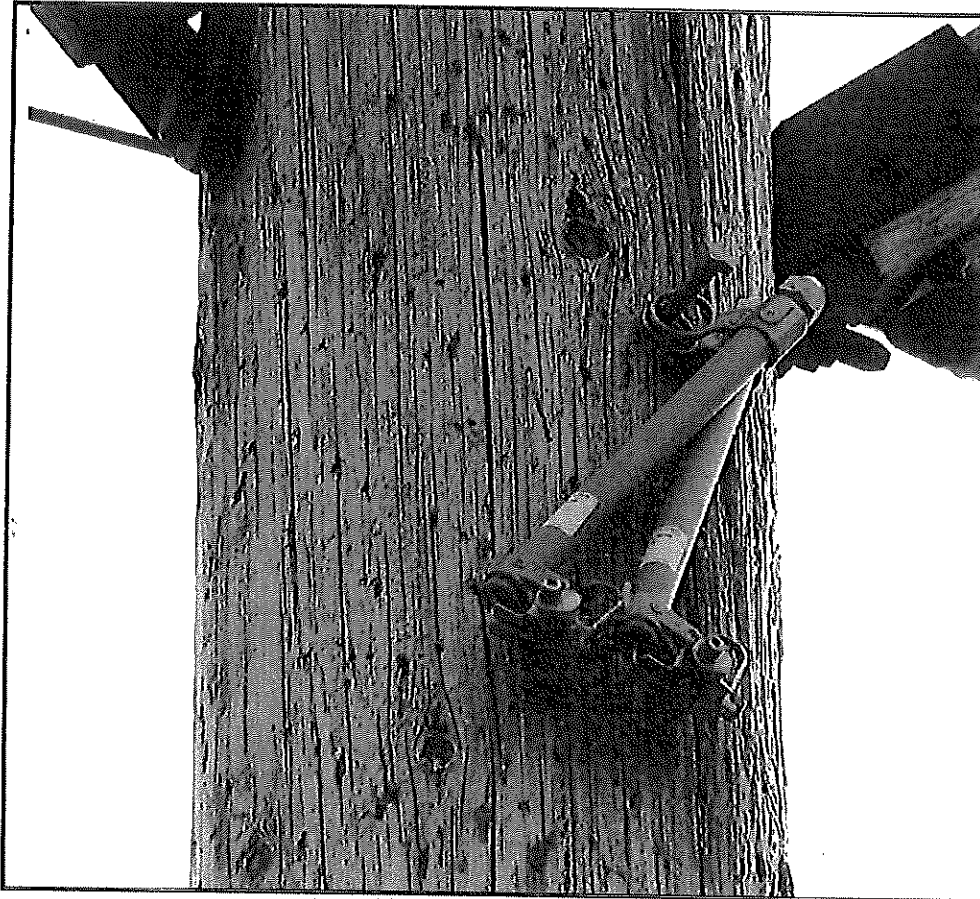
**Photograph Number:**  
19 Electrical  
**Date:**  
9/13/20  
**Time:**  
1122  
**Photographer:**  
b6 & b7C  
**Subject:**  
Close up of additional fuses hanging  
from pole

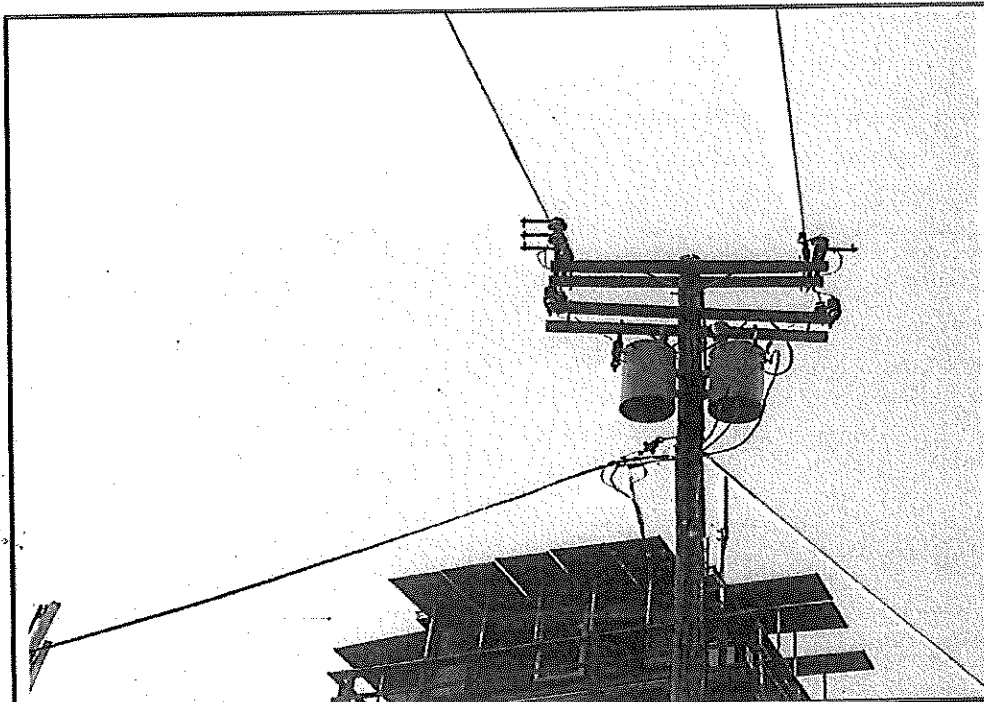
**Photograph Number:**  
55 Electrical  
**Date:**  
9/13/20  
**Time:**  
1228  
**Photographer:**  
b6 & b7C  
**Subject:**  
East side of Pole 1

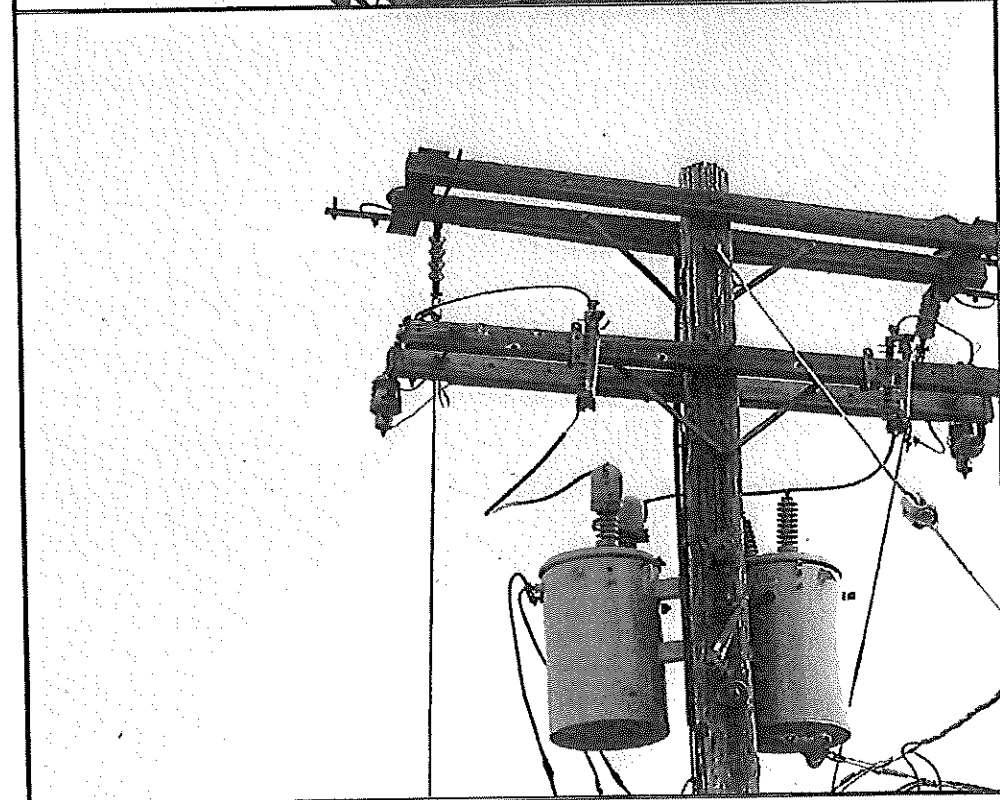
**Photograph Number:**  
58 Electrical  
**Date:**  
9/13/20  
**Time:**  
1230  
**Photographer:**  
b6 & b7C  
**Subject:**  
West side of Pole 1

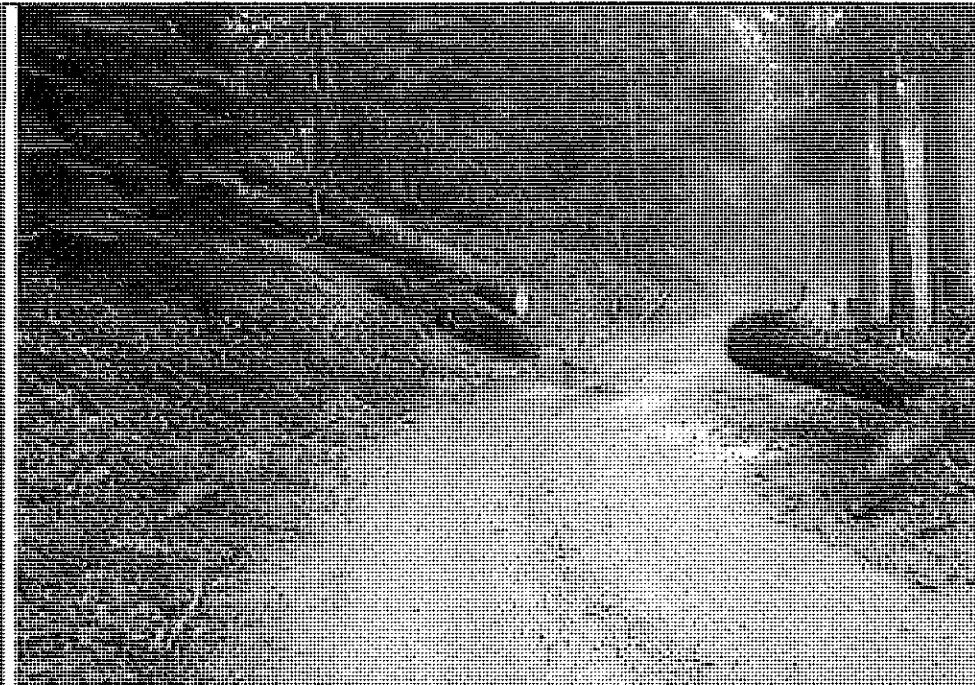
White Fir tree fallen across road  
across 12th distribution line to the  
west. Photo is looking to the north.

[b6 & b7C] located a tree across FR 17N48 when he left the lookout on the morning of September 8, 2020, just prior to the lookout gate across the road. Engine 327 was dispatched to remove the tree from the roadway in order to free [b6 & b7C]. Engine 327 cut five pieces out of the tree and rolled them off the downslope side of the road in order to open the road. The tree had partially uprooted as it fell. The trunk of the tree then cracked at about six feet above ground level on the windward (east) side. The tree then cracked open down to the ground level on the west side. The interior of the tree near the base was hollow with wet, rotten wood (**Exhibit 21- White Fire Tree Photos**). [b6 & b7C], a Forest Pathologist with the USFS examined the tree and determined it to be a White Fire. [b6 & b7C] found heart-rot in the basal portion of the bole from below ground level extending upwards approximately six feet. [b6 & b7C] also discovered a white-rot and Rhizomorphs (melanized mycelial cords) present on the decaying wood (**Exhibit 22- [b6 & b7C] REPORT**). A cross section of the tree base was collected and stored by the USFS as evidence. The tree measured approximately 137 feet tall. The upper branches of the tree, though now burned, showed evidence of green healthy needles and was producing cones. [b6 & b7C] an entomologist with the USFS described the tree as one that would not be identified or classified as a hazard given its outward appearance.

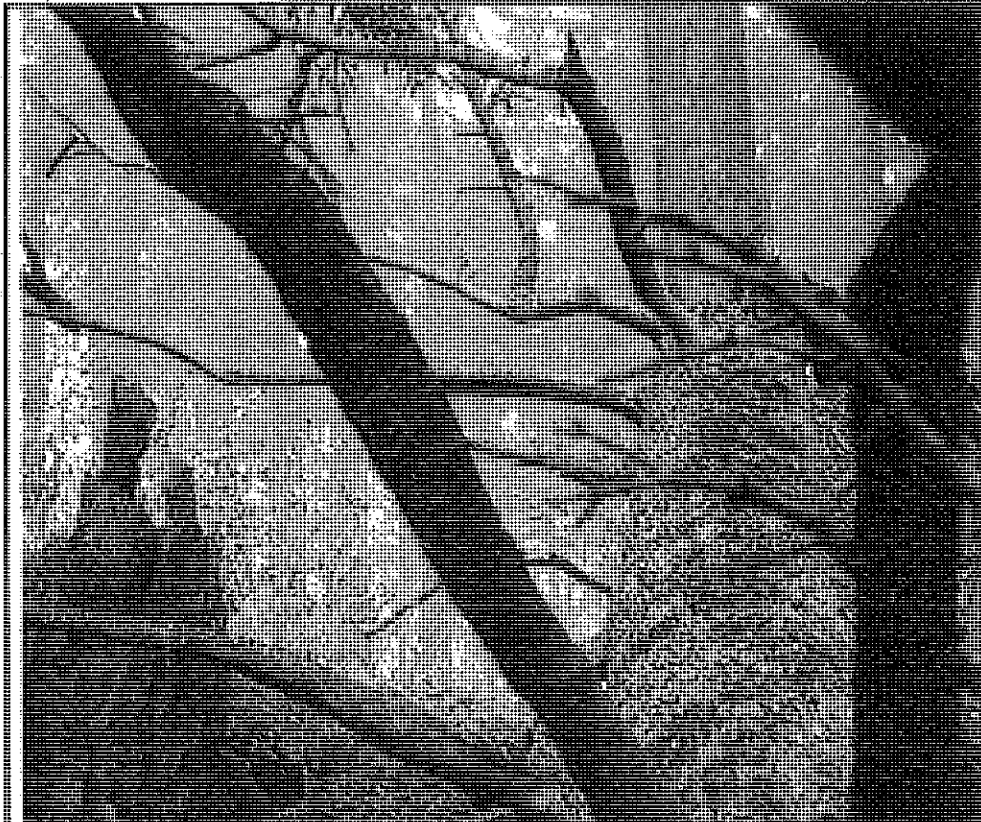
Photograph Number:  
57 Tree  
Date:  
9/12/20  
Time:  
10:51  
Photographer:  
EG & BTC  
Subject:  
Top of White Fir tree looking west  
with cum conductor visible near end  
of tree trunk.

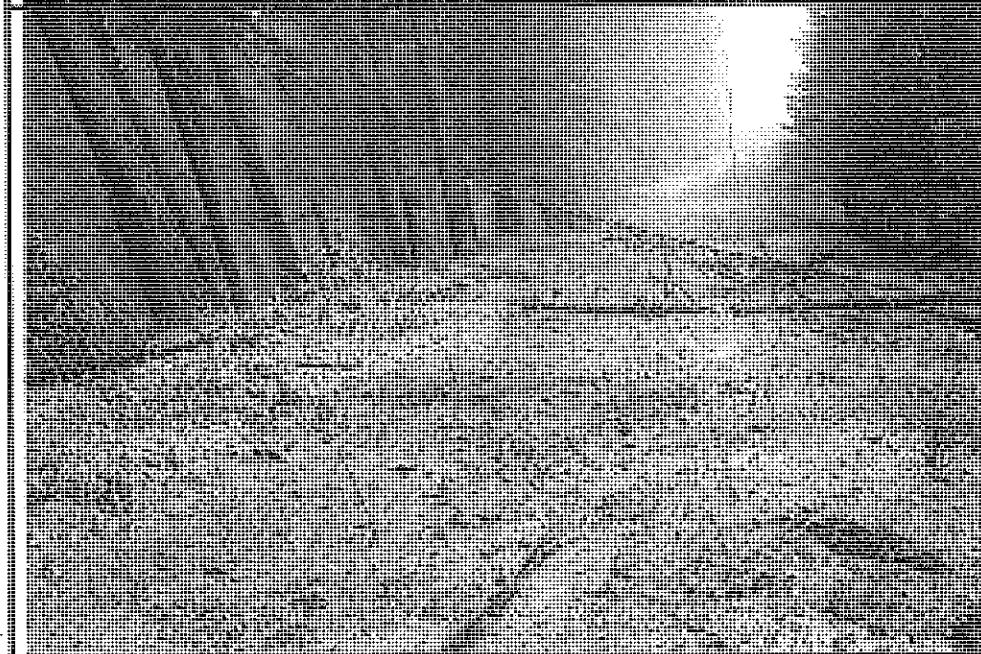
Photograph Number:  
58  
Date:  
9/12/20  
Time:  
10:52  
Photographer:  
EG & BTC  
Subject:  
Top of White Fir tree under EHV  
distribution line. Tree leaning on  
cum conductor not associated with  
initial wind event and cum.

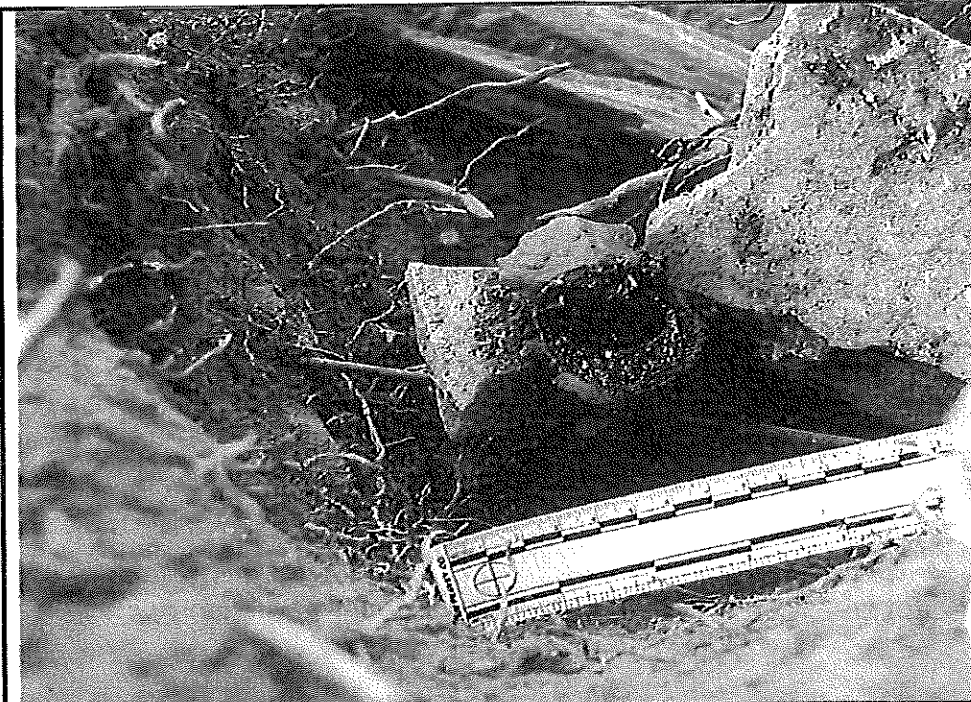
**Photograph Number:**  
38 Indicators and fulgurite  
**Date:**  
9/13/20  
**Time:**  
1337  
**Photographer:**  
b6 & b7C  
**Subject:**  
Solid copper wire fused to fulgurite  
below ground

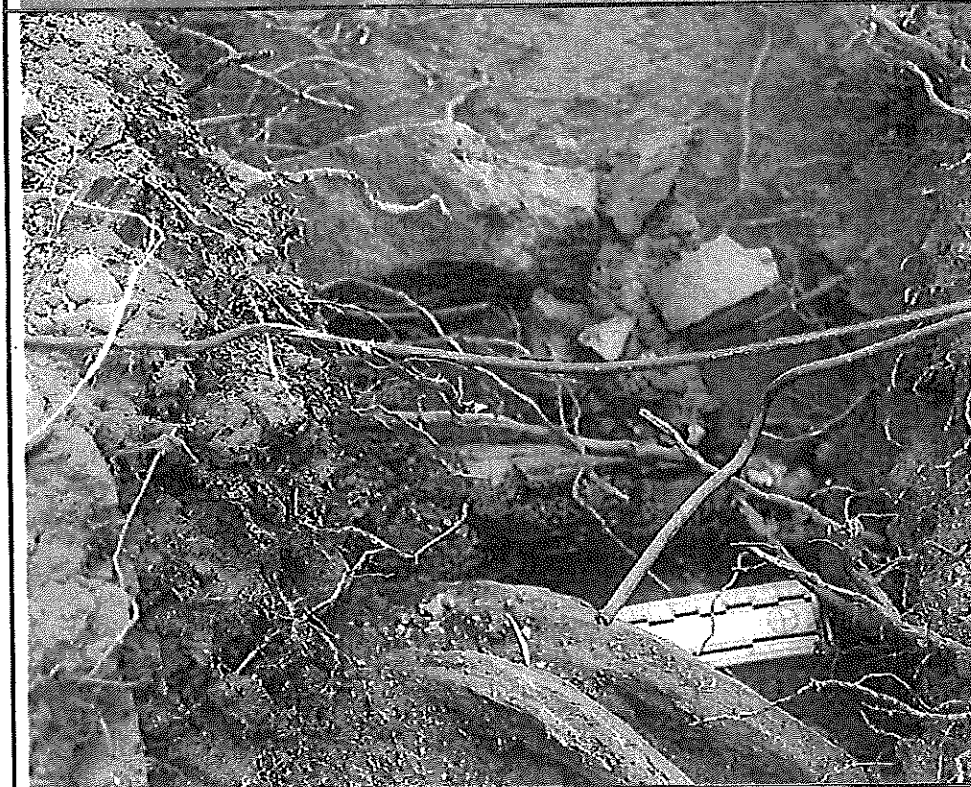
**Photograph Number:**  
39 Indicators and fulgurite  
**Date:**  
9/13/20  
**Time:**  
1338  
**Photographer:**  
b6 & b7C  
**Subject:**  
Base of fulgurite with discarded  
cooper wire from above.

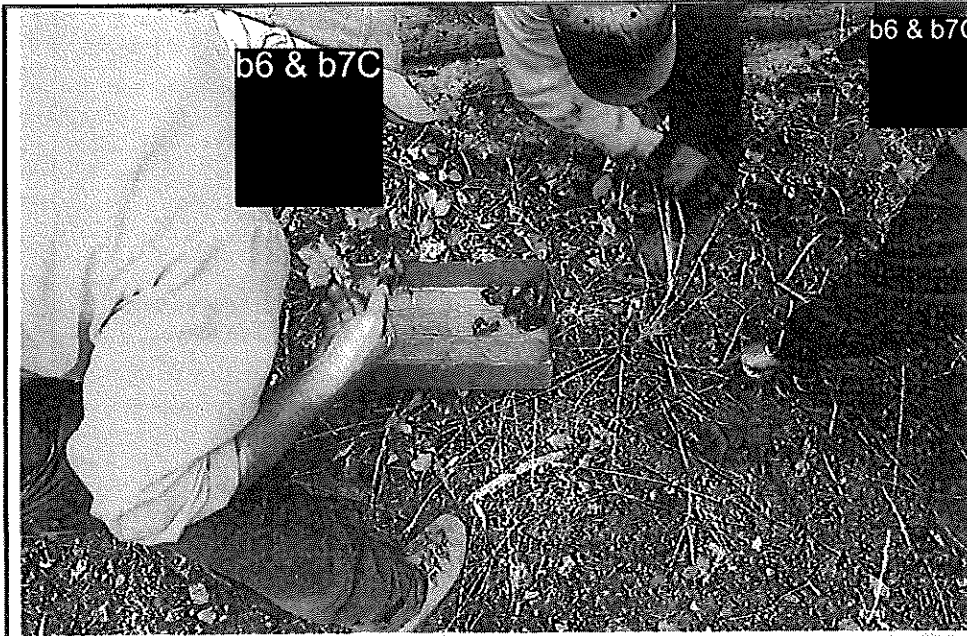
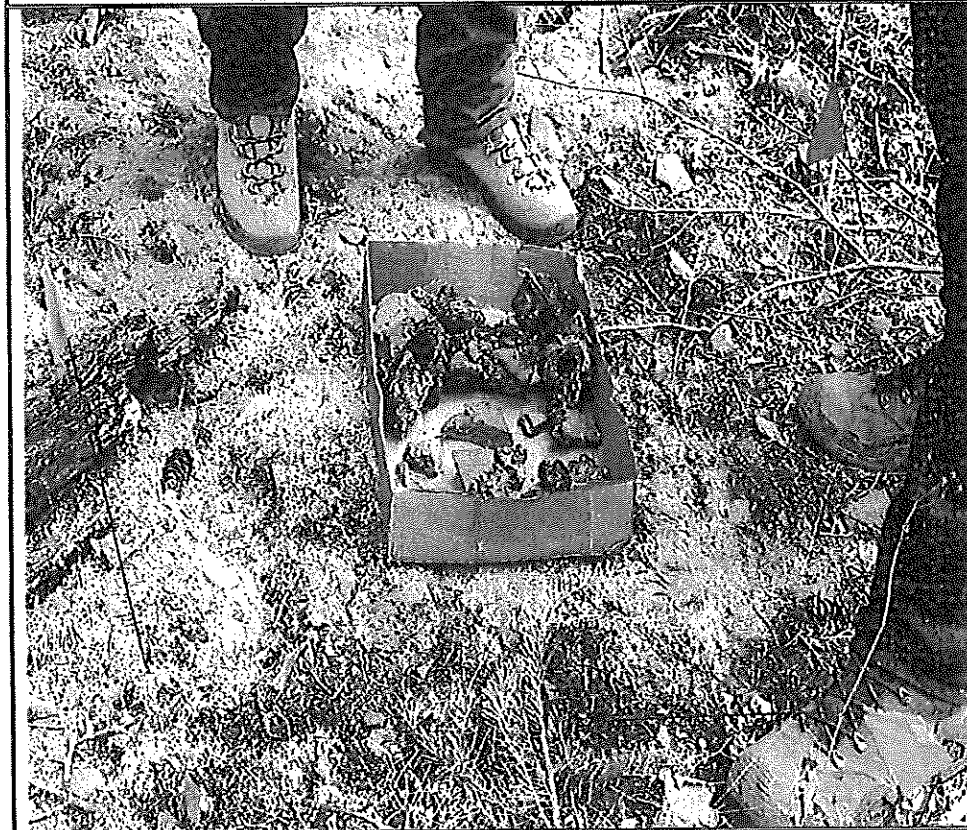
Photograph Number:  
b6 & b7C 2020-09-18 15-05-31  
Date:  
9/18/20  
Time:  
1508  
Photographer:  
b6 & b7C  
Subject:  
Fulgurite collection, created prior to Slater Fire.

Photograph Number:  
b6 & b7C 2020-09-18 15-07-02  
Date:  
9/18/20  
Time:  
1510  
Photographer:  
b6 & b7C  
Subject:  
Fulgurites created prior to Slater Fire

Outside of the general origin area, between Pole 5 and 6, SA **b6 & b7C** and SA **b6 & b7C** noticed numerous fulgurites. The fulgurites were generally small and weathered. Burn pattern indicators did not support any of these fulgurites being the origin of the Slater fire. A video was taken to document the locations of the fulgurites and at the conclusion of the investigation the fulgurites were removed and approximately 40 separate pieces of fulgurite were collected (**Exhibit 13- Prior Fulgurite Collection**). The presence of fulgurites indicates that at some point in the past live conductors had impacted the ground in this area.

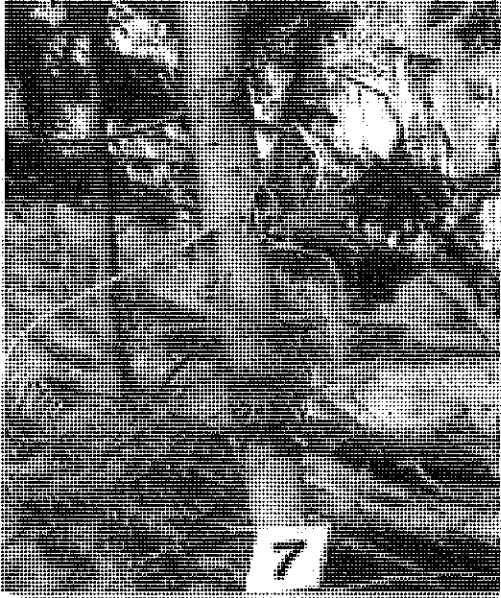
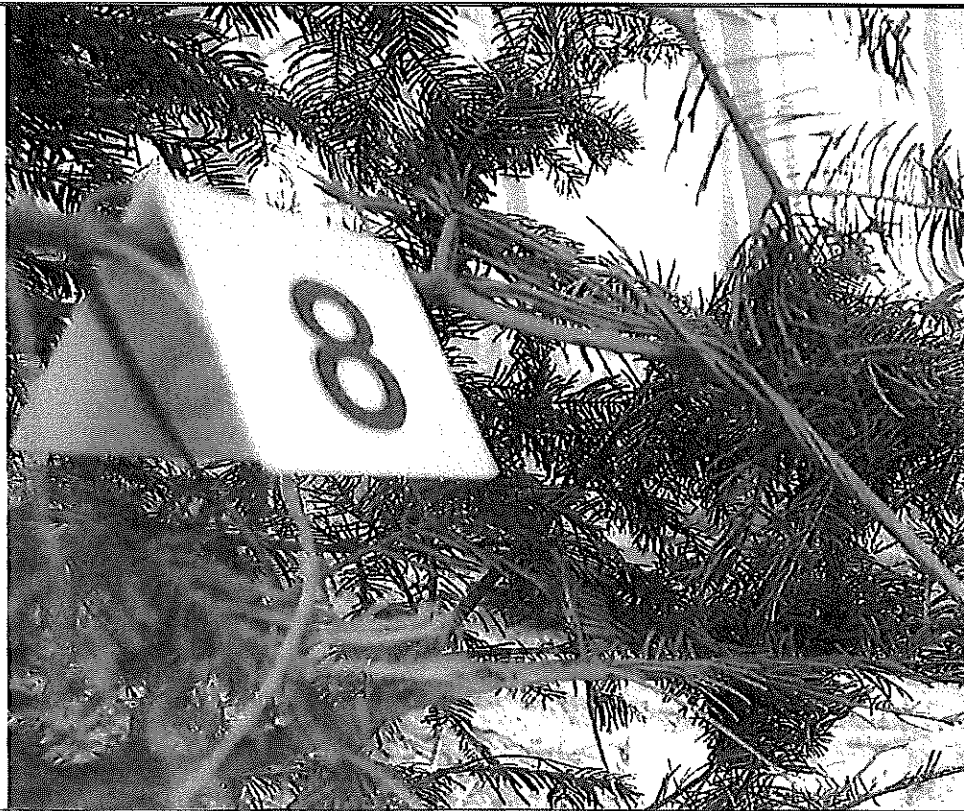
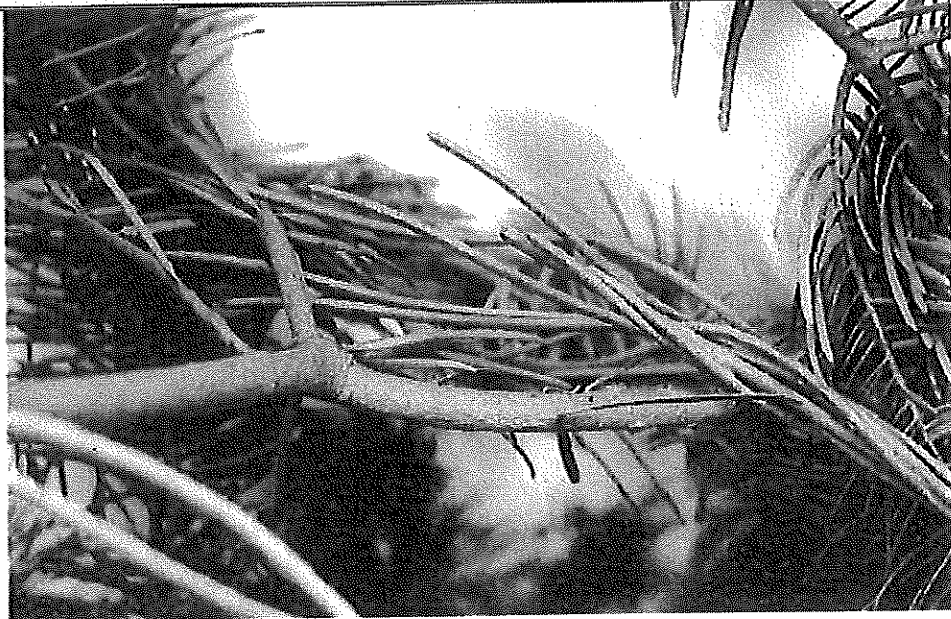
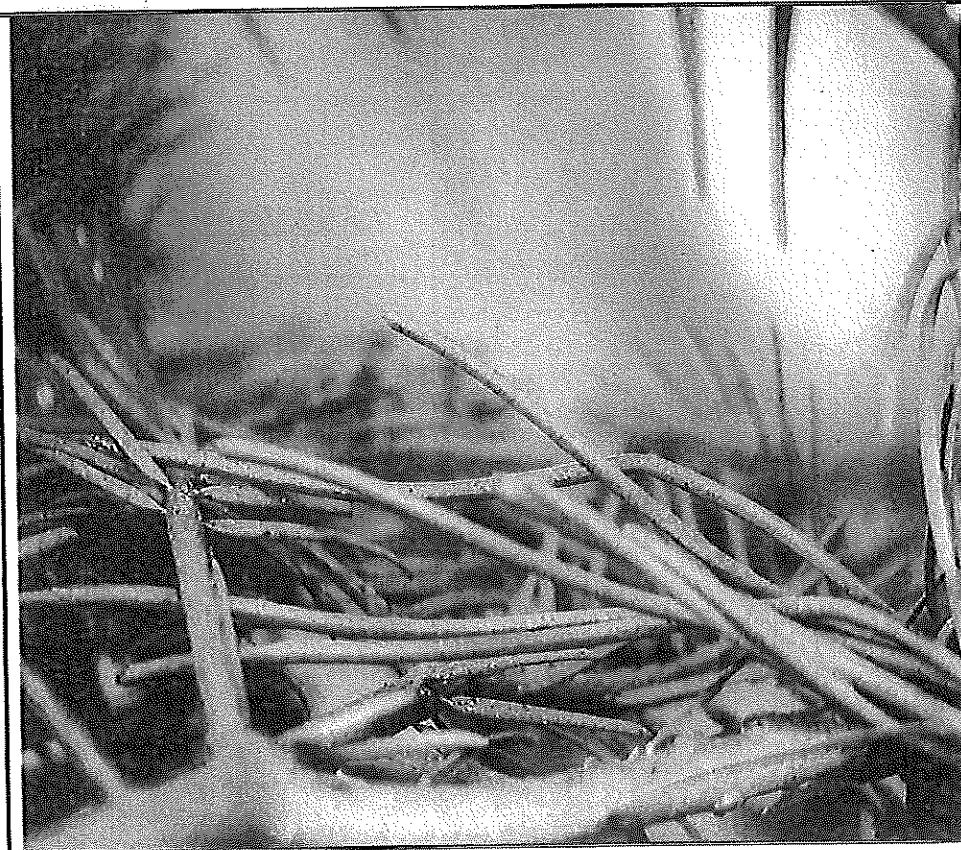
United States Department of Agriculture  
Forest Service  
**Exhibit 14**

**Photograph Number:**  
25 Electrical  
**Date:**  
9/12/2020  
**Time:**  
1402  
**Photographer:**  
b6 & b7C  
**Subject:**  
Charred tree with West Conductor  
north severed end in branches

**Photograph Number:**  
26 Electrical  
**Date:**  
9/12/20  
**Time:**  
1403  
**Photographer:**  
b6 & b7C  
**Subject:**  
West Conductor north severed end

**Photograph Number:**  
b6 & b7C 2020-09-18 13-27-55  
**Date:**  
9/18/20  
**Time:**  
1331  
**Photographer:**  
b6 & b7C  
**Subject:**  
Severed north end of west conductor

**Photograph Number:**  
b6 & b7C 2020-09-18 13-28-12  
**Date:**  
9/18/13  
**Time:**  
1331  
**Photographer:**  
b6 & b7C  
**Subject:**  
Severed north end of west conductor

The west conductor severed at the approximate location the top of the large fallen tree had entered the power line right of way between Pole 5 and Pole 4. The north end of the severed west conductor was gathered into a short tree and had more or less appeared to come down in the same place as it had been suspended. The tree had burn marks around all the branches emanating from the tree trunk indicating the tree had become electrically charged. The frayed north end of the west conductor had strands that were necked down consistent with a tensile overload fracture (**Exhibit 14- Photo of North End of West Conductor End in Charred Tree**). Several other stems on trees and shrubs were located nearby with electrically burned and charred vegetation. Marks on the conductor corresponded to the charred vegetation (**Exhibit 15- Charred Vegetation & West Conductor**). In several places along the conductor the outer aluminum strands had been melted and stretched revealing the inner steel center strand. Where the west conductor had severed the center steel strand was not visible and it appeared this thinner section may be comprised of only aluminum strands. Further testing will be required to determine the conductor configuration.

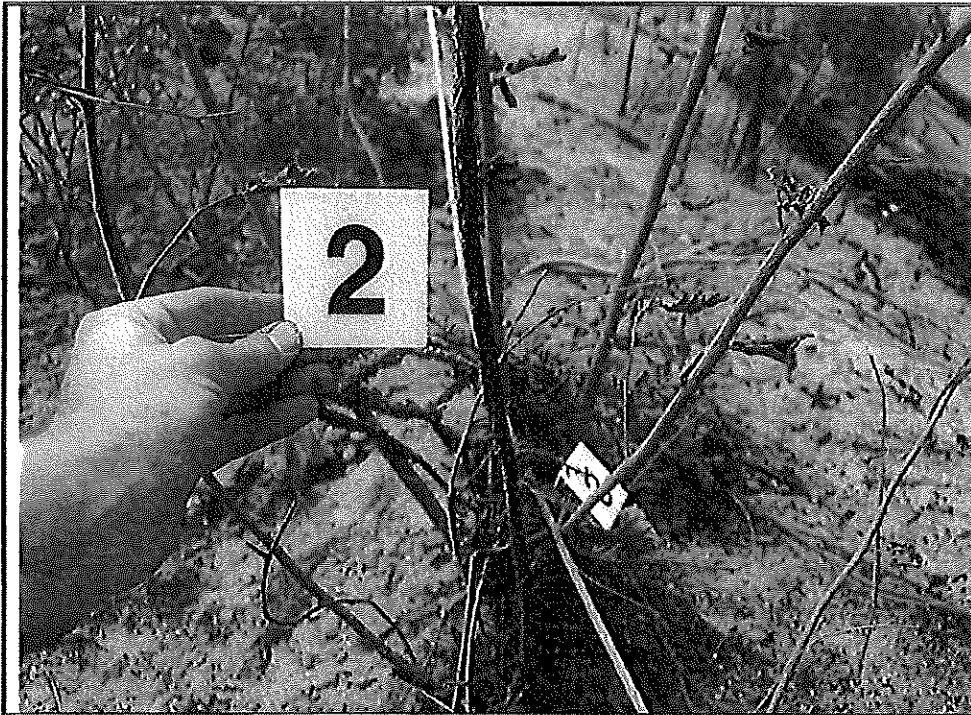
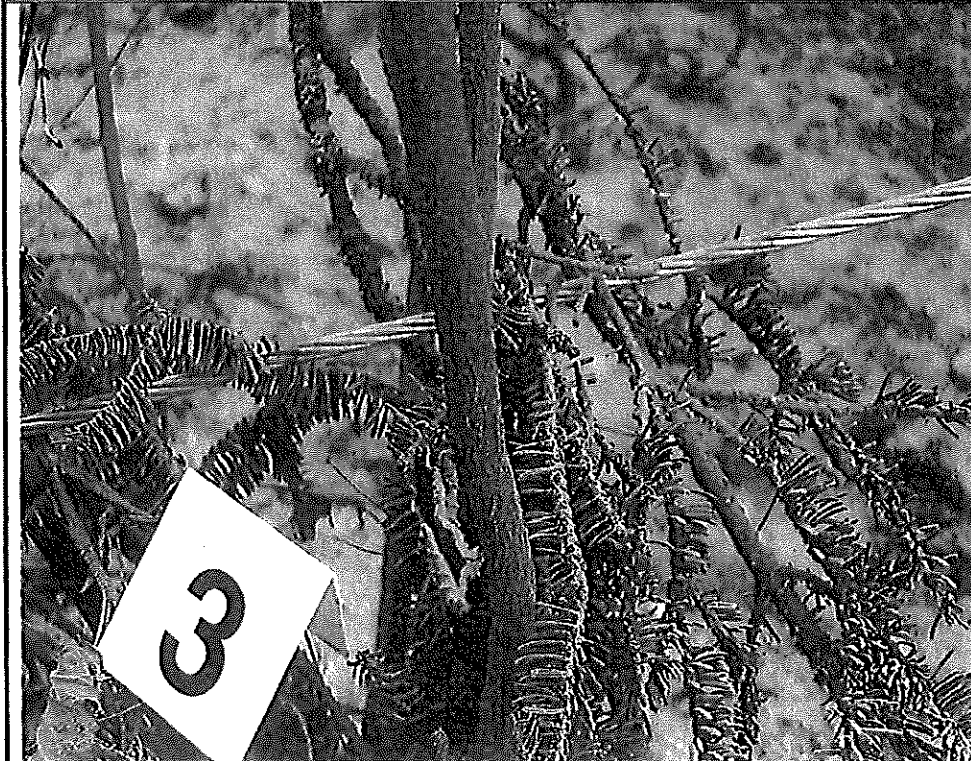
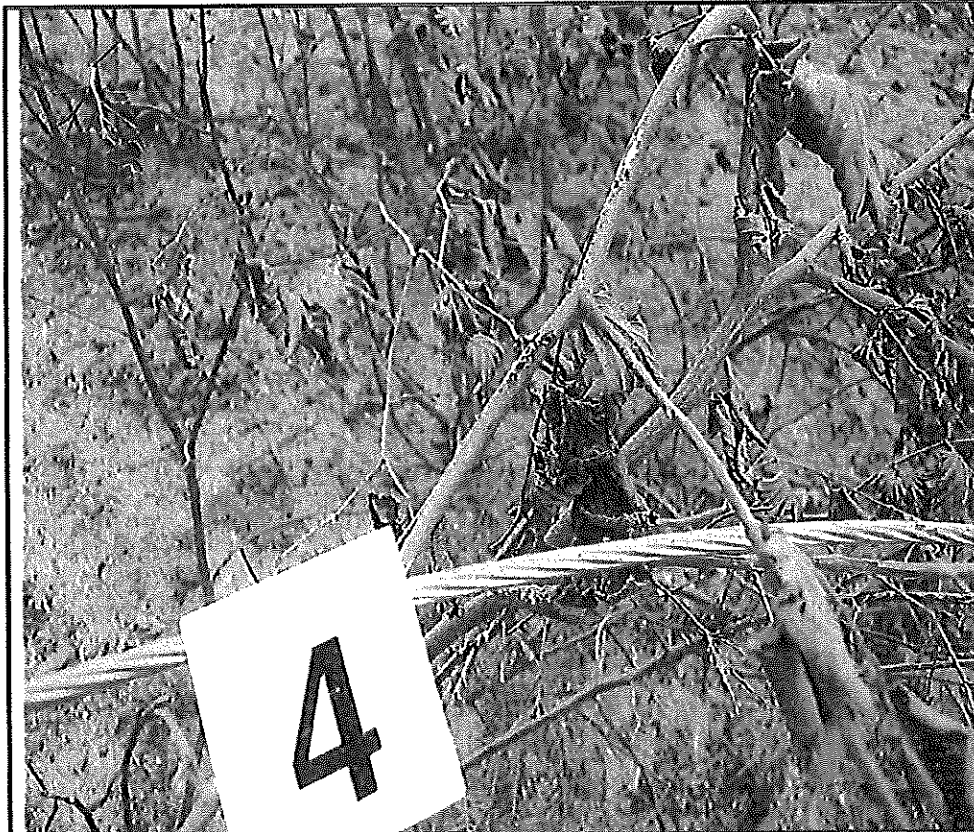
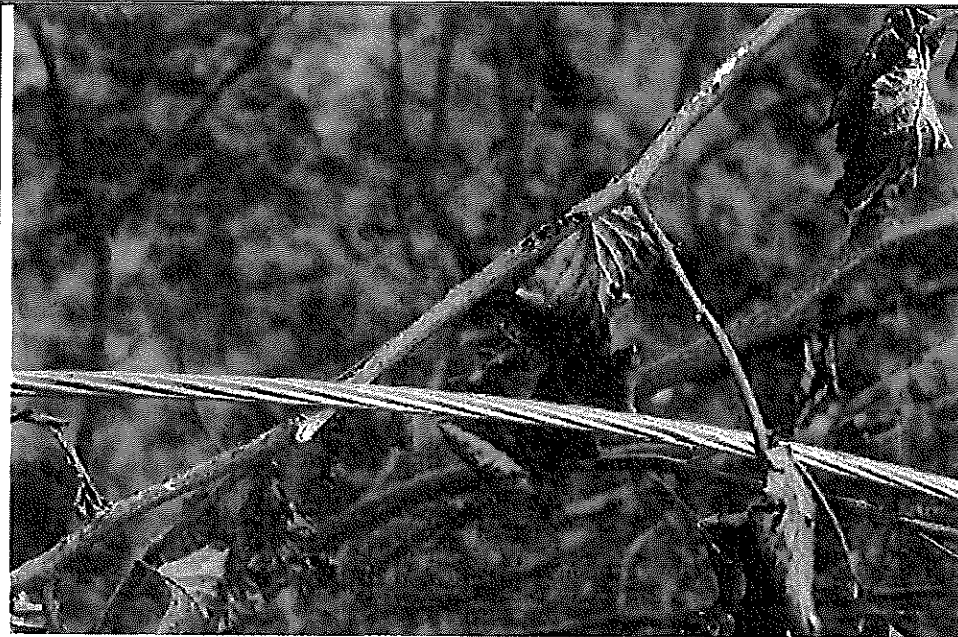
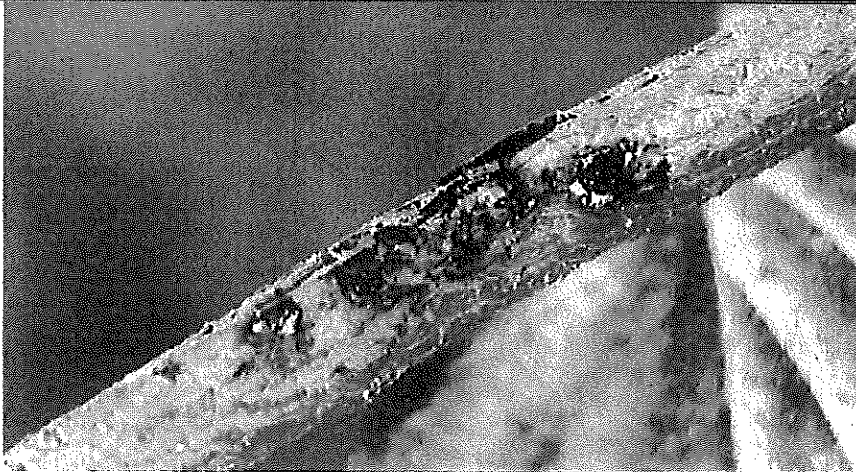
**Photograph Number:**  
20 Electrical  
**Date:**  
9/12/20  
**Time:**  
1355  
**Photographer:**  
b6 & b7C  
**Subject:**  
Charred Conductor Struck  
Vegetation

**Photograph Number:**  
21 Electrical  
**Date:**  
9/12/20  
**Time:**  
1356  
**Photographer:**  
b6 & b7C  
**Subject:**  
Charred Conductor Struck  
Vegetation

Photograph Number:  
22 Electrical  
Date:  
9/12/20  
Time:  
1358  
Photographer:  
b6 & b7C  
Subject:  
Charred Conductor Struck  
Vegetation

**Photograph Number:**  
b6 & b7C 2020-09-18 13-32-59  
**Date:**  
9/18/20  
**Time:**  
1336  
**Photographer:**  
b6 & b7C  
**Subject:**  
Electrically Charred Conductor  
Struck Vegetation

**Photograph Number:**  
b6 & b7C 2020-09-18 13-32-59  
**Date:**  
9-18-20  
**Time:**  
1336  
**Photographer:**  
b6 & b7C  
**Subject:**  
Close Up of Electrically Charred  
Conductor Struck Vegetation

The west conductor to the south of the severe had recoiled and had come to rest in the vegetation between Poles 4 and 3 (**Exhibit 16- Photo of South End of West Conductor End**). Vegetation in the area had charred marks indicating that the conductor remained energized after it had severed. An insulator was still attached to the west conductor from where it broke free from the top of Pole 4. The south end severe also had necked down strands consistent with a tensile overload fracture. No center steel strand was identifiable in the conductor.

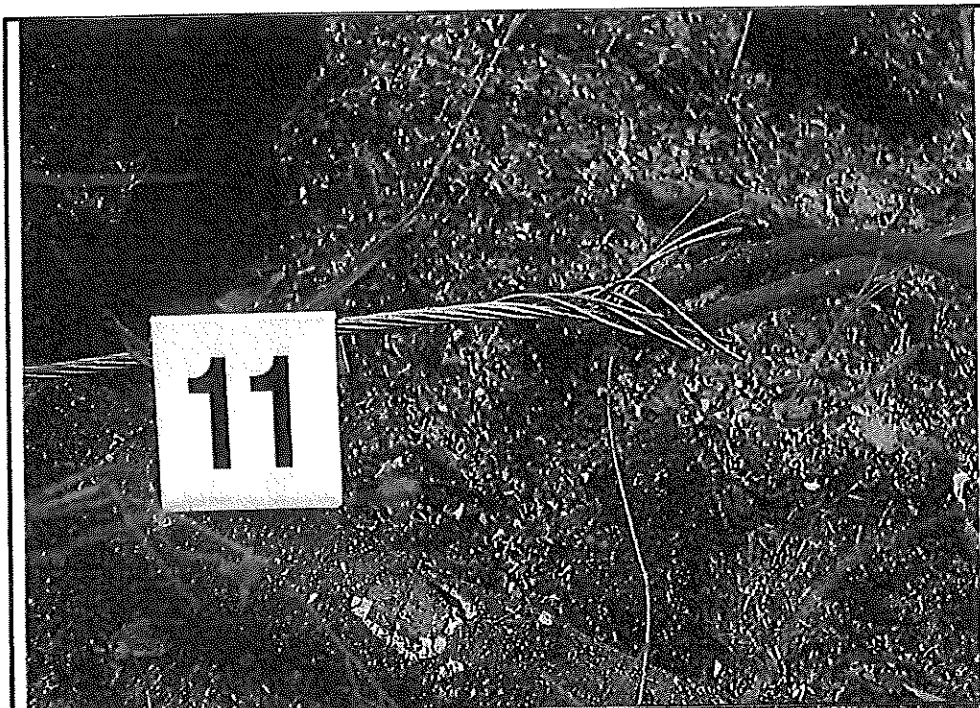
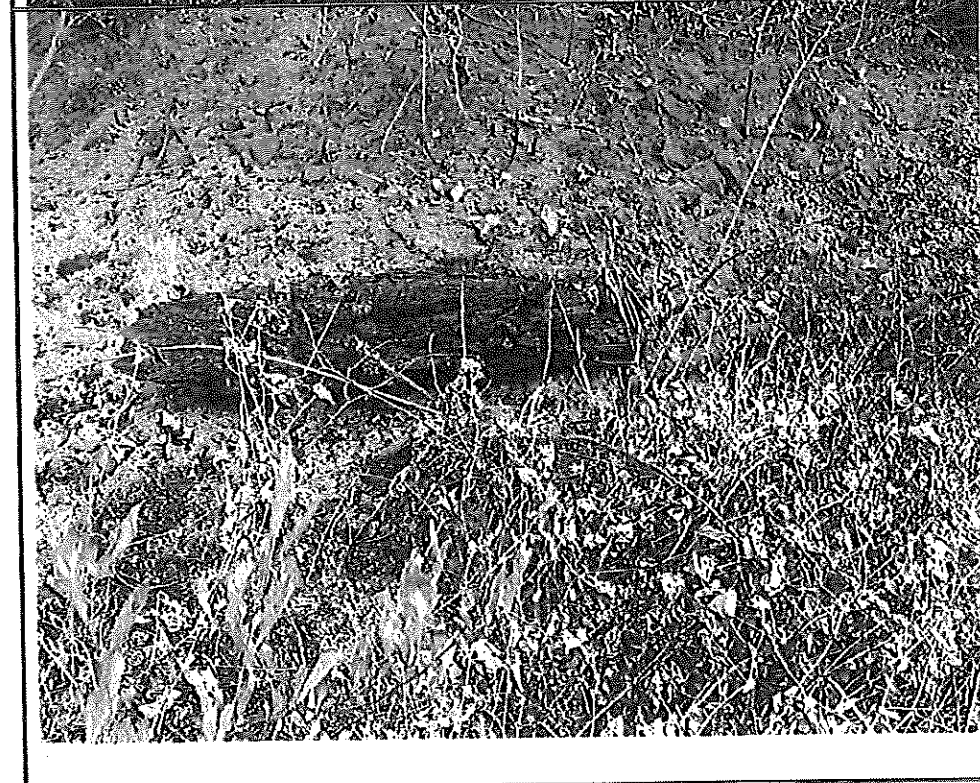
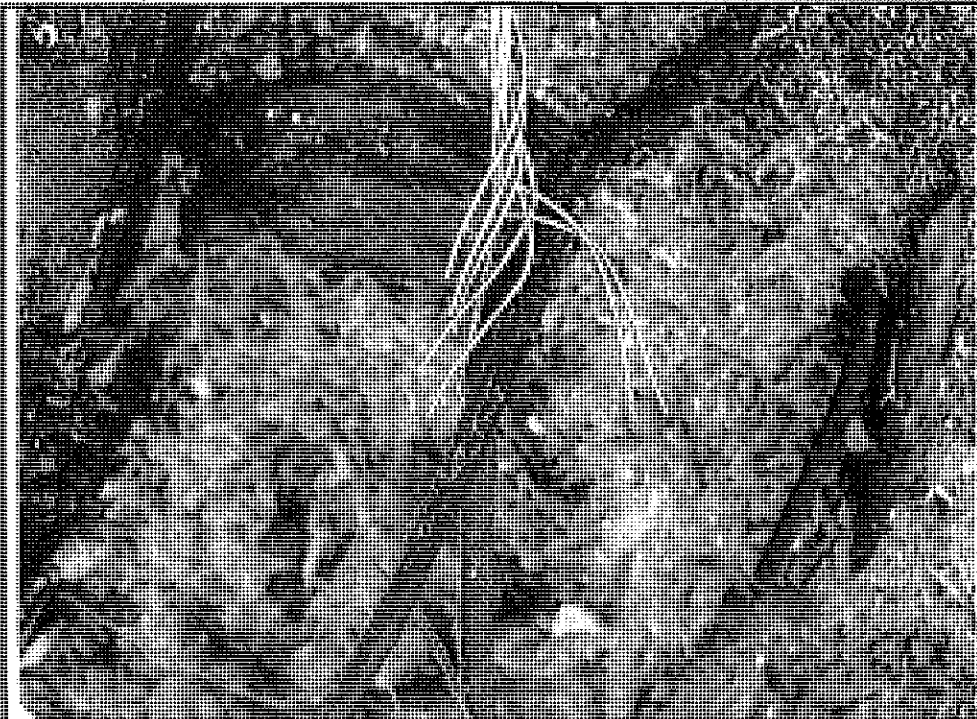
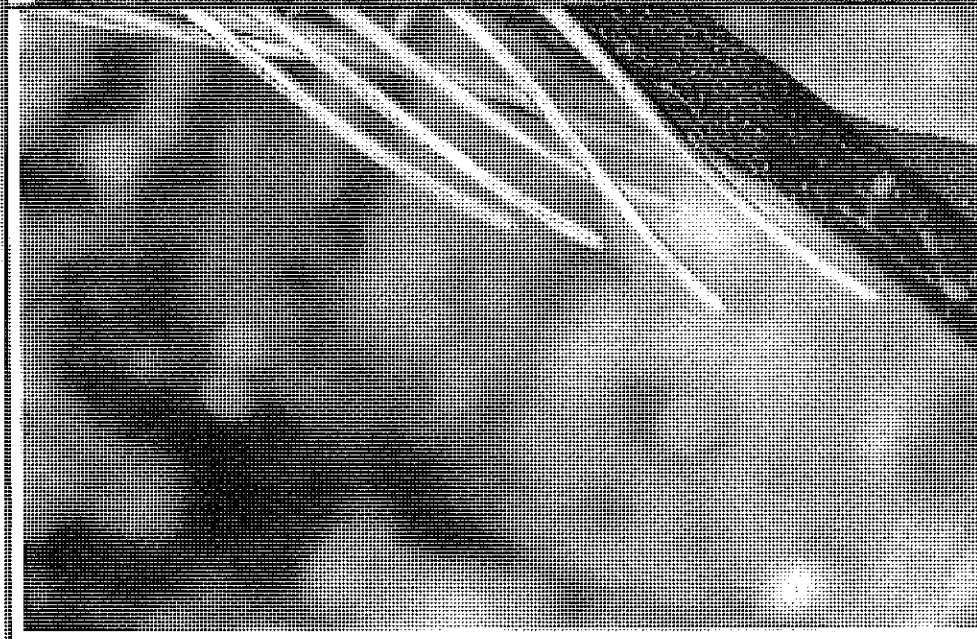
**Photograph Number:**  
29 Electrical  
**Date:**  
9/12/20  
**Time:**  
1410  
**Photographer:**  
b6 & b7C  
**Subject:**  
South End of Severed West  
Conductor

**Photograph Number:**  
b6 & b7C 2020-09-18 13-18-08  
**Date:**  
9/18/20  
**Time:**  
1321  
**Photographer:**  
b6 & b7C  
**Subject:**  
South End of Severed West  
Conductor

Photograph Number:  
[REDACTED] 2020-09-18 11-19-39  
Date:  
9/19/20  
Time:  
1323  
Photographer:  
[REDACTED]  
Subject:  
South end of West Conductor limb  
above

Photograph Number:  
[REDACTED] 2020-09-18 11-18-36  
Date:  
9/19/20  
Time:  
1311  
Photographer:  
[REDACTED]  
Subject:  
Close Up South End of West  
Conductor Limb
