**SAFETY ENFORCEMENT DIVISION  
California Public Utilities Commission**

**USFS Slater Fire Investigation Report**

The case originated on September 8, 2020 when fire was reported in the early morning hours on Slater Butte within the KNF. The fire would eventually spread to the north and west and impact 157,229 acres to also include portions of the Six Rivers NF, the Rouge Siskiyou NF, and the counties of Siskiyou (CA), Del Norte (CA), and Josephine (OR).

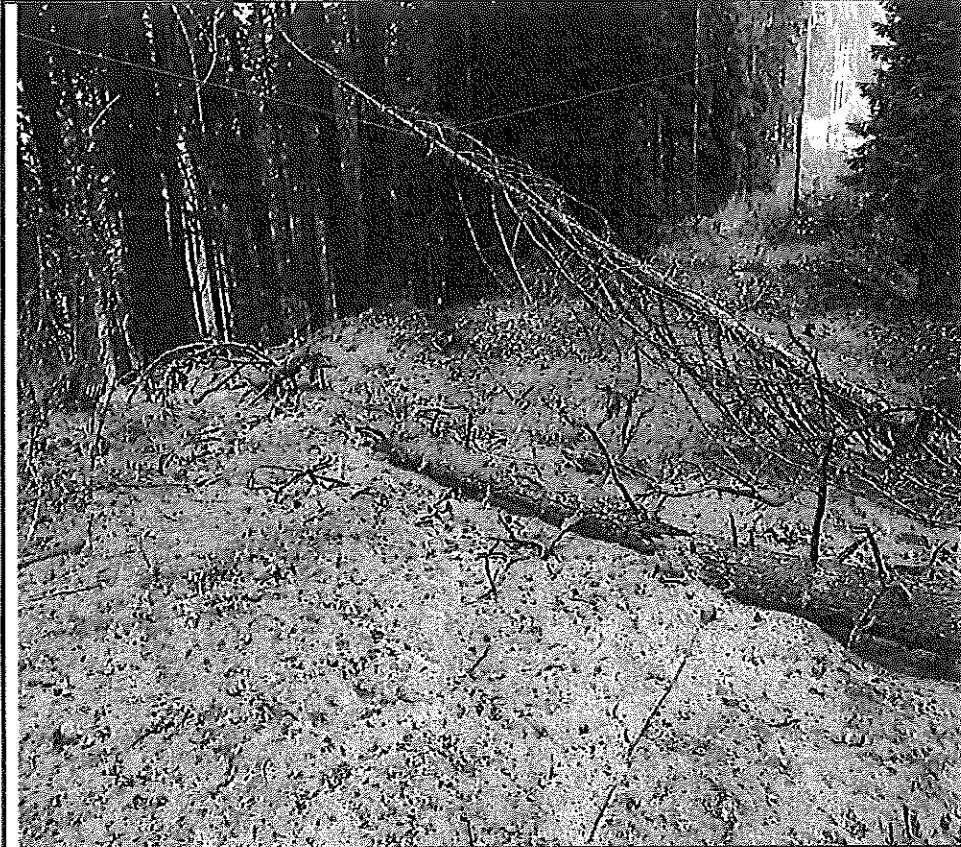
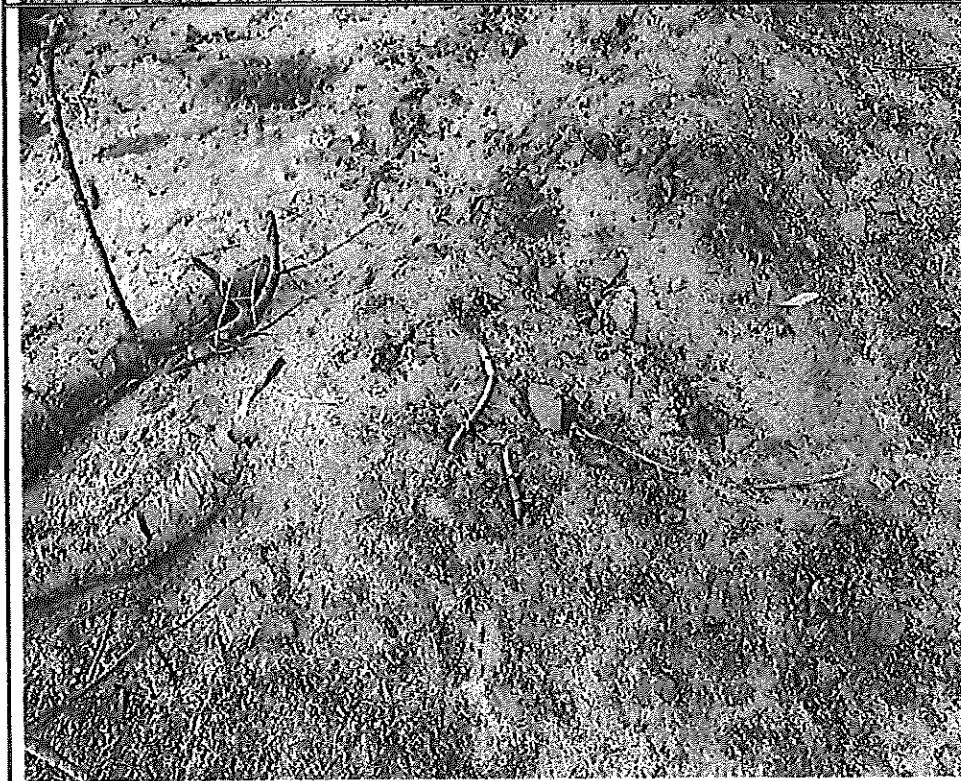
Photograph Exhibit 17

Photograph Number:  
b6 & b7C 2020-09-18 13-24-37  
Date:  
09/18/20  
Time:  
1327  
Photographer:  
b6 & b7C  
Subject:  
Heavily burned area at top end of  
White Fir tree

Photograph Number:  
b6 & b7C 2020-09-18 13-37-24  
Date:  
9/18/20  
Time:  
1340  
Photographer:  
b6 & b7C  
Subject:  
Melted conductor segments in area  
of White Fir tree top

The White Fir tree had fallen in the area just north of the severed north end of the west conductor and south of the fulgurite. The fallen tree top section had been largely consumed by fire and the west conductor had been melted into several sections in this area between Pole 4 and Pole 5 (**Exhibit 17- Photo of Melted Sections West Conductor**). No indication of the middle steel strand was found in these melted sections.

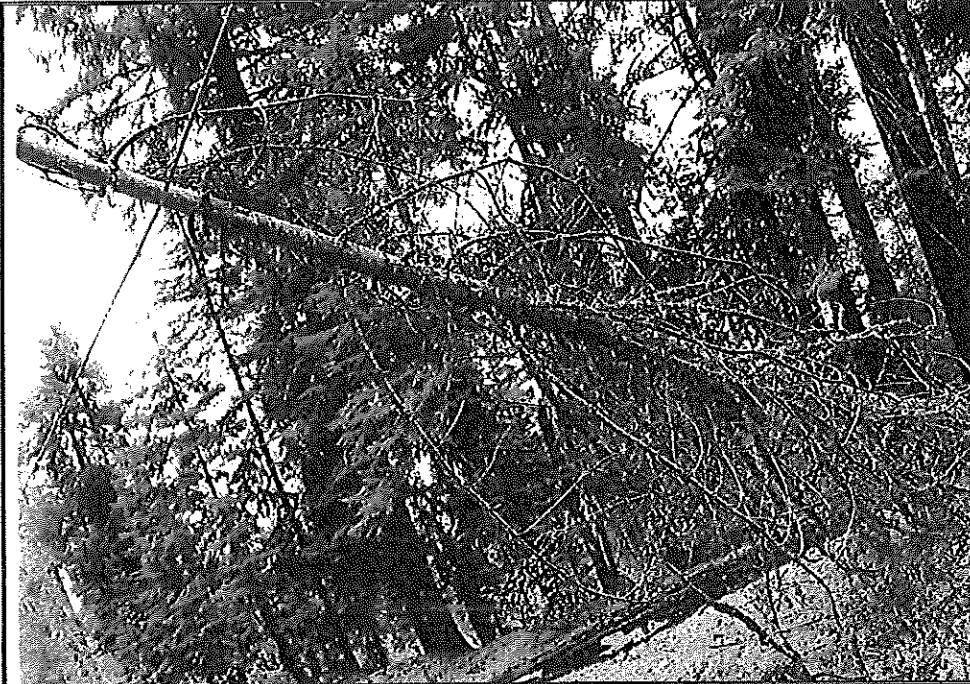
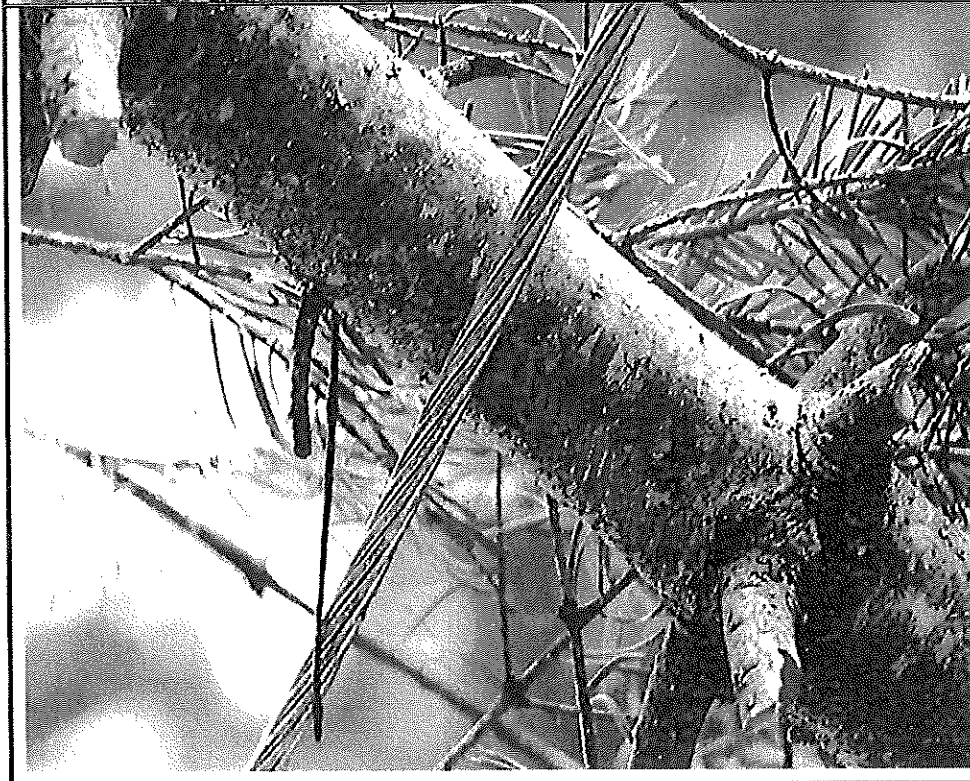
**Photograph Number:**  
b6 & b7C 2020-09-18 13-25-35  
**Date:**  
9/18/20  
**Time:**  
1328  
**Photographer:**  
b6 & b7C  
**Subject:**  
Tree resting on East Conductor post fire

**Photograph Number:**  
b6 & b7C 2020-09-18 13-25-59  
**Date:**  
9/18/20  
**Time:**  
1329  
**Photographer:**  
b6 & b7C  
**Subject:**  
Close up of Contact Point Tree Resting on East Conductor

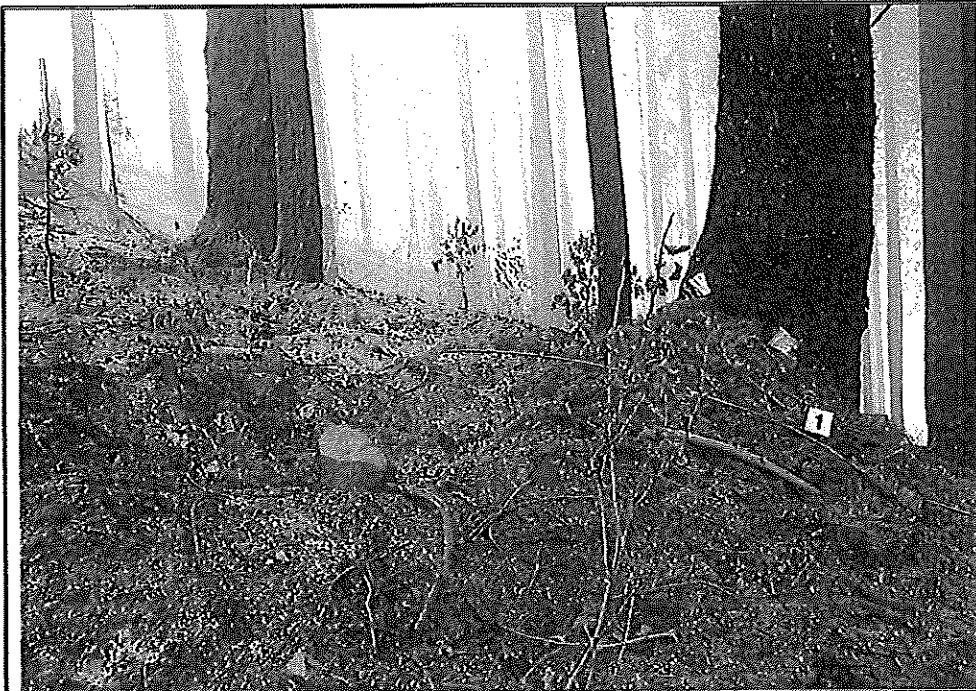
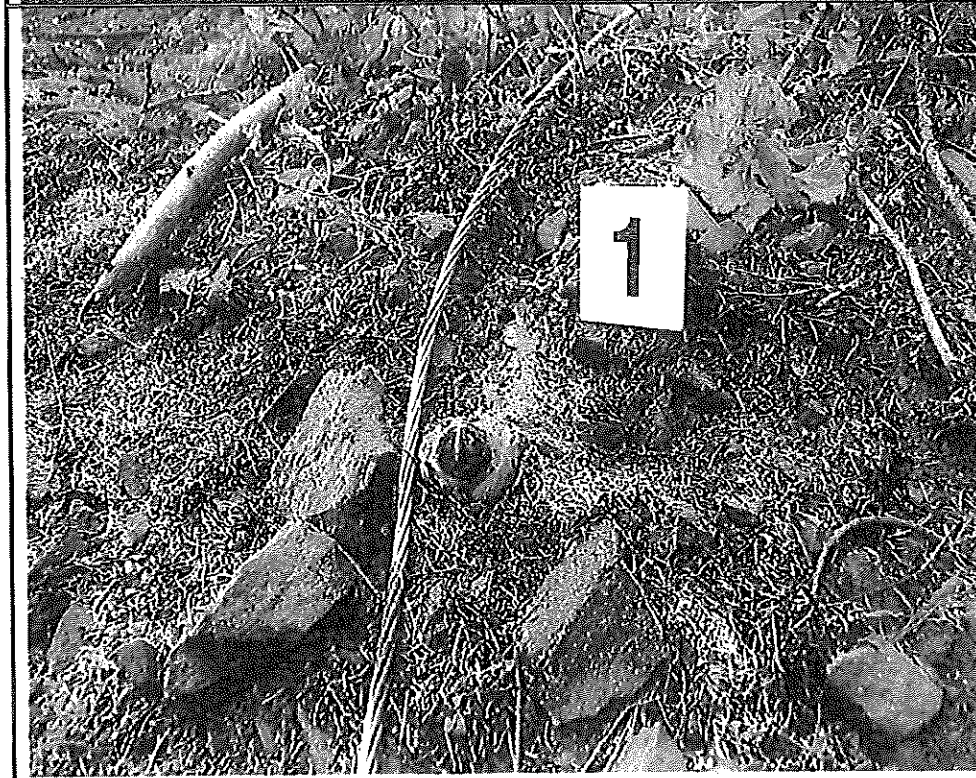
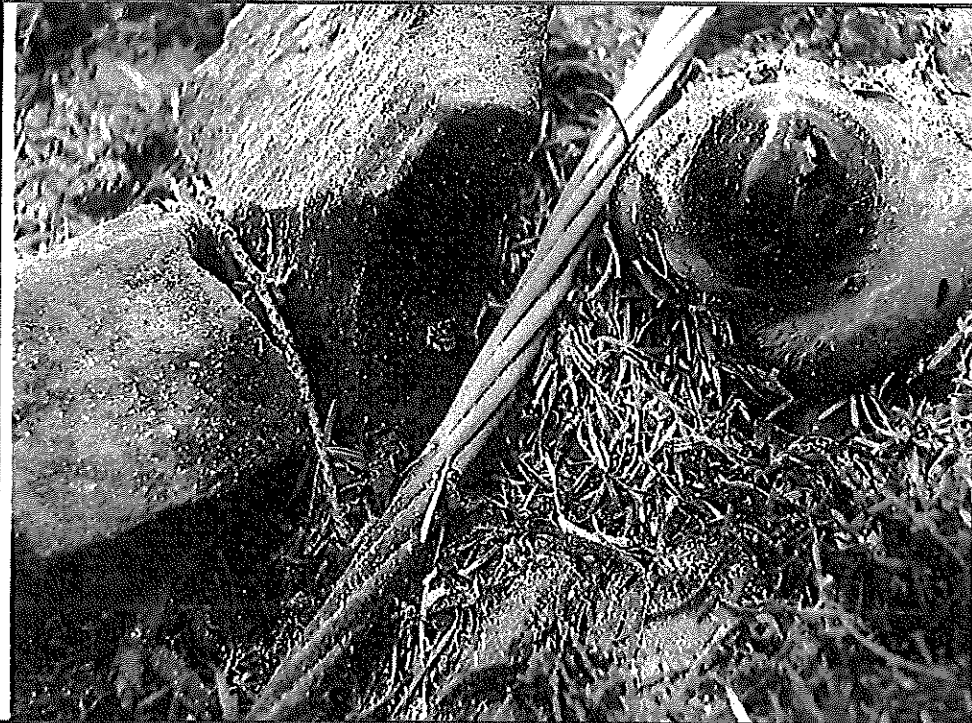
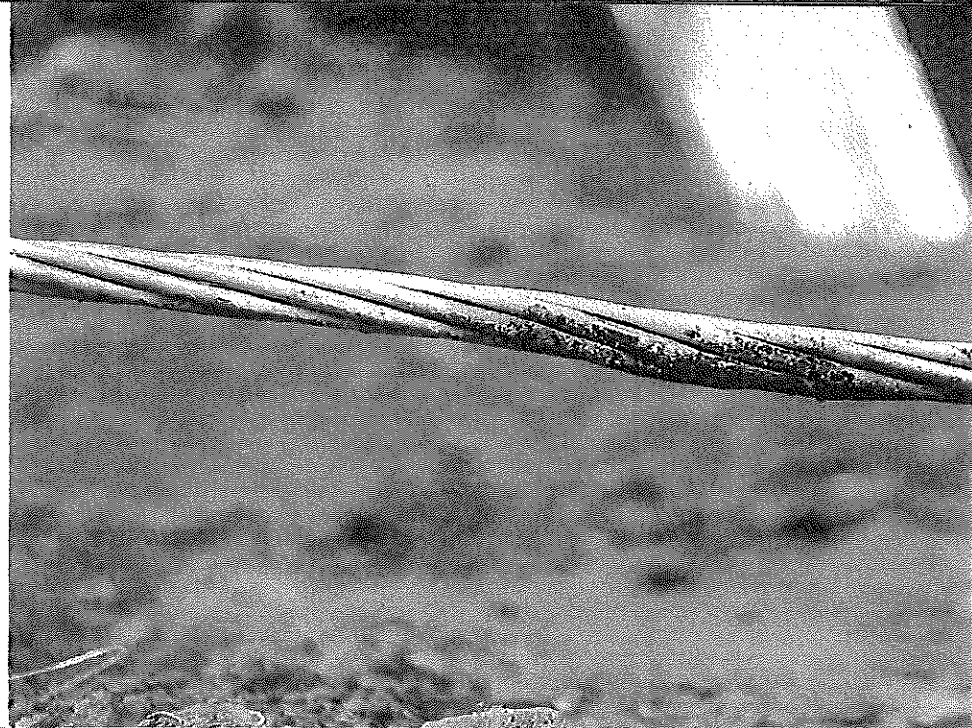
**Photograph Number:**  
6 Indicators & Fulgurite  
**Date:**  
9/12/2020  
**Time:**  
1314  
**Photographer:**  
b6 & b7C  
**Subject:**  
West Conductor at Specific Origin

**Photograph Number:**  
7 Indicators & Fulgurite  
**Date:**  
9/12/20  
**Time:**  
1315  
**Photographer:**  
b6 & b7C  
**Subject:**  
Fulgurite Located Within Specific Origin

**Photograph Number:**  
8 Indicators & Fulgurite  
**Date:**  
9/12/18  
**Time:**  
1316  
**Photographer:**  
b6 & b7C  
**Subject:**  
Arcing on West Conductor at  
Fulgurite

**Photograph Number:**  
35 Indicators & Fulgurite  
**Date:**  
9/12/20  
**Time:**  
1556  
**Photographer:**  
b6 & b7C  
**Subject:**  
Arc Erosion on Underside of West  
Conductor located after fulgurite  
excavation.

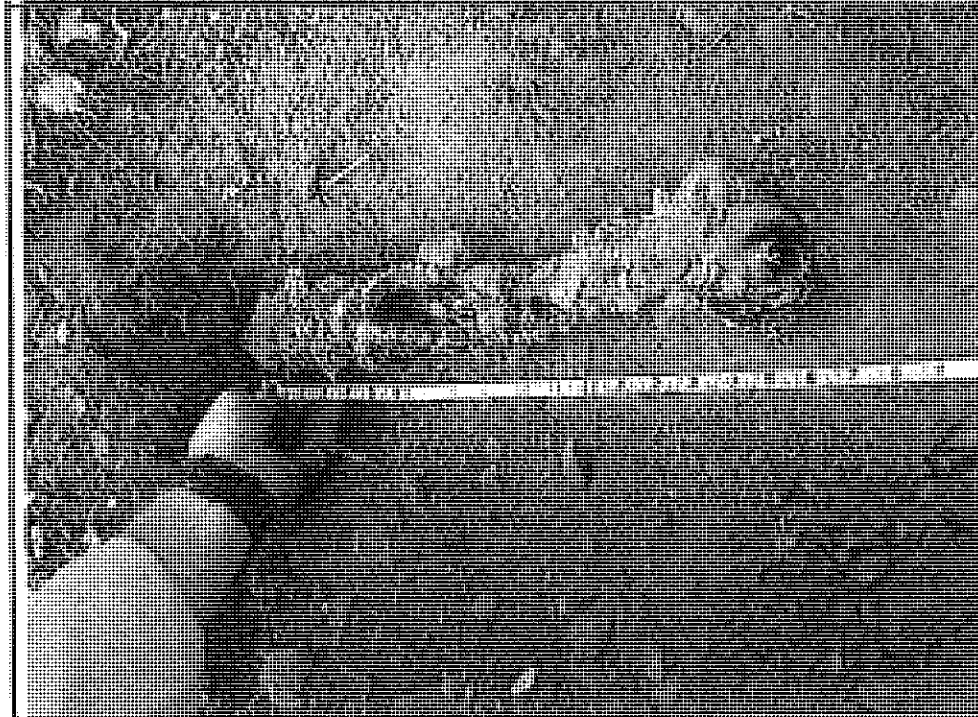
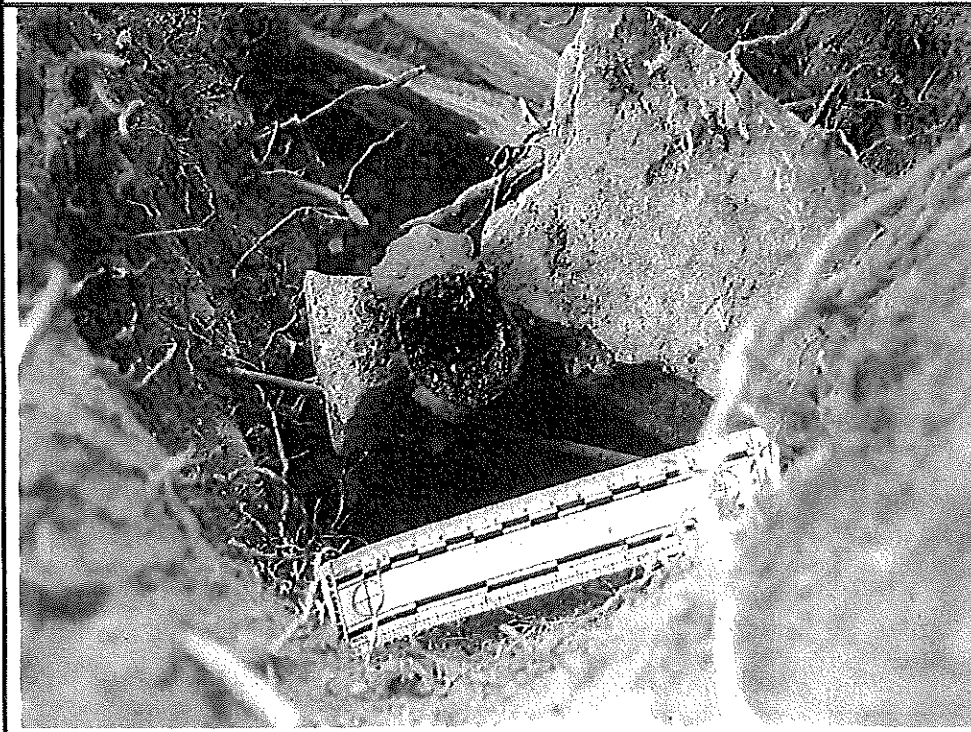
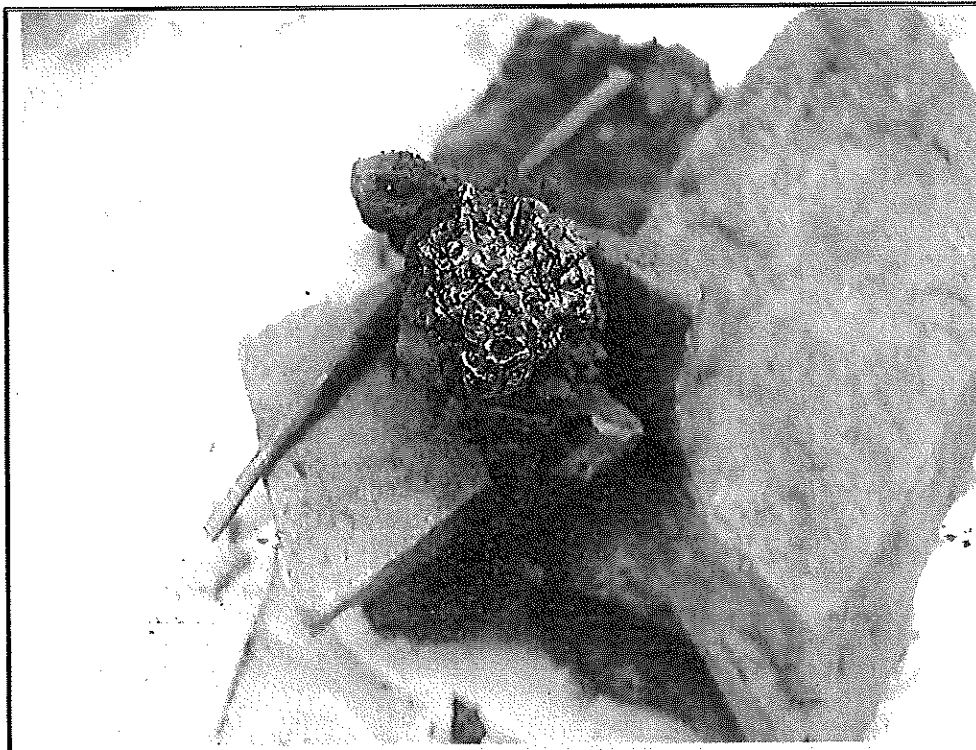
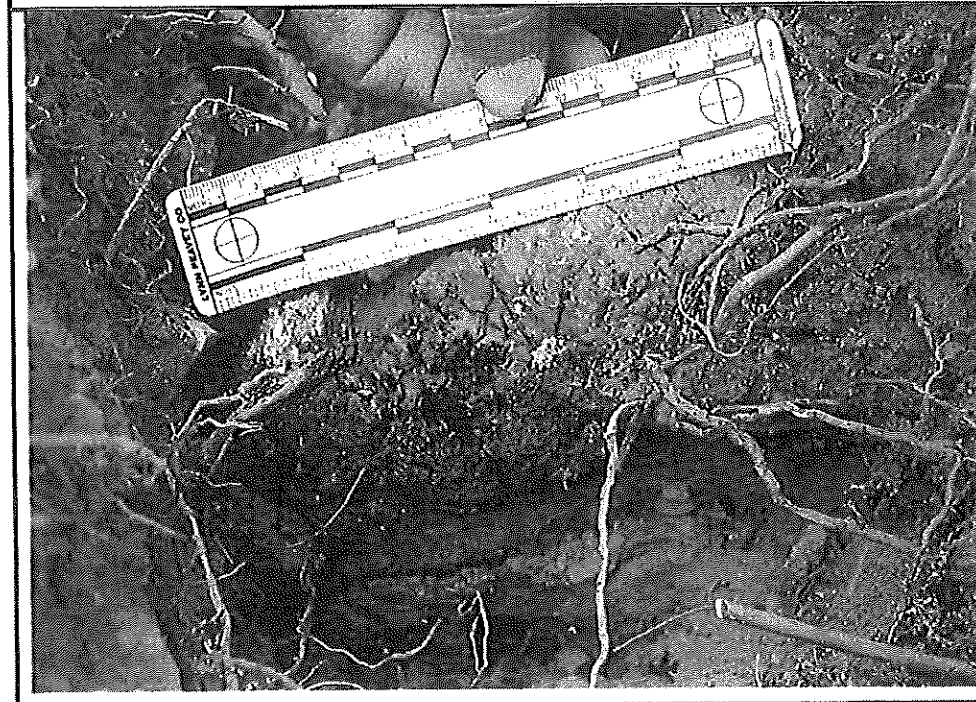
Photograph Number:  
33  
Indicator: Fulgurite  
Date:  
9/12/20  
Time:  
1444  
Photographer:  
JG & BJC  
Subject:  
Partially Excavated Parallel Portion  
of Fulgurite

Photograph Number:  
34  
Date:  
9/12/20  
Time:  
1517  
Photographer:  
JG & BJC  
Subject:  
Further Excavation of Fulgurite to  
point where Fulgurite Turns Vertical

**Photograph Number:**  
39 Indicators and Fulgurites  
**Date:**  
9/13/20  
**Time:**  
1330  
**Photographer:**  
b6 & b7C  
**Subject:**  
Vertical Portion of Fulgurite  
Terminating on Charred Tree Root  
with Buried Copper Conductor

**Photograph Number:**  
38 Indicators & Fulgurites  
**Date:**  
9/13/20  
**Time:**  
1337  
**Photographer:**  
b6 & b7C  
**Subject:**  
Hallow Center of Vertical Portion of  
Fulgurite with Fused Copper  
Conductor

**Photograph Number:**  
40 Indicators & Fulgurite  
**Date:**  
9/13/20  
**Time:**  
1344  
**Photographer:**  
b6 & b7C  
**Subject:**  
End of Vertical Portion of Fulgurite  
that Contacted Charred Tree Root

**Photograph Number:**  
42 Indicators & Fulgurite  
**Date:**  
9/13/20  
**Time:**  
1347  
**Photographer:**  
b6 & b7C  
**Subject:**  
Point Where Fulgurite Contacted  
Tree Root

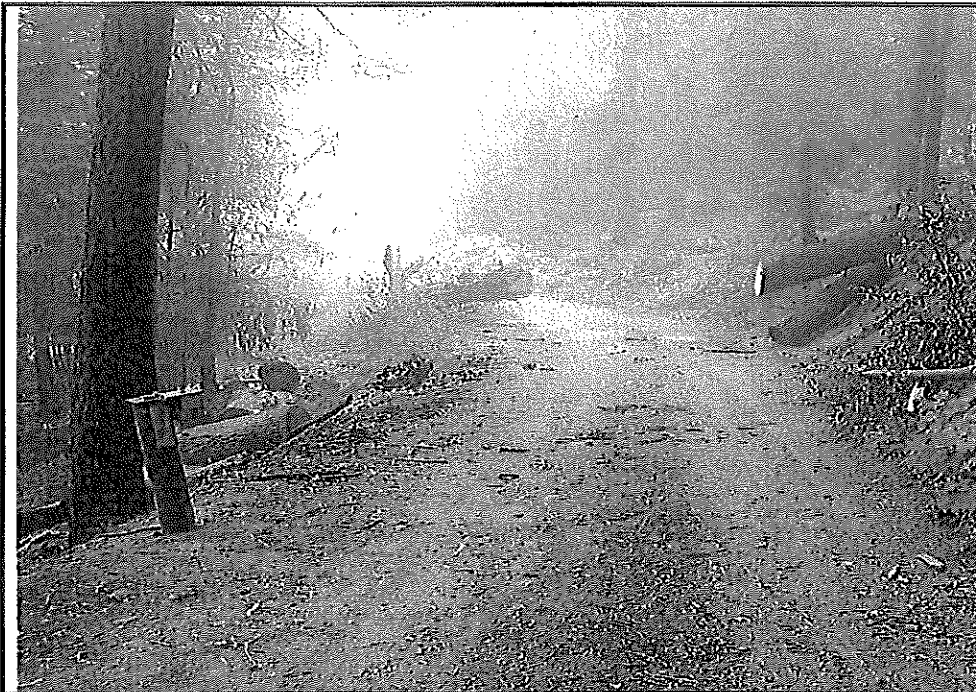
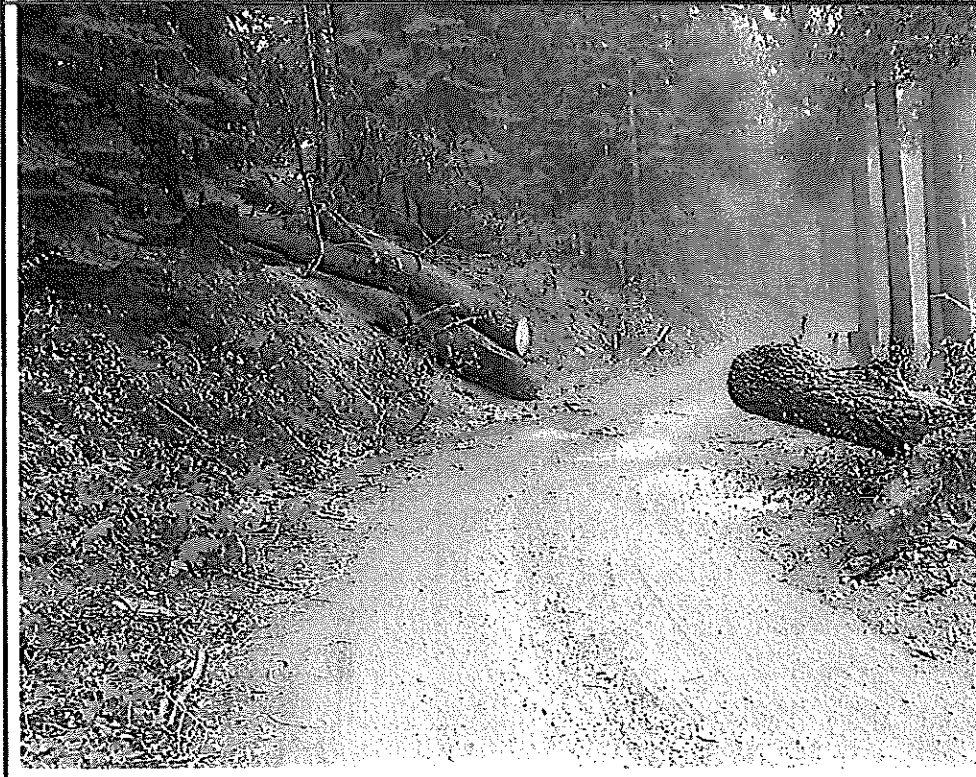
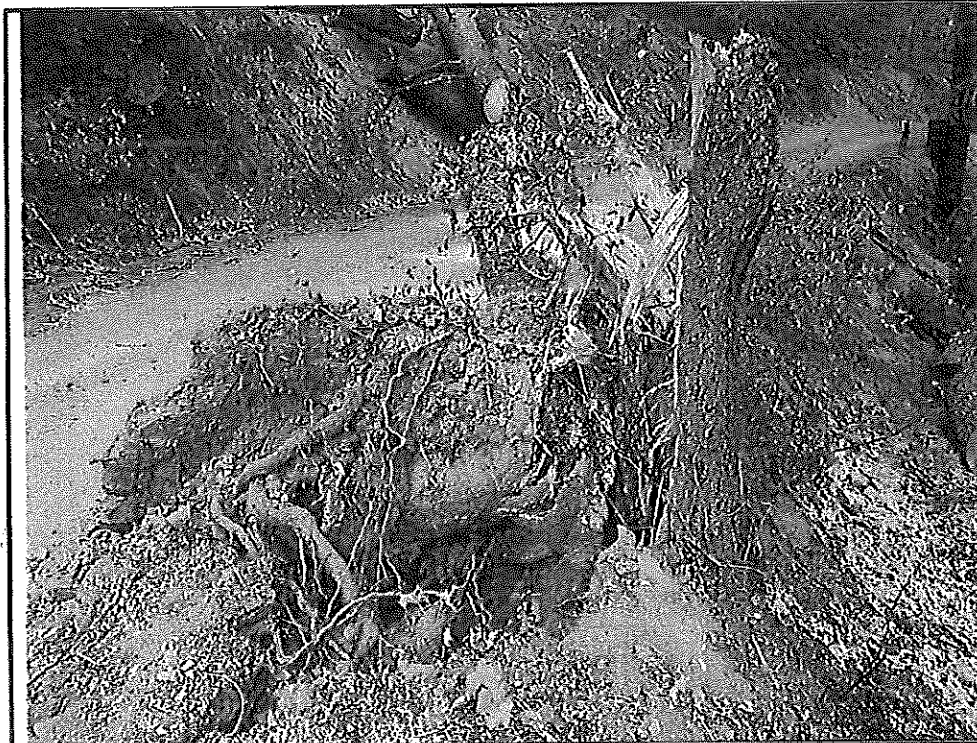
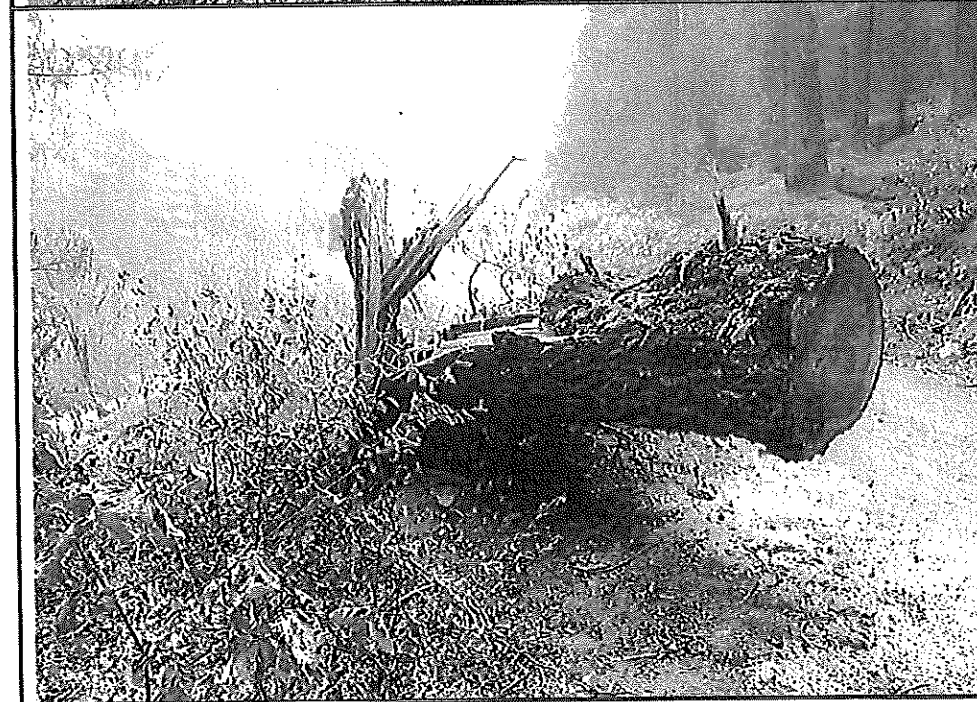
**Photograph Number:**  
52 Tree  
**Date:**  
9/12/20  
**Time:**  
1043  
**Photographer:**  
b6 & b7C  
**Subject:**  
Lookout Gate and White Fir Tree  
Looking South

**Photograph Number:**  
14 Tree  
**Date:**  
9/12/20  
**Time:**  
0951  
**Photographer:**  
b6 & b7C  
**Subject:**  
White Fir Tree Looking North

**Photograph Number:**  
15 Tree  
**Date:**  
9/12/20  
**Time:**  
0952  
**Photographer:**  
b6 & b7C  
**Subject:**  
Base of White Fir Tree from South Side

**Photograph Number:**  
36 Tree  
**Date:**  
9/12/20  
**Time:**  
1026  
**Photographer:**  
b6 & b7C  
**Subject:**  
Base of White Fir Tree from North Side

[b6 & b7C] located a tree across FR 17N48 when he left the lookout on the morning of September 8, 2020, just prior to the lookout gate across the road. Engine 327 was dispatched to remove the tree from the roadway in order to free [b6 & b7C]. Engine 327 cut five pieces out of the tree and rolled them off the downslope side of the road in order to open the road. The tree had partially uprooted as it fell. The trunk of the tree then cracked at about six feet above ground level on the windward (east) side. The tree then cracked open down to the ground level on the west side. The interior of the tree near the base was hollow with wet, rotten wood (**Exhibit 21- White Fire Tree Photos**). [b6 & b7C], a Forest Pathologist with the USFS examined the tree and determined it to be a White Fire. [b6 & b7C] found heart-rot in the basal portion of the bole from below ground level extending upwards approximately six feet. [b6 & b7C] also discovered a white-rot and Rhizomorphs (melanized mycelial cords) present on the decaying wood (**Exhibit 22- [b6 & b7C] REPORT**). A cross section of the tree base was collected and stored by the USFS as evidence. The tree measured approximately 137 feet tall. The upper branches of the tree, though now burned, showed evidence of green healthy needles and was producing cones. [b6 & b7C] an entomologist with the USFS described the tree as one that would not be identified or classified as a hazard given its outward appearance.

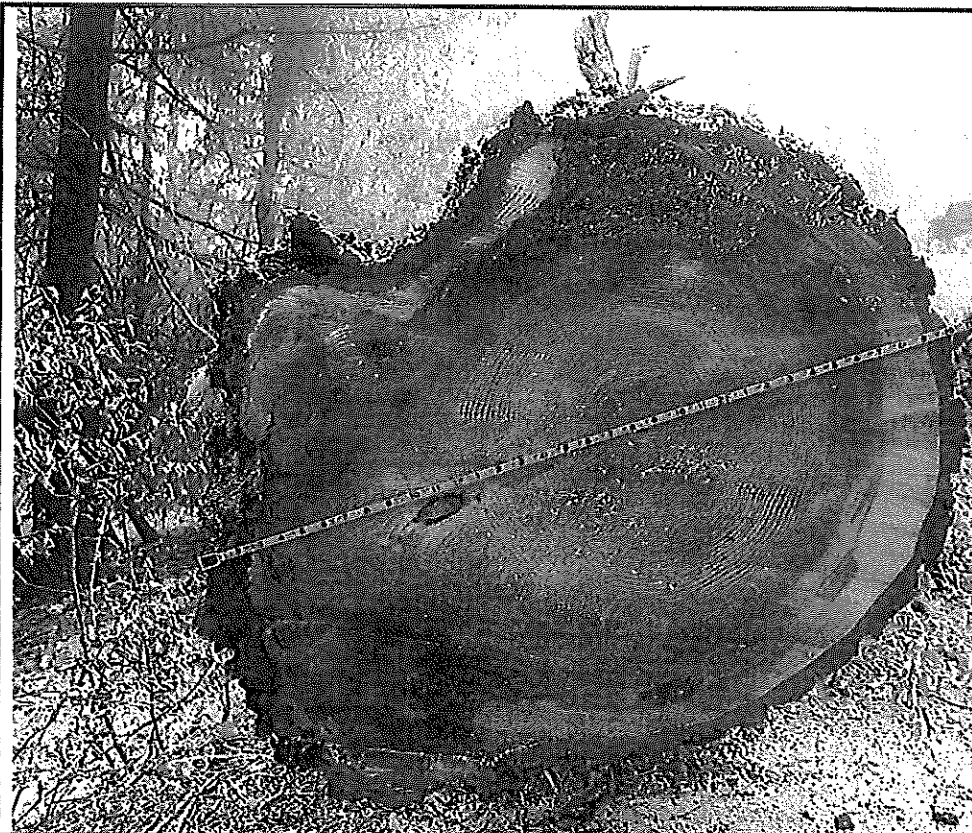
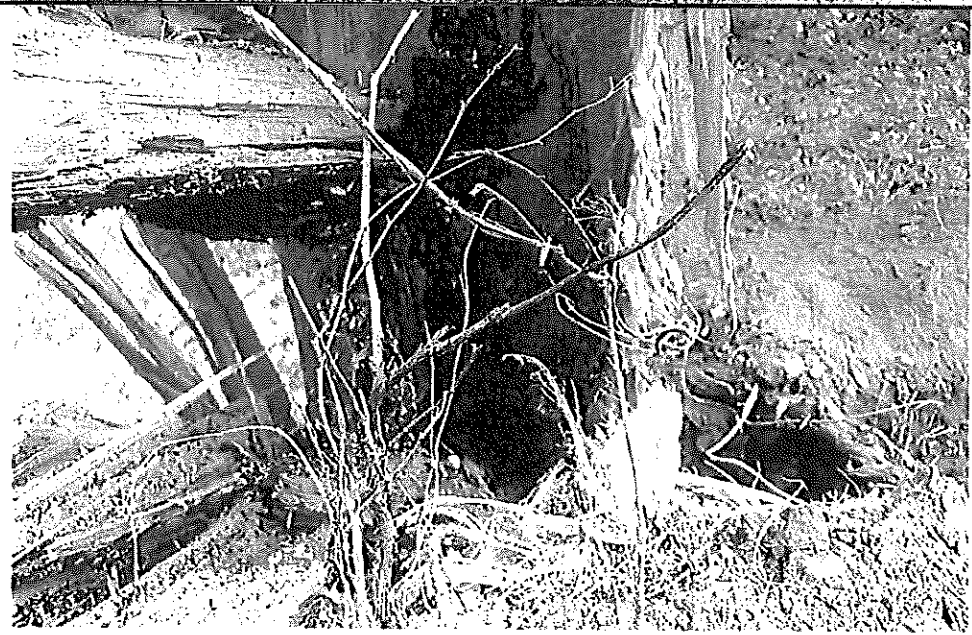
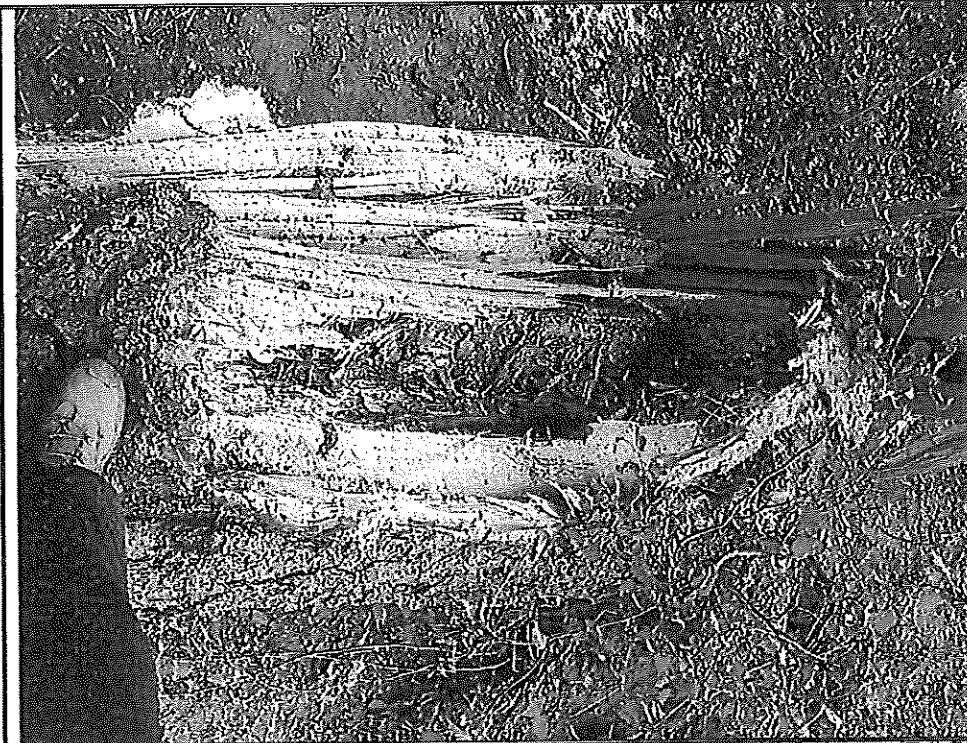
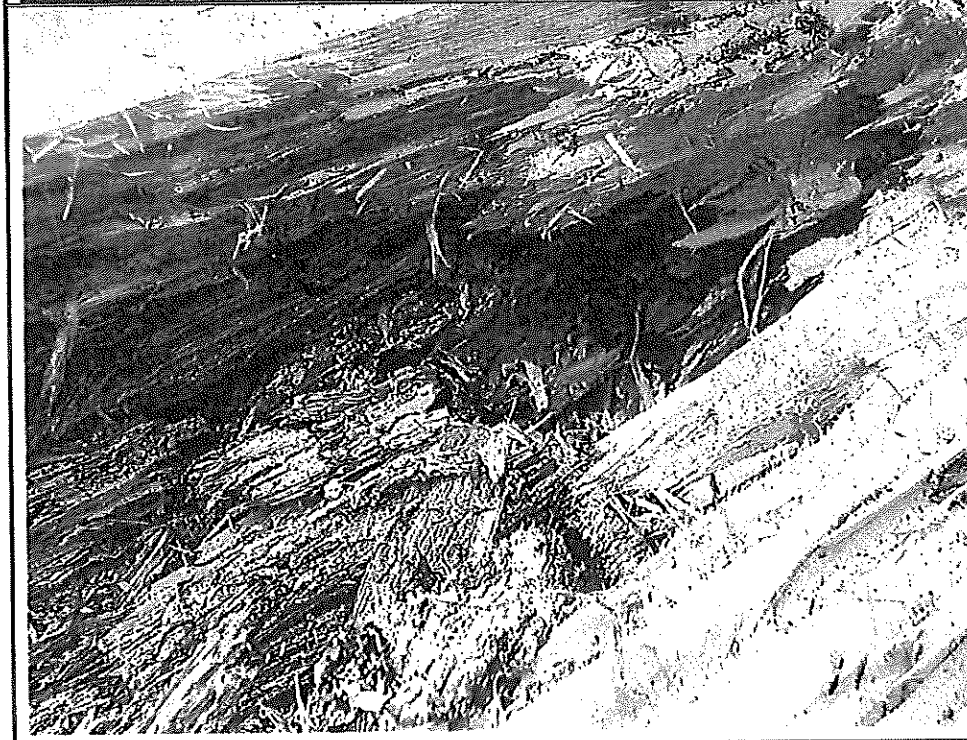
**Photograph Number:**  
25 Tree  
**Date:**  
9/12/20  
**Time:**  
1017  
**Photographer:**  
b6 & b7C  
**Subject:**  
Diameter of White Fir Tree

**Photograph Number:**  
23 Tree  
**Date:**  
9/12/20  
**Time:**  
1014  
**Photographer:**  
b6 & b7C  
**Subject:**  
Fracture at Ground Level of White  
Fir Tree

Photograph Number:  
30  
Date:  
9/12/20  
Time:  
1013  
Photographer:  
b6 & b7C  
Subject:  
Interior of White Fir Tree Fracture  
from Above

Photograph Number:  
32  
Date:  
9/12/20  
Time:  
1024  
Photographer:  
b6 & b7C  
Subject:  
Wet, Rotted, White Fir Tree Interior

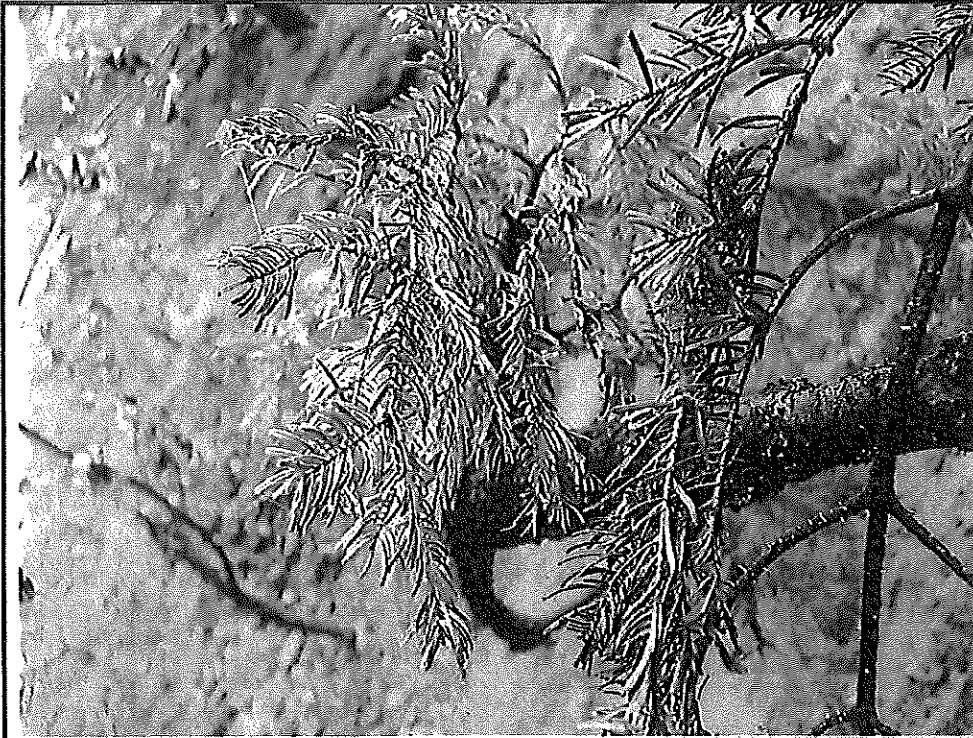
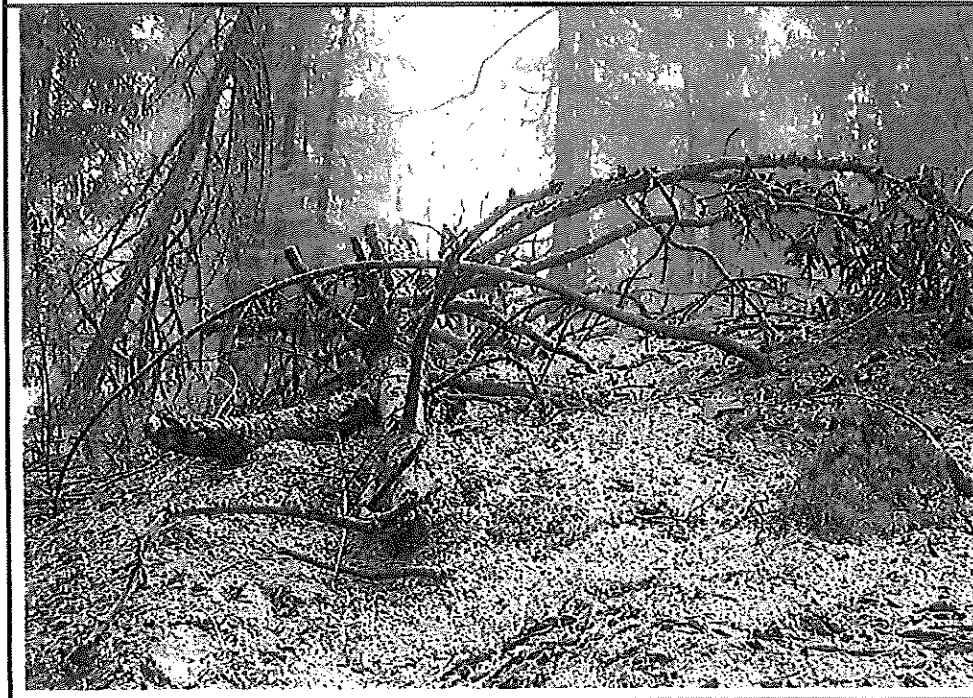
Photograph Number:  
54 Tree  
Date:  
9/12/20  
Time:  
1047  
Photographer:  
b6 & b7C  
Subject:  
Live Green Needles on White Fir  
Tree

Photograph Number:  
60 Tree  
Date:  
9/12/20  
Time:  
1056  
Photographer:  
b6 & b7C  
Subject:  
Uppermost Portion of White Fir Tree
