EXHIBIT: PacifiCorp PAC_400
CPUC PROCEEDING: H.25-07-005
SPONSOR/WITNESS: PacifiCorp/Brian King
DESCRIPTION: Public - PAC0008350 – LRA Verification NV5 Vegetation Management Inspection Reports
DATE IDENT. _____ RECD. _____
ALJ: GERALD F. KELLY

Tier 2 and WUI - Random Sample

VEGETATION MANAGEMENT INSPECTION REPORT

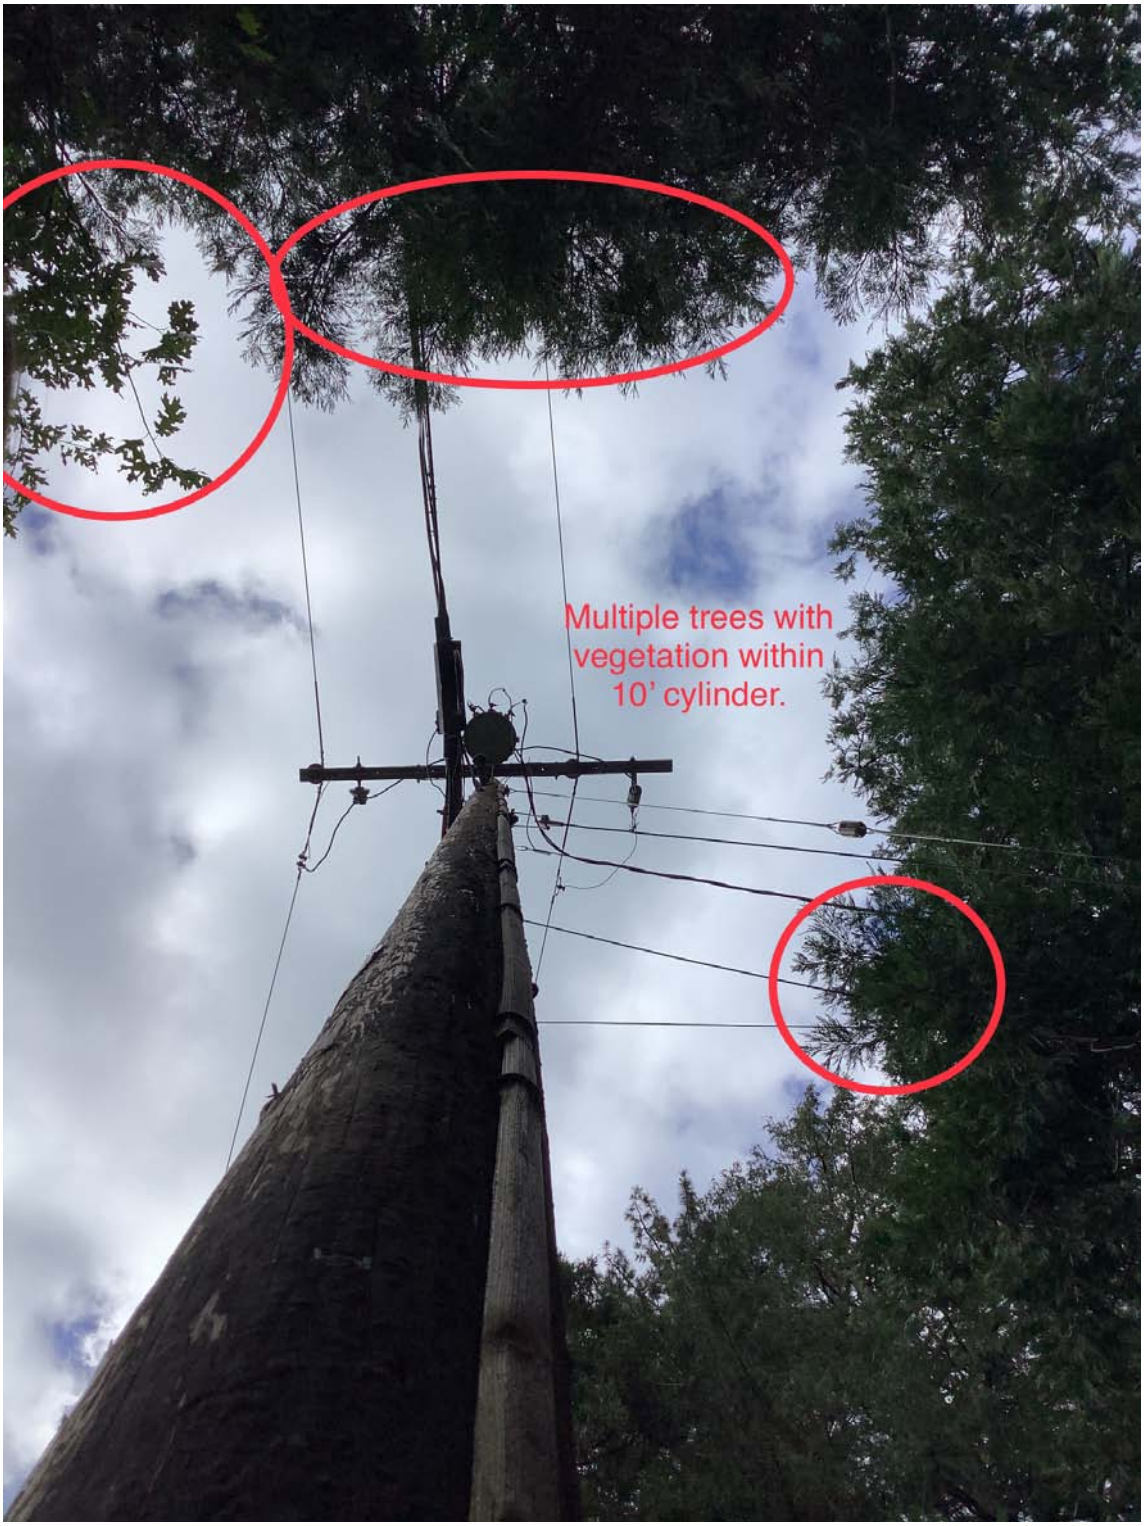
ID1314

Multiple trees with vegetation within the ground to horizontal line height compliance cylinder.

Multiple trees with
vegetation within
10' cylinder.

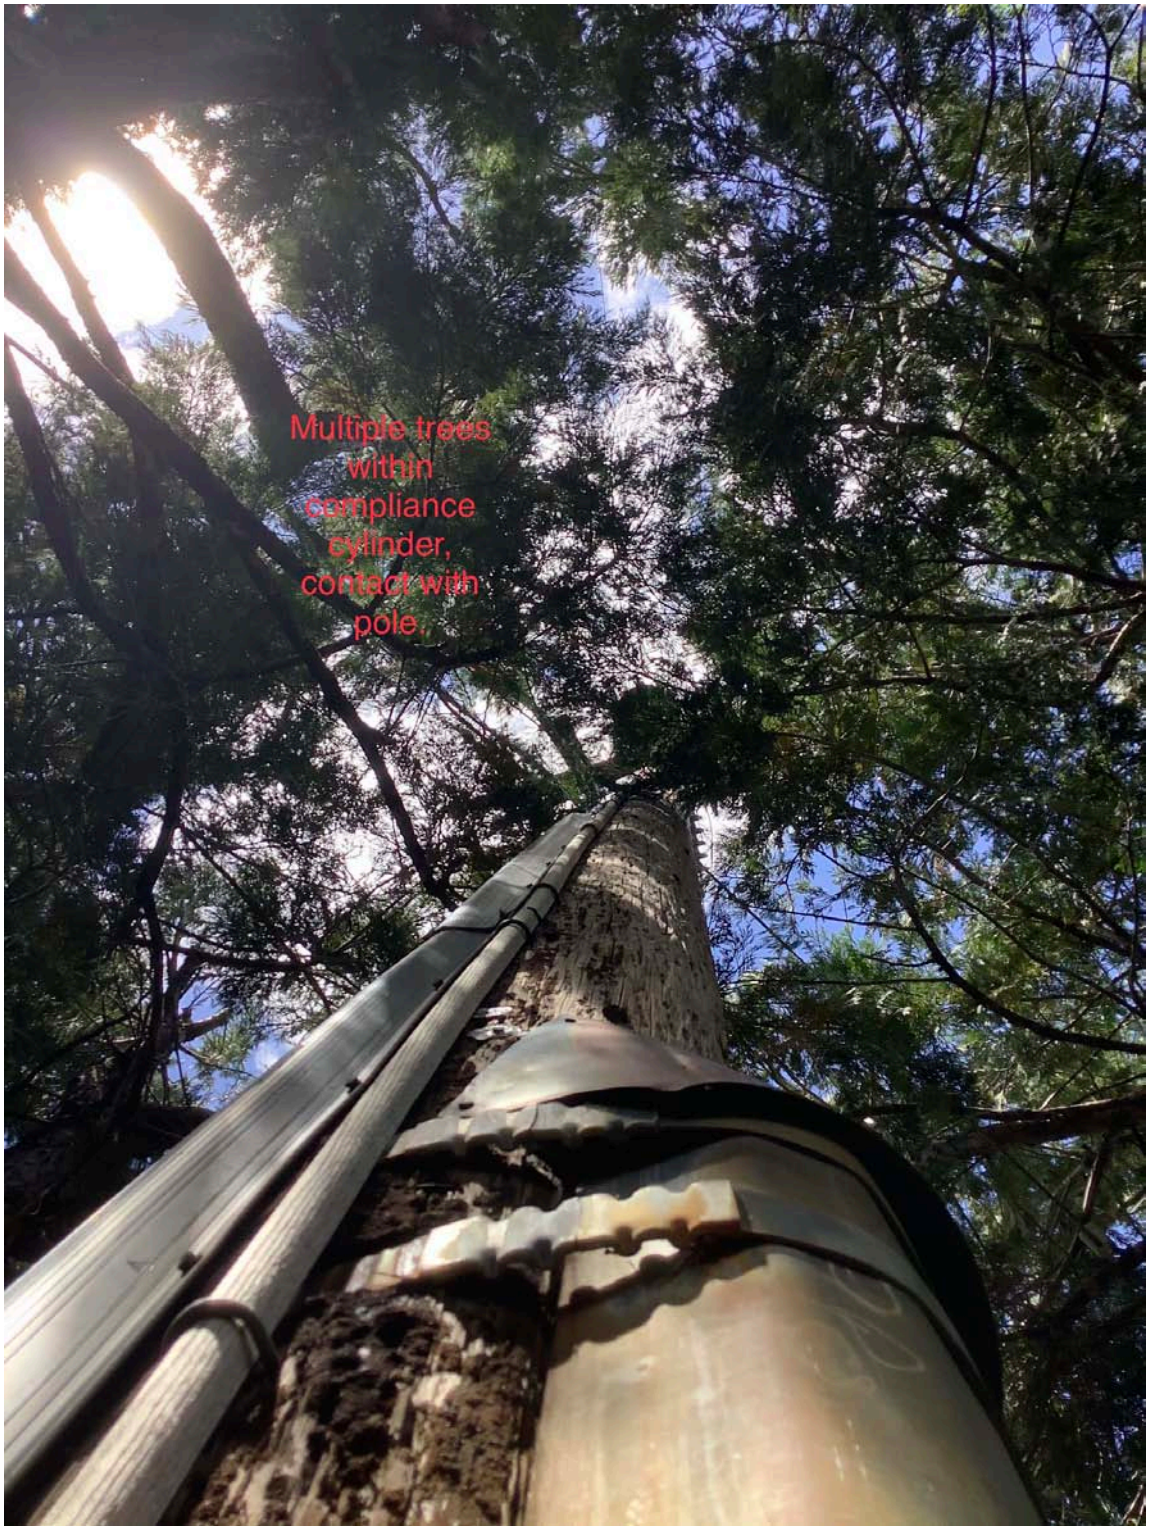
Multiple trees with vegetation within the ground to horizontal line height compliance cylinder, no clear path from hardware to ground.

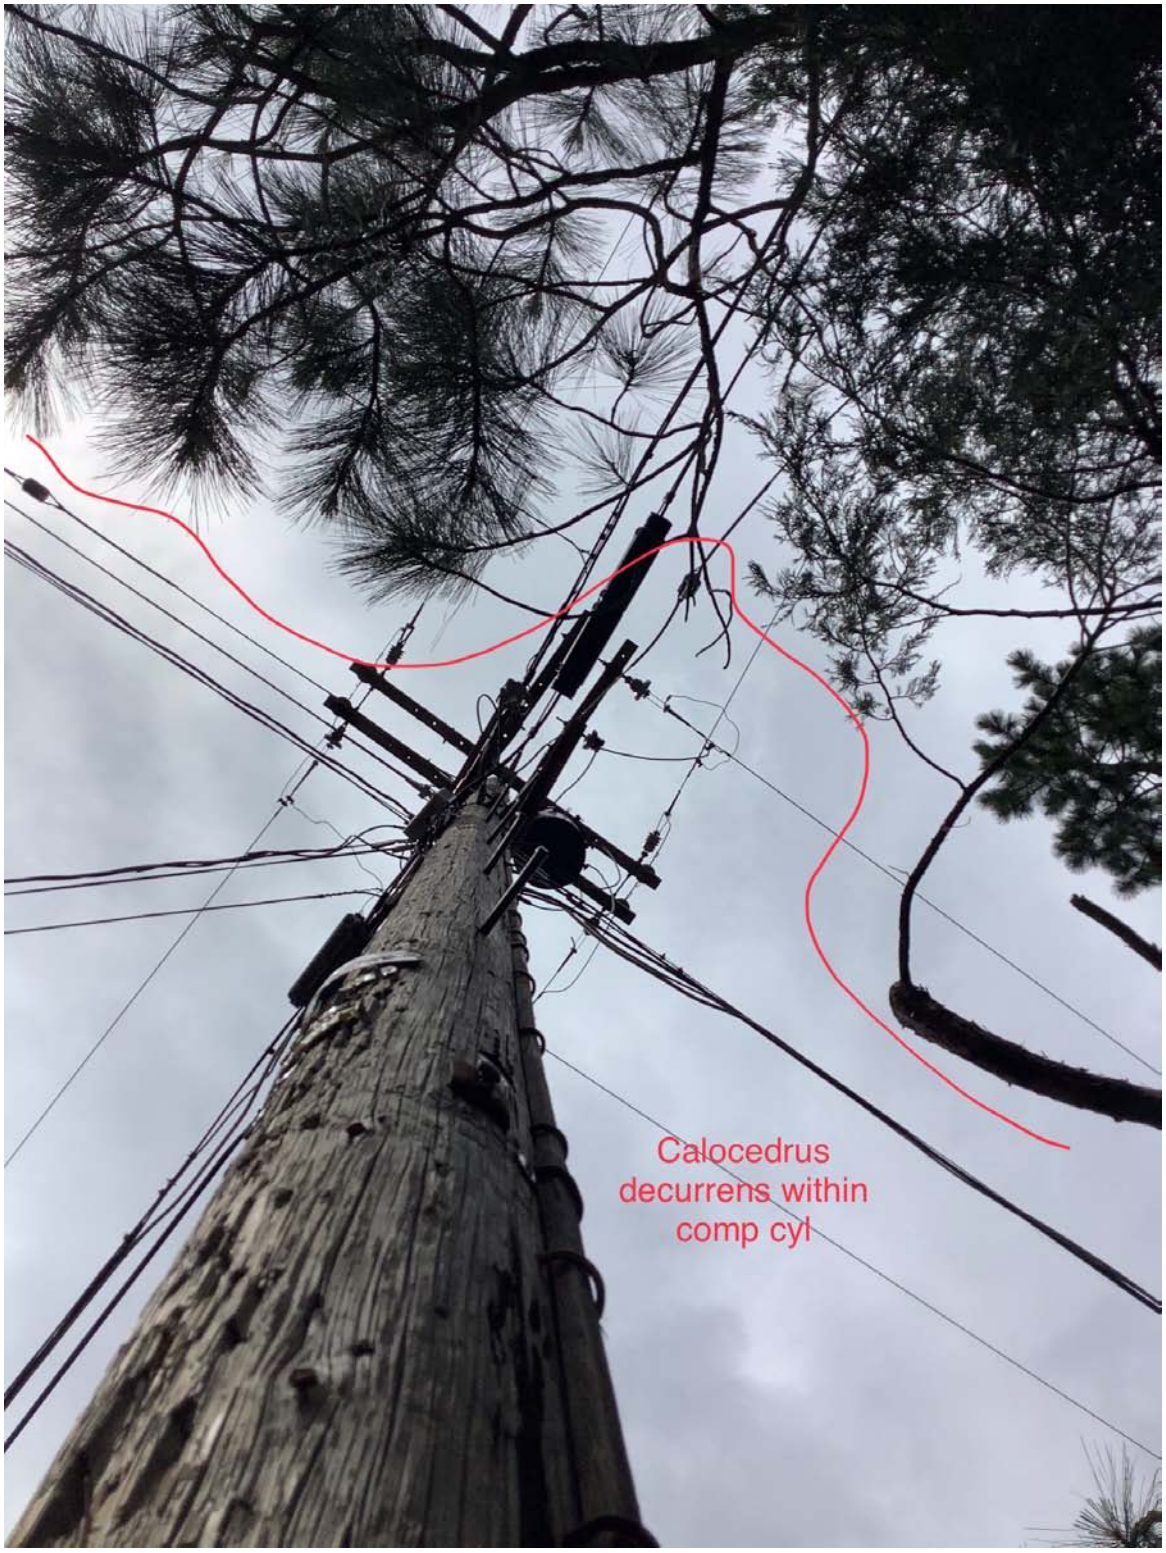
Calocedrus decurrens vegetation within the ground to horizontal line height compliance cylinder
