**CALIFORNIA PUBLIC UTILITIES COMMISSION  
Consumer Protection and Safety Division  
Utilities Safety and Reliability Branch  
Preliminary Incident Investigation Report**

**Incident Number:** E 20110114-01

**Utility:** Southern California Edison Company (SCE)

**Utility Facilities involved:** 12 kV Vargas Circuit in Redlands District

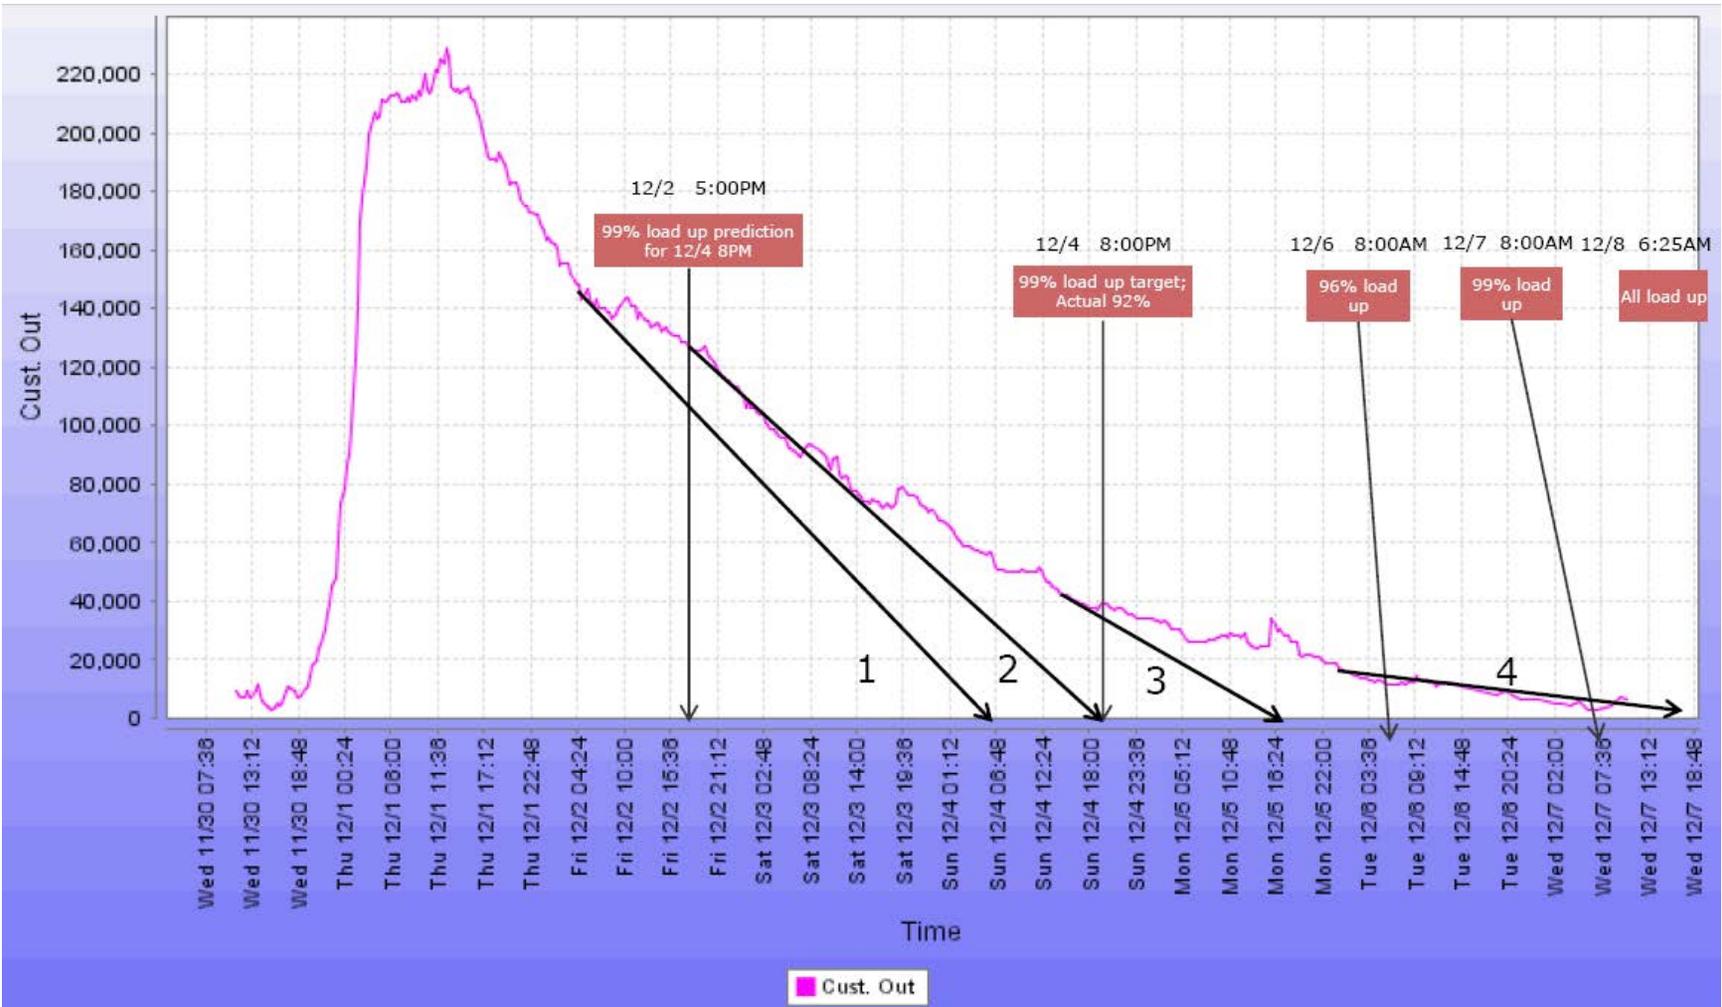
**Figure 33**  
SCE's Restoration Estimates

City government staff from Monrovia and Arcadia, as well as Gail Farber, Los Angeles County's Director of Public Works, expressed some frustration with restoration time estimates. JoEllen Chatham, LPA's Regional Director for the region which includes Arcadia and Temple City, told CPSD that a major complaint from the public and city officials was that SCE predicted 99% restoration by December 4, and failed to meet that goal. Los Angeles County's Ms. Farber opined that a better strategy would have been for SCE to immediately announce to the public that this could be a protracted event, and that customers should plan accordingly.

City officials should have complete and accurate restoration time estimates to pass on to their constituents. Because CPSD located an error in LPA's training exercise schedule, which may indicate other errors, CPSD recommends that SCE review and update its emergency planning documents. Finally, SCE's LPA procedures should ensure a smooth transition when liaison personnel change.
