**INVESTIGATION REPORT
OF THE
SEPTEMBER 30, 2013 SUBCONTRACTOR
FATALITY AT A SOUTHERN CALIFORNIA
EDISON COMPANY UNDERGROUND
VAULT IN HUNTINGTON BEACH**

PUBLIC REPORT

**SAFETY AND ENFORCEMENT DIVISION
ELECTRIC SAFETY AND RELIABILITY BRANCH**

**LOS ANGELES
OCTOBER 2015**

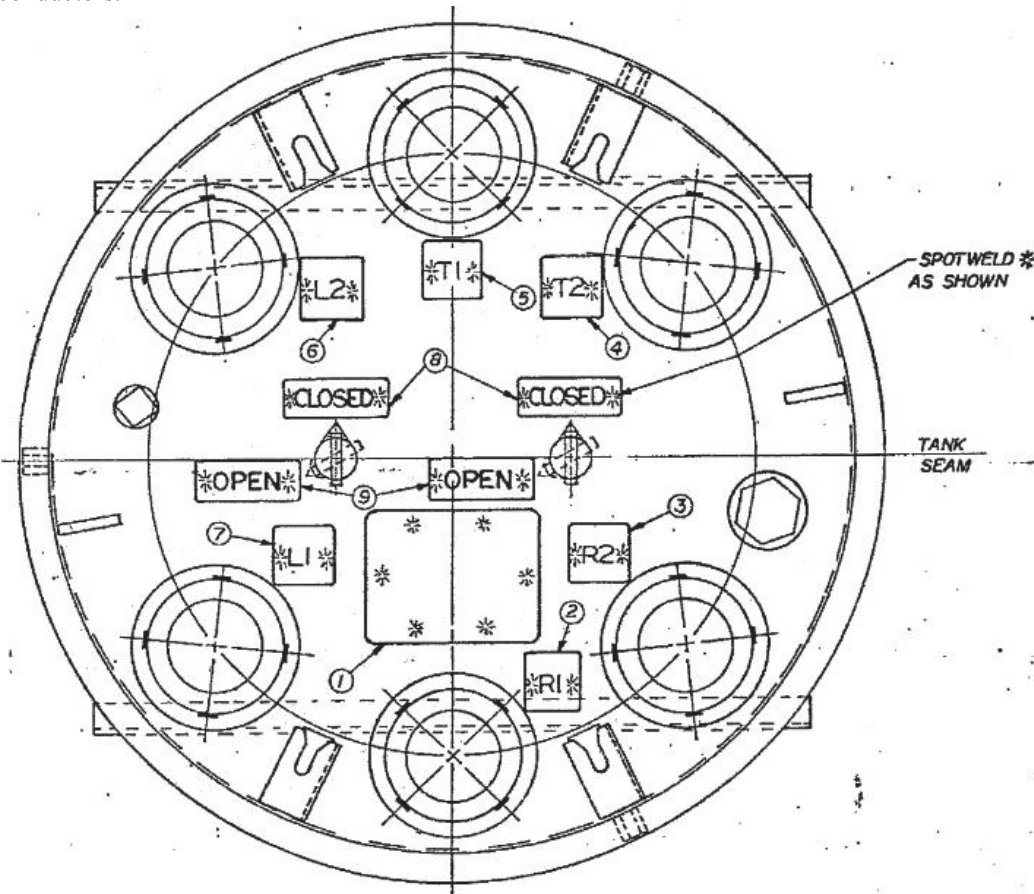
Figure 4: Drawing of the top face of switch number BS 0885 as presented in Kuhlman Electric Company schematics.

Switch number BS 0885 was manufactured by Kuhlman Electric Company, and is rated at an operating voltage of 15 kV. There are three positions on the switch: L, R, and T. Each position is comprised of two connection points (e.g., position L is comprised of L1 and L2) for a total of six connection points (see Figures 3 and 4). Each connection point is attached to a cable through a 200 amp dead-break elbow.³

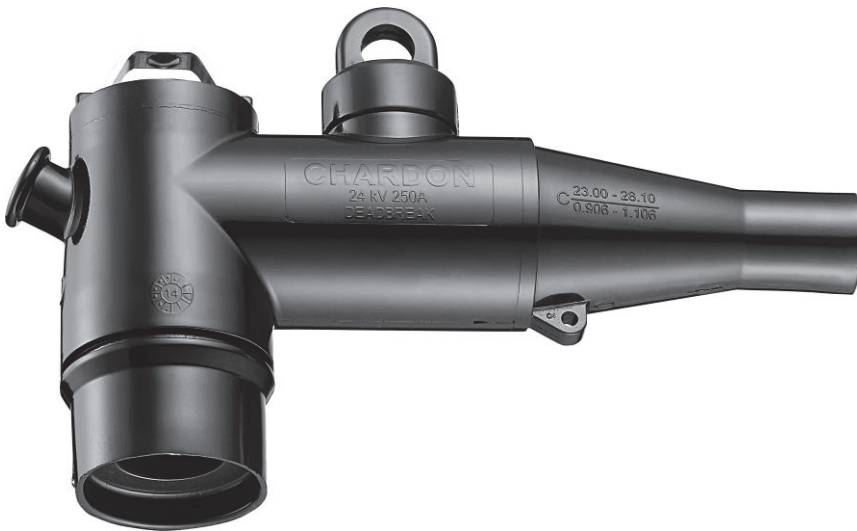
Figure 5: Dead-break elbow.

³ An elbow is an insulated 90-degree electrical appurtenance that enables a cable to be attached to electrical equipment (see Figure 5). One side of the elbow is connected to the cable while the other side is connected to a plug on the piece of electrical equipment. An elbow that is designed to be detached only when it is de-energized is called a “dead-break” elbow.
