| | Case 3:14-cr-00175-WHA D | ocument 1128 | Filed 12/19/19 | Page 1 of 14 |
|---|--|---|---|---|
| | RESPONSE TO FOLLOW-UP QUESTIONS F<br>BE ANSWERED BY PG&E BY D<br>Case | RE CPUC REPORT (<br>ECEMBER 19 AND<br>No. 14-CR-00175-V | ON CAMP FIRE, FU<br>SUPPLEMENTAL (<br>WHA | RTHER QUESTIONS TO<br>QUESTION 6a |

Defendant Pacific Gas and Electric Company ("PG&E") respectfully submits this response to the Court's December 5, December 6 and December 16, 2019 requests for information relating to the November 8, 2019 Incident Investigation Report regarding the Camp Fire issued by the Safety and Enforcement Division ("SED") of the California Public Utilities Commission ("CPUC").

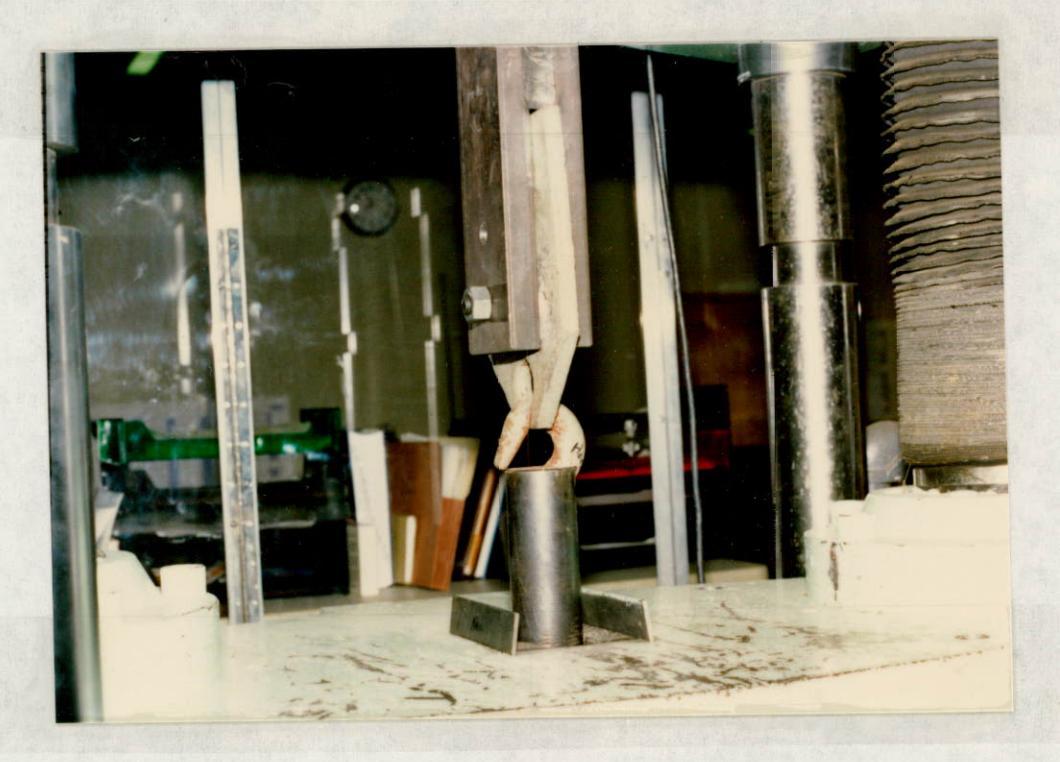
The tensile test was accomplished by making a fixture to hold the hook and the plate in the same position it would be while in service and applying tension using the Tinius Olsen universal test machine, (See Figure 3). American National Standards Institute, (ANSI), B30.10-1975 was used as a guideline, (See Appendix B).

Figure 3. This shows the fixture holding the plate and J-Hook in the simulated position it would be in service.
