CALIFORNIA PUBLIC UTILITIES COMMISSION
Safety and Enforcement Division
Electric Safety and Reliability Branch

Incident Investigation Report

Incident Number: E20191024-01

Regulated Entity Facilities Involved: Geysers #9 Lakeville 230 kV Line

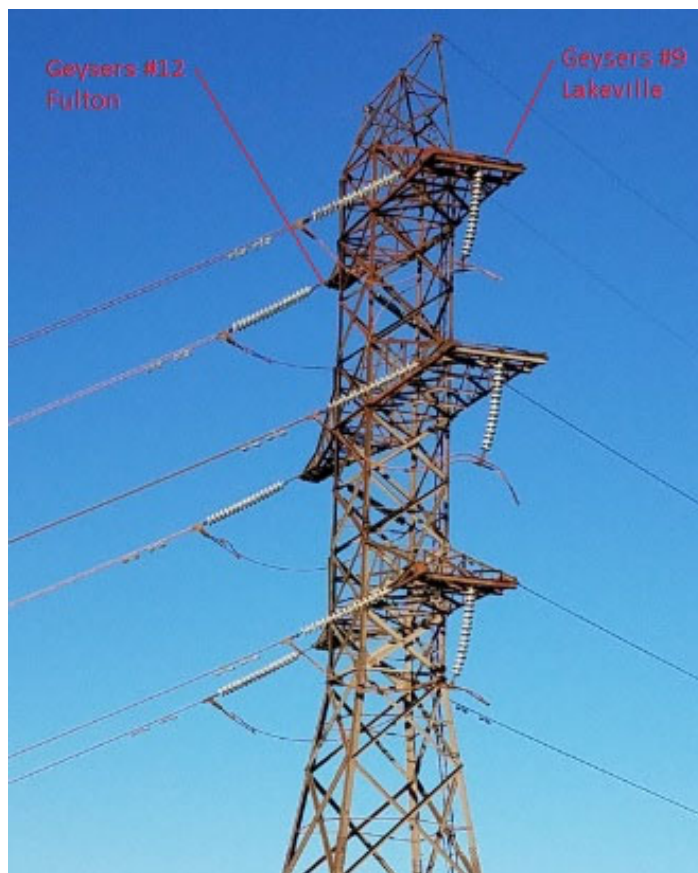
**Figure 1: View of the Incident Tower immediately prior to evidence removal.
Photograph is taken from the grounds of GPC Unit 9/10.**

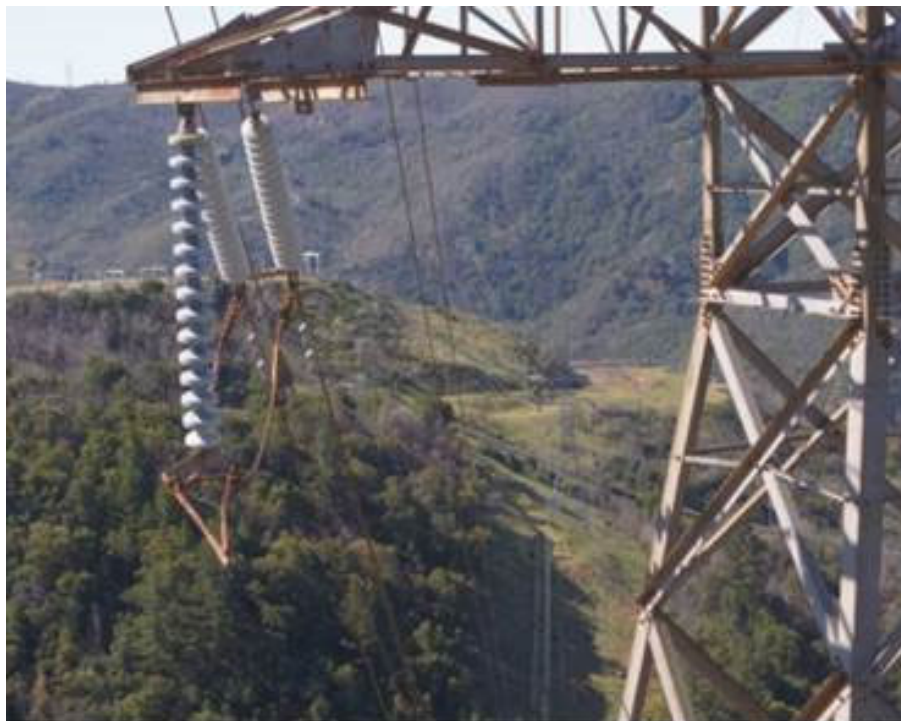
Figure 9: Configuration of the jumper cables and insulators on the Incident Line.²⁴

SED evaluated whether there was an issue with the design or construction of the equipment on the Incident Tower. SED noted that the design of the Lakeville-side jumper cables and insulator strings as they were prior to the incident was unusual. As can be seen in Figure 9, unlike typical span conductors, the ends of the jumper cables on the incident Circuit side of the Incident Tower were not secured to two fixed points (or points that were relatively stable by being under tension). Instead, the jumper cables were attached to the ends of suspension insulators that were hanging freely from the Incident Tower arm.

With regards to the incident, there was nothing that limited the movement of the bottom end of the Lakeville-side suspended insulator strings. As noted in CAL FIRE’s report, the original configuration of the Incident Tower secured the jumper cables and insulator strings in place and prevented excessive movement of that equipment.⁸¹ By configuring the Incident Tower’s jumper cables and insulator strings in the manner shown in Figure 9 after disconnecting GPC Unit 9/10 from PG&E’s transmission system, PG&E allowed that equipment to have a greater range of

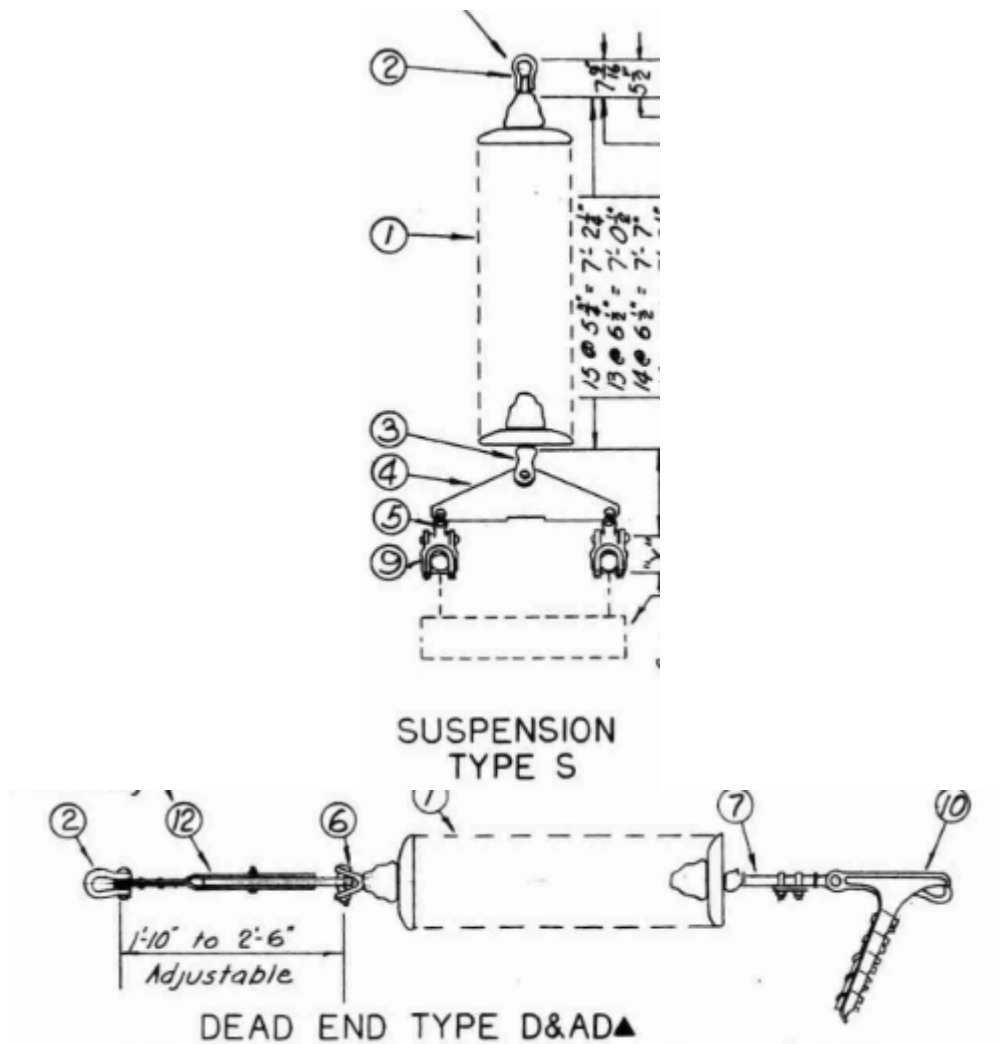
Figure 19: Design drawings of suspension and dead end type insulator configurations⁶¹

Design drawings provided by PG&E and shown in Figure 19 above, illustrate the use of a “jumper string” configuration at the Incident Tower that uses a weight to limit the movement of the insulator string.^{62,63} There are also items that were not on the tower at the time of the incident that are marked on a 1985 structure data sheet from PG&E. These include the aforementioned “hold down weights” and the “hold down shackles” that are used to attach the weights to the jumper cable assemblies.⁶⁴
