Safety and Enforcement Division

**Resolution SED-13
August 13, 2026**

**RESOLUTION SED-13 APPROVING ADMINISTRATIVE CONSENT
ORDER AND AGREEMENT OF THE SAFETY AND ENFORCEMENT
DIVISION AND PACIFIC GAS AND ELECTRIC COMPANY REGARDING
THE 2022 MOSQUITO FIRE PURSUANT TO RESOLUTION M-4846**

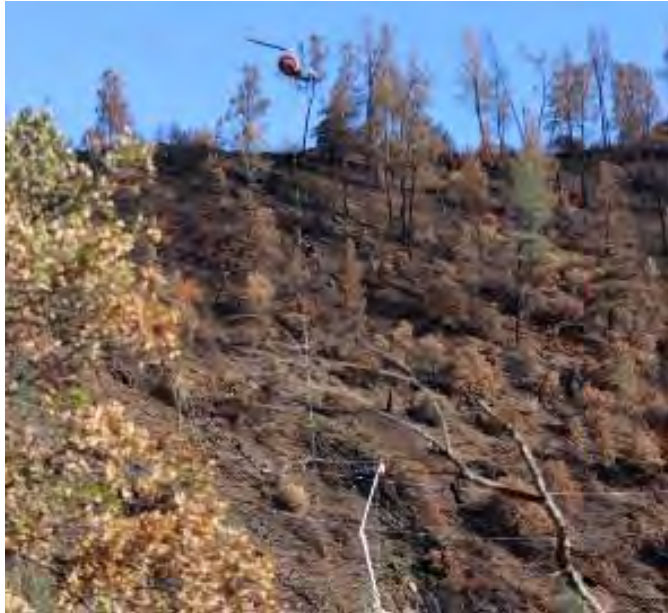
Figure 14: Conductor collection by helicopter and bucket truck⁴⁸

The condition of the conductors prior to collection appeared unchanged from the September 30, 2022, site visit. The ends of the Weimar circuit #1 conductors that were previously connected to the Oxbow Junction Pole lay on the ground. The conductor serving Middle Fork #1 circuit was spliced together in the air with conductor serving the Oxbow Tap.⁴⁹

PG&E collected conductor sections, as shown in Figure 14 above, using two helicopters and a bucket truck. PG&E's contractor then inspected and collected the conductors as evidence.

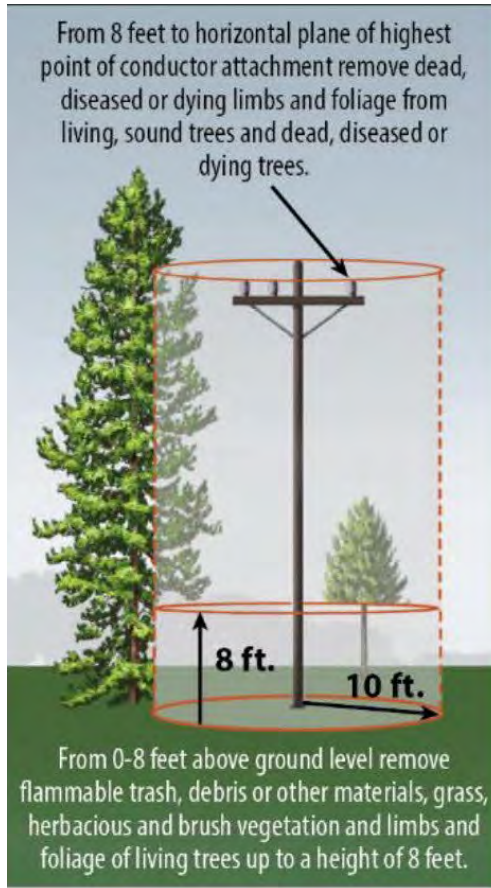
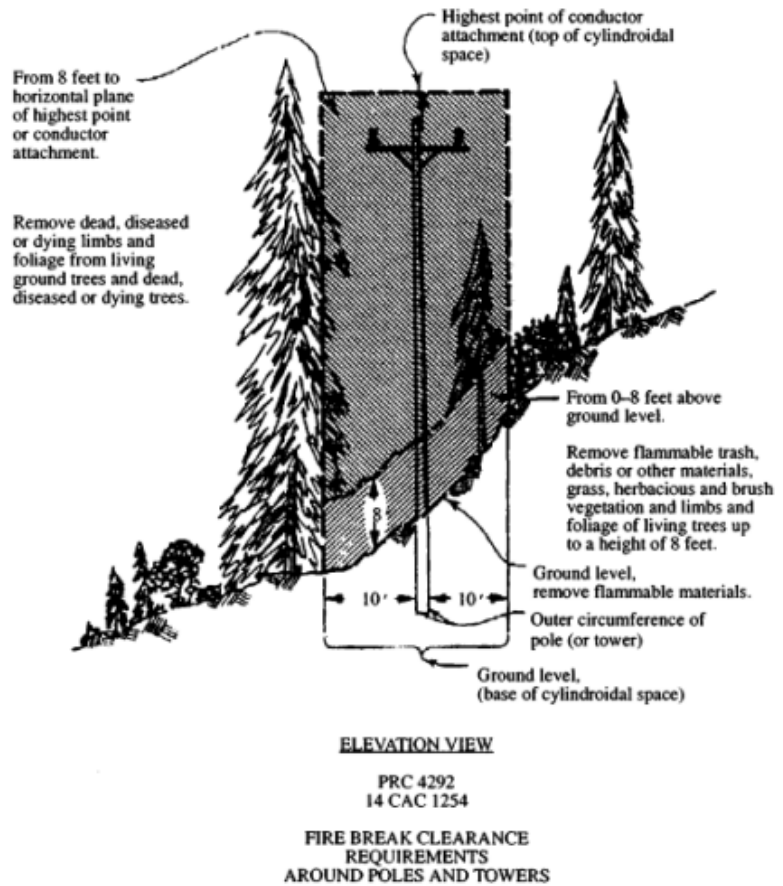
Figure 28 below (left image) below illustrates the requirements including clearing the ground within a 10-foot radius of the pole and to a height of eight feet above ground level.¹⁰⁵ Figure 28 (right image) shows the requirement to clear a cylinder up to eight feet above ground for a sloped surface.

Figure 28: Pole clearance requirements for level ground (left)¹⁰⁶ and sloped ground (right).¹⁰⁷

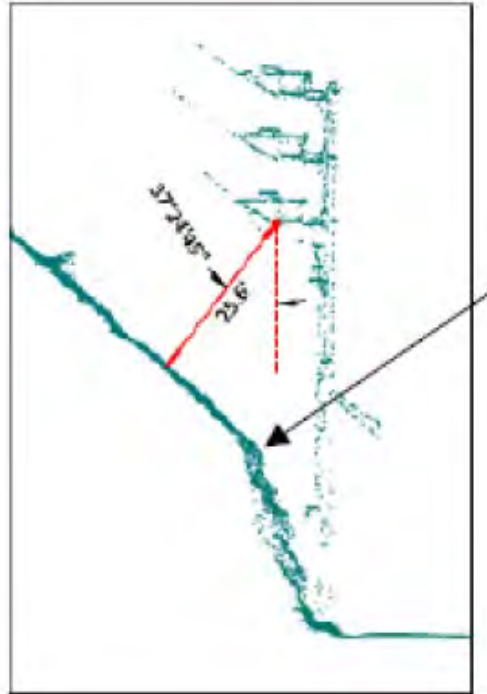
SED asked PG&E to provide measurements of the distance from the Oxbow Junction Pole to a point on the hillside where the terrain transitions from a rocky surface to a grassy slope (as shown in Figure 30, below). PG&E stated that the distance from the pole to points along the hillside at [the height of the terrain change] was “between 8.6 feet and 10.7 feet.”¹¹⁰ Thus, a 10-foot radius cylinder around the pole included vegetation on the hill.

Figure 30: Reference point (black arrow) for measurements of distance from Oxbow Junction Pole to slope.¹¹¹

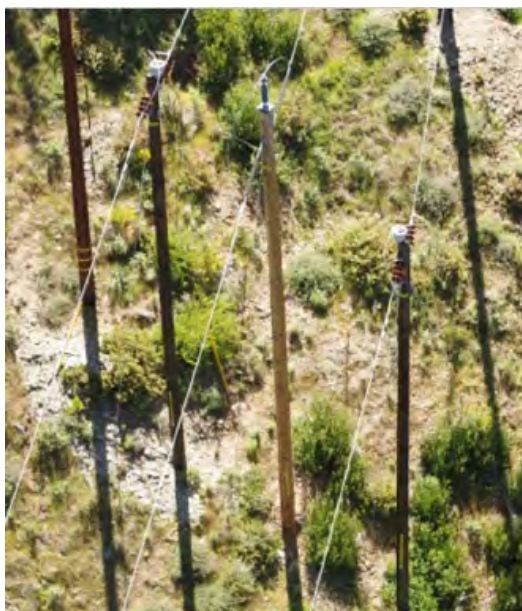
Notification 121584077 addresses pole "014 186 RIGHT", i.e. 014/186(C). PG&E refers to the right child of pole 014/186 as pole 014/186(C) – see the top row on page two of Table A (provided by PG&E as a supplemental response to SED-02 Q45).

Figure 36 below shows the group of poles that contains both 014/186(A) and 014/186(C).

**Figure 36: Photo from June 17, 2021, transmission notification.¹³⁵
PG&E did not specifically identify the label (e.g., 14/186(A), etc.) for each pole.**

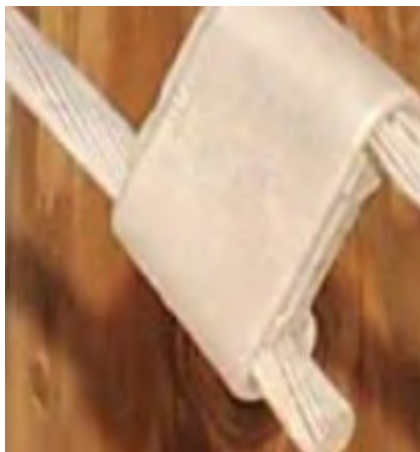
PG&E’s May 27, 2022, Transmission Notification inspection summary for Pole 014/187 shows that a PG&E inspector and a PG&E SME agreed to recommend repairs for "4 jumper connectors not shot or seated" as shown in Figure 39 below.¹⁷² PG&E inspection manuals show that the wedge connector is normally fully inserted, as shown for example in Figure 40 below.¹⁷³ In contrast, the partially inserted wedges at Pole 014/187 are not normal.

Figure 40: Photo of fully inserted wedge from PG&E manual¹⁷⁴

The partially inserted wedges created a safety issue. PG&E stated that “not shot or seated” means that an A-shaped wedge is partially inserted into u-shaped housing and not locked. Thus, the wedge could become loose.¹⁷⁵ The inspection summary states that “the jumpers can open up” and result in “a loose tail”¹⁷⁶ meaning that that the conductor could come loose and potentially ignite a fire.

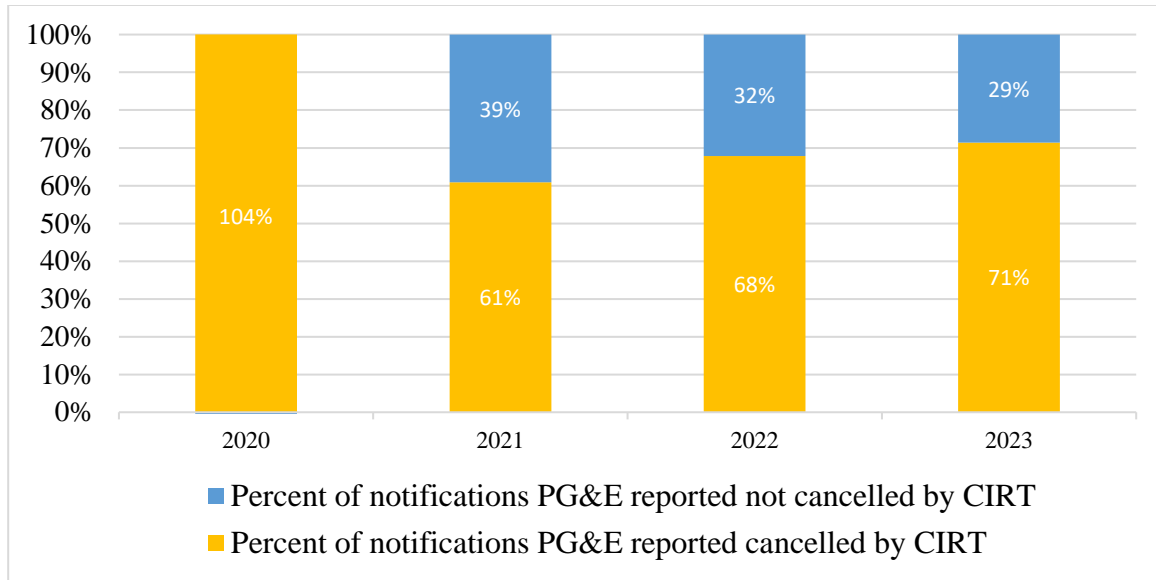
During this period, CIRT canceled the majority of repairs recommended in transmission inspection reports created by PG&E inspection staff and approved by a PG&E SME. Specifically, SED found that CIRT reviewed 447,365 recommendations and cancelled approximately 314,000 of the 447,365 recommendations reviewed, as shown in in Figure 44 below.¹⁹⁷

Figure 44: CIRT rate of notification cancellation (PG&E data for CIRT notification cancellations in 2020 is approximate and exceeds PG&E data for number of 2020 notifications reviewed by 4%).¹⁹⁸

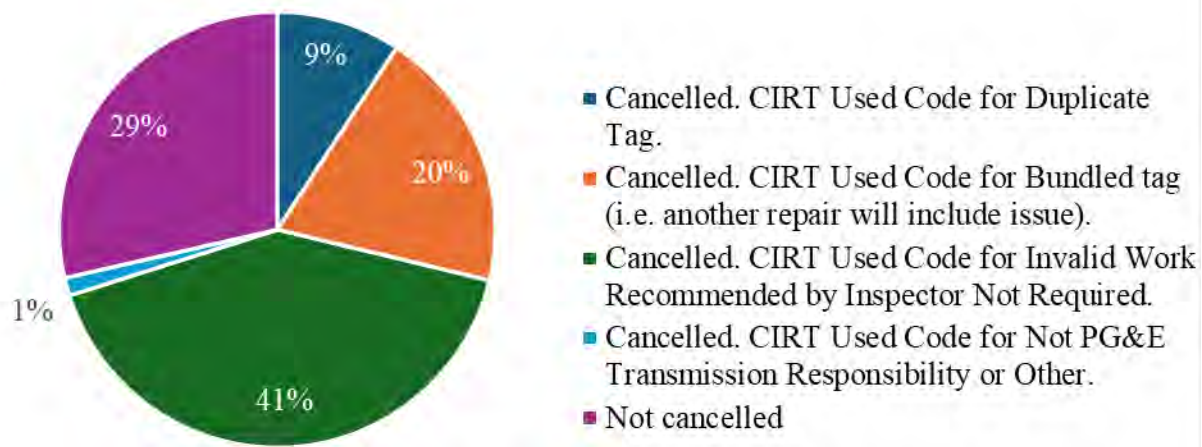
Prior to February 2, 2022, PG&E did not have a system for tracking “reason codes” that identify the category of reason for CIRT cancellations of recommended repairs¹⁹⁹, limiting visibility into the number of repair recommendations cancelled because CIRT disagreed with the inspector and their SME reviewer. In 2023, the first full calendar year that CIRT used reason codes for canceling repairs, CIRT cancelled 71% of recommended repairs. As shown in Figure 45 below, CIRT routinely cancelled repair recommendations because CIRT disagreed with a transmission inspection report. CIRT cancelled 75,901 repairs due to disagreement with these reports compared to 52,417 repairs that CIRT did not cancel.

Figure 45: CIRT review of 2023 transmission inspection reports recommending repairs²⁰⁰

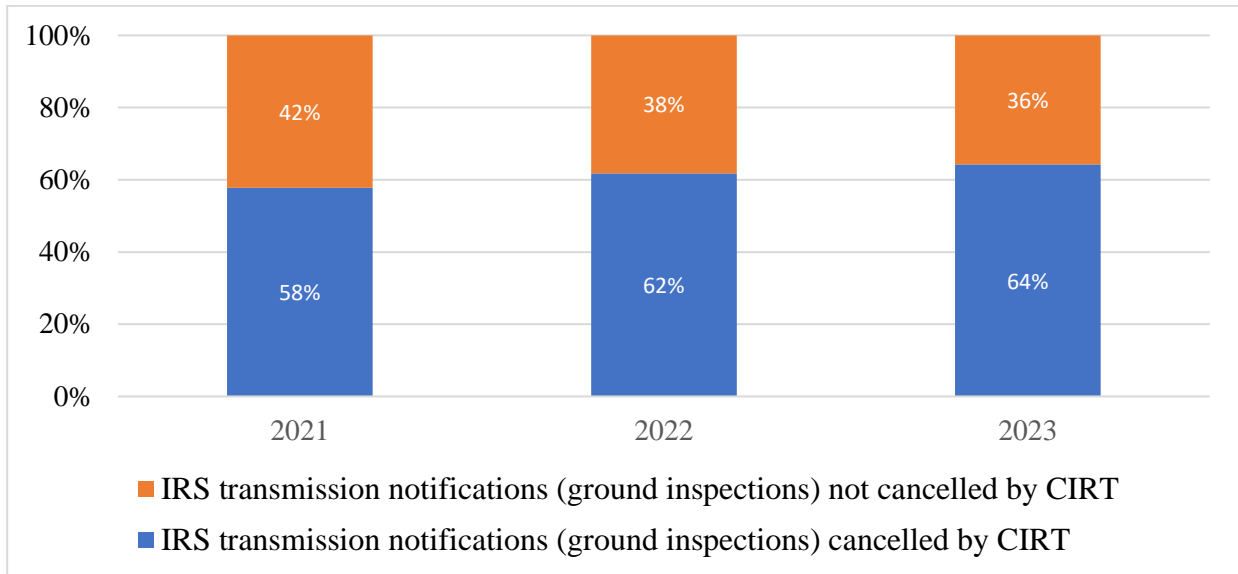
This pattern affected notifications originated by field inspectors and by the "inspection review specialists" responsible for the completeness of inspection reports. An Inspection Review Specialist (IRS) reviewed ground and aerial inspection for accuracy and completeness from 2020 to 2022.²⁰⁶ PG&E identified 5685 repair recommendations generated during by an IRS for ground inspections²⁰⁷ and CIRT cancelled 3245 of these repair recommendations as shown in Figure 46

below.²⁰⁸ (PG&E does not track notifications created by IRS for aerial inspections). This data indicates that efforts by PG&E SMEs to recommend repairs for safety issues missed in an initial inspection report were often over-ruled by CIRT.

Figure 46: CIRT cancellation of transmission notifications created by PG&E IRS SMEs²⁰⁹
