**PUBLIC UTILITIES COMMISSION OF THE STATE OF CALIFORNIA**

**Resolution SED-13  
August 13, 2026**

**RESOLUTION SED-13 APPROVING ADMINISTRATIVE CONSENT  
ORDER AND AGREEMENT OF THE SAFETY AND ENFORCEMENT  
DIVISION AND PACIFIC GAS AND ELECTRIC COMPANY REGARDING  
THE 2022 MOSQUITO FIRE PURSUANT TO RESOLUTION M-4846**

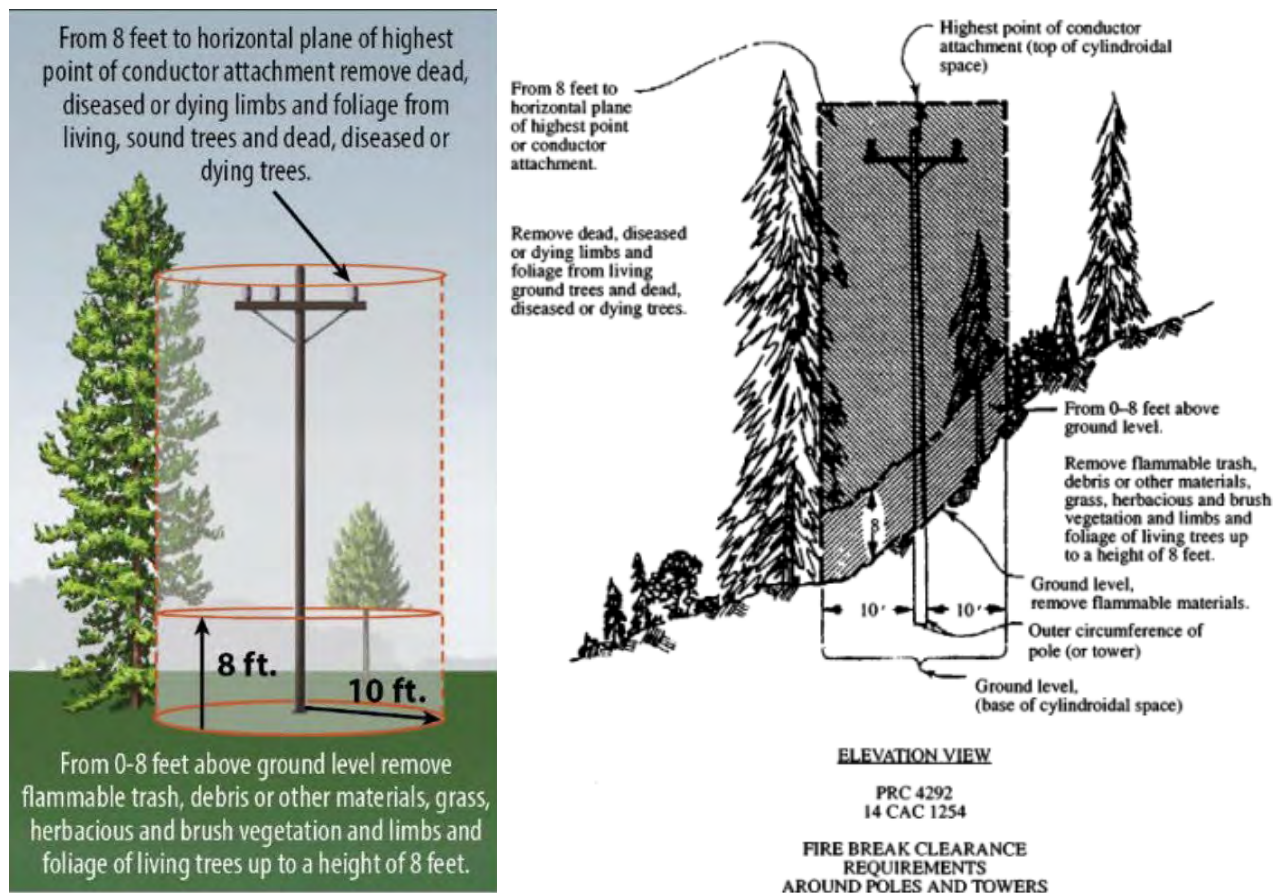
Figure 28 below (left image) below illustrates the requirements including clearing the ground within a 10-foot radius of the pole and to a height of eight feet above ground level.<sup>105</sup> Figure 28 (right image) shows the requirement to clear a cylinder up to eight feet above ground for a sloped surface.

Figure 28: Pole clearance requirements for level ground (left)<sup>106</sup> and sloped ground (right).<sup>107</sup>

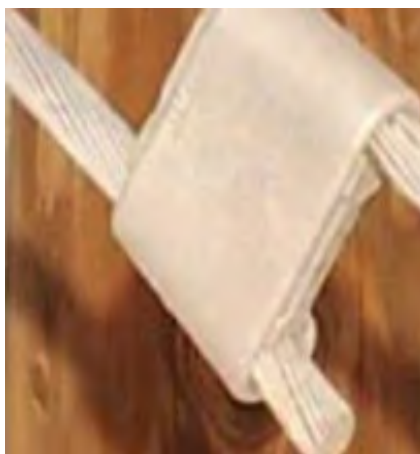
PG&E’s May 27, 2022, Transmission Notification inspection summary for Pole 014/187 shows that a PG&E inspector and a PG&E SME agreed to recommend repairs for "4 jumper connectors not shot or seated" as shown in Figure 39 below.<sup>172</sup> PG&E inspection manuals show that the wedge connector is normally fully inserted, as shown for example in Figure 40 below.<sup>173</sup> In contrast, the partially inserted wedges at Pole 014/187 are not normal.

Figure 40: Photo of fully inserted wedge from PG&E manual<sup>174</sup>

The partially inserted wedges created a safety issue. PG&E stated that “not shot or seated” means that an A-shaped wedge is partially inserted into u-shaped housing and not locked. Thus, the wedge could become loose.<sup>175</sup> The inspection summary states that “the jumpers can open up” and result in “a loose tail”<sup>176</sup> meaning that the conductor could come loose and potentially ignite a fire.

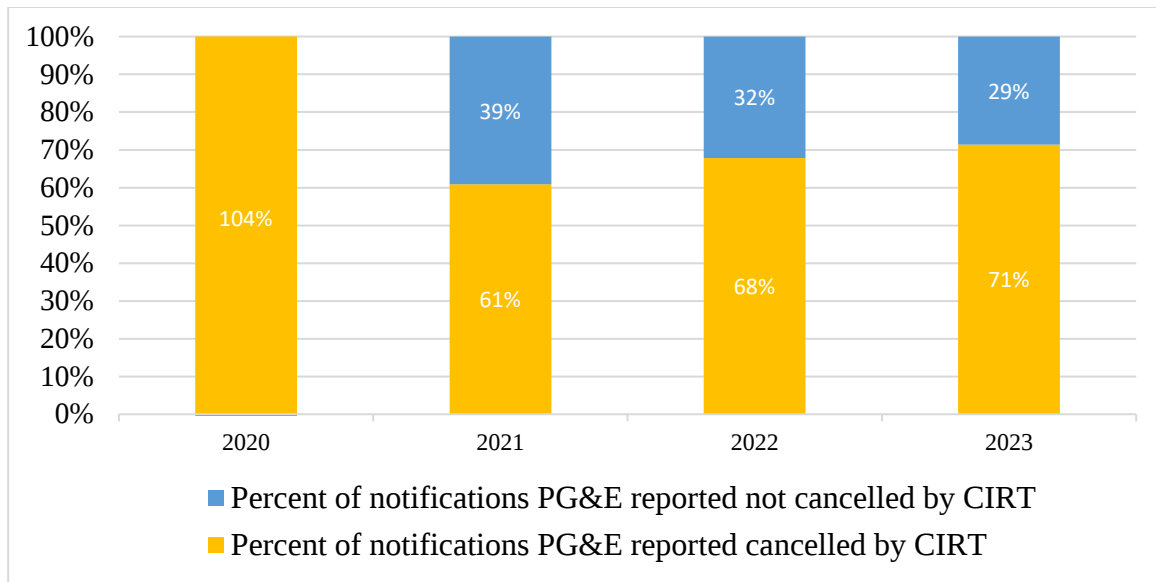
During this period, CIRT canceled the majority of repairs recommended in transmission inspection reports created by PG&E inspection staff and approved by a PG&E SME. Specifically, SED found that CIRT reviewed 447,365 recommendations and cancelled approximately 314,000 of the 447,365 recommendations reviewed, as shown in in Figure 44 below.<sup>197</sup>

Figure 44: CIRT rate of notification cancellation  
(PG&E data for CIRT notification cancellations in 2020 is approximate and exceeds PG&E data for number of 2020 notifications reviewed by 4%).<sup>198</sup>

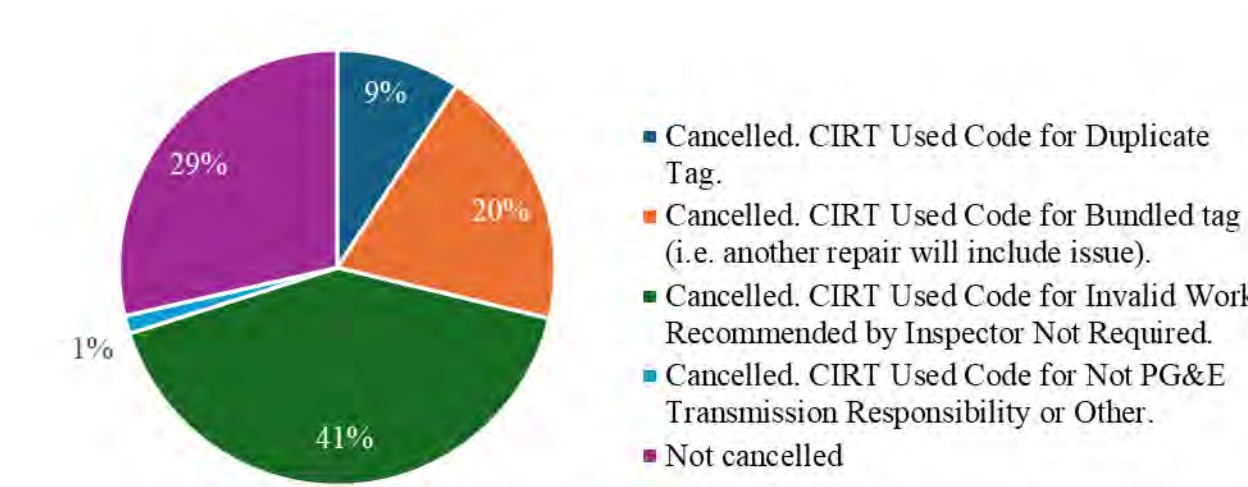
Prior to February 2, 2022, PG&E did not have a system for tracking “reason codes” that identify the category of reason for CIRT cancellations of recommended repairs<sup>199</sup>, limiting visibility into the number of repair recommendations cancelled because CIRT disagreed with the inspector and their SME reviewer. In 2023, the first full calendar year that CIRT used reason codes for canceling repairs, CIRT cancelled 71% of recommended repairs. As shown in Figure 45 below, CIRT routinely cancelled repair recommendations because CIRT disagreed with a transmission inspection report. CIRT cancelled 75,901 repairs due to disagreement with these reports compared to 52,417 repairs that CIRT did not cancel.

Figure 45: CIRT review of 2023 transmission inspection reports recommending repairs<sup>200</sup>

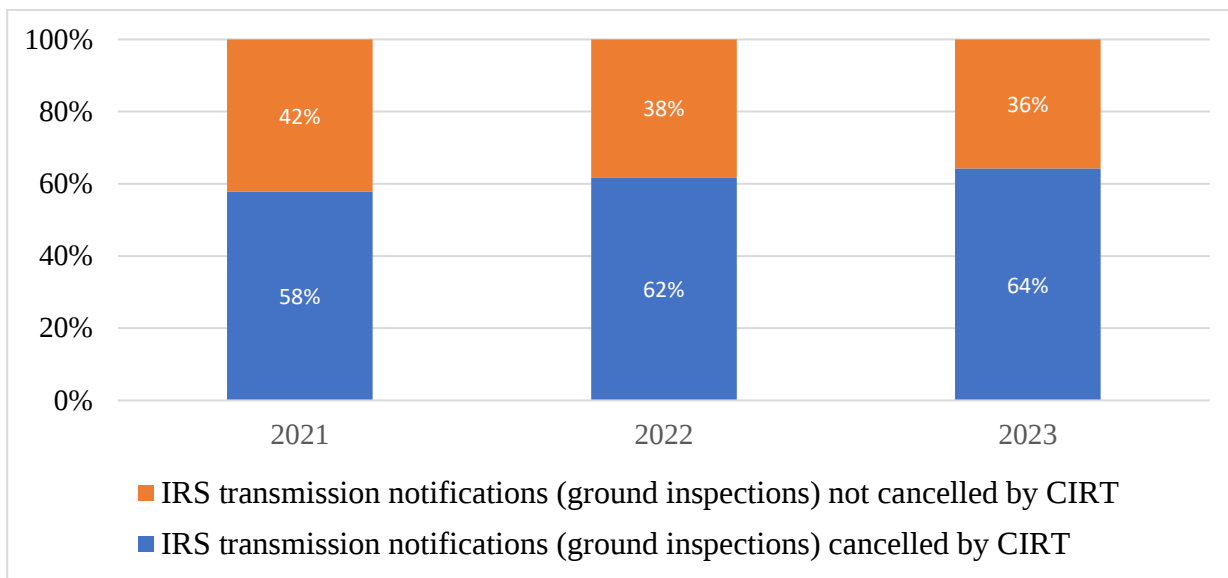
This pattern affected notifications originated by field inspectors and by the "inspection review specialists" responsible for the completeness of inspection reports. An Inspection Review Specialist (IRS) reviewed ground and aerial inspection for accuracy and completeness from 2020 to 2022.<sup>206</sup> PG&E identified 5685 repair recommendations generated during by an IRS for ground inspections<sup>207</sup> and CIRT cancelled 3245 of these repair recommendations as shown in Figure 46

below.<sup>208</sup> (PG&E does not track notifications created by IRS for aerial inspections). This data indicates that efforts by PG&E SMEs to recommend repairs for safety issues missed in an initial inspection report were often over-ruled by CIRT.

Figure 46: CIRT cancellation of transmission notifications created by PG&E IRS SMEs<sup>209</sup>
