Incident Investigation Report

Incident Number: E20220622-01 (Edgewood Fire)

Regulated Utility Involved: Pacific Gas and Electric Company (PG&E)

Regulated Utility Facilities Involved: Jefferson-Stanford 60 Kilovolt (kV) transmission circuit, and Emerald Lake 4.2kV distribution circuit.

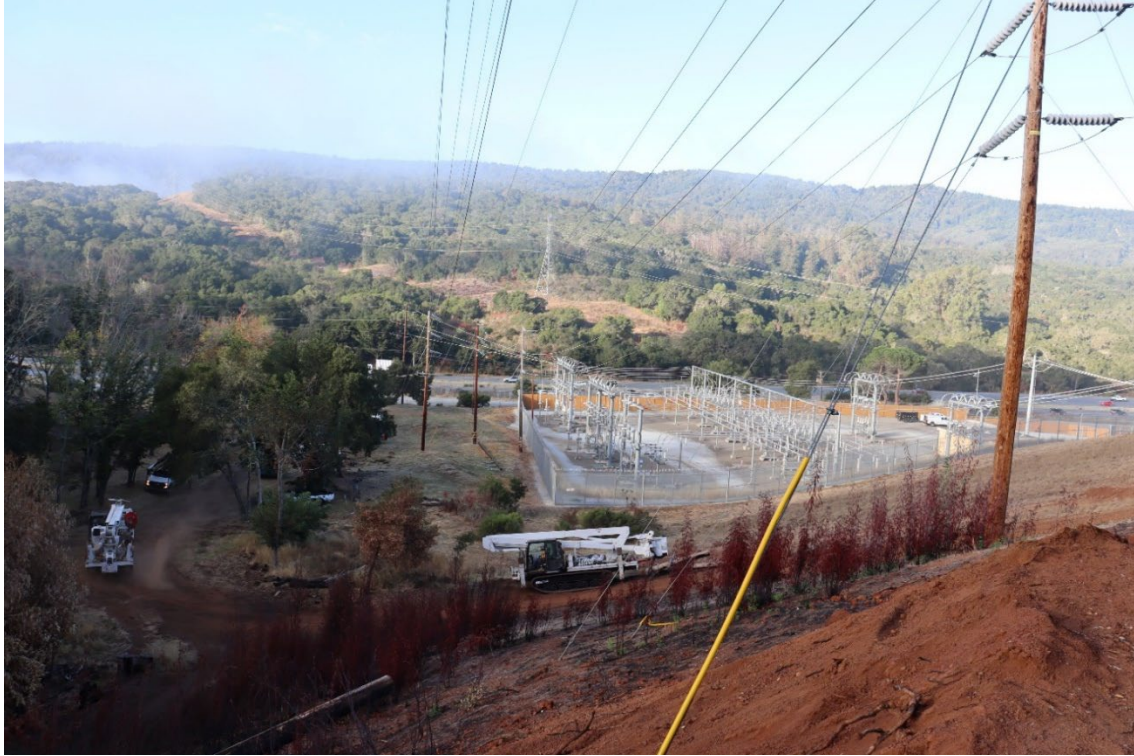
Figure 13: Staging Area for Repair Work (looking down at Jefferson Substation).

The PG&E construction supervisor confirmed that his crew had replaced Poles 000/002, 000/003, and 000/004 the night before the site visit, and that PG&E scheduled Pole 000/001 to be replaced that night or the next night (September 30, 2022). Figure 14 below shows Pole 000/001 prior to it being replaced.
