Company: San Diego Gas & Electric Company (U 902 M)
Proceeding: 2024 General Rate Case – Track 3
Application No.: A.22-05-016
Exhibit: SDG&E-T3-WMPMA-14

Investigation Report of the Woolsey Fire

INVESTIGATION REPORT OF THE WOOLSEY FIRE

**SAFETY AND ENFORCEMENT DIVISION
ELECTRIC SAFETY AND RELIABILITY BRANCH
LOS ANGELES**

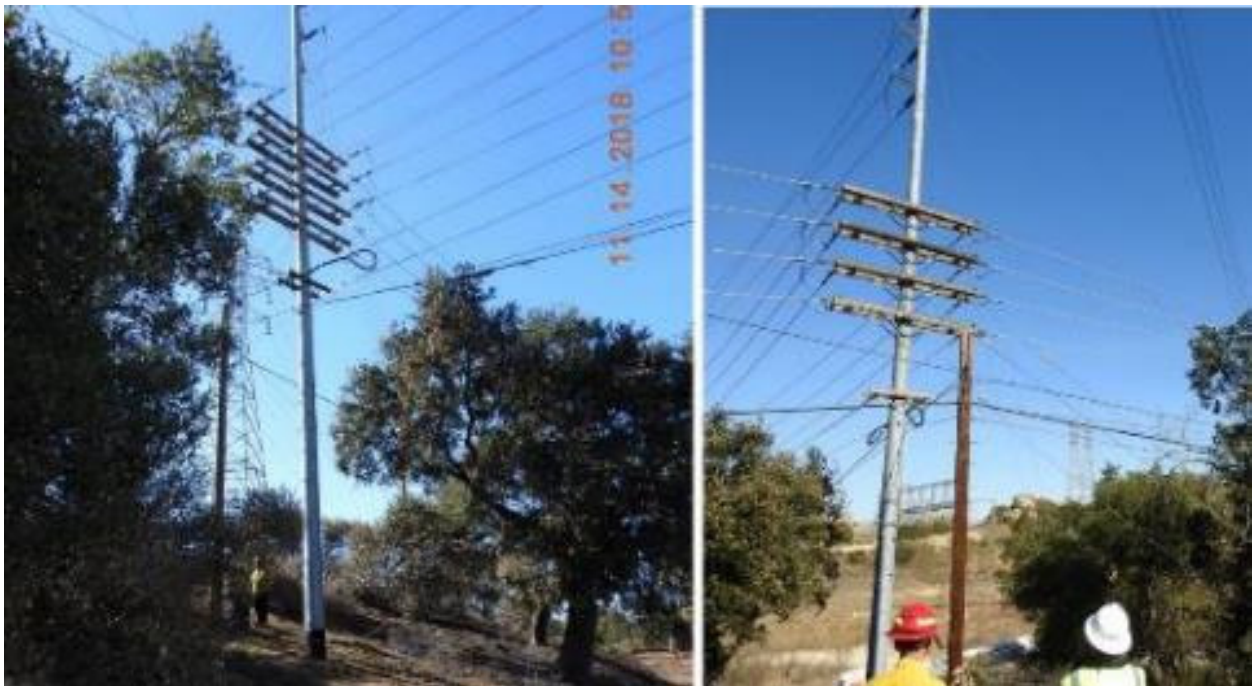
The facilities involved at Site 2 included pole number 4534353E (hereafter referred to as “the Steel Pole”) and pole number 984161E,² a stubbed wooden pole (hereafter “the Stubbed Pole”), located about thirty feet south of the Steel Pole. See Figure 2.

Figure 2: Site 2 as viewed from the north (left) and from the south (right).³

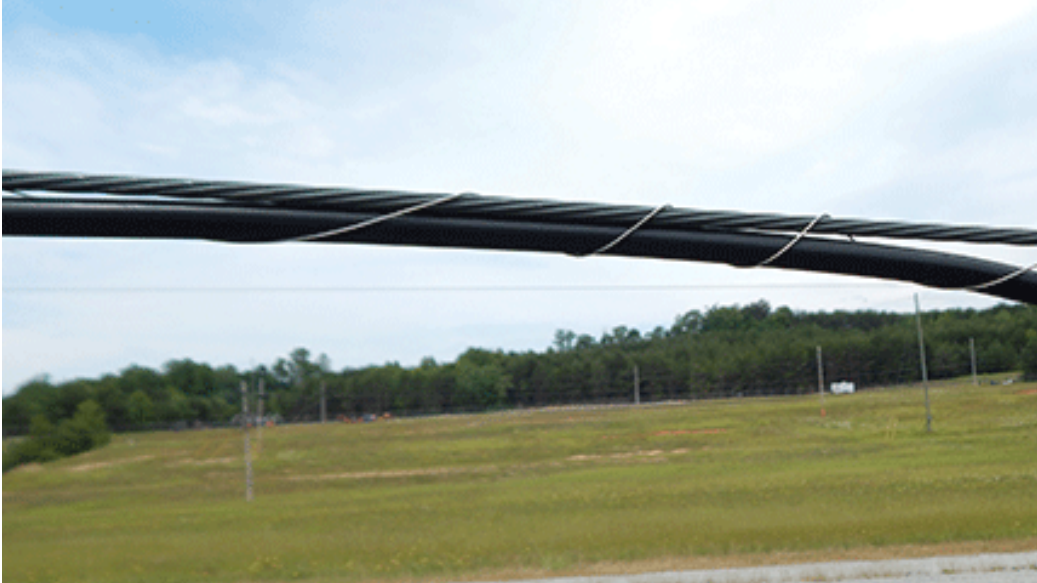
Figure 4: A messenger wire supporting a communications conductor and wrapped with lashing wire. Note that this is a stock image and that this particular communications conductor was not involved in the Woolsey Fire in any way. However, the communications infrastructure involved in the Woolsey Fire was very similar to that depicted in the image.

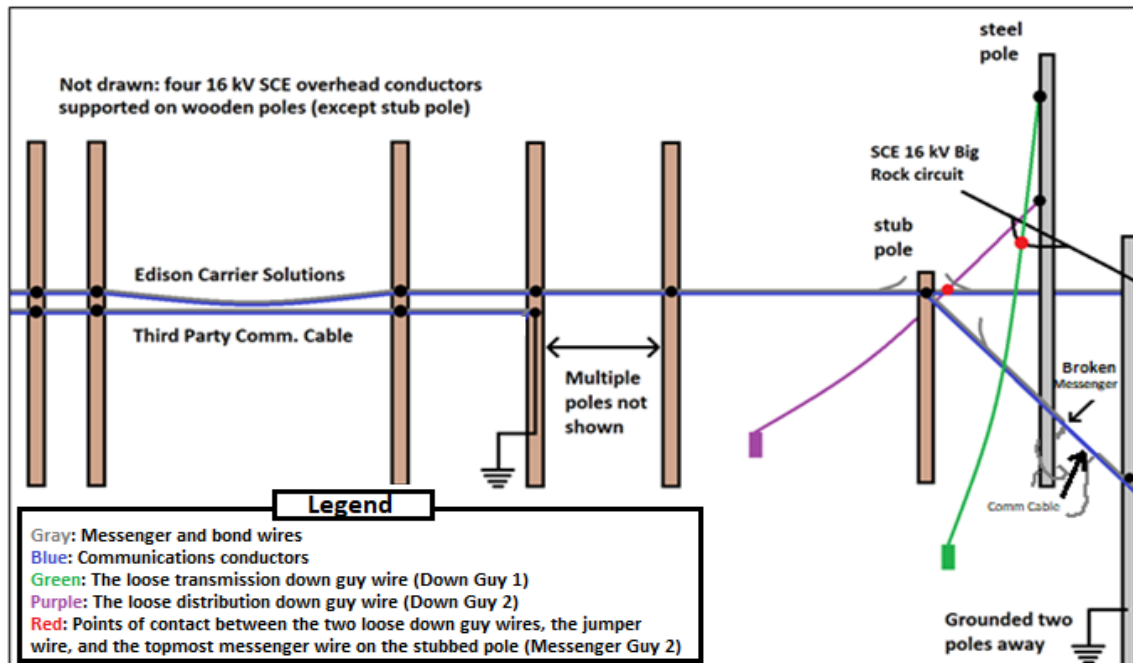
Figure 8: Diagram of the facilities at Site 1 and Site 2. Site 1 is on the left, and Site 2 is on the right.

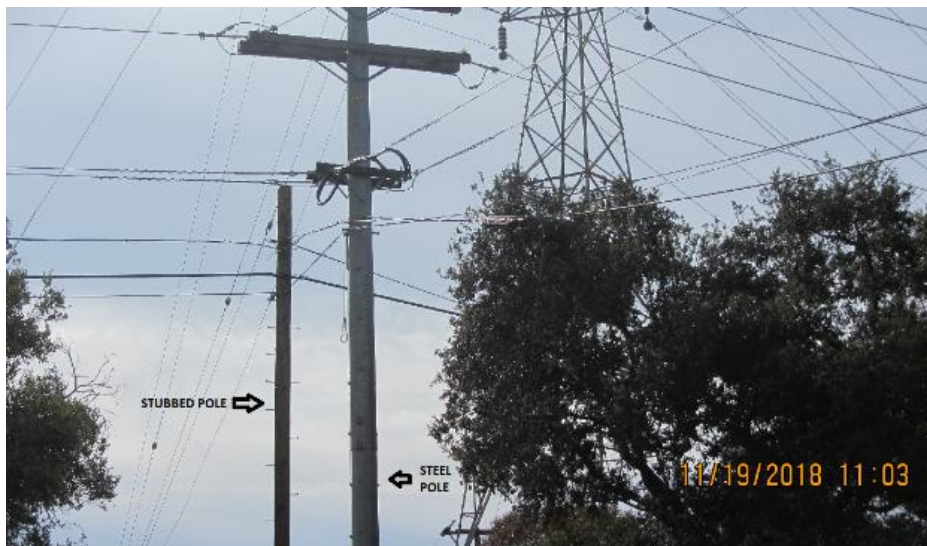
Staff observed that Down Guy 1 was loose and had sustained damage consistent with contacting the Edison 16 kV jumper wire. Staff noted that two other Edison down guy wires on the south side of the Steel Pole were also loose. The second loose down guy wire, Down Guy 2, was in contact with Messenger Wire 1 on the Stubbed Pole. The third loose down guy wire, Down Guy 3, was in contact with the top of the Stubbed Pole. Staff observed dark discoloration around the contact point between Down Guy 2 and the ECS through-bolt. See Figures 15-18.

Figure 15: The Steel Pole and Stubbed Pole as viewed from the northeast.
