**PUBLIC ADVOCATES OFFICE**  
**CALIFORNIA PUBLIC UTILITIES COMMISSION**

# **Testimony on the Koenigstein Ignition for Thomas Fire and Debris Flow Cost-Recovery Application**

**The Koenigstein Ignition:  
Supporting Attachments**

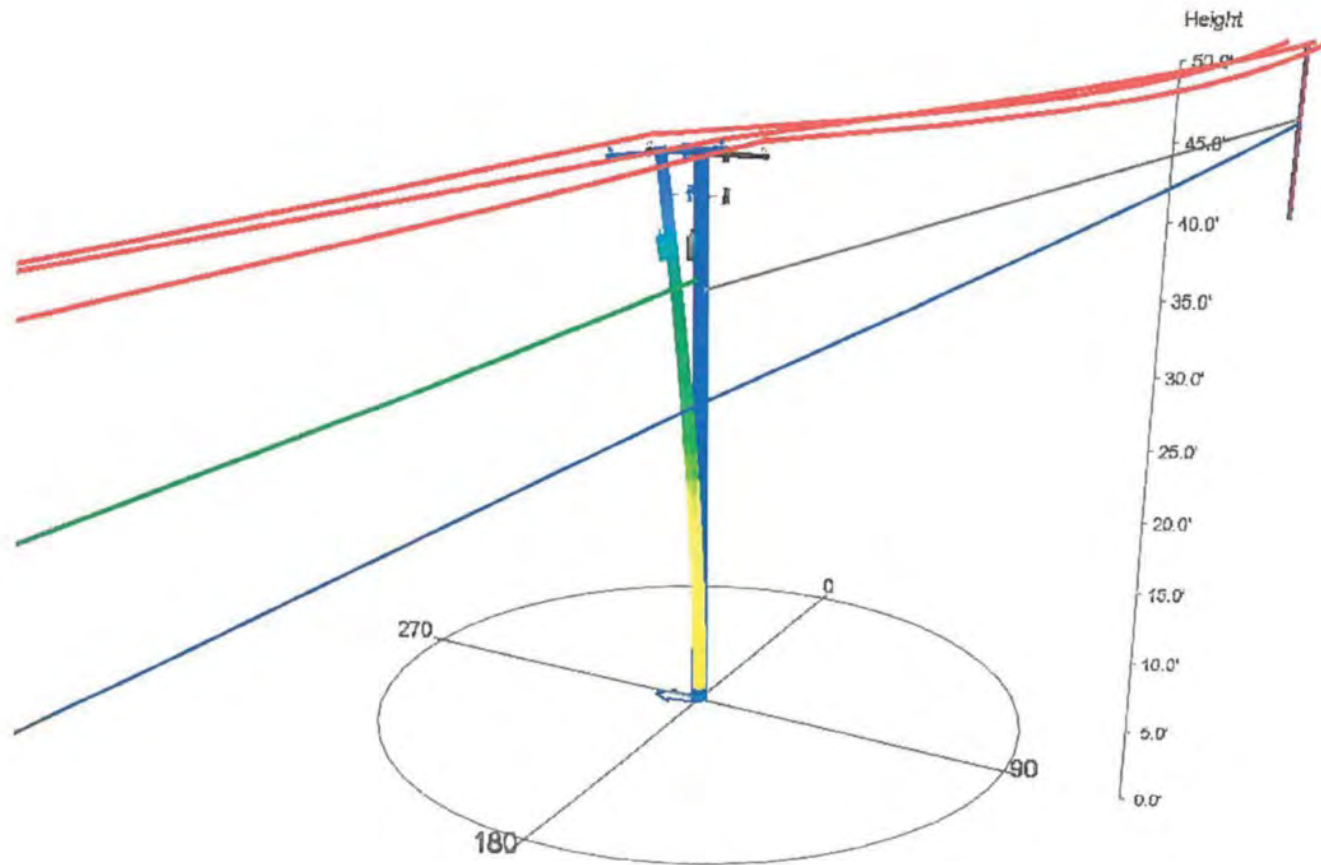
| Layer | Length/Class | Minimum Safety Factor | | | | | | Pole Strength Remaining | Loading Adjusted by Strength? | Clearance Violations Present? |
|---|---|---|---|---|---|---|---|---|---|---|
| As Designed | 40/2 | 0.54 from stress at 12' 11" | 2.33 (Guy#4) | No Data | No Data | No Data | No Data | 100% | N | N |

Theoretical: As Designed
