PACIFIC GAS AND ELECTRIC COMPANY

KINCADE AND DIXIE AB 1054 WILDFIRE COST REVIEW AND RECOVERY PROCEEDING

PREPARED TESTIMONY

VOLUME 1 OF 2

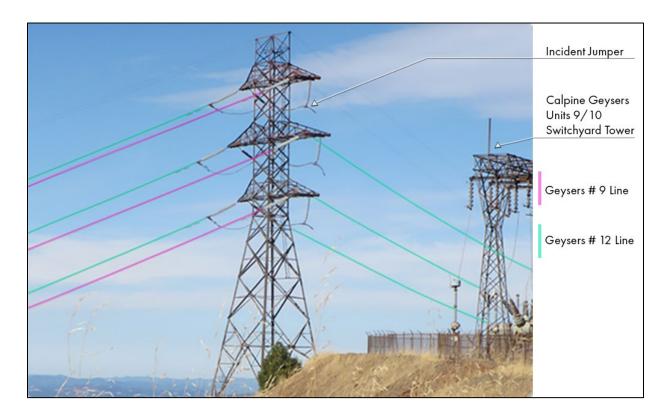
FIGURE 3A-1 TOWER 001/006

The numbering for Tower 001/006 is based on its position as the sixth tower in the first mile of the Geysers #12 Line.

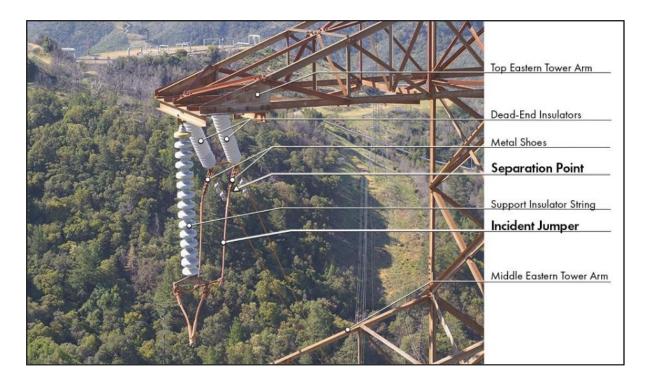
FIGURE 3A-3 TOWER 001/006 JUMPER CONFIGURATION

Based on my examination of the evidence, associated reports and documents, and my training and experience, I reached the following conclusions. I determined that the jumper conductor separated due to fatigue, i.e., the gradual weakening of the conductor, induced by gusting winds over time. I also determined that there was no visible indication of fatigue prior to the separation, and that the separation point was located within the solid metal shoe, which obscured the failure location prior to separation.

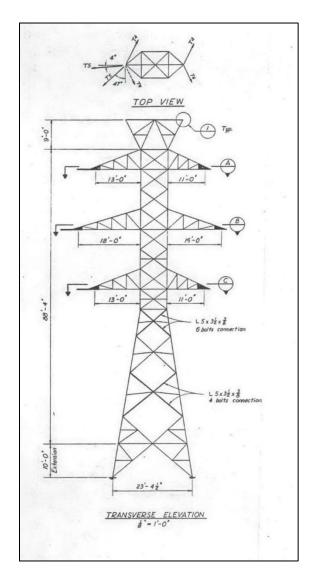
FIGURE 3A-6
DESIGN DRAWING APPLICABLE TO TOWER 001/006

Tower 001/006 conformed with PG&E's clearance requirements for towers in heavy loading districts like the Geysers, which met or exceeded regulatory requirements. Like other towers on the Geysers #9 Line, Tower 001/006 was designed with horizontal offsets of the conductors, which helped maintain required clearances and reduce the potential for conductor-to-conductor contact. The design drawing for Tower 001/006 in Figure 3A-6 below reflects that the middle arms are between four and five feet longer than the upper and lower arms.

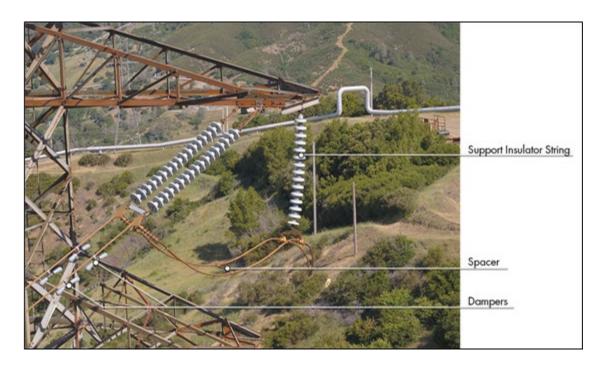
FIGURE 3A-7 WIND MITIGATIONS ON TOWER 001/006 AS OF MAY 2019

Dampers to Control Aeolian Vibration. PG&E's design standard for overhead electrical transmission lines, entitled "Overhead Transmission Line Design Criteria" and effective August 15, 2017, required the installation of dampers to control vibration from wind. Specifically, PG&E's standards required Stockbridge-type dampers, which were recognized as the most effective type for controlling aeolian vibration on spans above certain lengths. Figure 3A-7, a photograph taken during a May 2019 drone inspection, shows four Stockbridge-type dampers on the bundled conductors connecting to the incident jumper at Tower 001/006 (two per conductor in the bundle). The use of four dampers provided an even greater margin of safety than the industry-standard guidance, which would have required only two dampers (one per conductor in the bundle).

Spacers to Maintain Distance and Control Oscillation. PG&E's design standard also required the installation of staggered helical-type spacers on long spans of bundled conductors. These spacers were designed to mitigate oscillations from wind. By fixing the bundled conductors together, the spacers keep the bundle moving as a single unit and prevent the relative motion that causes oscillations of the individual conductors in the bundle. PG&E's standards required positioning the spacers at unequal intervals no

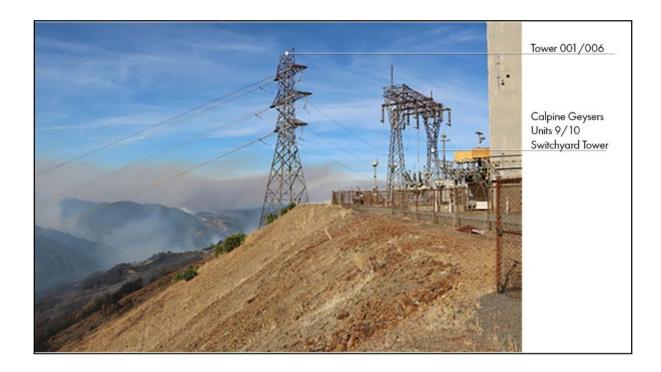
FIGURE 3A-9
PHOTOGRAPH OF TOWER 001/006 AND GEYSERS UNITS 9/10 SWITCHYARD

Consistent with the status of Geysers Units 9/10, when disconnecting the generation tie line from Tower 001/006 in 2006, PG&E performed the work in a manner that made it feasible to reconnect the plant in the future. In particular, the crew that performed the disconnection work left in place the jumpers on Tower 001/006 in an "open" configuration to allow the plant to be more easily and safely reconnected to the Geysers #9 Line when Calpine was ready to do so. This configuration facilitated reconnection by maintaining the jumper conductor, including the structural connection to the support insulator, and avoiding further modification to the equipment. After the disconnection work, for each of the three phases of the Geysers #9 Line, the ends of the two jumper conductors—previously connected to the

generation tie line—were fused together and the support insulator string helped maintain tension and secure the conductors. 32

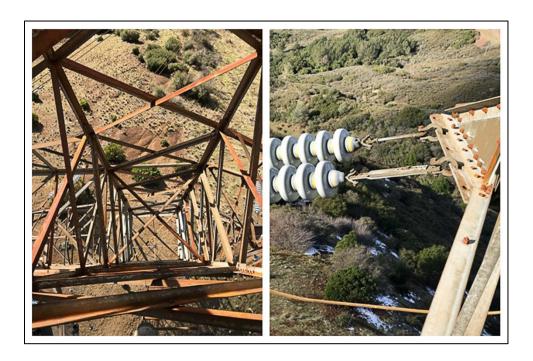
FIGURE 3A-10
ILLUSTRATIVE PHOTOGRAPHS FROM FEBRUARY 6, 2019 CLIMBING INSPECTION

five work orders. The WSIP inspection form documented these non-conformances, including issues with the amount of rust on the tower structure and a small crack in one of the concrete footings. None of the non-conformances related to the jumper conductors. Under the prompt "Jumper in poor condition," the inspectors answered "no." As shown in Figure 3A-10, the climbing inspectors were in close proximity to the insulator and jumper assemblies, meaning they could observe a visible problem.

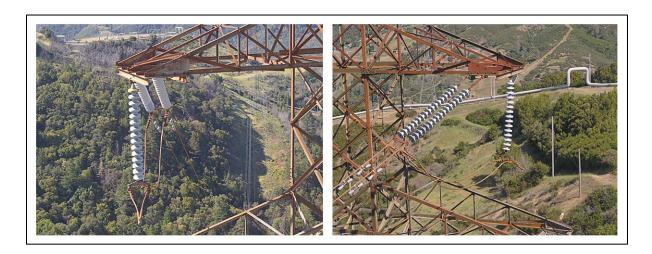
FIGURE 3A-11 ILLUSTRATIVE PHOTOGRAPHS FROM MAY 11, 2019 DRONE INSPECTION

Drone Inspection. On May 11, 2019, PG&E conducted a drone inspection of Tower 001/006 as part of the WSIP. Through that inspection, PG&E took high-resolution photographs of the facilities from a high elevation and from multiple angles. Those photographs were then sent to the Drone Inspection Review Team (DIRT) for review and made available to the Centralized Inspection Review Team (CIRT). A few illustrative photographs from the drone inspection are shown in Figure 3A-11 below. That inspection identified no issues related to the jumper.

On June 18, 2019, DIRT re-reviewed the May 2019 drone photographs as part of a routine review of inspection forms where no conditions were reported. Again, no issues related to the jumper were identified. ³⁷ PG&E's DIRT conducted an additional re-review of the drone photographs in August 2019, which also identified no issues related to the jumper. This re-review focused on identifying wear on certain equipment, specifically towers located in HFTDs with C-hooks and hanger plates. In this assessment, between 10% and 30% wear was noted for the hanger plates for Tower 001/006, which did not warrant a maintenance tag under PG&E's inspection guidance.

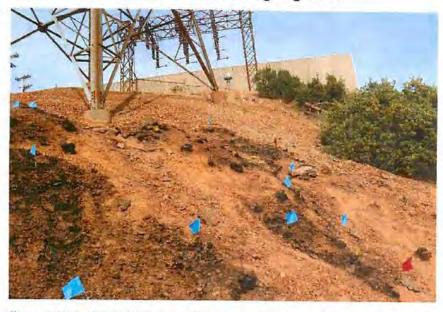
³⁹ Section 451.1(c) provides: "If the electrical corporation has received a valid safety certification for the time period in which the covered wildfire ignited, an electrical corporation's conduct shall be deemed to have been reasonable pursuant to subdivision (b) unless a party to the proceeding creates a serious doubt as to the reasonableness of the electrical corporation's conduct. Once serious doubt has been raised, the electrical corporation has the burden of dispelling that doubt and proving the conduct to have been reasonable."

- 1 I located a specific origin area (SOA), down slope / south of the electrical transmission
- 2 tower at the 9-10 Fumarole site. This SOA consisted of both advancing and backing fire
- 3 spread indicators within a proximity of each other. This area of interest indicated to me
- 4 that there was a high probability a heat source initially ignited vegetation from this
- 5 location which spread to surrounding vegetation.

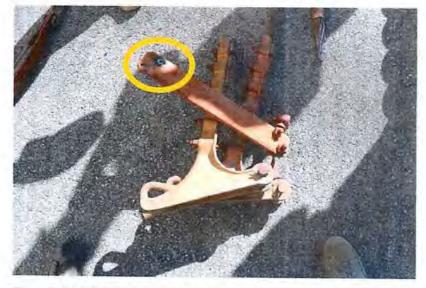
Figure 6.(IMG-1866JPG) Six holt wire clamp with electrical are marks near the holt holes from Tower 1-6.41129171.

The increased cycle and range of movement from the wind accelerated the low cycle fatigue phenomenon at the location of the six-bolt saddle clamp resulting in an eventual fatigue and failure at the location of the six-bolt saddle clamp on electrical transmission

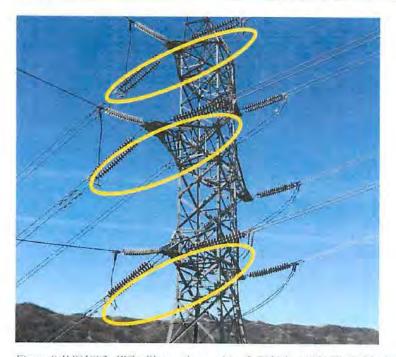
Figure 8(IMG1902-JPG.) Photo taken on May 5, 2020 by UBOLDI, G. The highlighted sections are where PG&E removed the conductor wires from tower 001,009 on the Geysers #9 - Lukeville electrical transmission line after the Kineade Fire

If the above proper corrective measures were originally taken by PG&E when the 9/10 Fumarole (Geysers #9 / #10) power plant was decommissioned in 2001 the Kincade fire would have not occurred on October 23, 2019 due to a failure on tower 1-6 41129171.

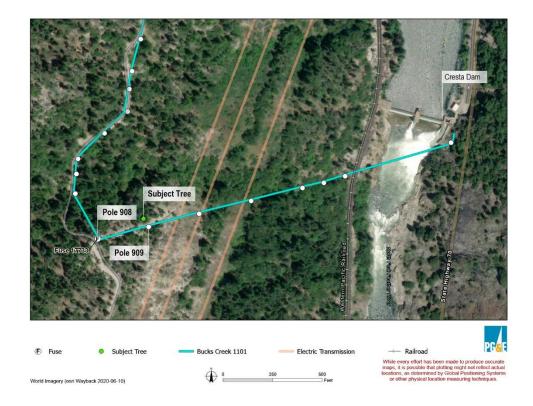
FIGURE 3B-1 SUBJECT SPAN ON BUCKS CREEK 1101 CIRCUIT

The PG&E facilities at issue are part of the Bucks Creek 1101 Circuit, at the span between pole numbers 100403908 (Pole 908) and 100403909 (Pole 909). This span (the Subject Span) is near the end of the circuit and located on a steep slope that runs down from a single-lane dirt road to the Cresta Dam in the Feather River Canyon. This area was designated as a Tier 2 High Fire Threat District (HFTD) in the Commission's final 2018 Fire Threat Map, though the area had not previously been designated as high fire risk under the earlier interim fire threat map. The figures below show the specific facilities at Poles 908 and 909 as of July 13, 2021, as well as an aerial view of the Subject Span.

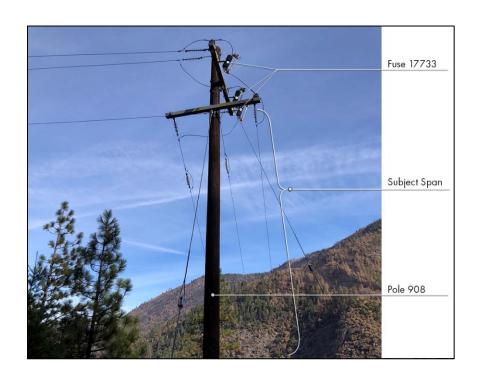
FIGURE 3B-2 POLE 908

When a fuse operates to shut off power, it hangs down from the "cutout" where it is installed on the pole top. The fuses at Fuse 17733 are shown in Figure 3B-2 above. From the troubleshooter's perspective at the dam, the fuses were in a line behind one another on the upper crossarm of the pole, making it difficult for him to discern whether one, two, or all three of the fuses had operated.

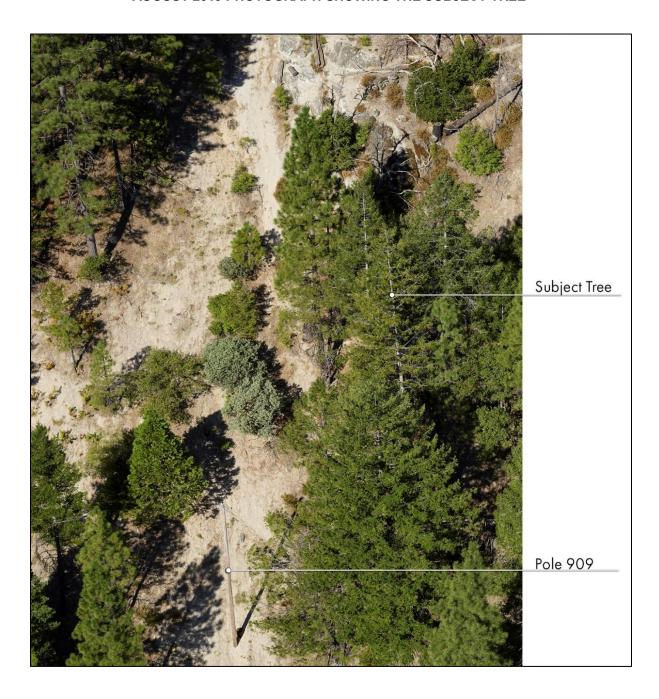
FIGURE 3B-5 AUGUST 2019 PHOTOGRAPH SHOWING THE SUBJECT TREE

The Live Crown Ratio is the measure of the length of the live foliage compared to the overall height of the tree. Trees with a live crown ratio of less than 30 percent are not expected to be long-term trees.

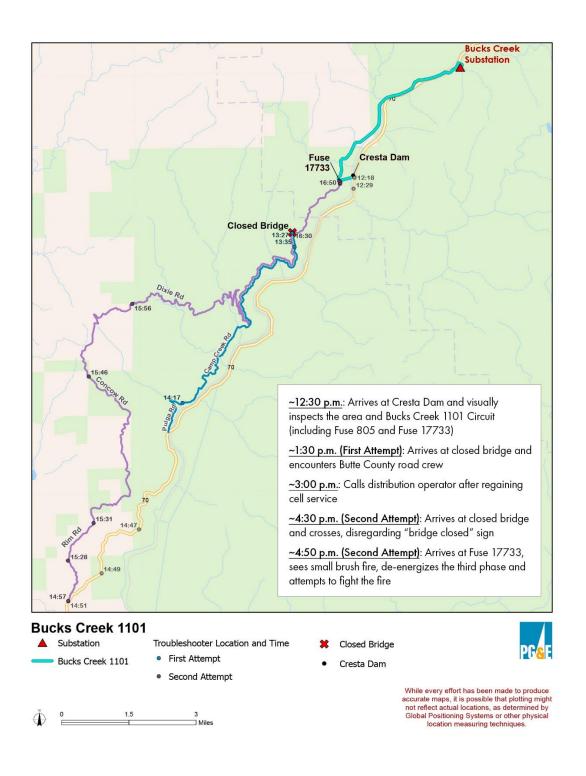
FIGURE 3B-9 TROUBLESHOOTER'S ROUTE TO ACCESS FUSE 17733²⁴

The troubleshooter's first attempt to reach Fuse 17733 was blocked by a bridge closure and slowed by an access road in poor condition. When the troubleshooter reached the bridge, he was stopped by a Butte County road crew performing maintenance work on the bridge. He observed that portions of the bridge decking were missing, and the crew told him it would be at least two hours before he could pass. He then drove back down the access road to a location with cell service.

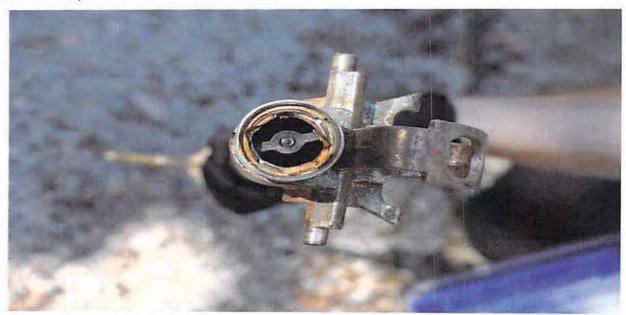
- 5 Fuse from conductor #1 (southern conductor) or far right conductor looking downhill
- 6 from Camp Creek Road was labeled E-1.

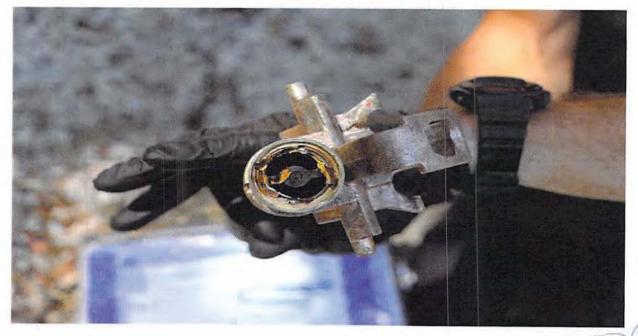
8 Fuse from conductor #2 (middle conductor) was labeled E-2.

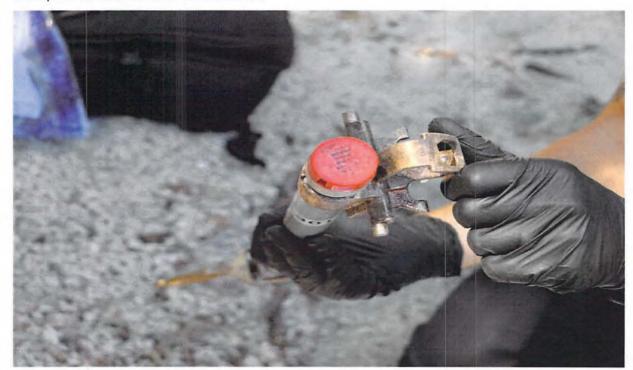
- 1 Fuse from conductor #3 (northern conductor) or far left conductor looking downhill from
- 2 Camp Creek Road was labeled E-3.

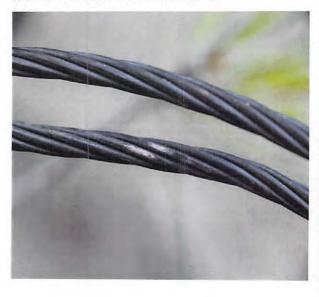
Conductor #1 (southern conductor) Approximately 5 feet of conductor was removed and packaged as evidence labeled E-6. This conductor showed remnants of tree bark and materials transfer approximately 4-5 feet uphill (west) from the insulator on the unmarked pole and within 16 inches from the insulator where the tree came to rest. This section of conductor also showed signs of deformation, arcing, and flattening where the tree contacted the conductor.

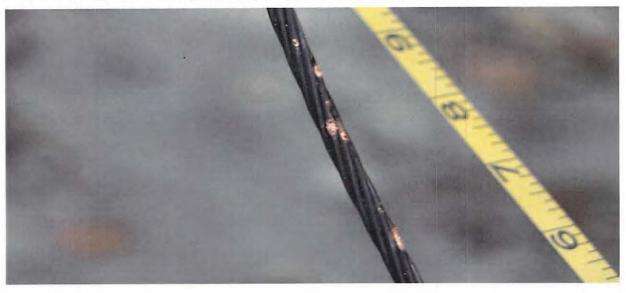
Conductor #2 (middle conductor) Approximately 12 inches of conductor was removed and packaged as E-10. This section of conductor was located approximately 32 feet uphill from the insulator on the unmarked pole. This section of conductor showed signs of fresh arcing and beading in multiple spots over the approximate 12-inch section.

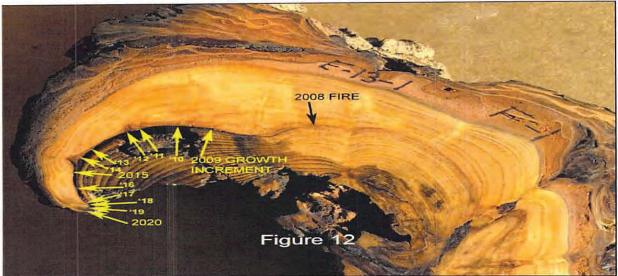
and over time led to significant advanced decay at the base of the tree. MCNEILL's report also concluded the discovery of two "major buttressing and mechanically supporting" roots had sustained damage from the 2008 Butte Lightning Complex which killed a half to two thirds of the roots circumference. The south side of the lower trunk burned in 2008, killed over half of the circumference, this would have formed a wound with no bark cover, visible as exposed and decaying wood. MCNEIL concludes this wound would have been visible from 18-38 inches above the ground. After the 2008 fire the only live tissue keeping the tree canopy green was on the side away from the conductors. After the unknown 2015/2016 event more than half of the tree in the lower three feet was dead, open, and decaying. This left the tree with insufficient wood to support the tree mechanically.

MCNEIL concluded that the degraded condition of the base of the tree was the primary

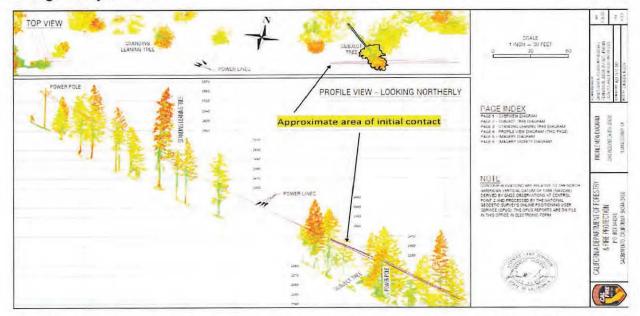
On November 29, 2021, I received a copy of HYLTON's report. HYLTON concluded the most probable scenario, based upon pole location, subject tree location, fuse status, SCADA data and markings found on conductors is the subject tree fell across the line approximately 32 feet west (uphill) of its final resting place (up against the unmarked pole) at approximately 6:48 AM on July 13, 2021. The subject tree contacted all three conductors (12kV) and, because the line is built on a steep slope, it slid down the conductors and came to rest next to the pole. Two of the three fuses blew upon the initial contact (fuses 1&2). The third fuse (fuse 3) remained intact and kept the line energized. All three conductors were energized through back feed by the transformers LE80 (Rev. 7/2011)

- 4 HYLTON concluded the tree being in contact with energized conductors (prior to PG&E
- 5 de- energizing) and the ground created a high impedance fault. The tree may have
- 6 initially stayed connected to the stump; or it may have broken loose and came to rest on
- 7 the ground. In either case, the connection to the earth would create a poor (high
- 8 impedance) path to ground. Poor electrical connections, especially at high voltage,
- 9 create heat and cause arcing. (See HYLTON'S full report attachment X)

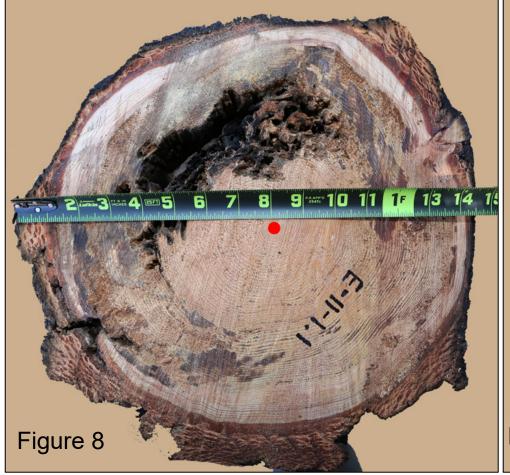
Below, in Figure 8 we cut a disk from the trunk at the two lines in Figure 7. The cut face shown here is identified as E-11-1.1. It is the face illustrated by the black arrow on Figure 7, upward toward the top of the tree.

The upper surface of the trunk after the tree came to rest on the slope was approximately at the 14 ½ inch mark in Figure 8, the right of that figure. The tree may have rotated slightly as it separated from the trunk. Because the stump and the end of the bole were so severely burned we were unable to match the parts for precise rotational orientation. However, the most heavily decayed portion of this cross section was on the side of the trunk approximately toward the conductors, placing this decay in-line with the decay seen in the stump.

The center of the tree when it was a sapling is marked on Figure 8 by a red dot. It was nearly centered in the tree on the day it failed, as the concentric rings of annual growth are similar in thickness on all sides. This is evidence the tree grew relatively vertically,

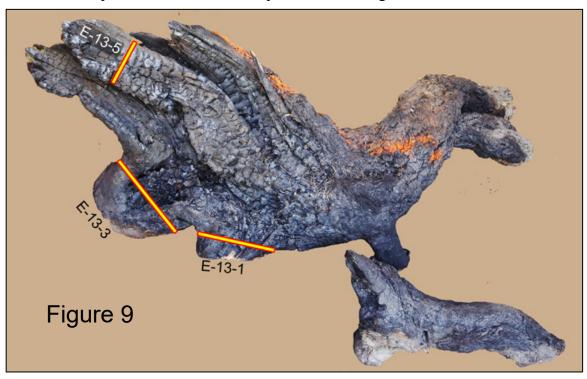
On the same day we visited the Calfire storage site on Nelson Avenue in Oroville, where the stump of the tree was sequestered. Figure 9 illustrates the stump and one collected root. We took several cross-section samples E-13-1 through E-13-5 for analysis. We returned on September 11 to collect samples E-13-6 through E-13-9

Three of the sample locations are illustrated above, sample E-13-1, E-13-3 and E-13-5. See the next page, Figure 10 for a more complete index of sample locations. For orientation the three locations seen in Figure 9 are highlighted in Figure 10.

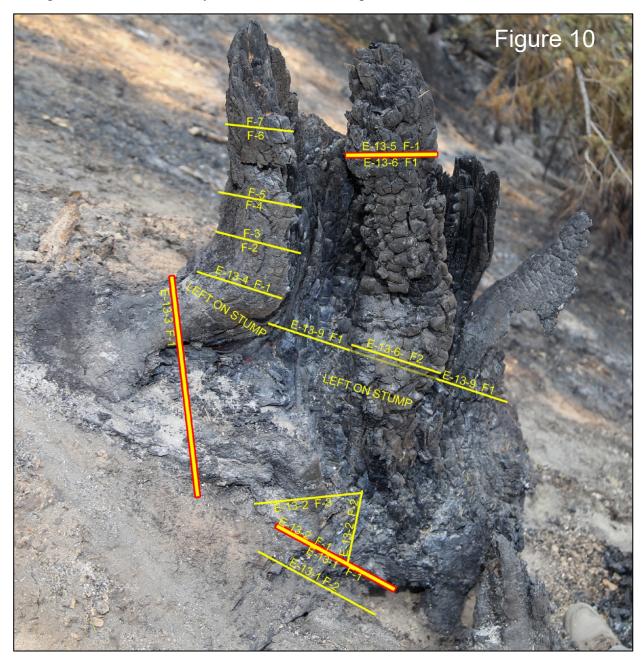
Figure 10 is a key to the samples we collected, some of which are referenced later in this report. All samples from the stump have the prefix "E-13". This is followed by a sample number, 1 through 9. Some of the samples have two or three sides or faces, denoted by F-1, F-2, or F-3. Samples E-13-7 and E-13-8 are not illustrated here, as they are obscured behind foreground samples. All samples with an "F" designation were to some degree sanded, to allow distinction and analysis of annual growth increment rings.

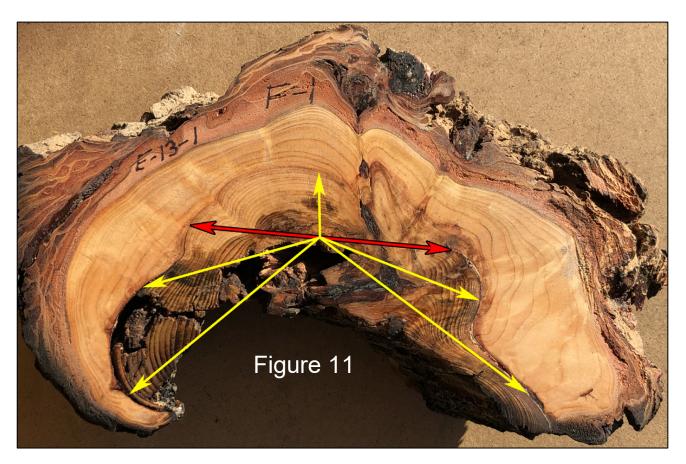
On the previous page, Figure 11 illustrates the entire face F-1 of sample E-13-1. Left is the uphill side. The open face is toward the conductors. The arrows outline the extent of the root prior to the 2008 fire. The red arrow indicates the distance back to which live tissue was killed by the fire.

A single layer of cells called the cambium covers the entire root, trunk, stem and twig system. It creates new bark toward the outside of the tree and lays down new wood over older wood toward the inside. In this instance the cambium was killed back to the red arrow. The cambium at the single arrow at the top, and over to the red arrow tips left at right remained alive. Further to the left and right the cambium was killed, but the wood was not burned. Each year the cambium, starting at the tips of the red arrow extended new woody tissue over the dead substrate, both left and right.

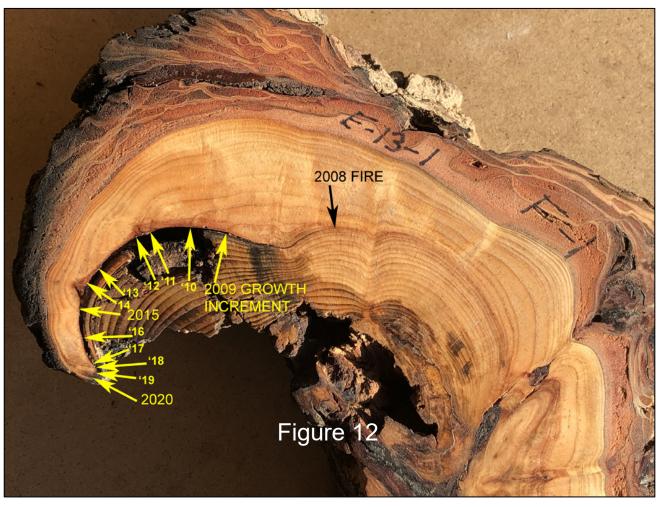
Figure 12 illustrates how this happened on the left, or uphill side. Each arrow represents the incremental growth of new wood over the sound, but dead substrate, year by year from 2008 to 2020. By the time of the Dixie fire the increments had reached the end of the substrate, assuming that older wood did not partially burn away in 2021, and in the future new growth would have curled over and around the older material. This section was at or just above ground level.

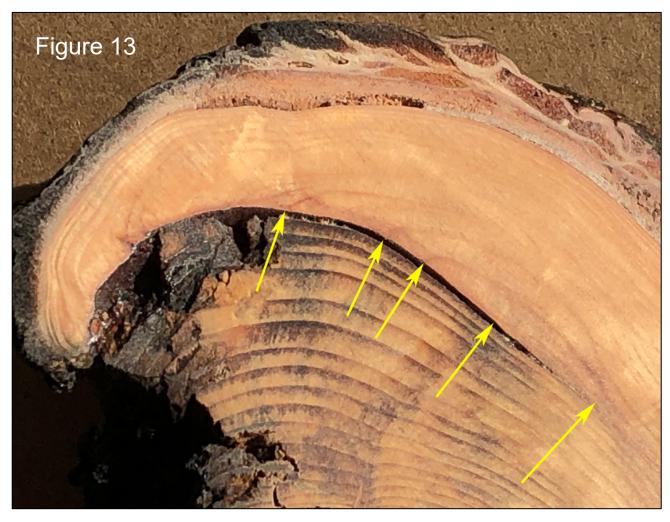
Figure 13 is face 3 of sample E-13-2. It is a few inches higher than the face of E-13-1 in Figure 12, but is similar. The 2008 fire and incremental growth since are apparent.

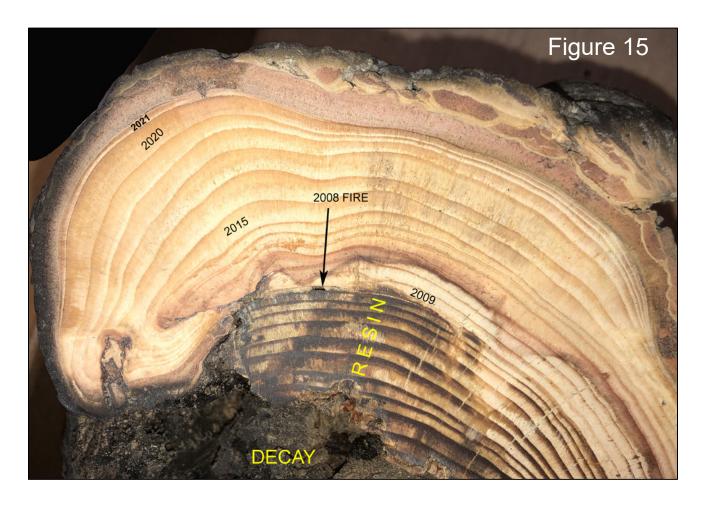
Figure 15 is an enlargement of the upper part of the root E13-3-F-1 illustrated in the previous figure. The tree pumped resin into the rings near the burn margin after the 2008 fire as protection against decay⁴. The more central part of the root has decayed. The 2009 growth increments, through early 2021 are visible.

Both the large mechanical roots represented by E-13-1 and E-13-3 were killed over half or more of their circumference, and remained visibly dead on the side toward conductors.

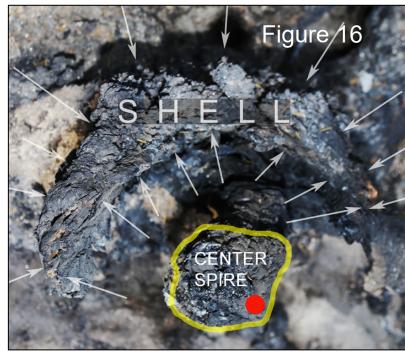
Figure 16 is a photo of the stump taken from above on July 15 in the field. The stump remnant was a shell on the north side outlined by the arrows, with a separate spire, outlined in yellow. The red dot is at the original center or the tree. All other woody tissues at this level are burned, decayed or otherwise missing.

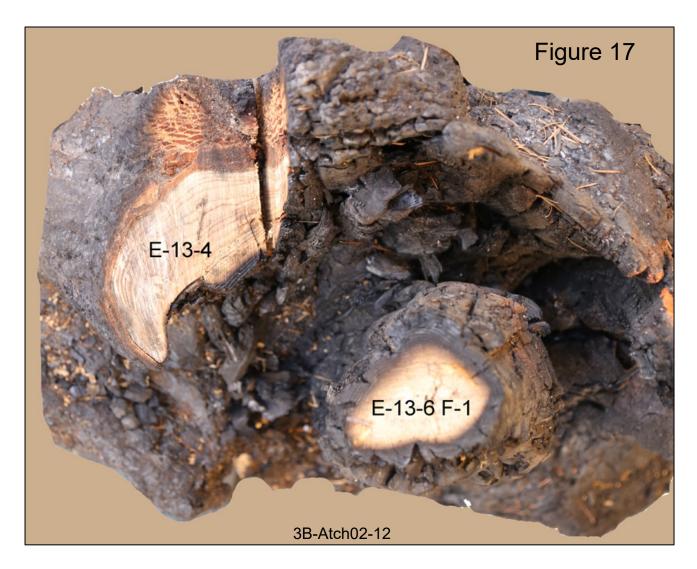
Figure 17 is of the stump from the same orientation with samples E-13-4 and E-13-5 removed. This figure is included to provide orientation for sample E-13-4, a 15 inch tall section from the west side of the shell.

The face seen here as E-13-4 has not been sanded or otherwise prepared

beyond a rough saw cut. It is the face that mates with E-13-4 F1, Figure 18.

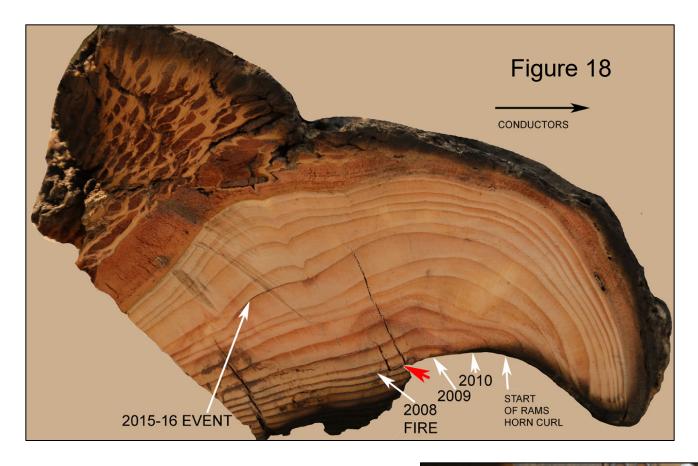
Figure 18 mates with the left side of Figure 17, E-13-4. It is F-1, the first exposed face within this sample, which was cut into four sections along its 15 inch length, as illustrated in Figures 10 and 20. Injury from the 2008 Butte Lightning Complex Fire is evident here. The live cambium of the tree was killed from the right, the south side of the tree toward the conductors, back to the red arrow. The growth increments of 2009 and 2010 are extended relatively straight, suggesting they are growing on a sound, but dead substrate. By 2011 and 2012 the growth begins to form around a smaller radius, suggesting there is no substrate, that the interior of the tree had burned away to that point in 2008 and new growth was curling around itself, forming a ram's horn. The tip of that ram's horn along with any remnant of the pre-2008 substrate to the right of the red arrow was burned away in the 2021 fire. We now see evidence of an event at the boundary between 2015 and 2016. At the time of this report Calfire has not reported a fire in that time period.

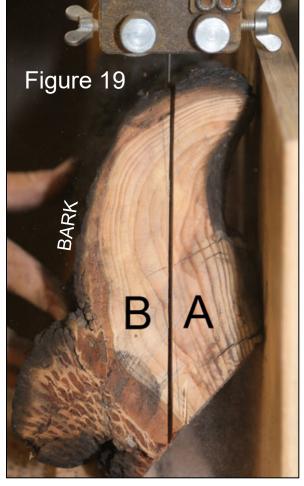
We split E-13-4 longitudinally into "A" and "B" sides with a band saw, as seen in Figure 19. This figure is also F-1, the lowest face of E-13-4.

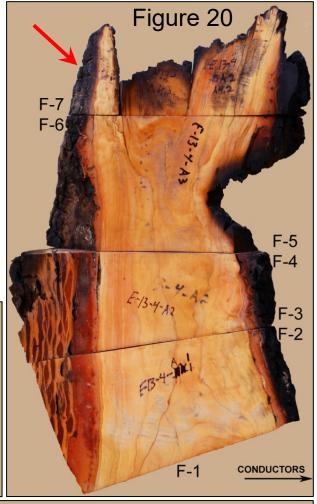
The inside face of side A, sample E-13-4 is illustrated in Figure 20. The divisions into faces F-1 through F-7 are similar to the illustration in Figure 10. The Right-of-Way (ROW) and conductors were to the right in this figure.

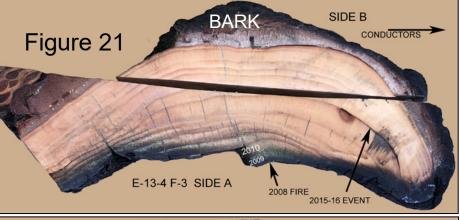
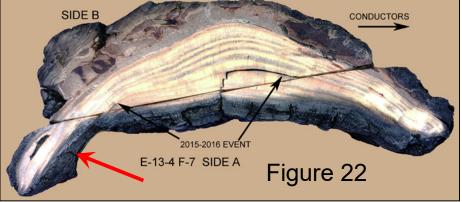
The red arrows in Figures 20 and 22 highlight the sample in Figures 23 and 24, which are the Side A and F-7 faces respectively. This sample may be near the top margin of the 2015 injury event as well as near a wound edge on the side away from the conductors and ROW.

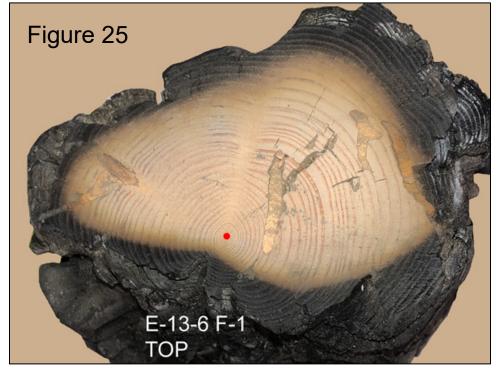
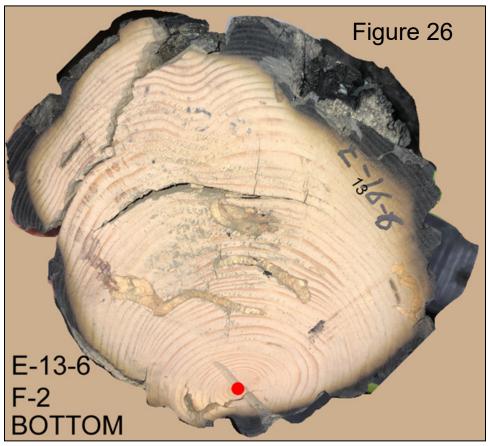
Sample E-13-6 is the center spire seen identified in Figure 10. Sample E-13-5 is a cap, the upper several inches of this spire. The surface in Figure 25 mates to the base of that cap.

On each figure, the red dot is the central pith, the original center of the tree. The side toward the conductors, downward in these images, has burned differentially along the length of this central remnant. This suggests it was previously open to that side or decayed or both.

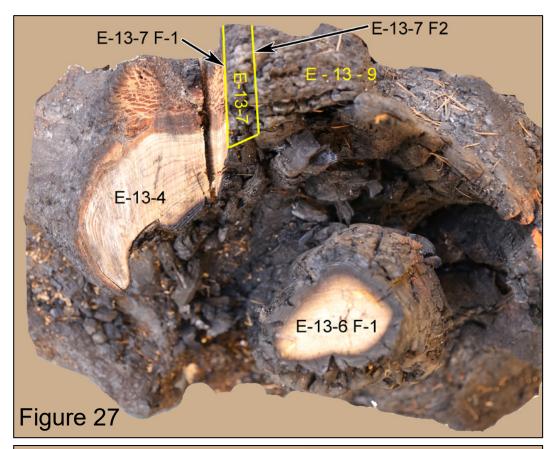
In Figure 27 sample E-13-4, seen in Figures 19 and 20 has been removed. Sample E-13-5, the cap of the central spire has been removed, exposing the top face of E-13-6, F-1. This illustration is to establish the location of sample E-13-7 between the sides of E-13-4 and E-13-9.

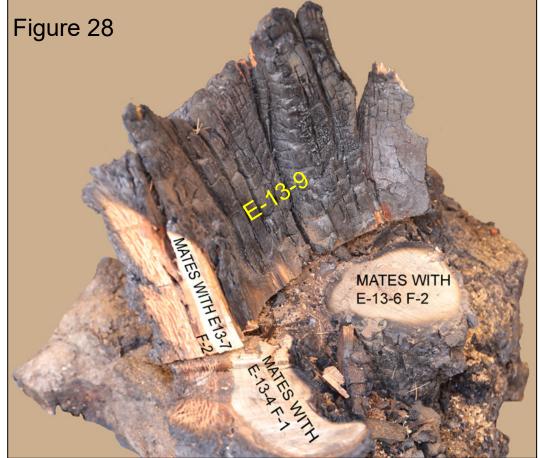
In Figure 28, samples E-13-6 and E-13-7 have been removed from the stump. Sample E-13-9 has been severed from the stump but is still resting on it, shifted back and to the left for illustration and reference.

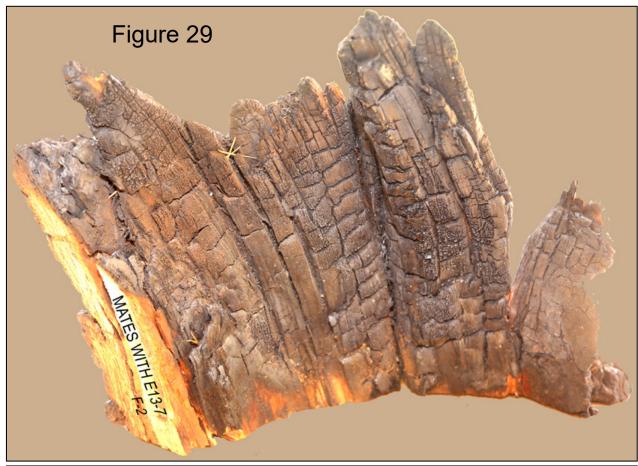
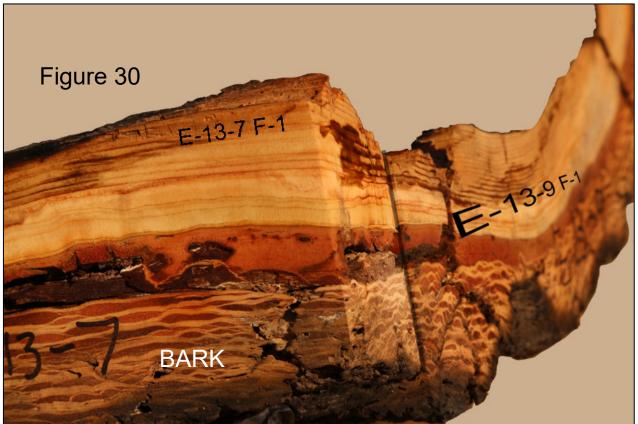
Figure 29, freestanding E-13-9. The exposed face to the left mates with face E-13-7 F-2. In Figure 30, sample E-13-9 is on its back, samples E-13-7 and E-13-9 are placed together as in the tree, E-13-7 F-1 is exposed.

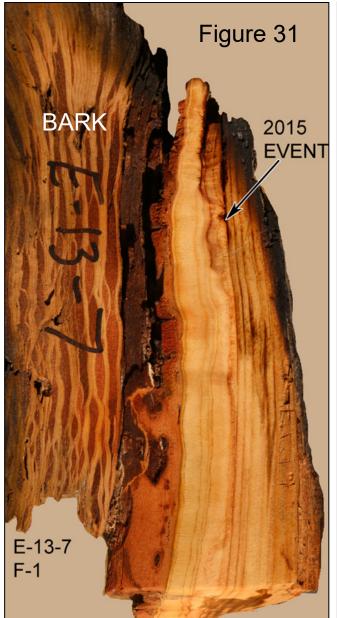
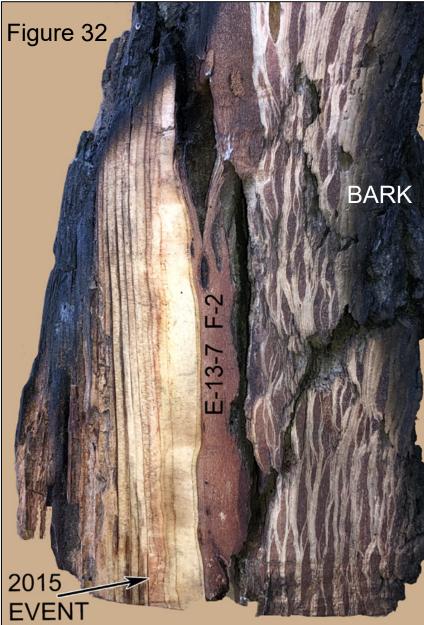
In Figures 31 and 32 both faces of E-13-7 indicate the 2015-16 event. The uneven growth of both sides since 2015 suggests the live cambium was killed by this event to a point shown within these photographs, below the arrow in Figure 31.

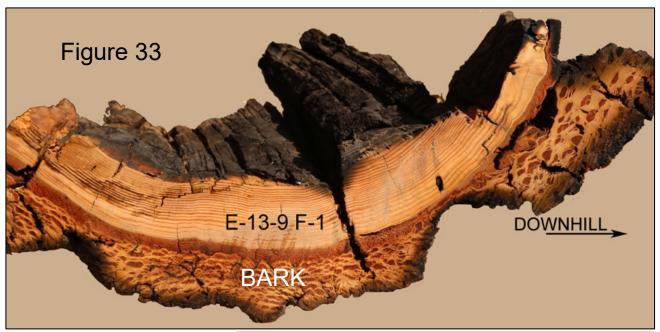
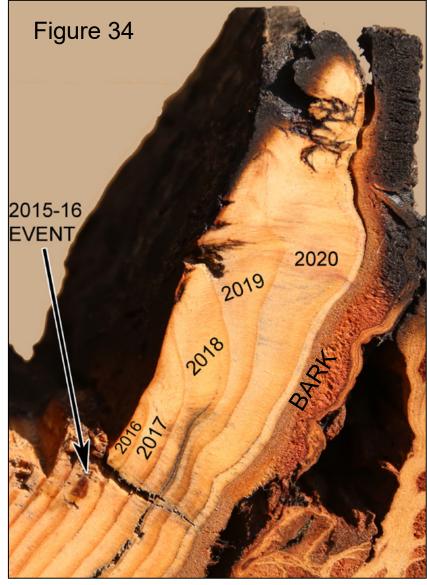
Figure 33 is the base of sample E-13-9. Figure 34 is a close-up of the right, or downhill tip of that face.

The 2015-16 event killed live cambial tissue back to the tip of the arrow. The growth from that period onward did not curl into a ram's horn, but was laid down on a supportive substrate. The evidence within annual ring growth is the relatively straight line along which the 2016-2020 tissues were laid down. The substrate tissues likely decayed, as the pre-2016 rings have, near the tip of the arrow. That tissue was then susceptible to the 2021 fire and is now absent.

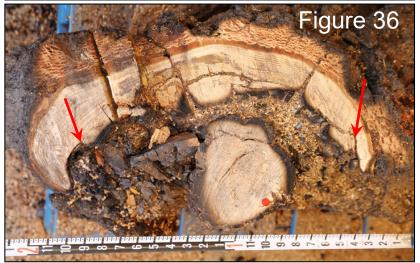
The tree was significantly injured by the Butte Lightning Complex Fire of 2008 and by an unidentified event of 2015-2016. Figure 35 is a reprint of Figure 16, the stump of the tree taken on site on July 15, 2021. The arrows outline a remnant standing shell of wood, with bark on the outside. The yellow outlines a free-standing spire or column, once at the center of the tree. The red dot is at the pith, or original center of the tree. The photograph is oriented so that downhill is approximately right, the PG&E conductors are toward the bottom of the photo, 50 feet away.

Figure 36 is of similar orientation, taken in the storage facility on September 11, 2021 after removal of samples E-13-4, E-13-6, E-13-7 and E-13-9. On the left or uphill side the red arrow illustrates the point back to which the live cambium was killed by the 2008 Butte Lightning Complex Fire. Growth since that time has curled inward, forming the beginning of a ram's horn as the interior of the tree decayed and disappeared. This is illustrated in Figure 18.

uphill side of the central column and that formed prior to 2015 on the downhill side of the central column was decayed and is missing.

The pith or center of the tree is present in the central column, at the base as illustrated here, right up to the burned tip. Nearly all the wood in that column to the south, toward the conductors is missing. It is my opinion that the missing wood throughout this stump was in a state of advanced decay, as seen higher in the tree trunk in Figure 8, and was

either consumed completely by decay organisms or was so susceptible to combustion that it quickly burned in the 2021 fire.

Above the roots evidence suggests that the south side of the lower trunk was burned and killed over more than half its circumference. This would have formed a wound with no bark cover, visible as exposed and decaying wood. The extent of this wound is well-illustrated in Figures 35 and 36. It is my opinion that most of the sound wood supporting the tree is represented graphically in Figure 36. The absence of sound wood where expected elsewhere is dramatic.
