# **FINAL REPORT ON THE AUDIT OF THE DELTA ENERGY CENTER POWER PLANT**

**CONDUCTED UNDER GENERAL ORDER 167  
TO DETERMINE COMPLIANCE WITH  
OPERATION, MAINTENANCE, AND LOGBOOK STANDARDS**

ELECTRIC GENERATION PERFORMANCE BRANCH  
CONSUMER PROTECTION AND SAFETY DIVISION  
CALIFORNIA PUBLIC UTILITIES COMMISSION  
505 VAN NESS AVENUE  
SAN FRANCISCO, CA 94102

May 29, 2009

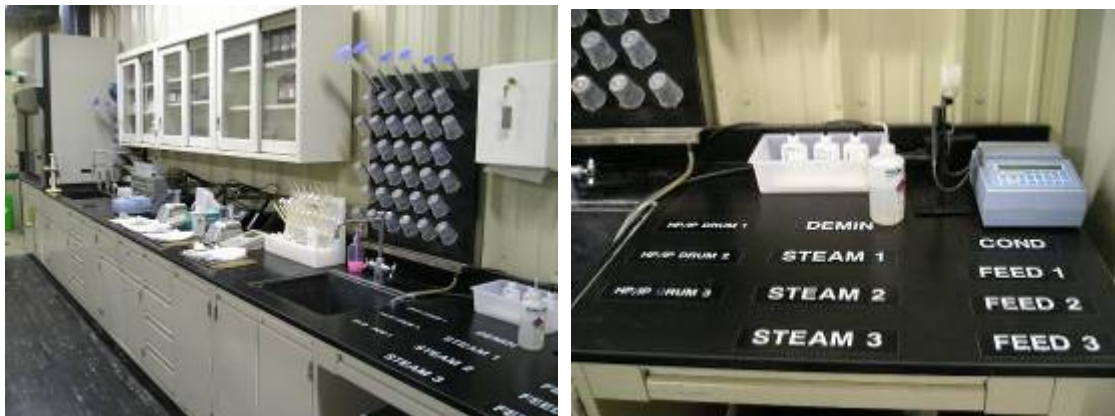
The CPSD Auditor found the water chemistry laboratory to be very well-organized and clean (Photos 23 thru 25).

Photo 23: The chemistry analysis table holds multiple water analysis devices and is well organized.

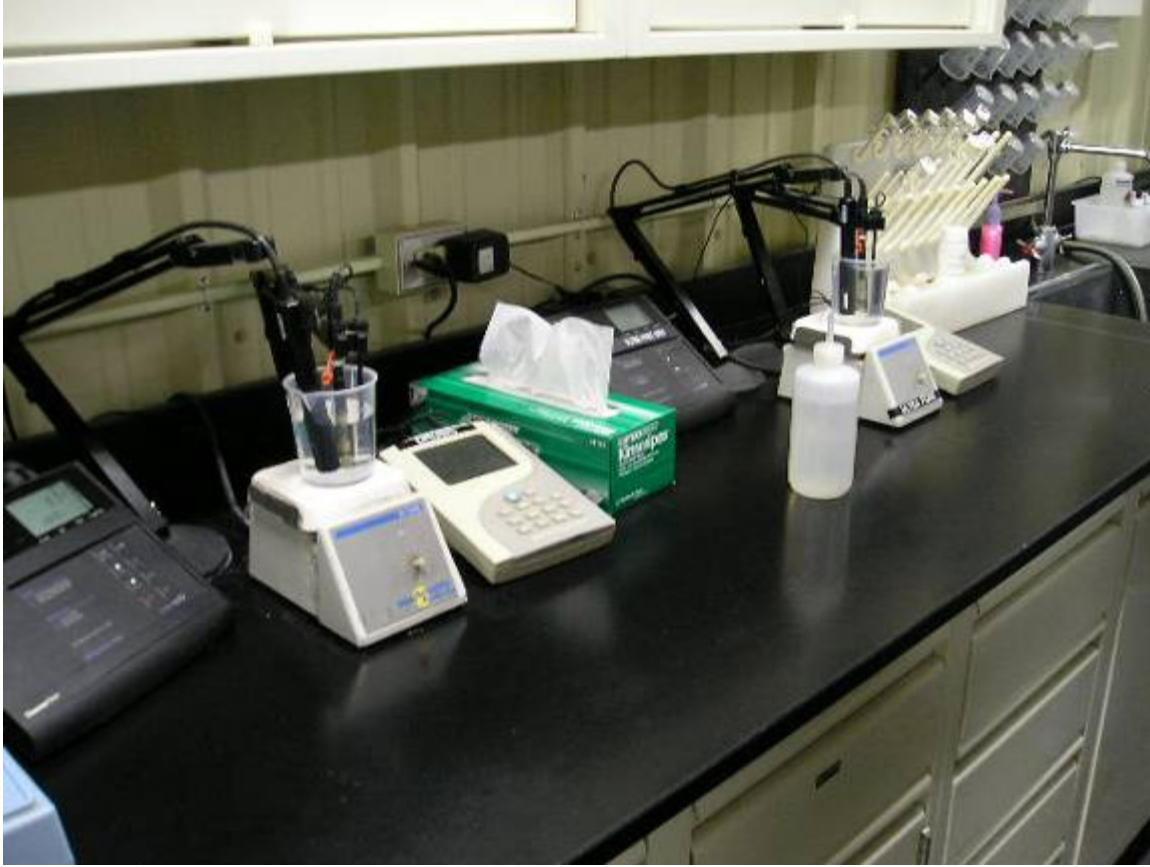
The chemistry lab contains multiples of various kinds of water analysis equipment (Photo 27) which allows staff to double-check measurements and to calibrate one device against another. These pieces of equipment measure water pH, silica, chlorine and iron, among other things.

Photo 27: Multiple water analysis devices can be seen on a clean, well organized lab table.

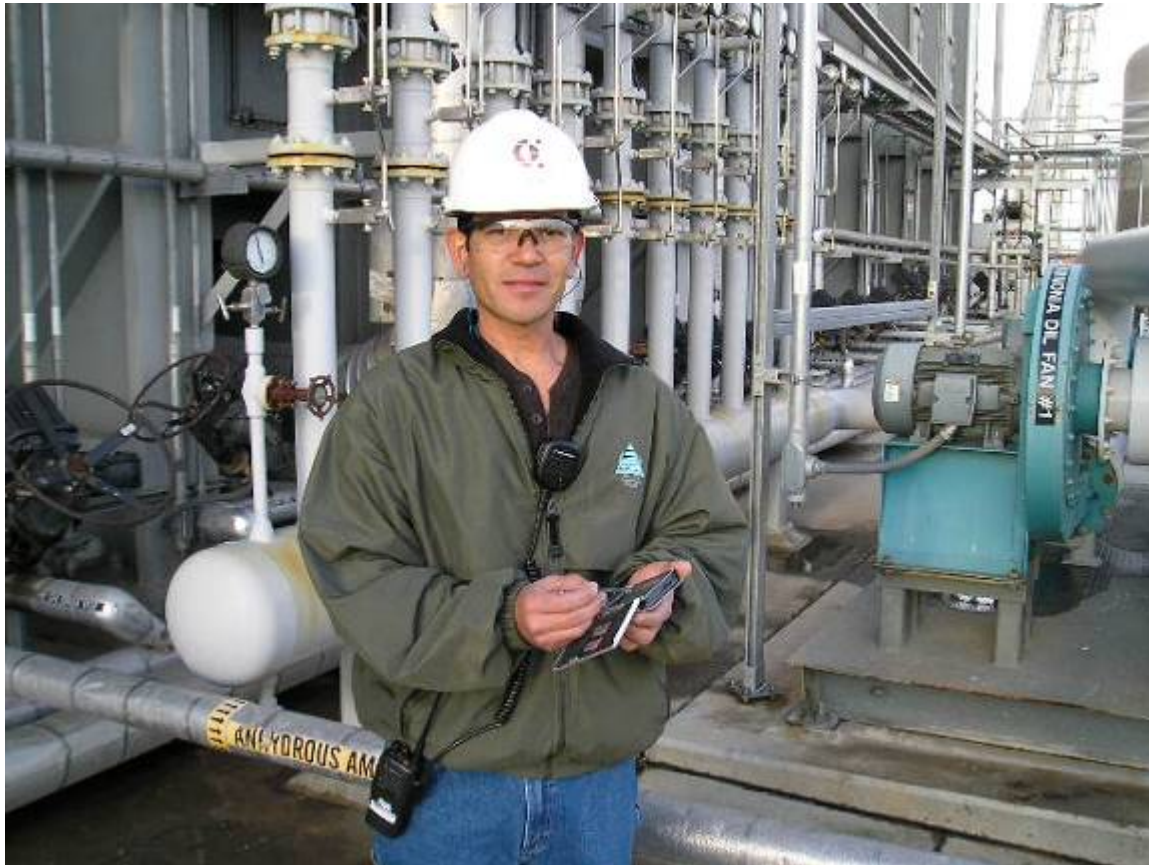
The plant uses effective systems to record and track information collected during daily walk-downs. The plant collects data (Figure 32) in Personal Digital Assistants (PDAs) for analysis and trending in a centralized data storage and analysis system.

Photo 32: A roving operator seen with the digital personal assistant used for gathering plant information during routine walk downs.

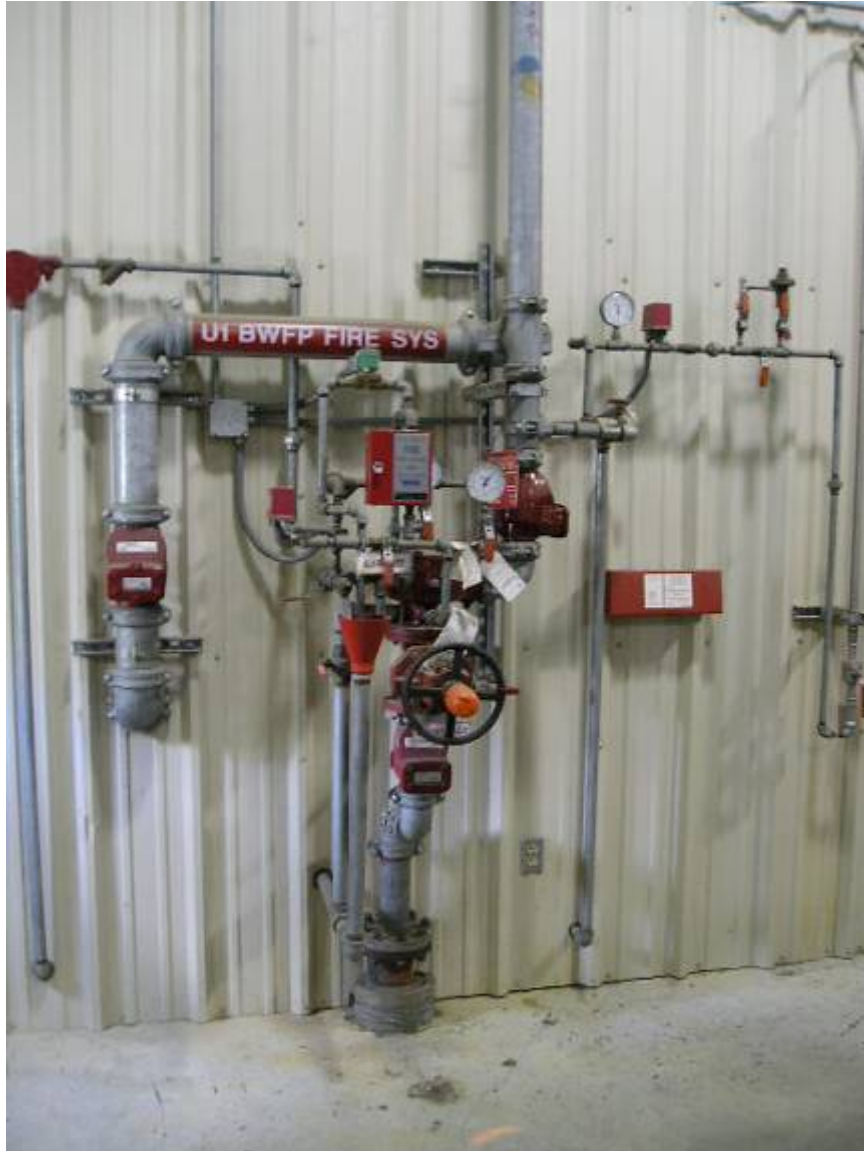
- All extinguishers and remote equipment have current inspection tags (Photos 33 & 34)
- Plant operators test run the main diesel powered fire pump weekly (Photo 35).
- The contractor inspected the fire protection system on May 11, 2006. The contractor wrote a report and plant staff implemented all of the suggested changes and upgrades from the report (i.e. valve locks; see Photo 36).

Photo 33: Inspection tags are visible on the boiler feedwater pump fire suppression system.

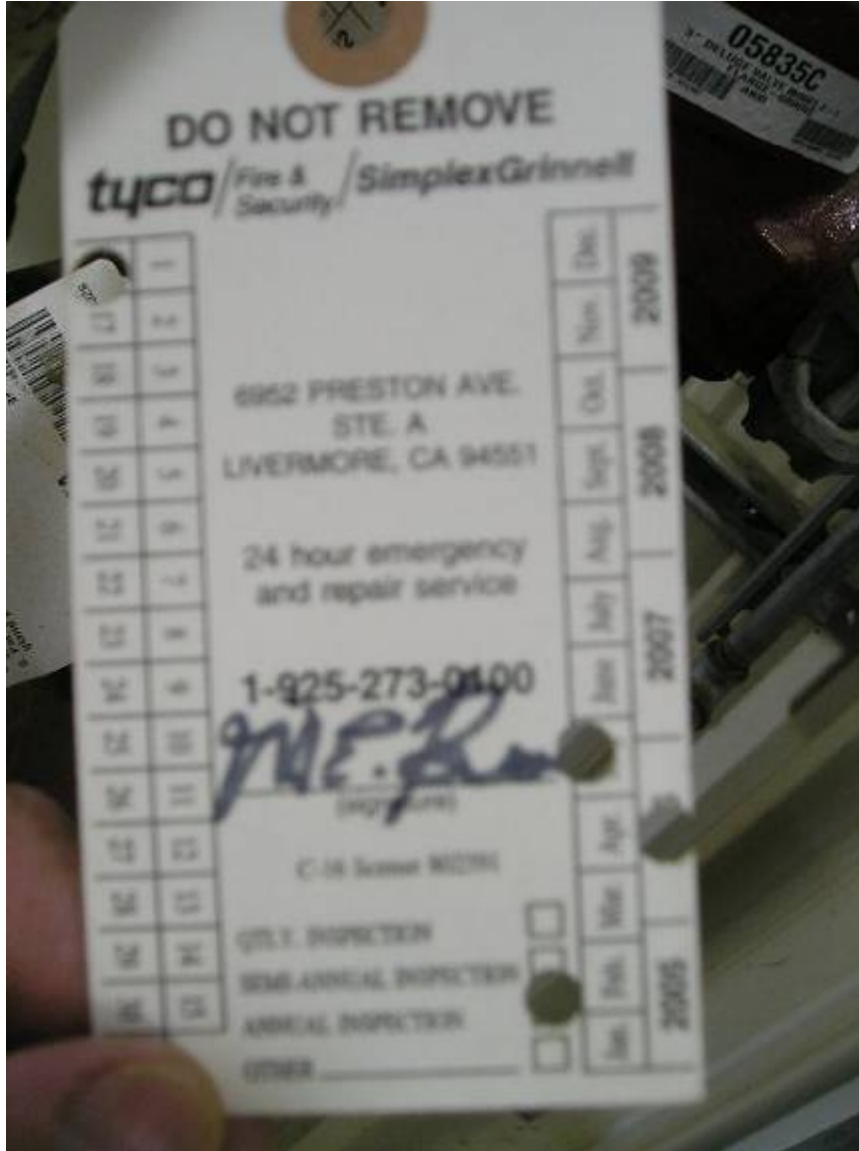
Photo 34: Close-up of the fire suppression system inspection tags show an inspection date of May 2006.

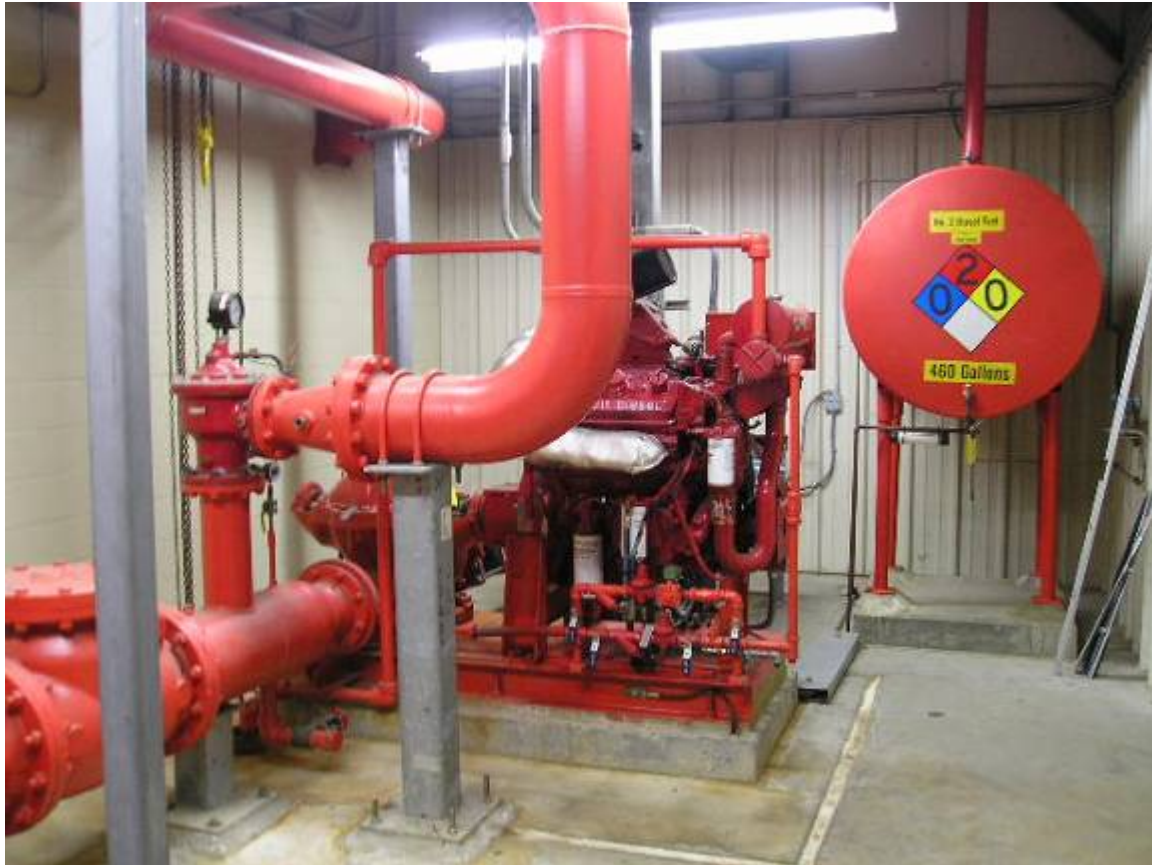
Photo 35: The main diesel powered fire pump
