**UTILITY VEGETATION MANAGEMENT AND BULK ELECTRIC RELIABILITY
REPORT FROM THE FEDERAL ENERGY REGULATORY COMMISSION**

SEPTEMBER 7, 2004

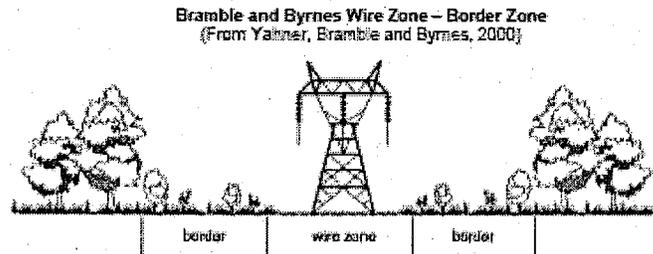
Several transmission owners employ a wire zone – border zone approach which is both environmentally friendly and effective in ensuring reliability. This method involves creating a low-growing vegetation environment directly under transmission lines, which physically prevents dangerous vegetation from encroaching into energized transmission facilities. The CNUC Final Vegetation Report stated that the wire zone-border zone has

“been proven to be effective in reducing and/or eliminating outages related to vegetation on transmission ROW [rights of way].”³⁰ The wire zone-border zone concept is depicted in the graphic below.

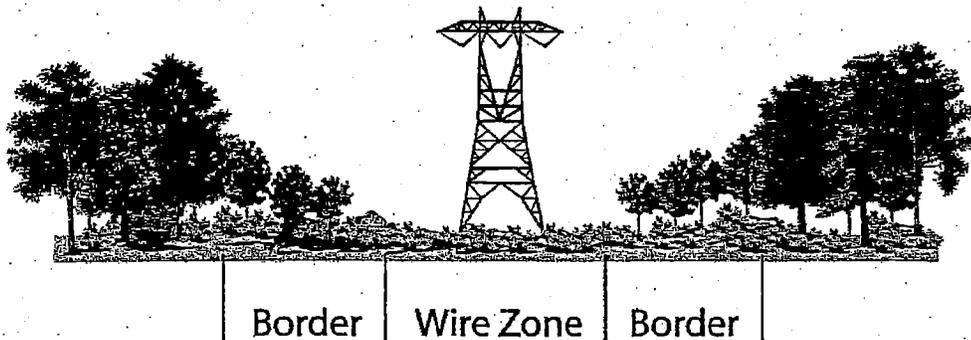
Figure 1: Wire Zone – Border Zone

A-1.2 Wire zone: An area on an electric utility right-of-way directly beneath and between the energized conductors farthest out on the pole/tower. This area is the most likely to contain vegetation that could potentially grow into contact with the energized conductors. This area is also typically used as access to the poles, towers, and conductors for repair, inspection, and maintenance. Applies to electric utility rights-of-way only.

A-2 On electric utility rights-of-way, selective management may be implemented in the border zone whenever there is sufficient compatible vegetation.

A-3 On electric utility rights-of-way, non-selective management may take place in the wire zone of a right-of-way.

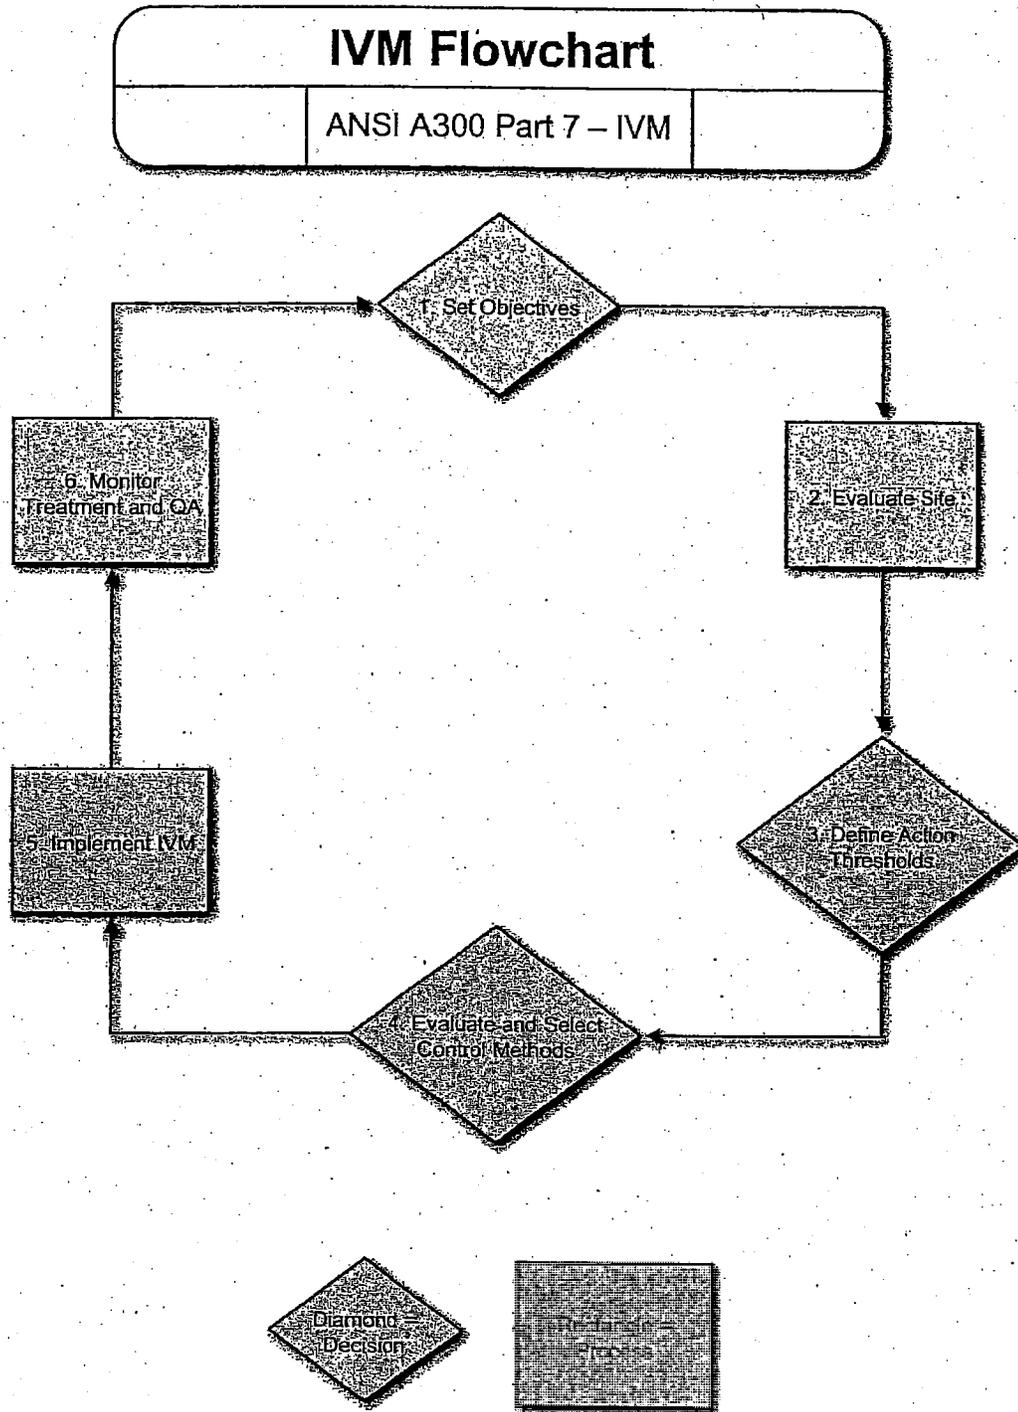
Annex B: Integrated Vegetation Management Flow Chart

The following flow chart illustrates the IVM process as represented in the A300 Part 7 standard. Each element is explained in this standard.

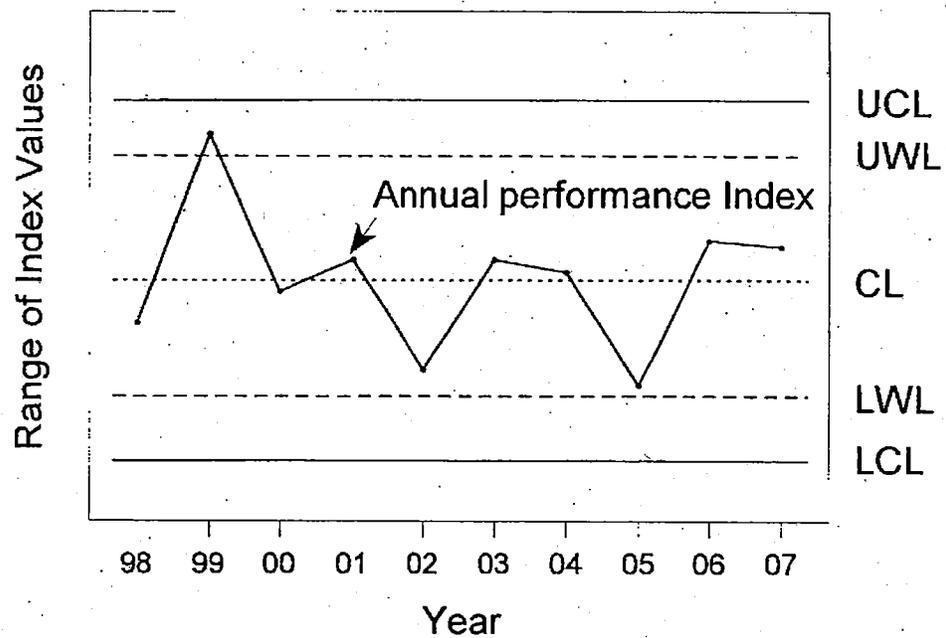
Figure 4.2.1 Sample Control Chart

The Availability Measure Targets described herein shall be phased in over a period of five calendar years beginning on the date a Transmission Owner becomes a PTO in accordance with the provisions of the Transmission Control Agreement. The adequacy of each PTO's Availability Measures shall be monitored through the use of charts. These charts, called control charts as shown in Figure 4.2.1, are defined by a horizontal axis with a scale of calendar years and a vertical axis with a scale describing the expected range of

magnitudes of the index in question. Annual performance indices shall be plotted on these charts and a series of tests may then be performed to assess the stability of annual performance, shifts in performance and longer-term performance trends.

Control charts for each of the following indices shall be developed and utilized to monitor Availability Measures for each Voltage Class within each PTO's system:

- Index 1: Annual Average Forced Outage^(IMS) Frequency for All Transmission Line Circuits.
- Index 2: Annual Average Accumulated Forced Outage^(IMS) Duration for those Transmission Line Circuits with Forced Outages^(IMS).

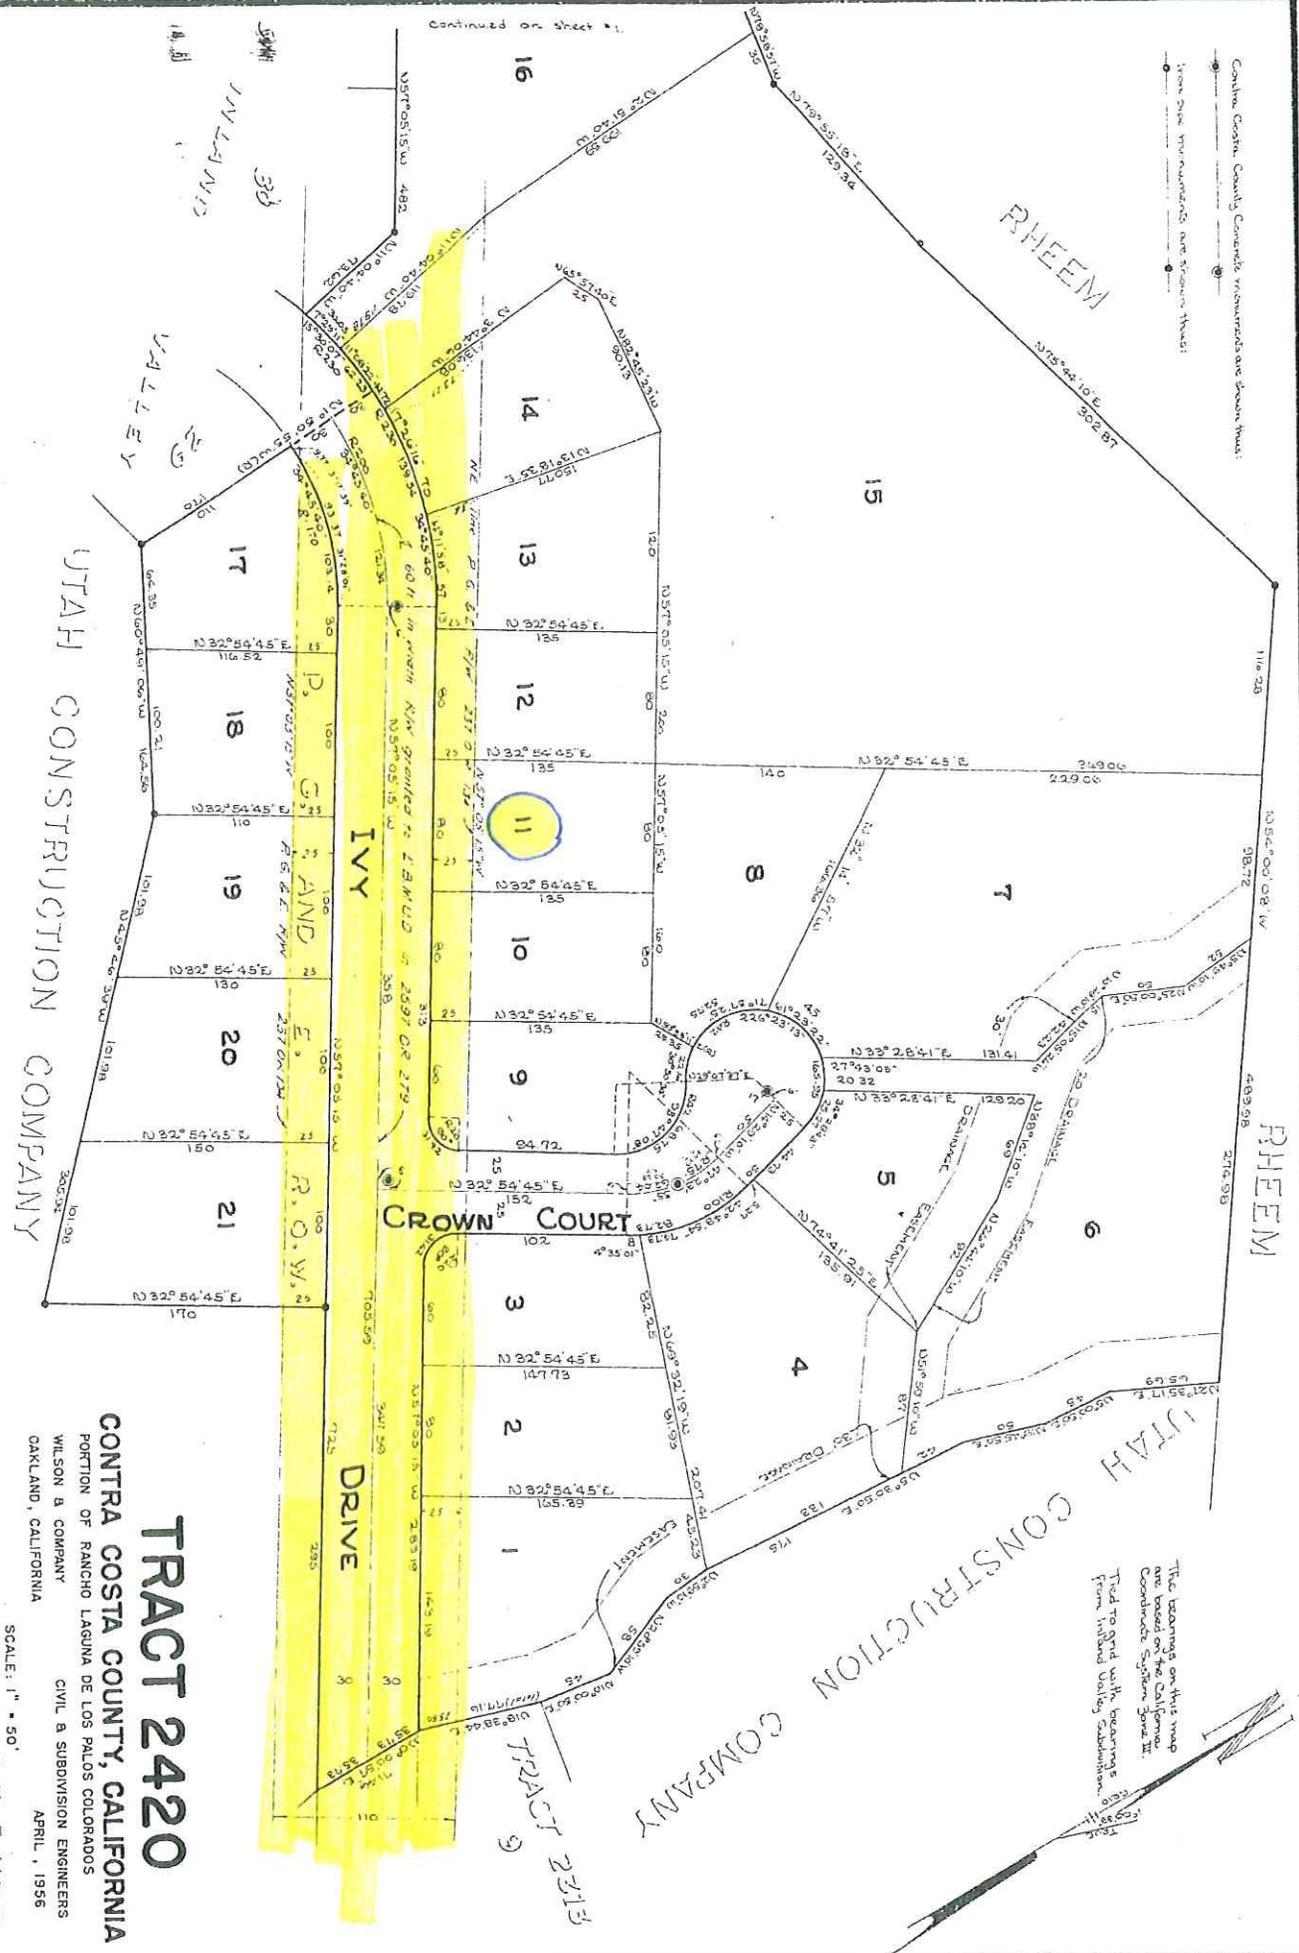
TRACT 2420
 CONTRA COSTA COUNTY, CALIFORNIA
 PORTION OF RANCHO LAGUNA DE LOS PALOS COLORADOS
 WILSON & COMPANY
 CIVIL & SUBDIVISION ENGINEERS
 OAKLAND, CALIFORNIA
 APRIL, 1956

The bearings on this map are based on the California Coordinate System 1911.

Tract No. 2420 is being from Inland Valley Subdivision.
