Docket	:	<u>A.23-08-013</u>
Exhibit Number	:	<u>CA-10</u>
Commissioner	:	<u>Alice Reynolds</u>
Admin Law Judge	:	<u>John Larsen</u>
Witness	:	<u>H. Eng</u>

**PUBLIC ADVOCATES OFFICE
CALIFORNIA PUBLIC UTILITIES COMMISSION**

**Testimony on Prudence of Operations
for
Thomas Fire and Debris Flow
Cost-Recovery Application**

System Protection

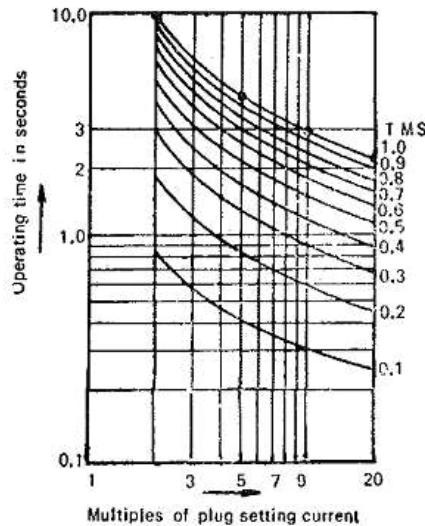
The figure below shows typical Inverse Definite Minimum Time (IDMT) characteristics with different times multiplier settings on an overcurrent relay.³⁴

The time-current characteristic is conveniently plotted on a log-log scale. Figure (4.7) shows the IDMT characteristics with different time multiplier settings (TMS).

To interpret this figure:

- The Y-axis on the left is the tripping time (in seconds) of the overcurrent relay.
- The Y-axis on the right is the TMS (time multiplier settings). SCE can adjust these settings.
- The X-axis is the magnitude of the electric current.
- The current settings aligned with 2 (between the 1 and 3) on the X-axis is called the pickup current. The recloser will record the current reading once the pickup current is met or exceeded.
