Application No.: A.24-10-002  
Exhibit No.: SCE-12 Vol. 02  
Witnesses: R. Daffern  
D. Dickerson  
R. Fugere  
S. Menon  
M. Stark

***Woolsey Fire Cost Recovery Application –  
Rebuttal Prudence of Operations – Inspection  
and Maintenance Testimony***

**Public Utilities Commission of the State of California**

# SCE-12, Vol. 02: Woolsey Fire Cost Recovery Application – Rebuttal Prudence of Operations – Inspection and Maintenance Testimony

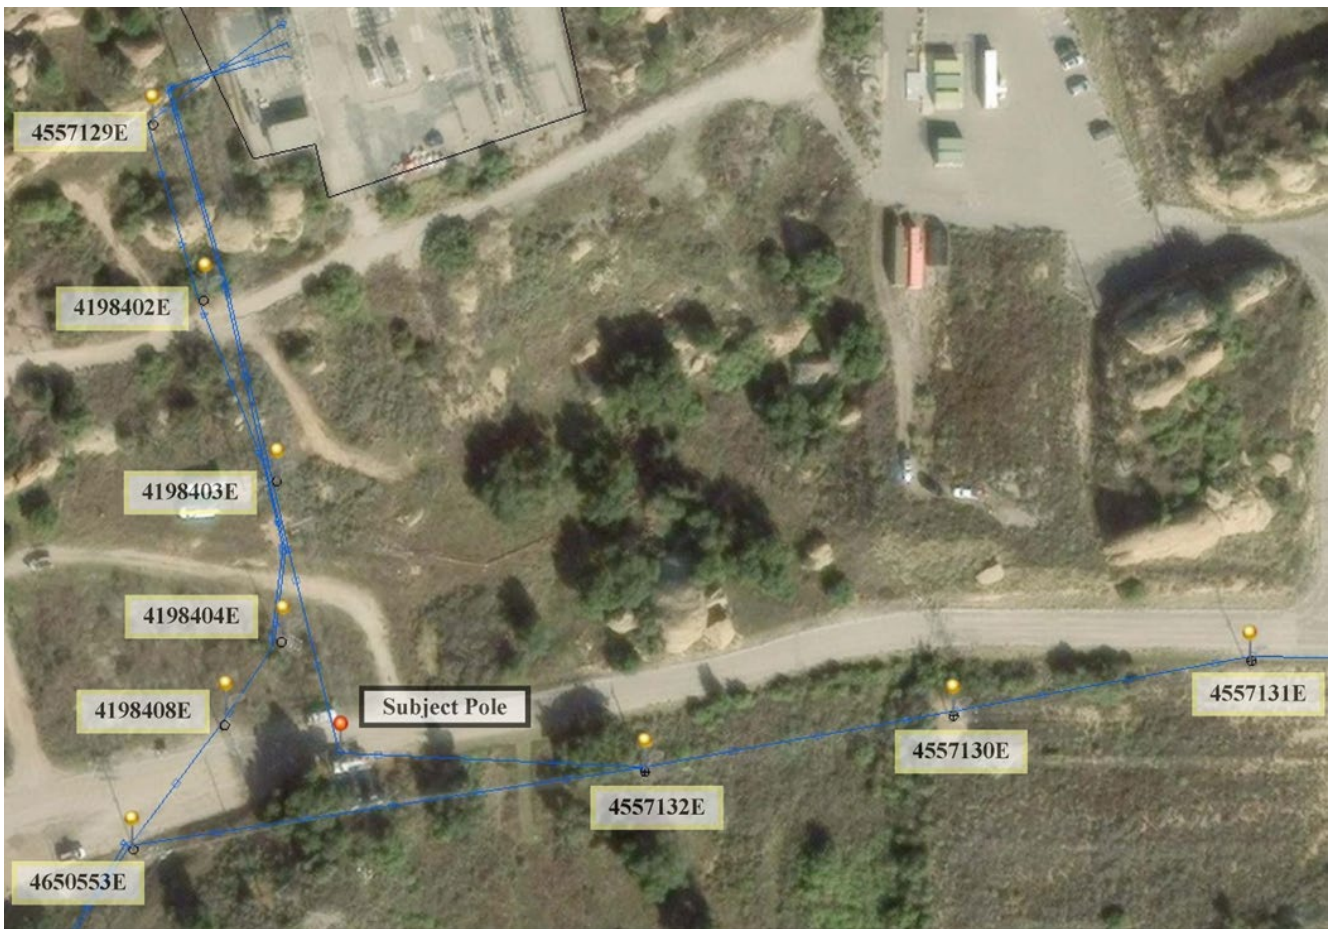
**Figure II-2**  
***Poles in the Vicinity of the Subject Pole with January 16, 2013 ODIs***

1 It would defy the inspector's training, DIMP guidance, and logic for the inspector to ignore the  
2 Subject Pole while completing ODIs for all other distribution facilities in the area. The inspector who  
3 completed the ODIs in 2013 had undergone two QC reviews in 2012 and received high conformance  
4 rates on both (between 91 percent and 100 percent), indicating familiarity with and adherence to DIMP  
5 guidelines. Thus, while SCE regrets the recordkeeping error, SCE's program guidelines and available  
6 ODI records indicate that the inspector would have reviewed the Subject Pole and identified any  
7 nonconformances.
