# **ATTACHMENT A**

(Motion for Approval of Cruise LLC's Offer of Settlement)

**MOTION FOR APPROVAL OF CRUISE LLC'S OFFER OF SETTLEMENT IN  
RESPONSE TO ADMINISTRATIVE LAW JUDGE'S RULING ON MOTION OF  
CRUISE LLC FOR ALTERNATIVE DISPUTE RESOLUTION AND DEFERRAL OF  
THE ORDER TO SHOW CAUSE PROCEEDINGS**

**MOTION FOR APPROVAL OF CRUISE LLC’S OFFER OF SETTLEMENT  
IN RESPONSE TO ADMINISTRATIVE LAW JUDGE’S RULING ON MOTION OF  
CRUISE LLC FOR ALTERNATIVE DISPUTE RESOLUTION AND DEFERRAL OF  
THE ORDER TO SHOW CAUSE PROCEEDINGS**

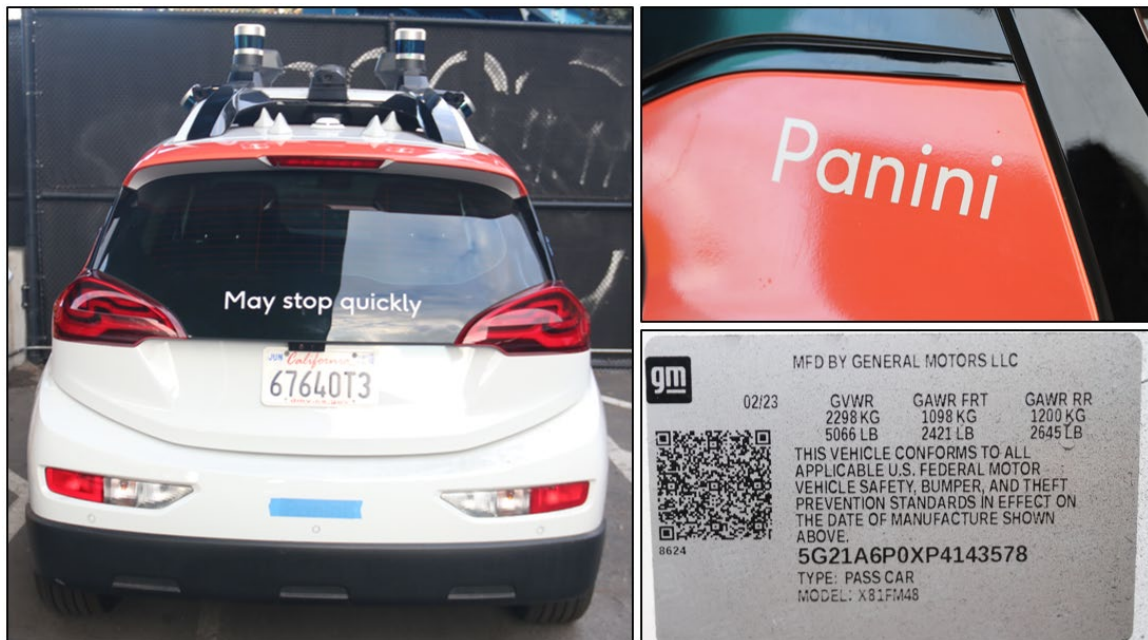
Figure 3. Photographs showing the rear of AV (left), vehicle moniker label on left side C-pillar (top-right), and vehicle VIN sticker (bottom-right).<sup>5</sup>

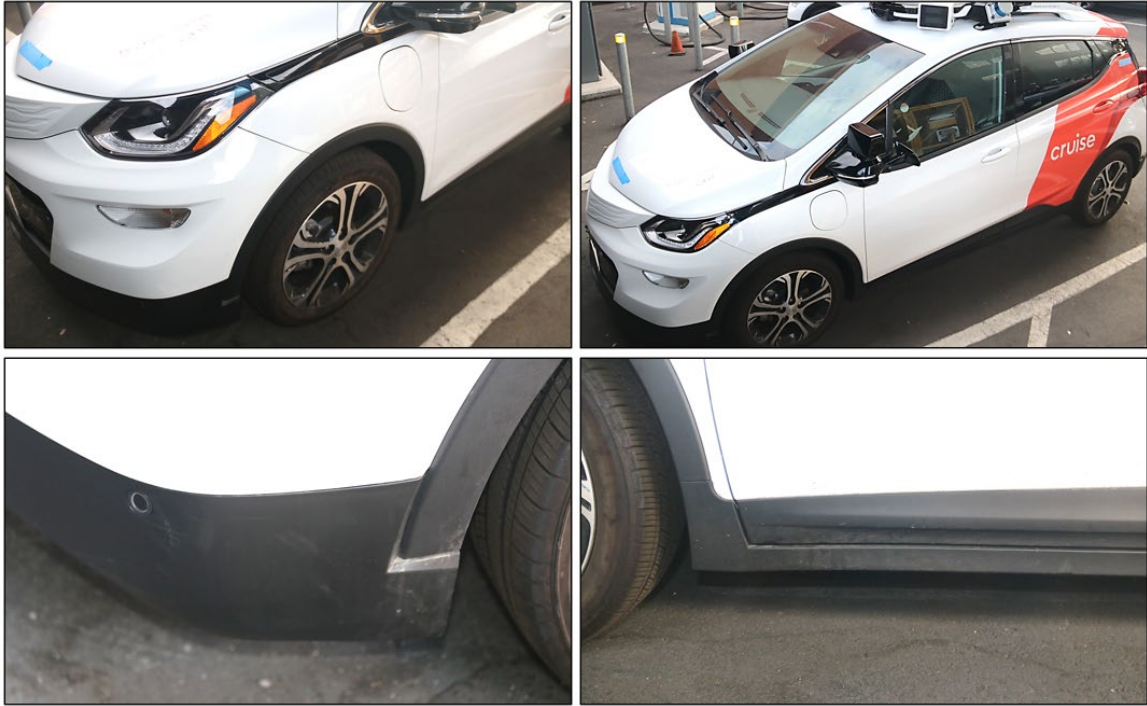
Figure 4. Photographs of the outside of the AV.

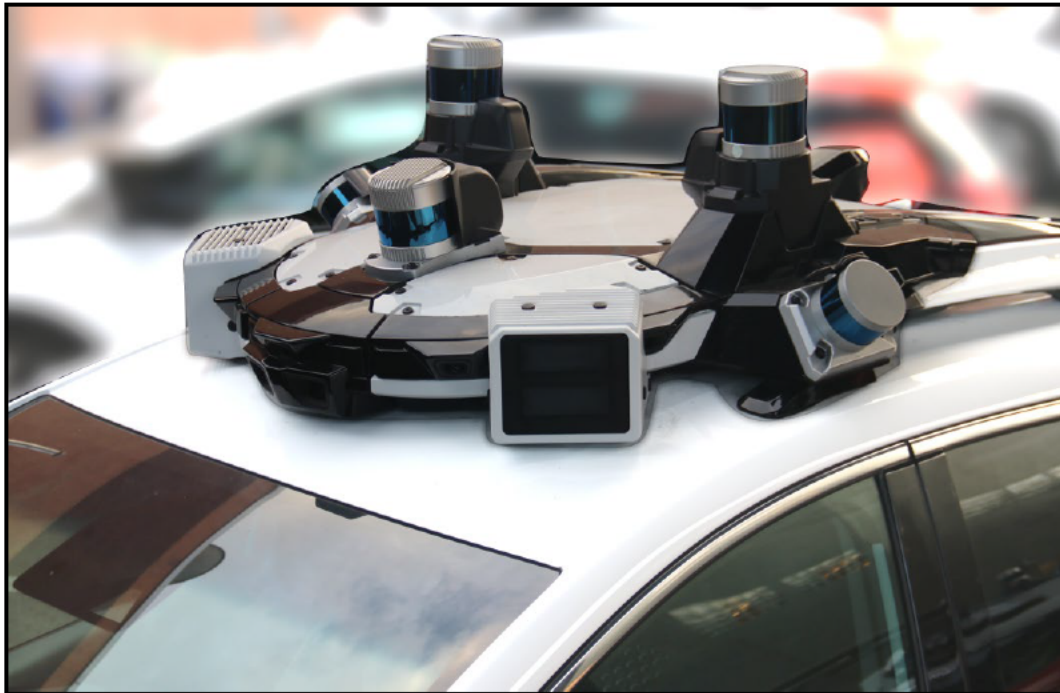
Figure 7. Roof mounted sensor array which includes lidars, cameras, and radars.
