**PUBLIC UTILITIES COMMISSION OF THE STATE OF CALIFORNIA**

**Resolution SED-7  
November 16, 2023**

**RESOLUTION SED-7 APPROVING ADMINISTRATIVE CONSENT ORDER  
AND AGREEMENT OF THE SAFETY AND ENFORCEMENT DIVISION  
AND PACIFIC GAS AND ELECTRIC COMPANY REGARDING THE 2021  
DIXIE FIRE PURSUANT TO RESOLUTION M-4846**

On July 13, 2021, at 0648 hours, the Pacific Gas and Electric Company (PG&E) received a Supervisory Control and Data Acquisition (“SCADA”) alert regarding the Buck Creek 1101 Circuit.<sup>1</sup> The alert indicated that there was an outage at Cresta Dam, which is serviced by Bucks Creek 1101 Circuit. PG&E dispatched a troubleman (Dixie Troubleman) to investigate, who arrived at the dam at 1218 hours. The Dixie Troubleman observed blown fuses located on a pole up the hill from Cresta Dam. The Dixie Troubleman did not identify the reason the fuses blew while at Cresta Dam. When the Dixie Troubleman arrived at the location of the fuses at 1650 hours, he observed two of the three fuses blown, a tree resting on the circuit down the hill from the fuses, and a small fire. The Dixie Troubleman attempted to fight the fire in addition to radioing for help. The California Depart

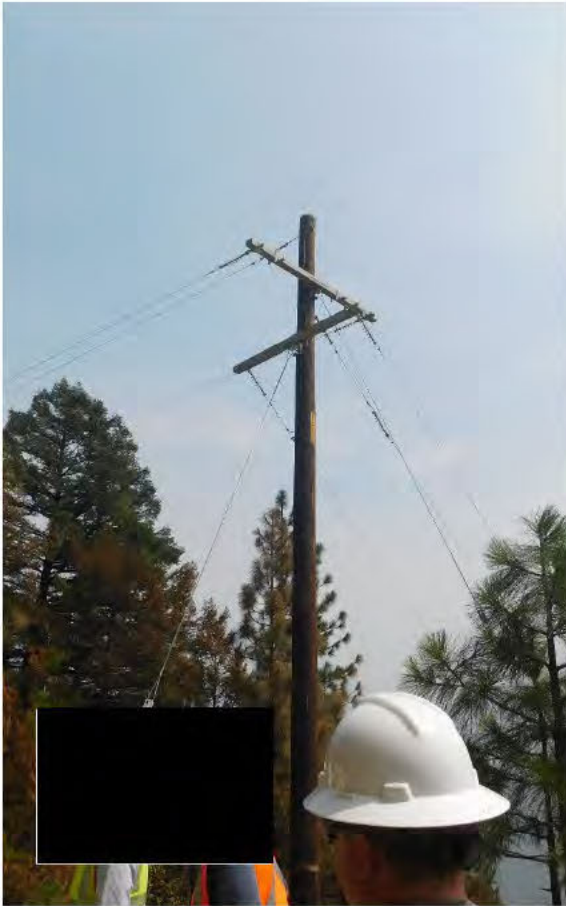
Figure 7: Pole 100403908. The fuse cutout and jumpers connecting the spans were removed by CAL FIRE.

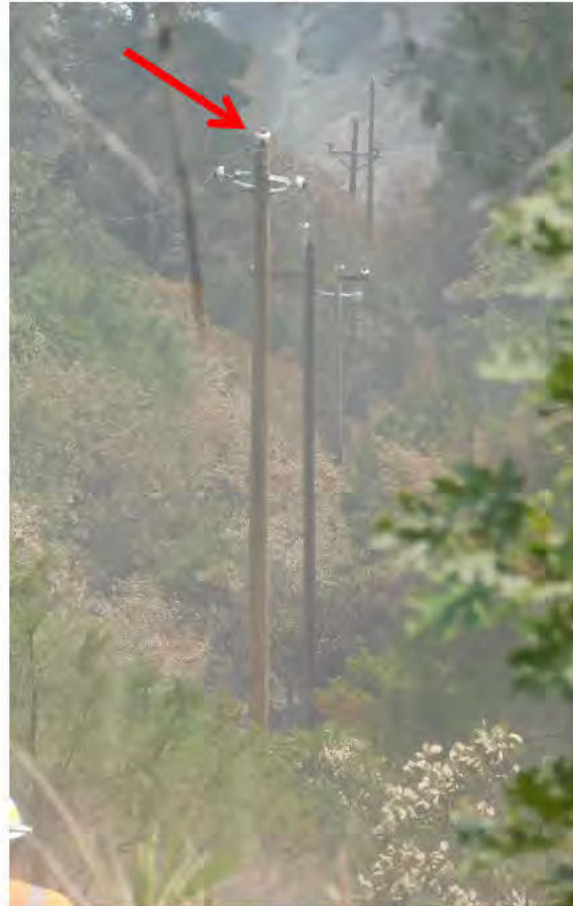
Figure 8: Pole 100403909 (red arrow) down a steep hillside with very loose soil. The incident occurred closer to Pole 100403909.

SED viewed Pole 100403909 and the surrounding area. Pole 100403909 appeared to be in sound condition and no obvious signs of fire were present. Copper insulators were observed near the pole where CAL FIRE had previously removed the conductor. CAL FIRE had previously collected a portion of the Subject Tree. The remaining portion of the tree was located near the pole (Figure 11 and Figure 12). The tree did not appear to be burned, and signs of ignition were not apparent on the tree.<sup>23</sup> There was a cluster of roots from the stump removed by CAL FIRE estimated to be 40 feet from Pole 100403909 (Figure 13). This root cluster was the base of the Subject Tree. The root shown in Figure 14 had a significant amount of rot at the center.

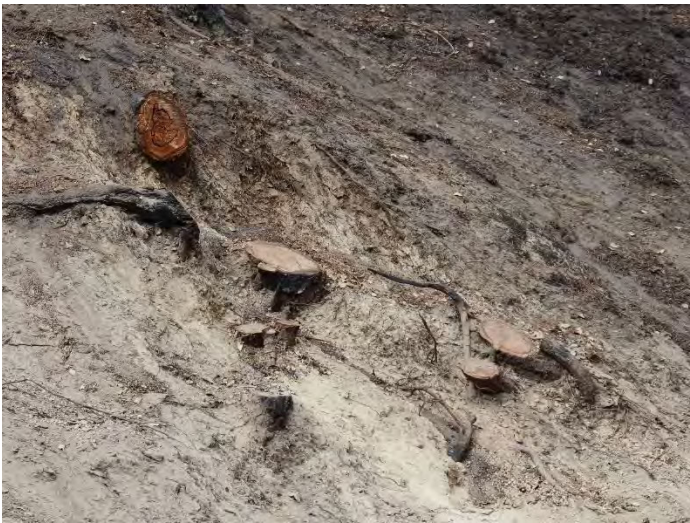
Figure 13: *Cluster of roots*

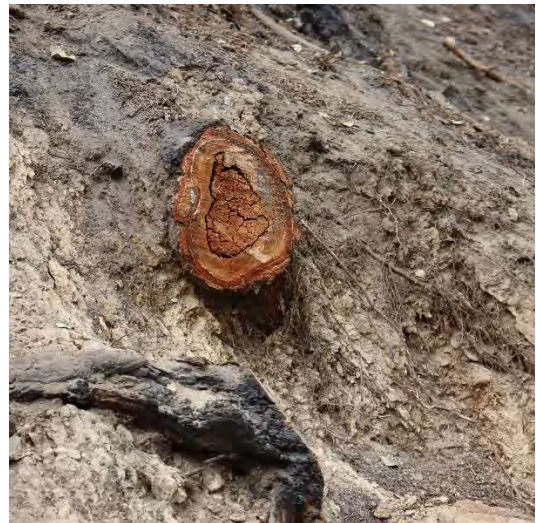
Figure 14: *Root showing significant rot*

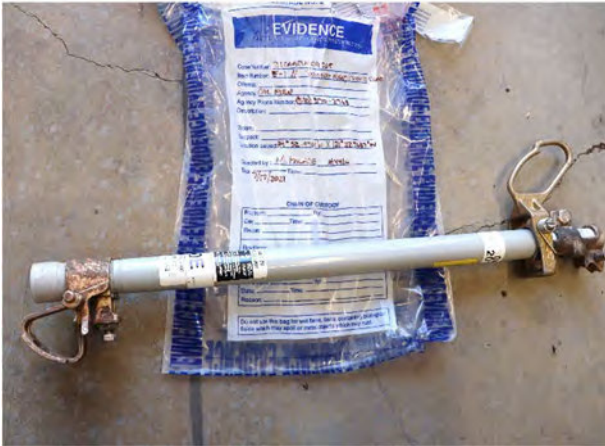
Figure 17: *One of two fuses that operated*

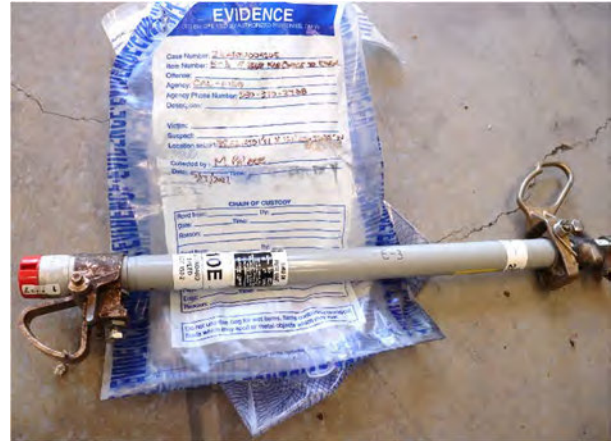
Figure 18: *Fuse that did not operate*

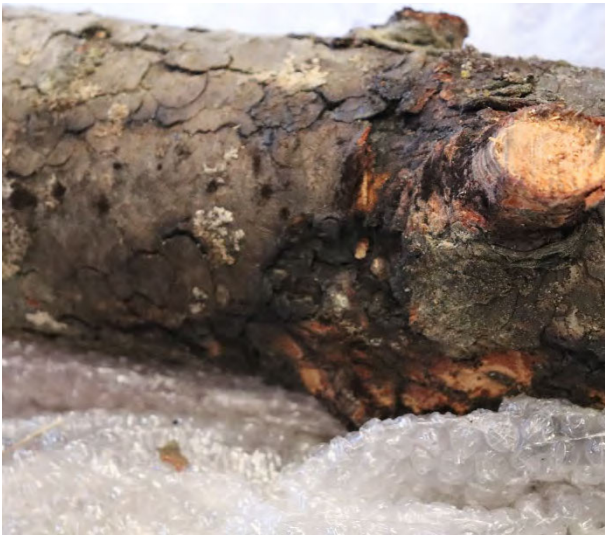
Figure 19: *Subject Tree trunk where energized conductor contacted tree.*

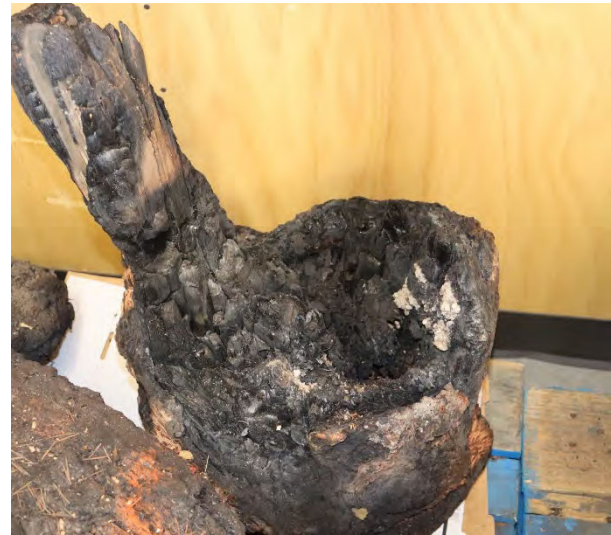
Figure 20: *Section of the Subject Tree trunk that failed causing the tree to fall.*

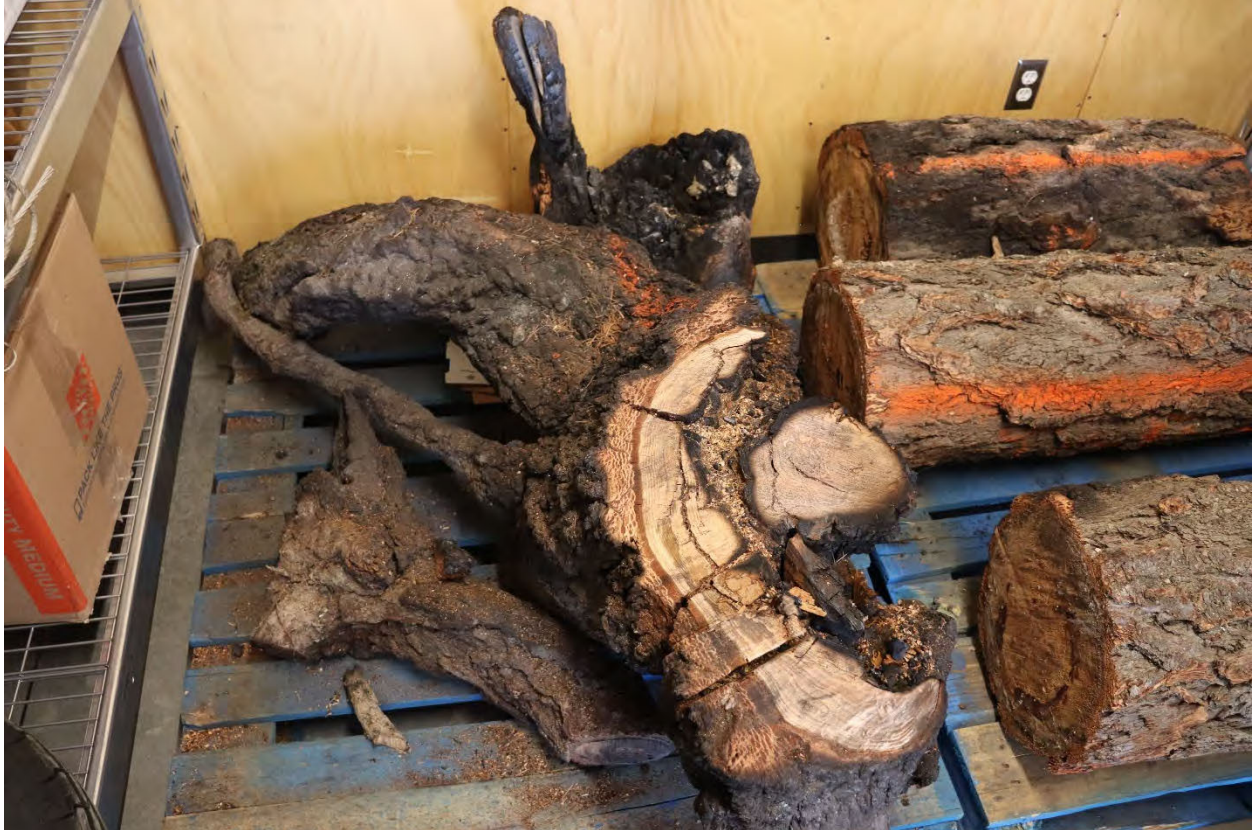
Figure 21: *Subject Tree stump. A large portion of tree trunk was damaged before the fire started.*

- Conductors
  - Multiple conductors showing signs of tree contact
  - Conductors typically had fibers from the tree embedded between the individual wires of the conductor (Figure 15).
  - Two conductors showing signs of arcing and phase-to-phase contact (Figure 16)
- Fuses (3)
  - Two fuses operated, one did not operate (Figure 17 and Figure 18)
  - The two fuses that operated appeared to have operated correctly.
- Fuse Cut Outs: No signs of misfiring fuses.
- Jumpers: No signs of arcing.
- Subject Tree
  - Burned portion of the trunk that was in contact with the energized conductor (Figure 19)
  - A tree limb that had folded up and contacted the energized conductor
  - Sections of the Subject Tree showing signs of decay. A segment of the tree where it broke off from the stump was severely burned (Figure 20).
  - Subject Tree stump with burn marks and decay (Figure 21).

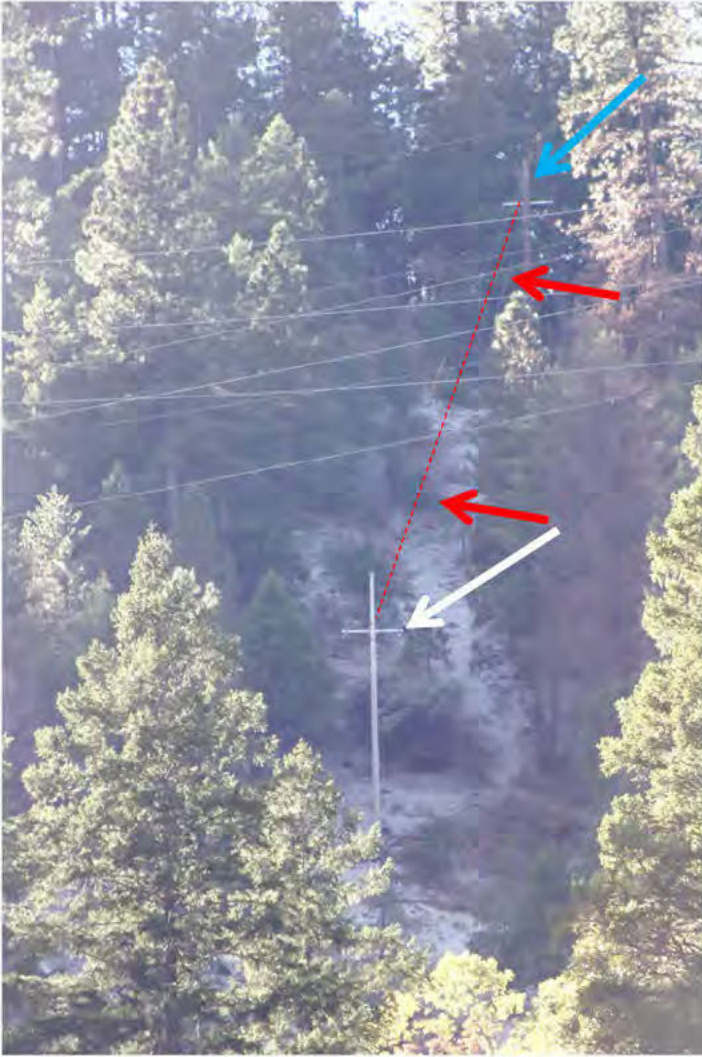
Figure 22: View of the line from Cresta Dam. The white arrow shows approximately where the tree fell adjacent to Pole 100403909. Pole 100403908 that supported the fuses is at the top of the hill (blue arrow). The cable PG&E installed between the two poles is the white line directly below and to the right of the dashed red line and is indicated by two red arrows.

From the CAL FIRE evidence locker in Oroville, SED representatives continued to Cresta Dam. The goal of the visit was to view, from the dam, the segment of the Bucks Creek Line where the fire originated.<sup>24</sup> Both Pole 100403909 that was closest to the fallen tree and Pole 100403908 that supported the fuses were visible from Cresta Dam without binoculars. With binoculars, features of the two poles and the line were easily distinguishable. SED observed that due to the positioning of the fuses, it would likely have been difficult to accurately determine how many fuses had blown. As of the date of the site visit, PG&E had not replaced the conductor between the two poles but had installed a single cable between the two poles. The cable was visible over the entire span between the two poles (Figure 22).

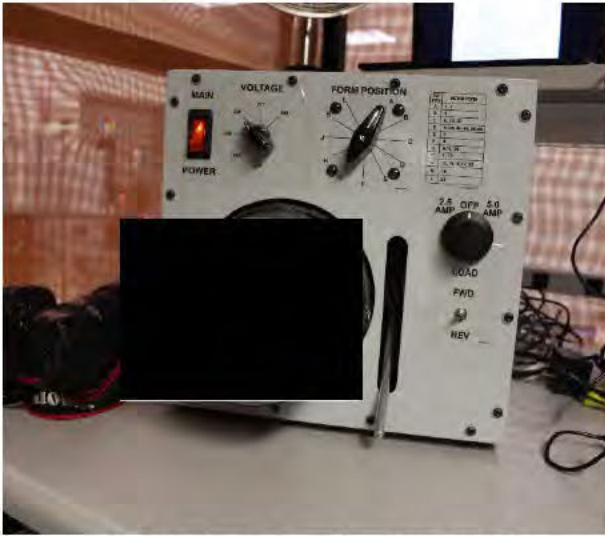
Figure 23: Machine downloading data from a SmartMeter

The purpose of the site visit was for PG&E to download data from SmartMeters collected for the investigations of the Dixie Fire and the Fly Fire. In total, four SmartMeters were collected for the Dixie Fire and eleven collected for the Fly Fire. A machine inside a faraday cage downloaded data from the SmartMeters (Figure 15).<sup>25</sup> Data was downloadable from all but two of the SmartMeters.<sup>26</sup> One of the two damaged SmartMeters, labeled Evidence Tag 7401 and collected for the Dixie Fire, had a melted plastic cover that prevented opening the device without potentially destroying the meter (Figure 24).

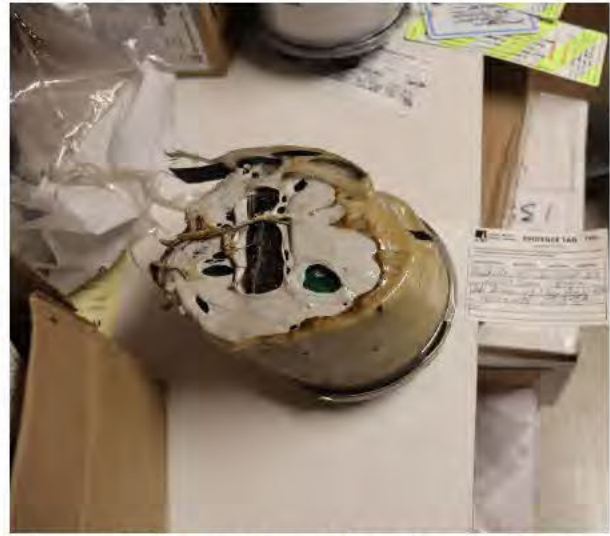
Figure 24: Melted SmartMeter from the Dixie Fire

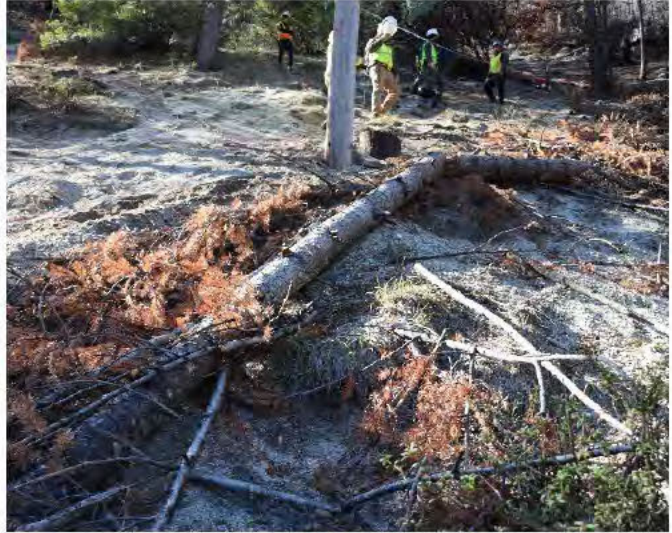
*Figure 26: Portion of the collected Subject Tree in situ*
