**Resolution SED-8
January 11, 2024**

**RESOLUTION SED-8 APPROVING ADMINISTRATIVE CONSENT ORDER
AND AGREEMENT OF THE SAFETY AND ENFORCEMENT DIVISION
AND PACIFIC GAS AND ELECTRIC COMPANY REGARDING THE 2021
DIXIE FIRE PURSUANT TO RESOLUTION M-4846**

Bucks Creek 1101 Area of Interest

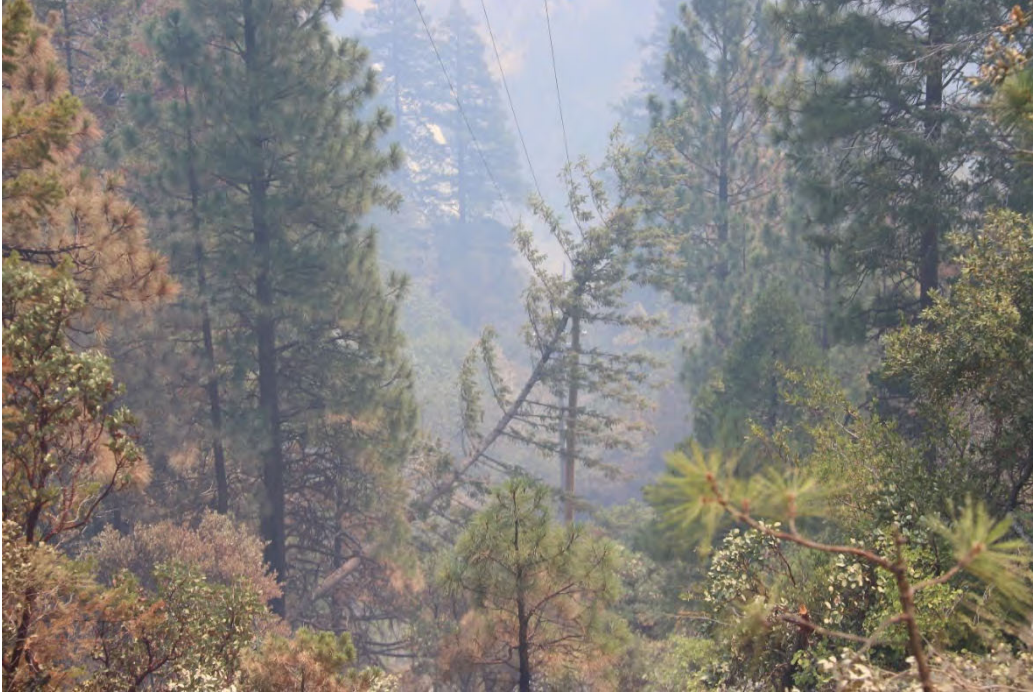
Figure 5: *Subject Tree leaning on the Bucks Creek 1101 circuit.*¹² *The photo was taken on July 18, 2021, standing near Pole 100403908 looking downhill toward Cresta Dam and Pole 100403909.*

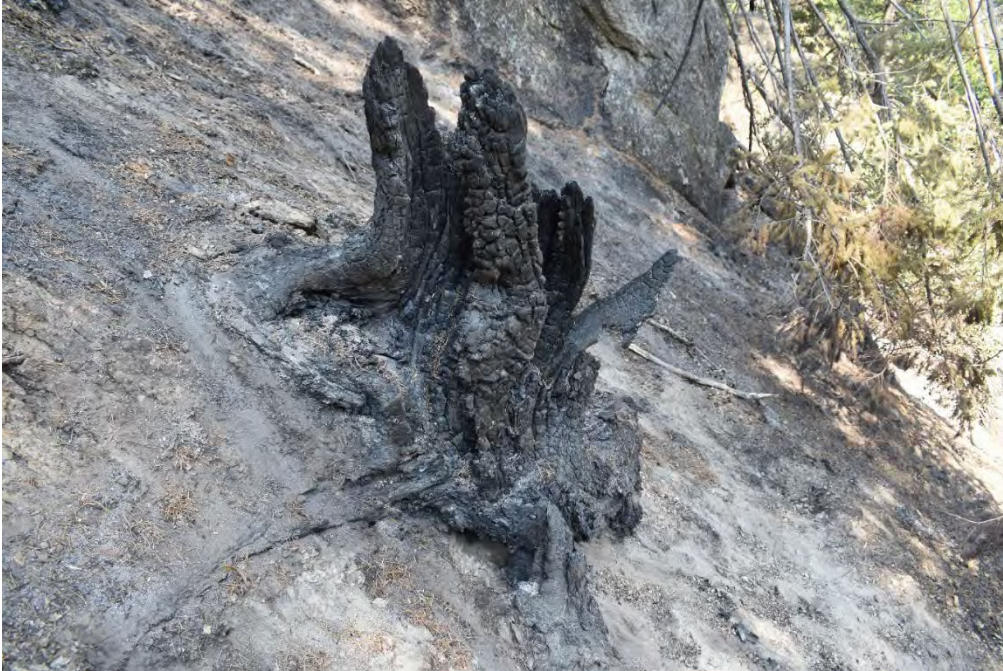
Figure 6: *Subject Tree stump*¹³

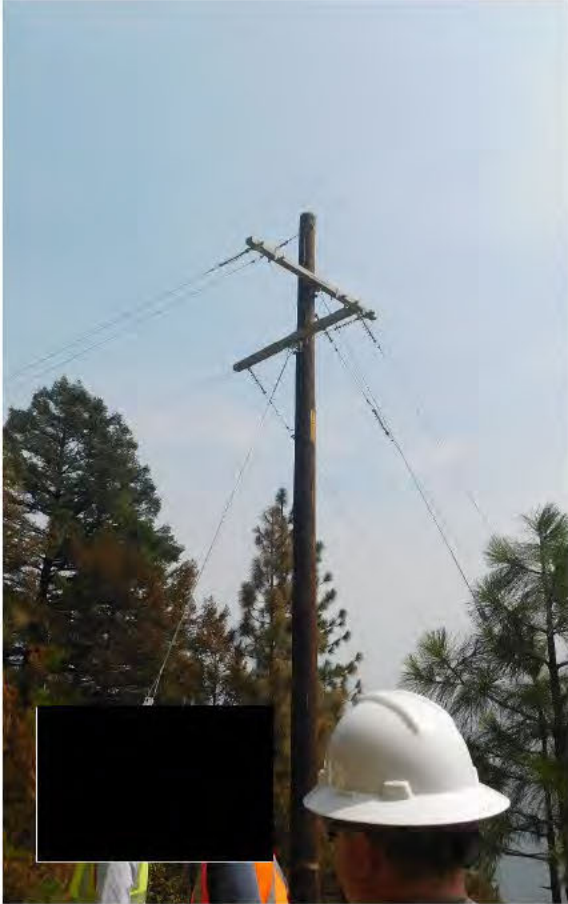
Figure 7: Pole 100403908. The fuse cutout and jumpers connecting the spans were removed by CAL FIRE.

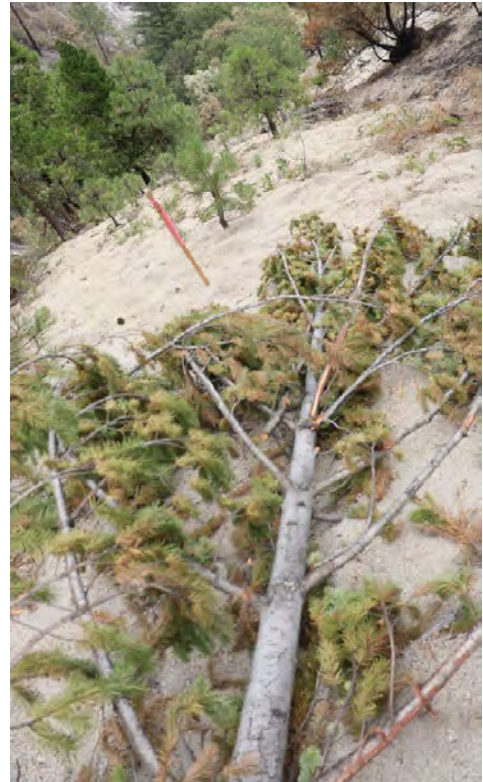
Figure 12: *Subject Tree*

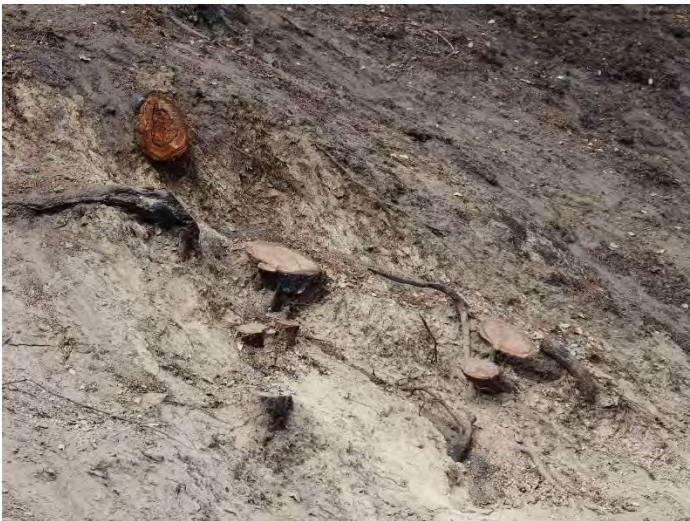
Figure 13: *Cluster of roots*

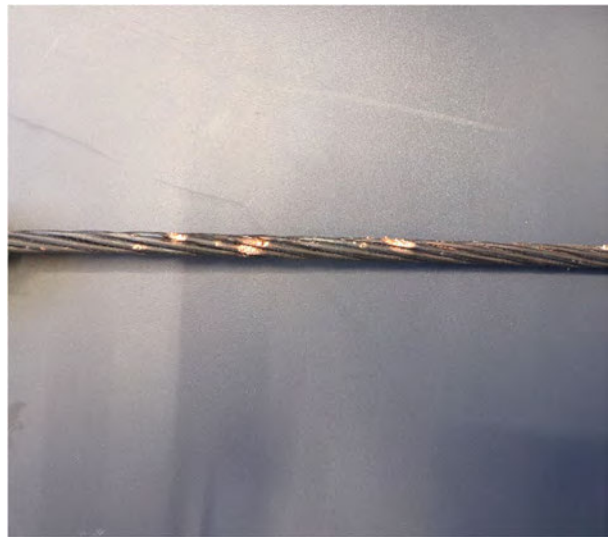
Figure 16: *Signs of arcing from phase-to-phase contact on conductor*

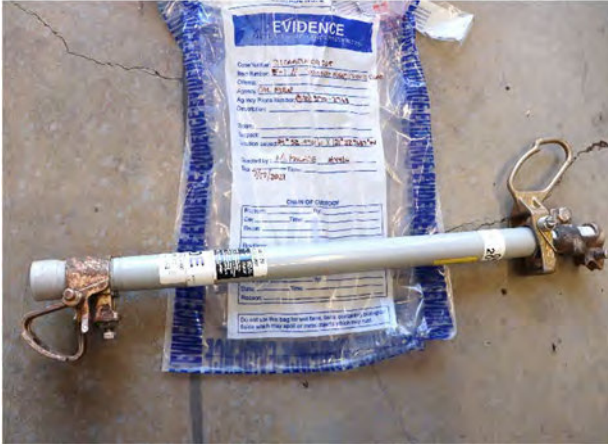
Figure 17: *One of two fuses that operated*

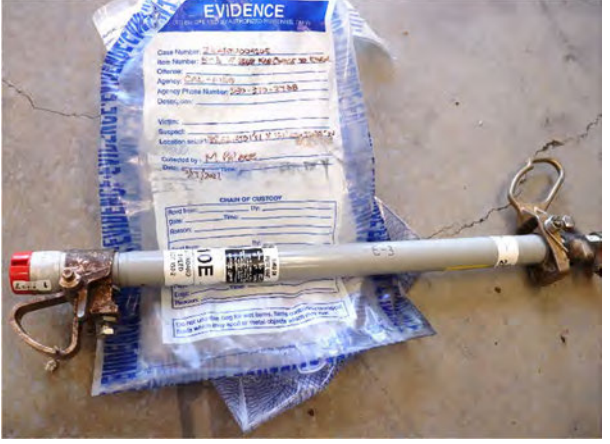
Figure 18: *Fuse that did not operate*

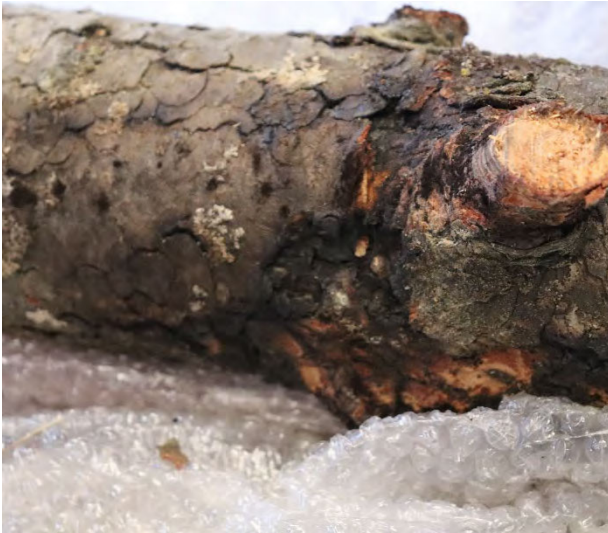
Figure 19: *Subject Tree trunk where energized conductor contacted tree.*

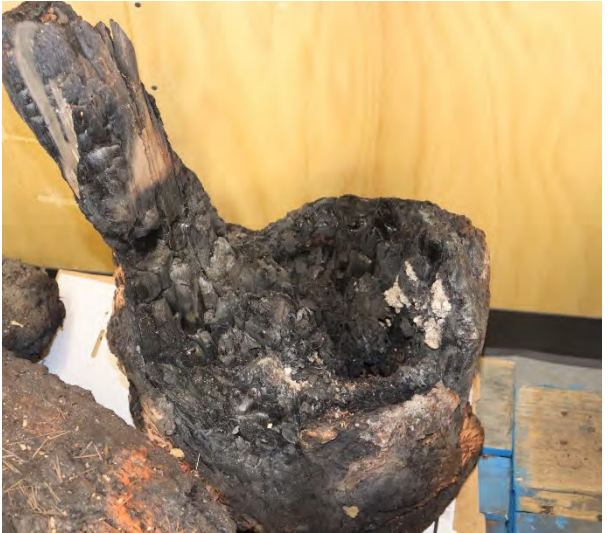
Figure 20: *Section of the Subject Tree trunk that failed causing the tree to fall.*

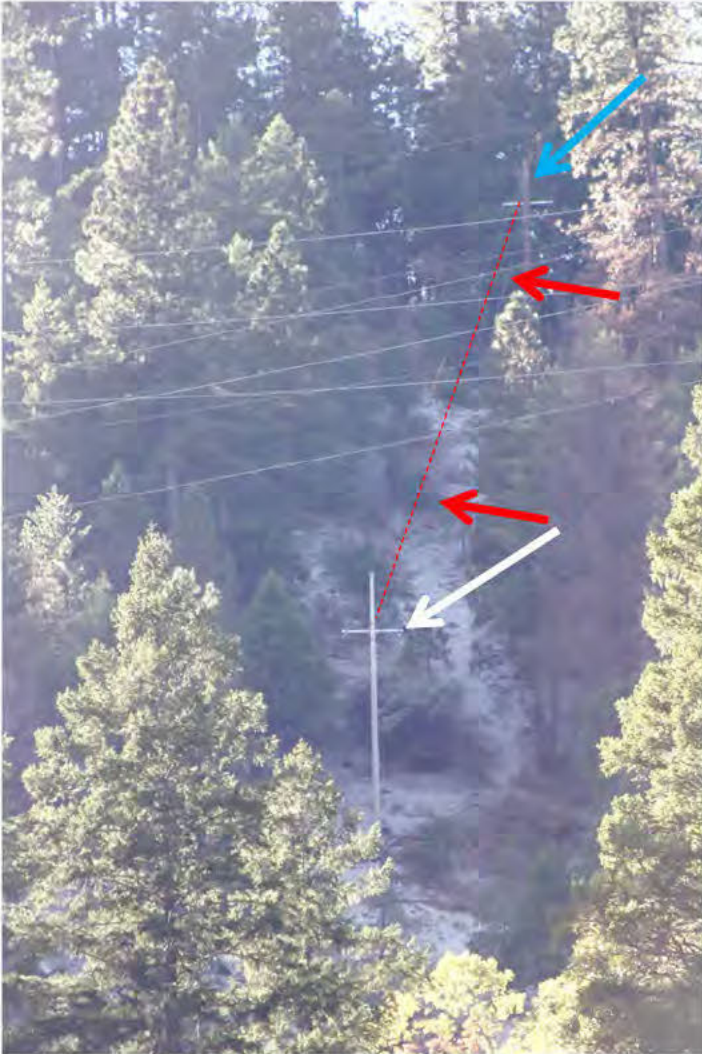
From the CAL FIRE evidence locker in Oroville, SED representatives continued to Cresta Dam. The goal of the visit was to view, from the dam, the segment of the Bucks Creek Line where the fire originated.²⁴ Both Pole 100403909 that was closest to the fallen tree and Pole 100403908 that supported the fuses were visible from Cresta Dam without binoculars. With binoculars, features of the two poles and the line were easily distinguishable. SED observed that due to the positioning of the fuses, it would likely have been difficult to accurately determine how many fuses had blown. As of the date of the site visit, PG&E had not replaced the conductor between the two poles but had installed a single cable between the two poles. The cable was visible over the entire span between the two poles (Figure 22).

Figure 22: View of the line from Cresta Dam. The white arrow shows approximately where the tree fell adjacent to Pole 100403909. Pole 100403908 that supported the fuses is at the top of the hill (blue arrow). The cable PG&E installed between the two poles is the white line directly below and to the right of the dashed red line and is indicated by two red arrows.

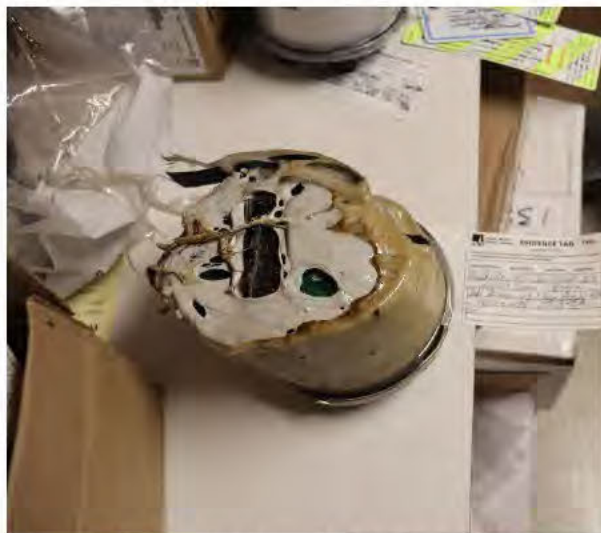
The purpose of the site visit was for PG&E to download data from SmartMeters collected for the investigations of the Dixie Fire and the Fly Fire. In total, four SmartMeters were collected for the Dixie Fire and eleven collected for the Fly Fire. A machine inside a faraday cage downloaded data from the SmartMeters (Figure 15).²⁵ Data was downloadable from all but two of the SmartMeters.²⁶ One of the two damaged SmartMeters, labeled Evidence Tag 7401 and collected for the Dixie Fire, had a melted plastic cover that prevented opening the device without potentially destroying the meter (Figure 24).

Figure 24: Melted SmartMeter from the Dixie Fire

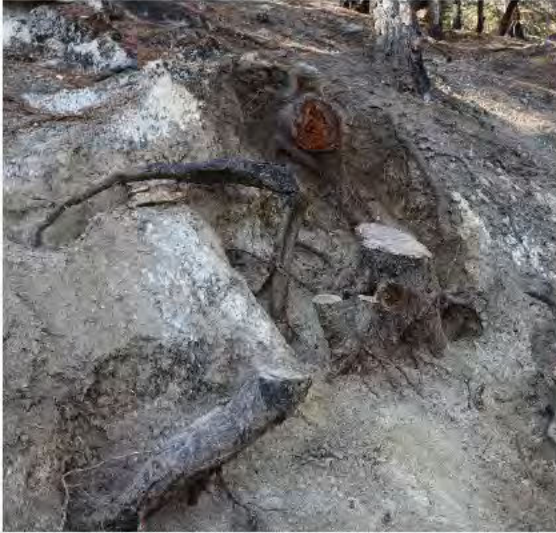
Figure 25: *Root structure dug out by PG&E contracted tree workers.*

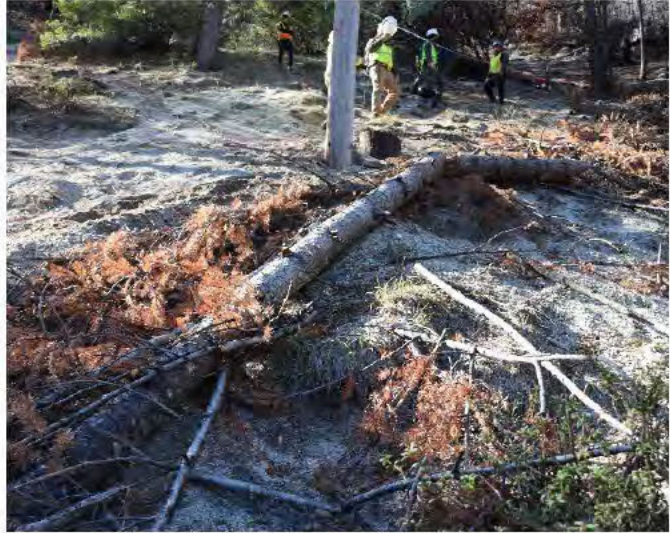
Figure 26: *Portion of the collected Subject Tree in situ*

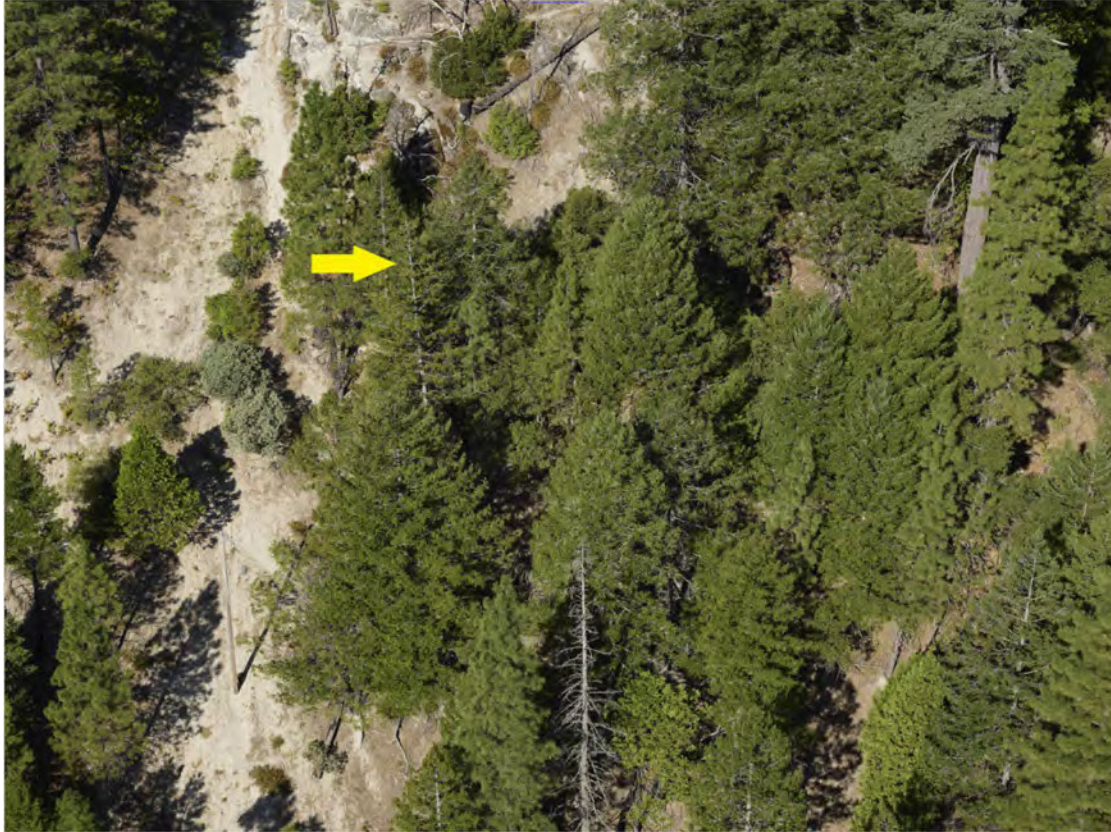
Figure 27: *The yellow arrow points to the tree that fell on the circuit and started the Dixie Fire.*⁷³
